# Inspection Report

## Building Inspection

This report Complies with Australian Building Standards AS 4349.1-2007. Inspection of Buildings Part 1: Pre- Purchase Inspections-Residential Buildings- Appendix "C"

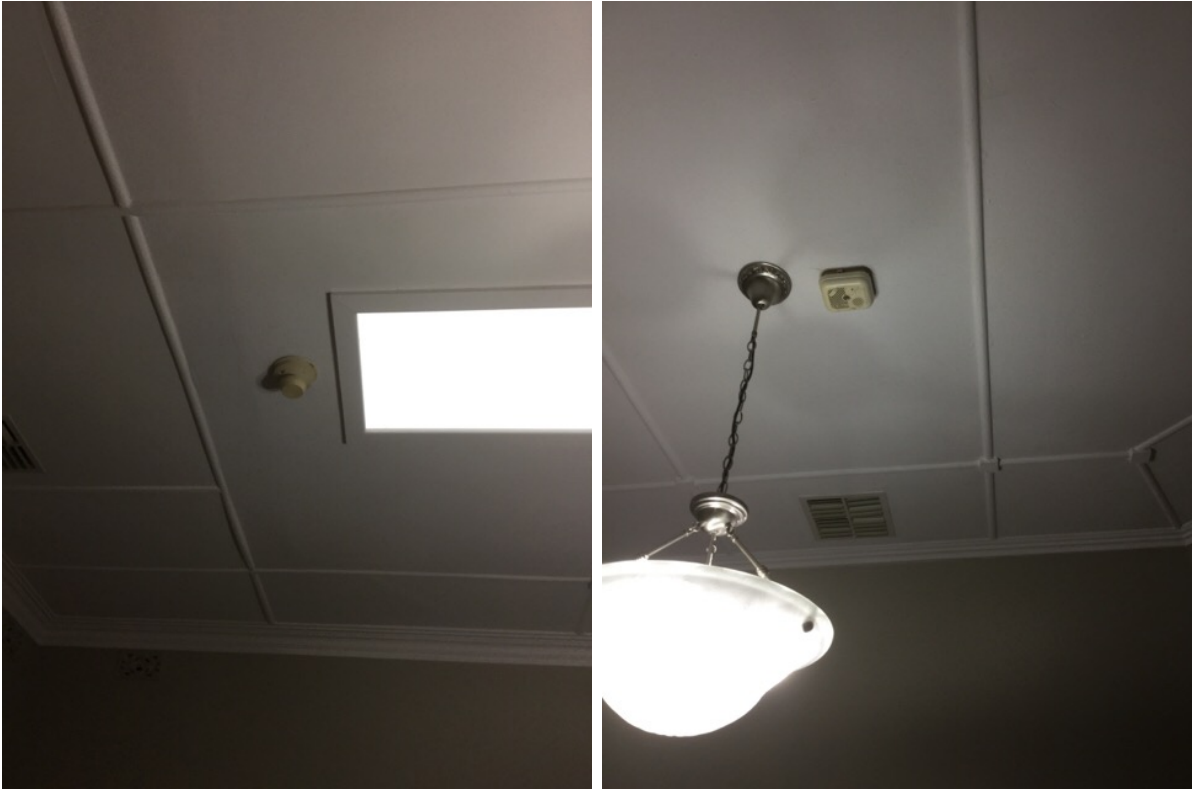
Need hard wired smoke alarm within 1.5m from bedrooms.

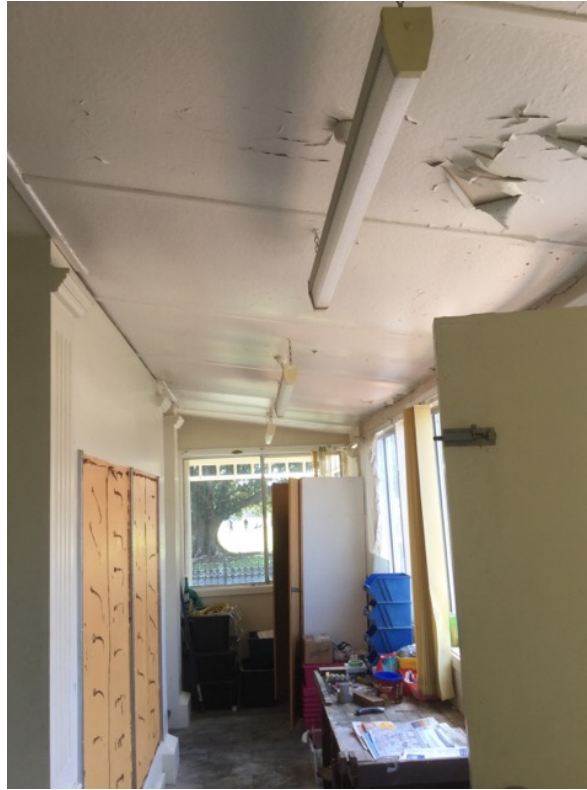
Ceilings sagged, paint peeling windows leaking, moisture in walls high.

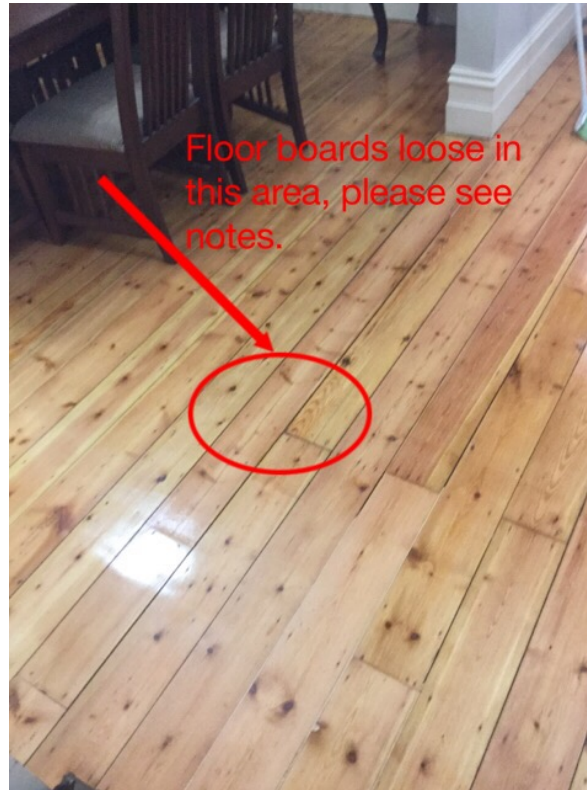
Timber floor boards loose under arch, ensure not caused by white ants or rot. No activity present at time of inspection.

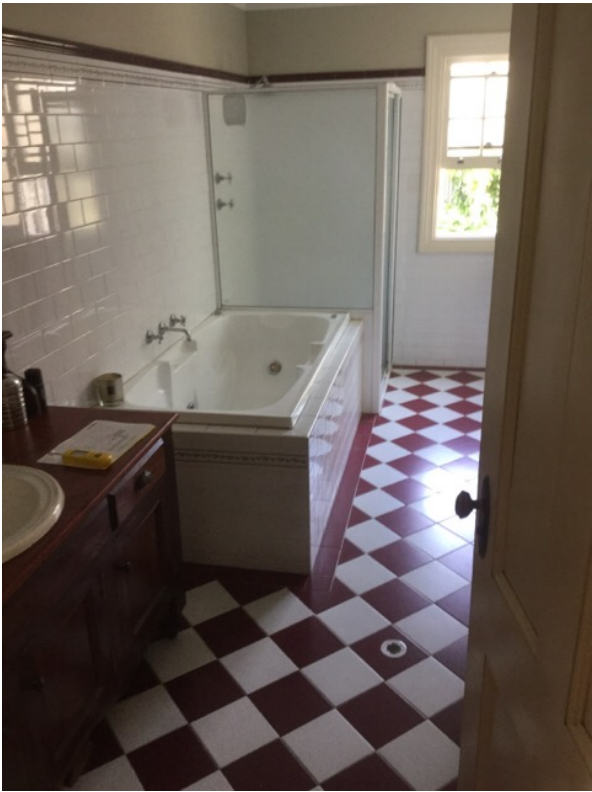
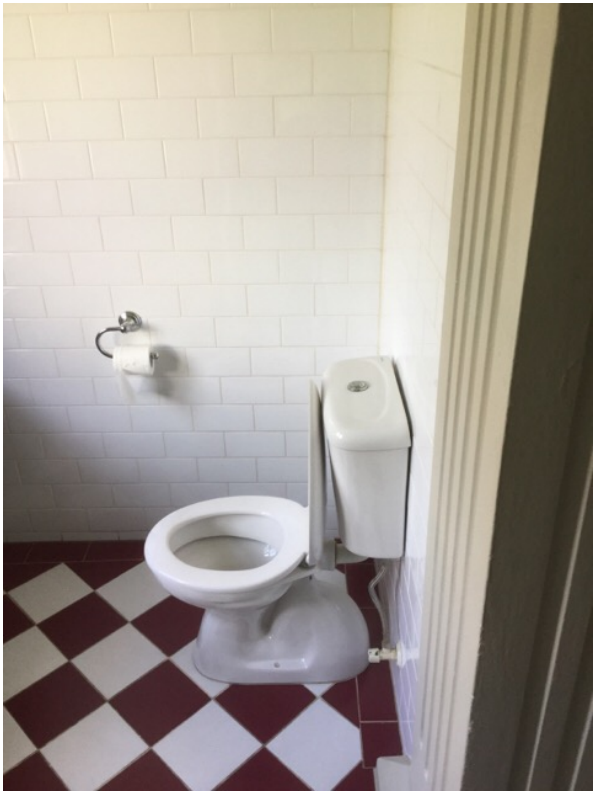
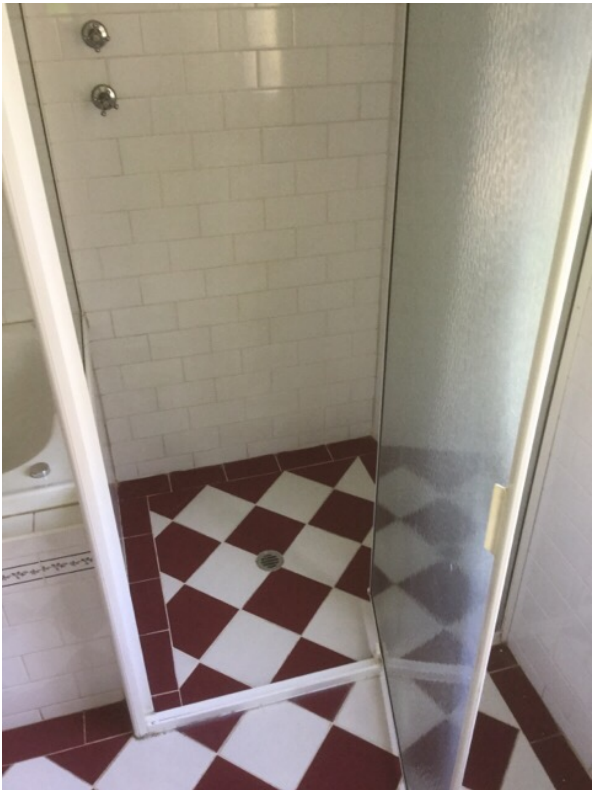
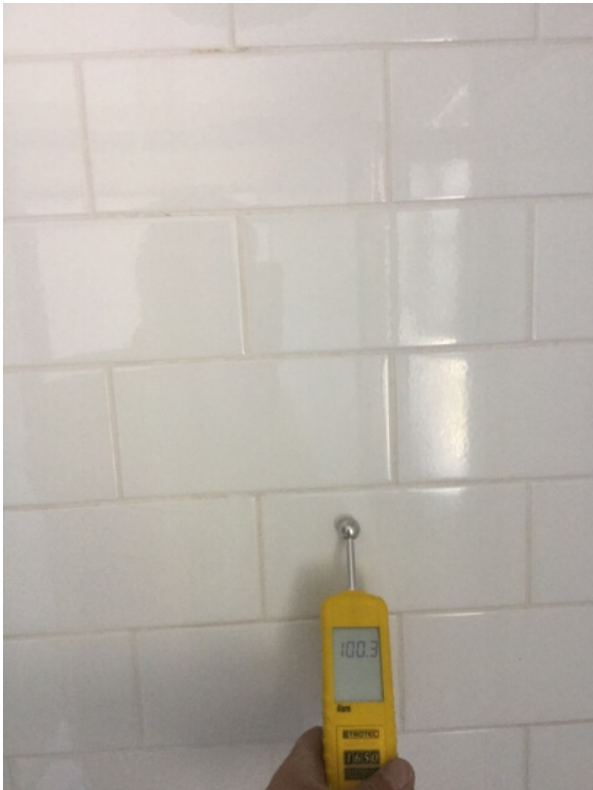
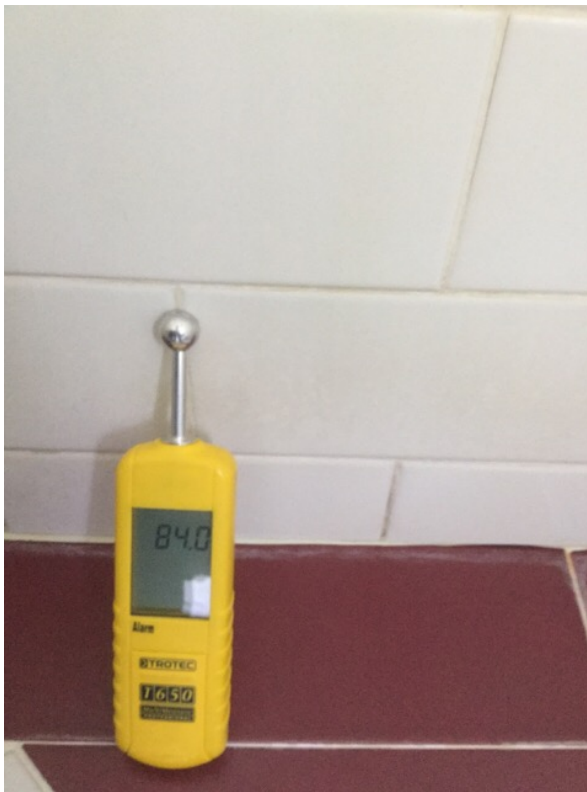
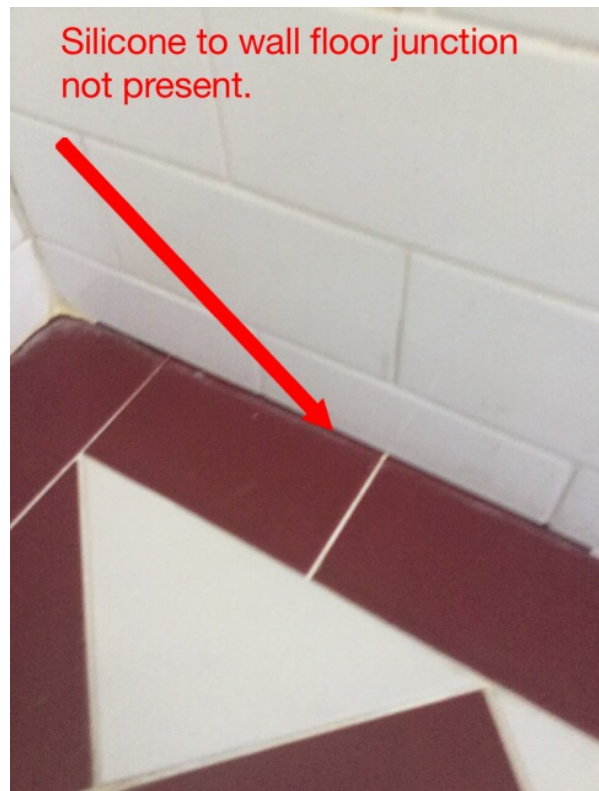
Very high moisture readings, all walls of shower silicone missing and or deteriorated.  
Recommend re silicone, seal, grout and monitor.  
Static shower head leak test also recommended.

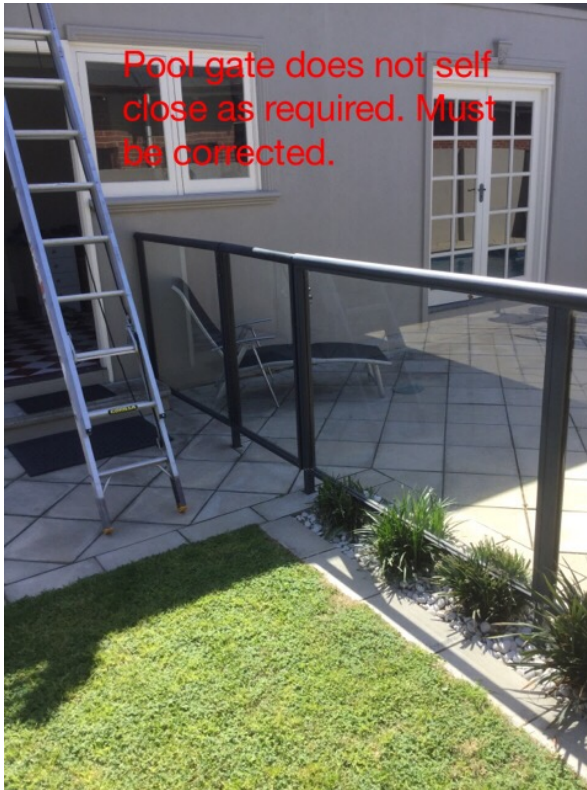
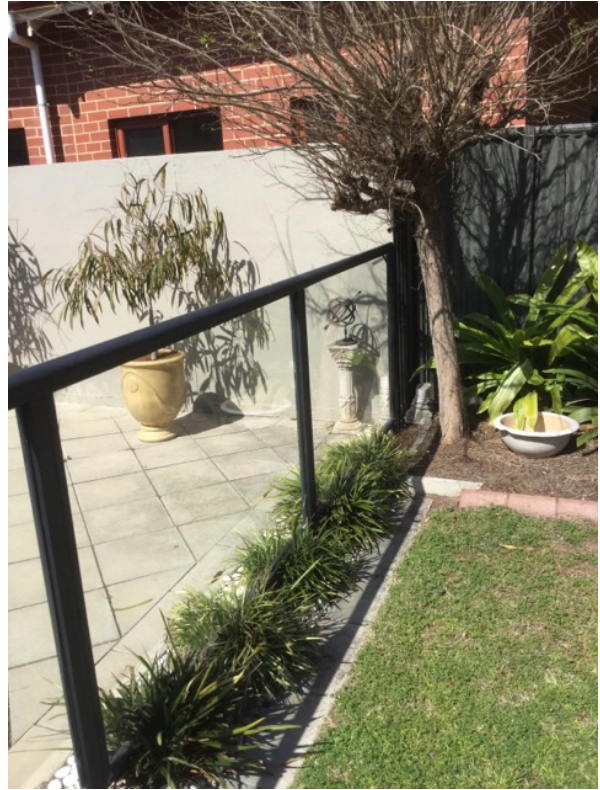
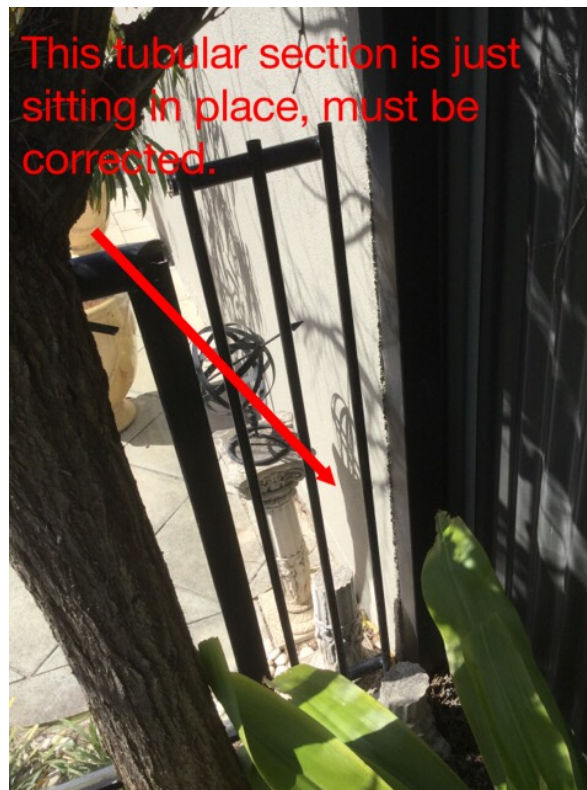
A swimming pool is present but the pool fence appears inadequate. The gate is not closing and latching as it should. This should be repaired The pool fence should be checked for compliance with safety regulations. Considered safety Hazard

A swimming pool is present but the pool fence appears inadequate. The pool fence should be checked for compliance with safety regulations. Considered a Safety Hazard

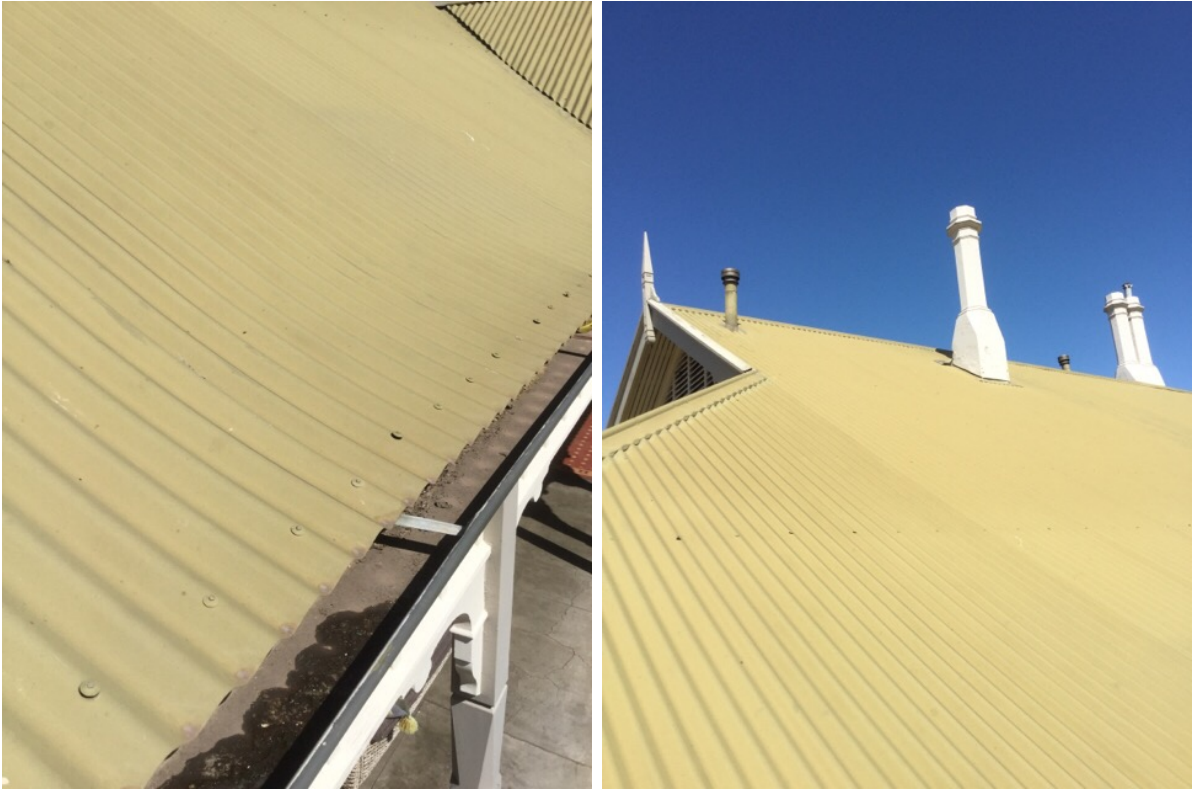
Some spots of moss, which will cause rust evident on Southern side.

Nail fixings lifting in some spots mainly along the lowest fixing on the verandah edge beam.

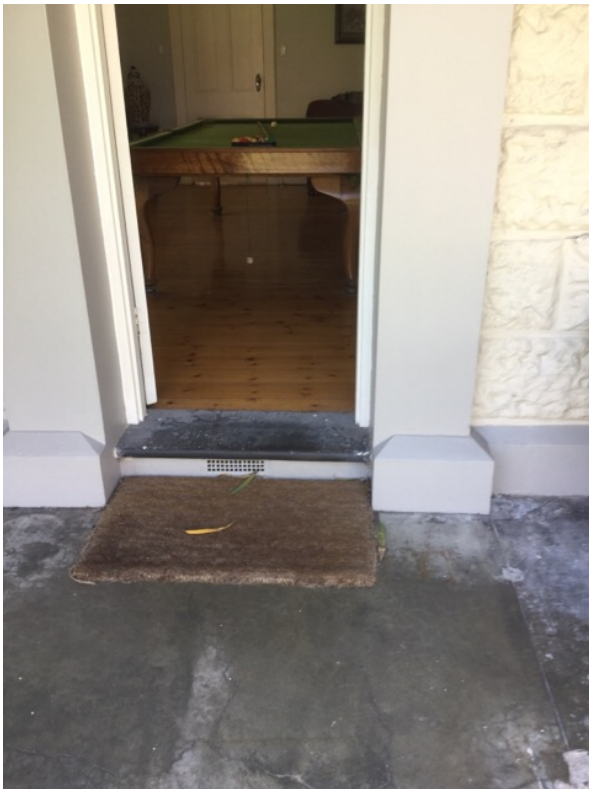
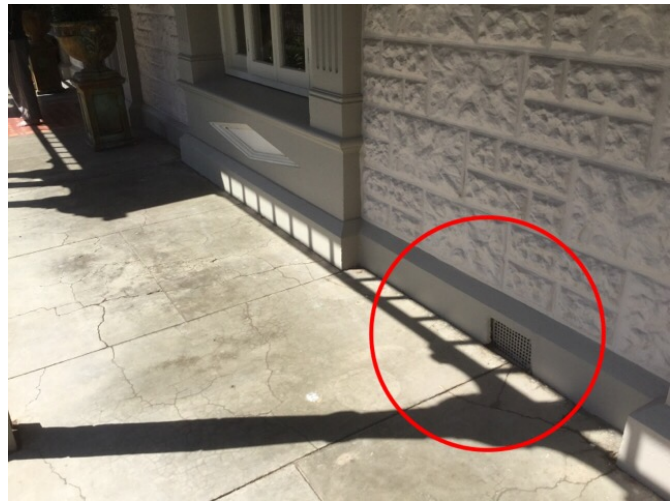
The majority of the vents are unobstructed however the topping slab is slightly higher than the bottom of the vents on the porch. This may cause water to run into the subfloor.

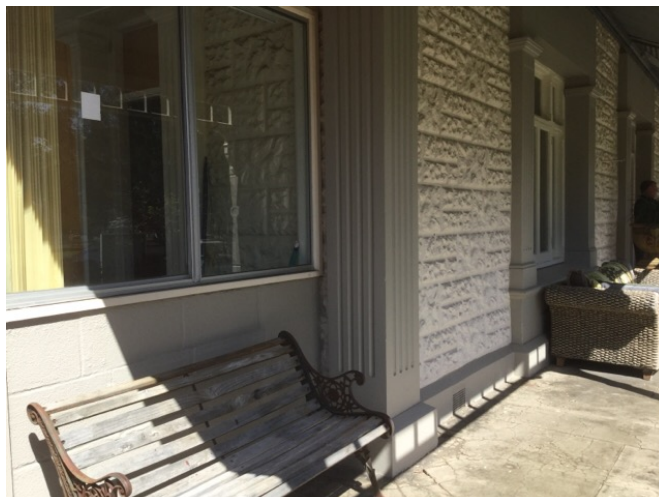
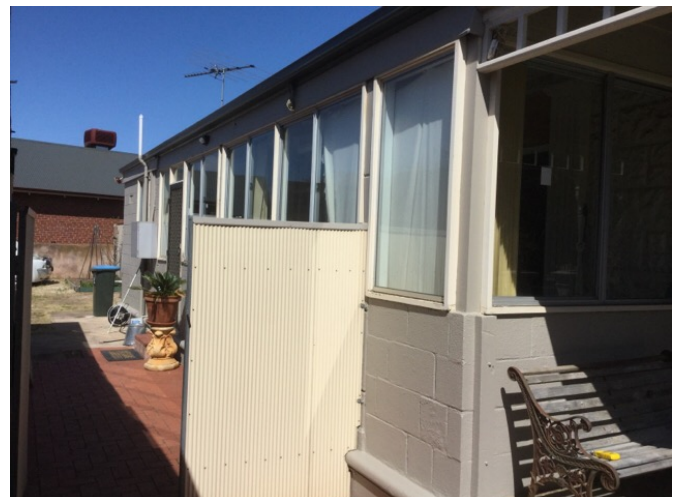
Path moisture content around 90% at time of inspection, however highest reading in walls was 66% most around 45%.

High moisture readings were present in the Besa Block exterior walls to North West corner. We recommend a damp proof course specialist be engaged for further evaluation and repairs.

Average moisture readings of 97% in the 2 lowest blocks.

A damp proof course is not visible or could not be visually identified. This may cause rising damp issues. Contact a damp proof course specialist to further investigate and make recommendation.

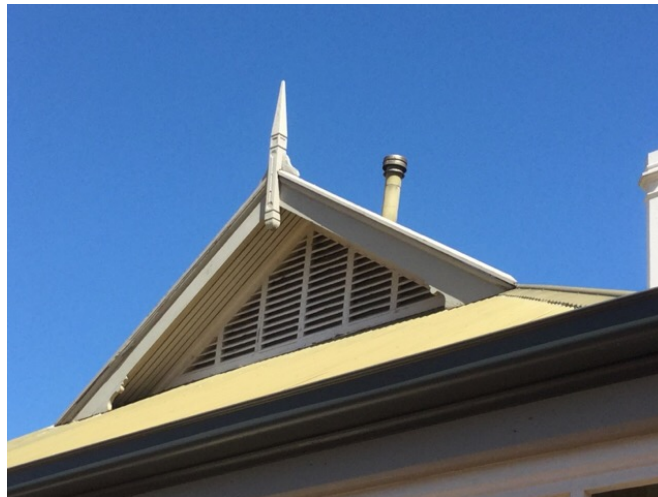
Minor eave deterioration & ageing evident. Recommendations: Maintenance works, general upkeep should be carried out.

We strongly recommend you re-finish and paint the eaves and timber trim to preserve same.

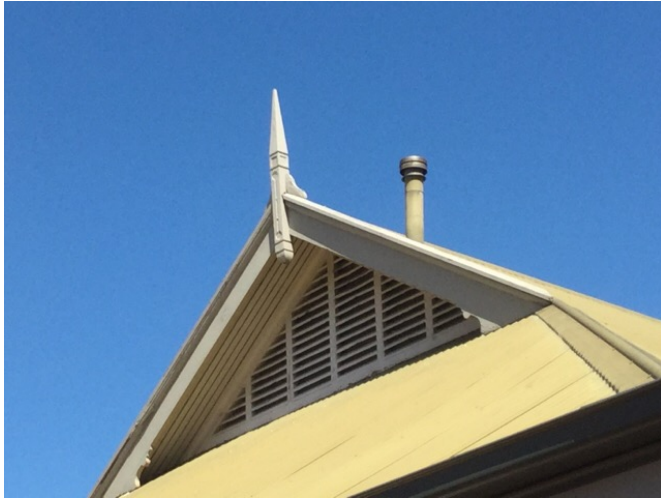
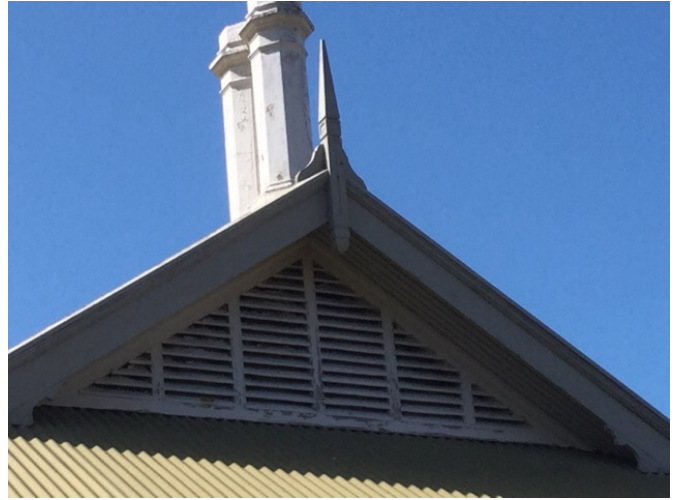
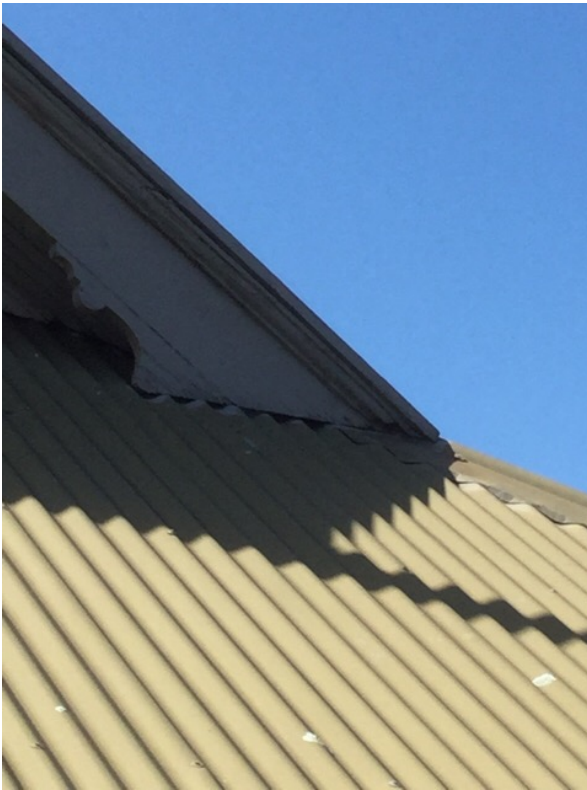
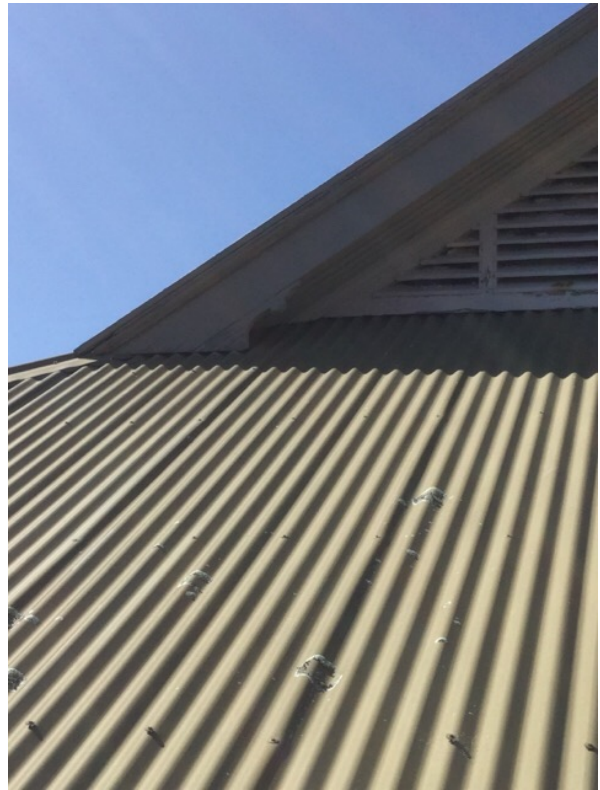
Minor deterioration & ageing evident. Recommendations: Maintenance works, general upkeep should be carried out.

Paint / finish was deteriorated in areas and is in need of maintenance - Sanding back affected areas and painting required.

Timber decay (rot) visible. Recommendations: A qualified carpenter should be engaged to replace all affected timbers.

Low level timber work has been painted, all timber on roof ie. Barges verges gable vent need maintenance and painting.

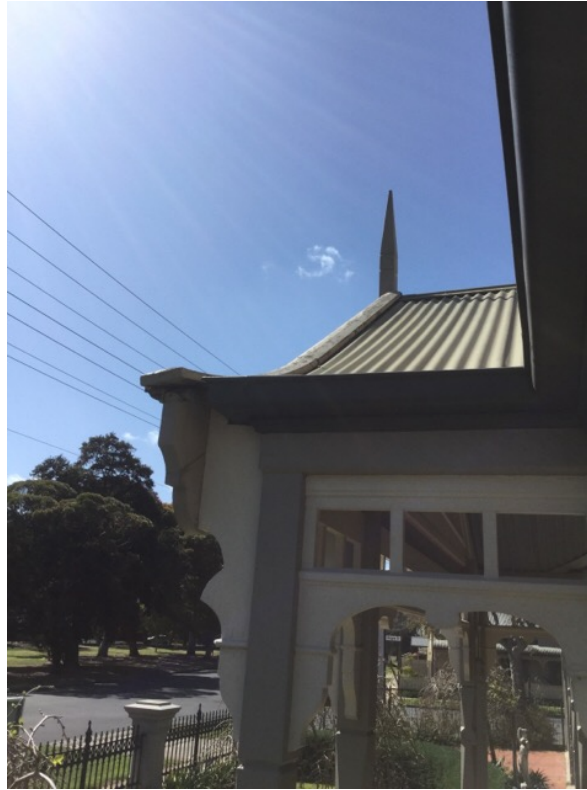
Timber work needs maintenance / painting etc.

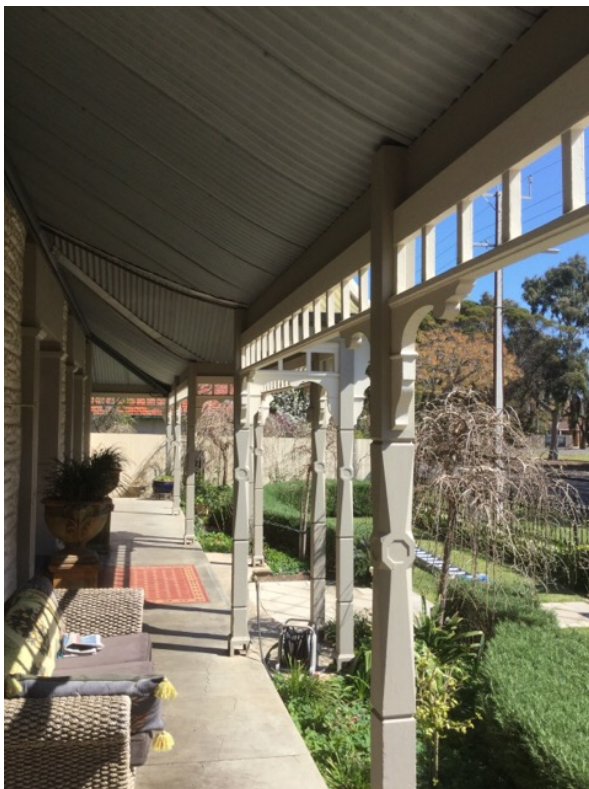
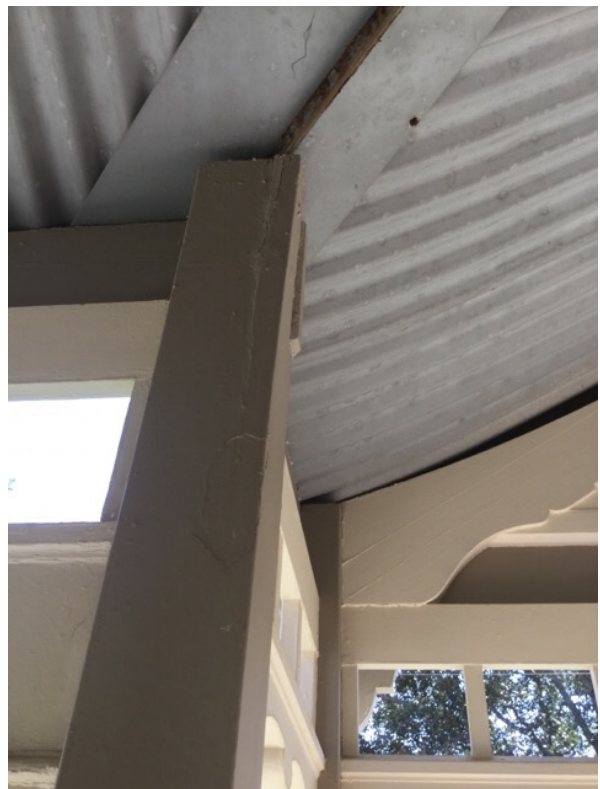
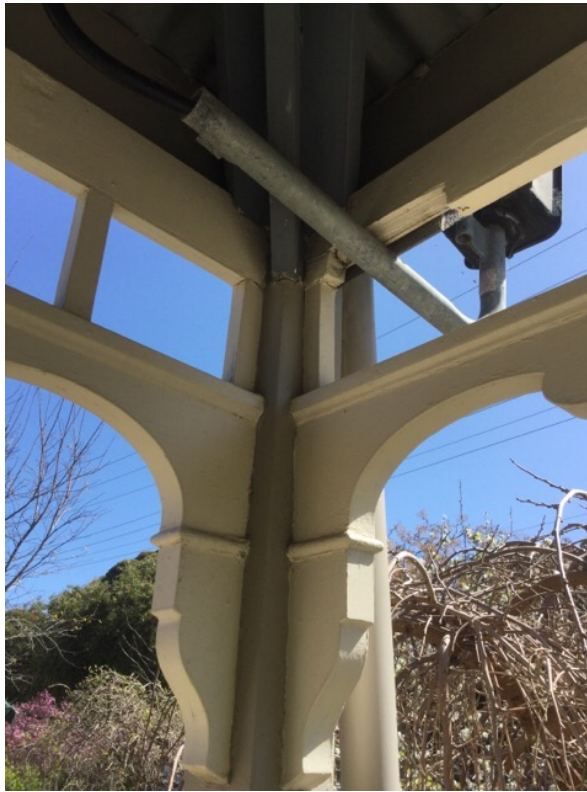
It appears rot has been repaired and painted, at time of inspection all appear ok, monitor over time, if repairs inadequate this may need to be looked at in the future.

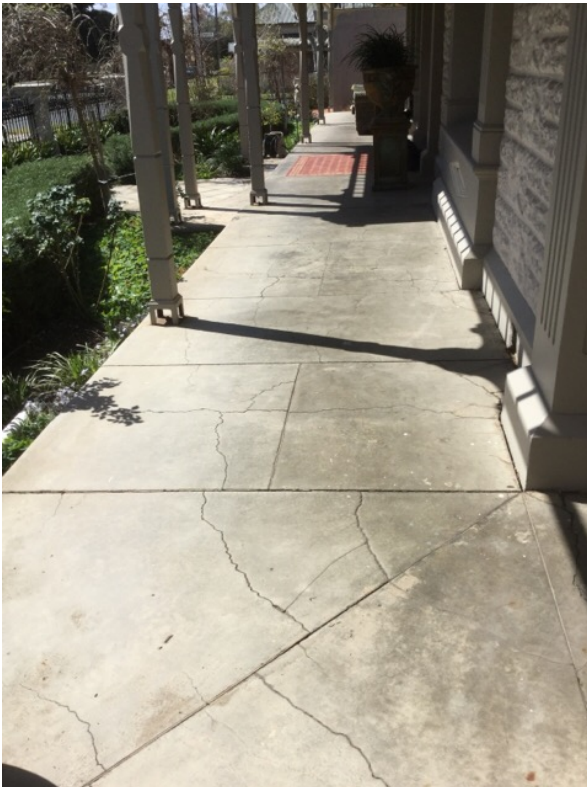
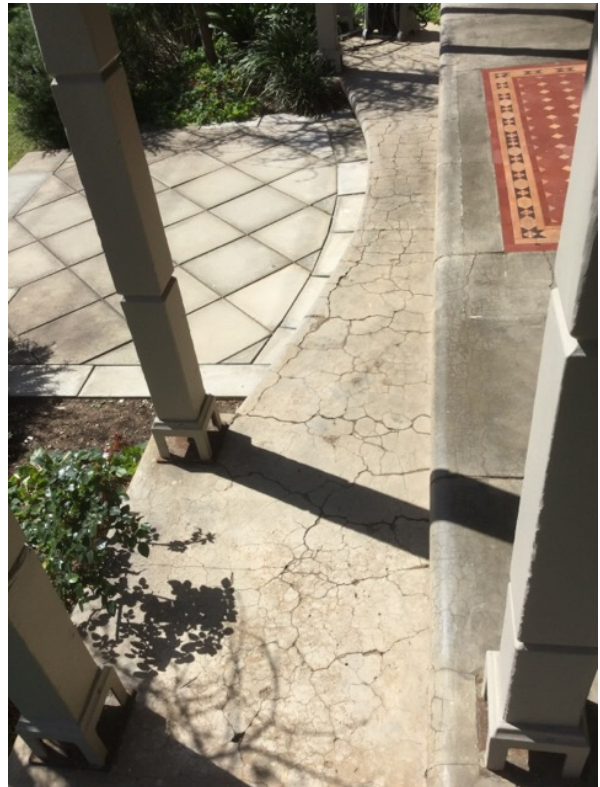
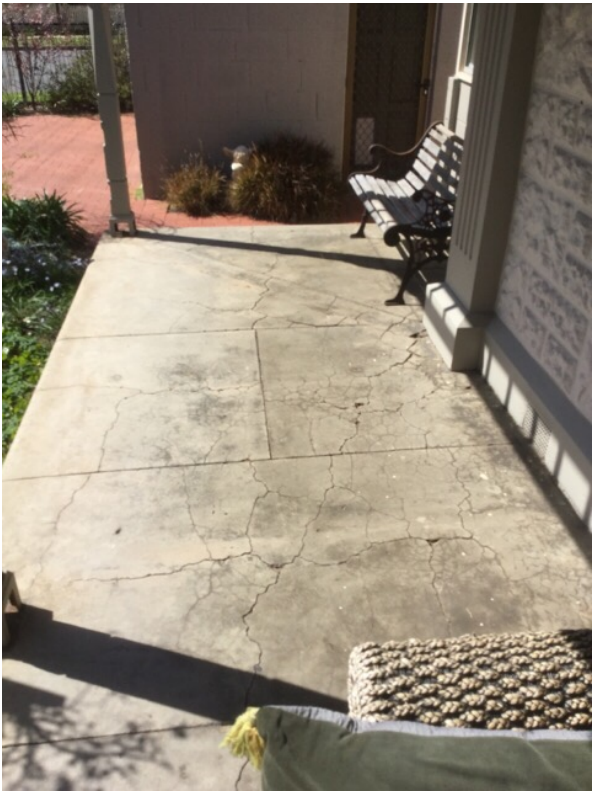
Concrete to the porch flooring is cracked throughout. Some of these cracks are wide and may require major works and further evaluation. I suspect this is a topping slab, Contact a concreter for repairs.
