Parts Quality Initiative (PQI) Archive

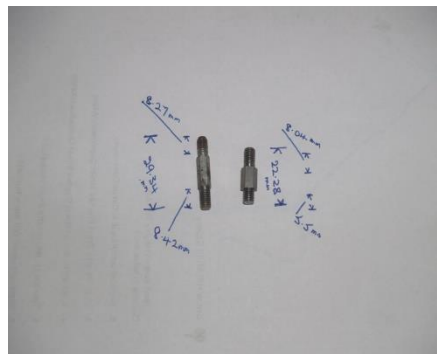
October: Incorrect windscreen wiper mounts – supplier amended their products to suit.

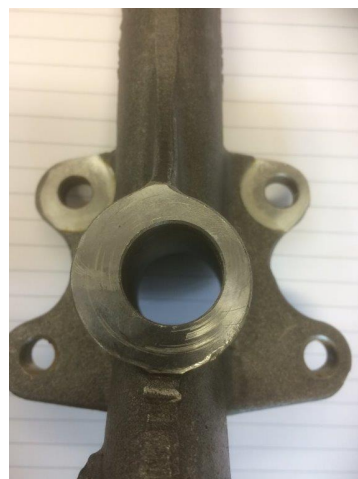
October: Vertical link quality – supplier rectified the issue.

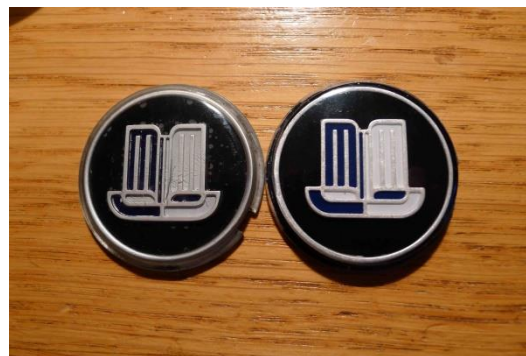
November: TR4/4A horn push poor fit – owner solved the problem himself.

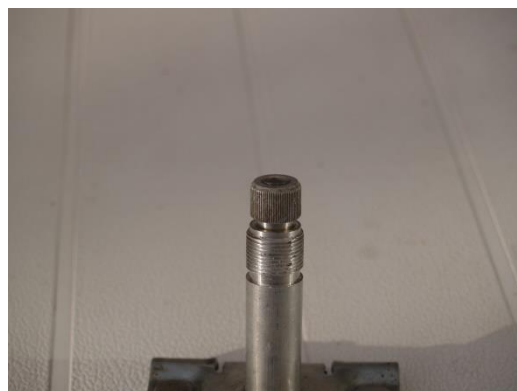
December: Wiper spindle quality – problem solved by owner and their restorer.

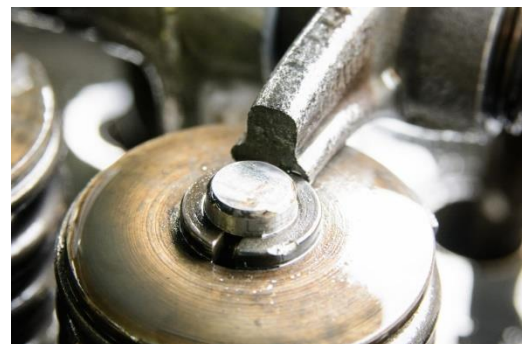
November: TR3 rocker arm – after investigation thought to be a one off rogue part.

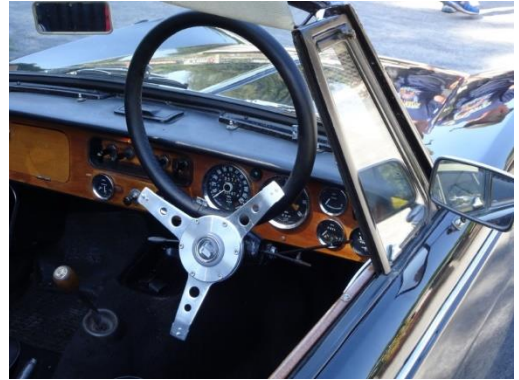
June: Mountney steering wheel failed – suppliers advised.

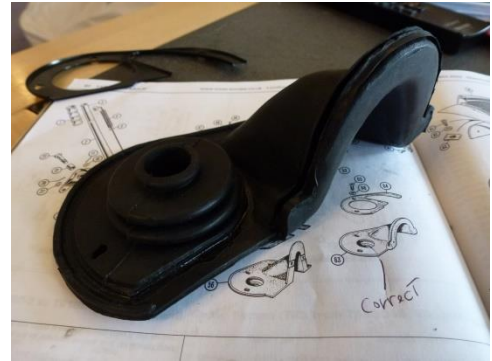
July: TR4 handbrake gaiter – resolved.

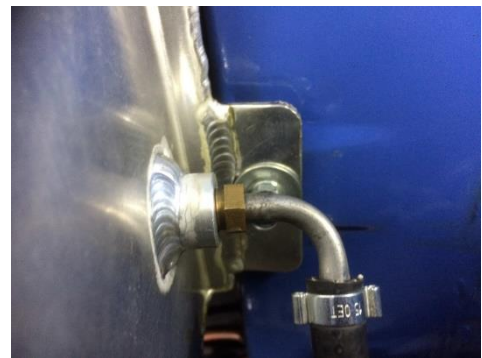
August: TR6 alloy fuel tank mountings cracked, tank was 4 years old and out of warranty – improved design sourced.

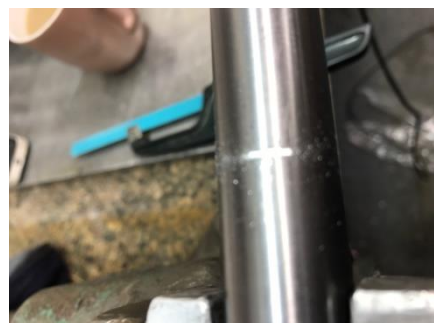
April: Gearbox layshaft not hardened – old stock carry over from known problem, supplier resolved and all faulty stock removed.

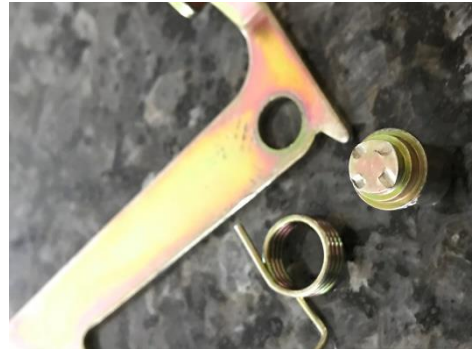
July: TR bonnet catch poor repro quality – various suppliers advised, and major supplier will improve design.

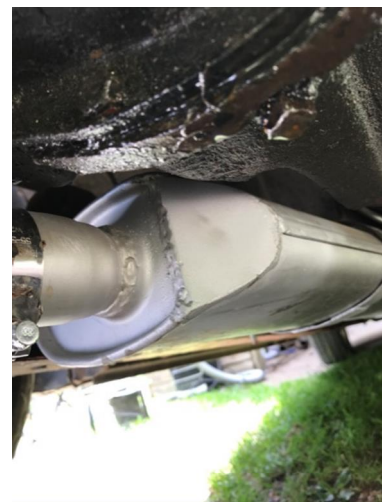
December: TR2-4 rear silencer incorrect – supplier will correct issue.
