Residential Inspection Report

January 8, 2019

123 IBM St NW
Rochester, MN 55902

Home Doctors

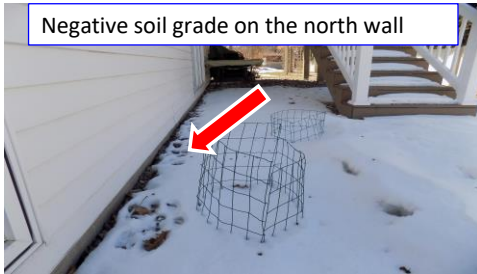
- The north side of the house has negative soil grade. We recommend adjusting the grade to shed water away from the foundation wall.

Further Comments: The north side of the house has negative soil grade. We recommend adjusting the grade to shed water away from the foundation wall.

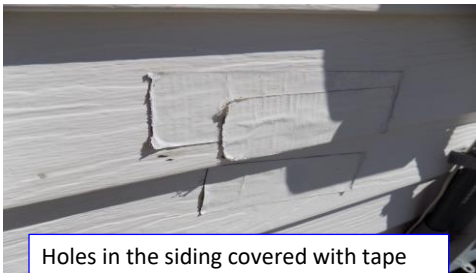
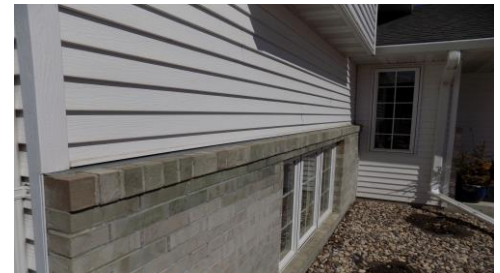
- We observed holes in the steel siding covered by white duct tape.

Further Comments: We observed holes in the steel siding covered by white duct tape.

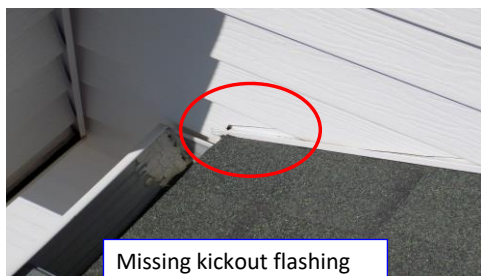
Further Comments: Over the front entryway, there is missing kickout flashing.

Missing kickout flashing

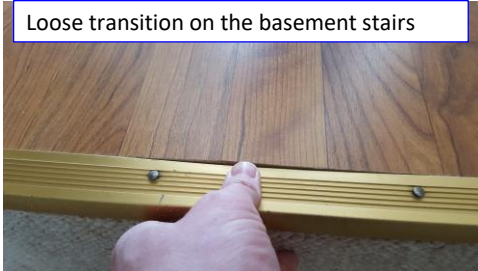
- The living room carpet has noticable bulges and appears to be loose. We recommend stretching the carpet to remove the bulges. There is a loose transition strip on the stairs leading to the basement.

Further Comments: The living room carpet has noticeable bulges and appears to be loose. We recommend stretching the carpet to remove the bulges. There is a loose transition strip on the stairs leading to the basement.

Bulge in the living room carpet

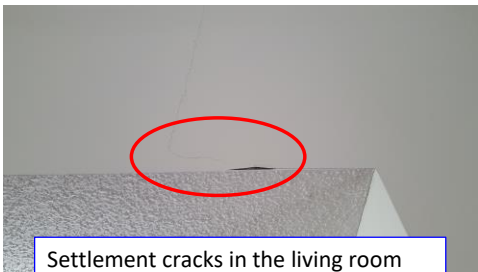
Further Comments: The living room drywall shows signs of minor settlement. The textured ceiling in the bathroom is cracked and chipped due to condensation.

Cracked and chipped ceiling texture

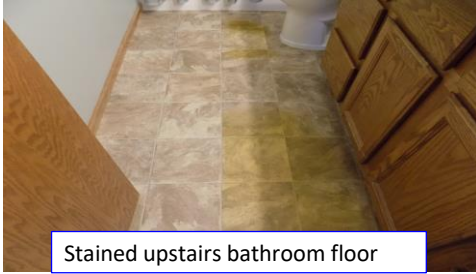
- The upstairs bathroom has yellow stains in the floor by the toilet and the vanity.

Further Comments: The upstairs bathroom has yellow stains in the floor by the toilet and the vanity.

Stained upstairs bathroom floor

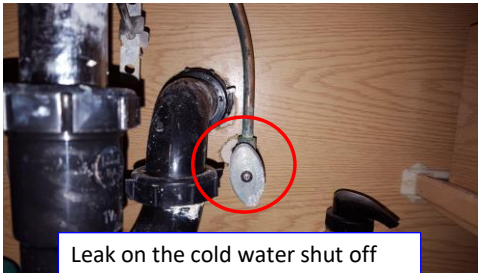
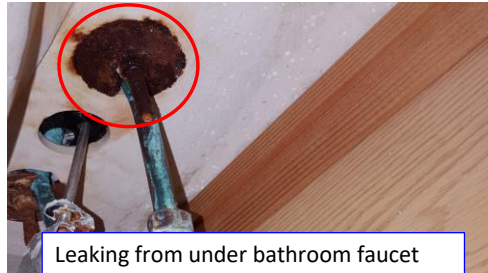
- The basement bathroom sink has a leak on the faucet and the cold water shut off valve.

Further Comments: The basement bathroom sink has a leak on the faucet and the cold water shut off valve.

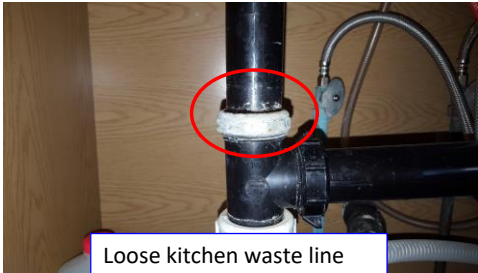
- The waste line on the left kitchen sink is loose. The dishwasher waste line is missing a highloop - this could lead to cross contamination during drain back ups.

Further Comments: The waste line on the left kitchen sink is loose. The dishwasher waste line is missing a highloop - this could lead to cross contamination during drain back ups.

Loose kitchen waste line

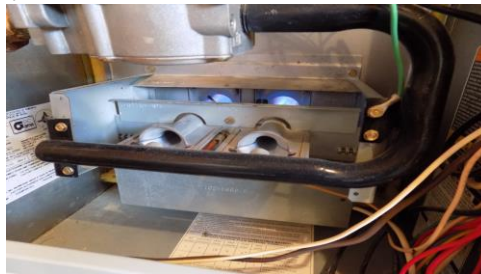
- We recommend yearly service on all heating equipment and monthly filter changes. The furnace is beyond its expected service life. We recommend budgeting for the future replacement of the unit.

We recommend yearly service on all heating equipment and monthly filter changes. The furnace is beyond its expected service life. We recommend budgeting for the future replacement of the unit.
