Inspection:

Date: March 22, 2019
Property 1 Sample Road
Address: Small Town, NY

GENERAL PROPERTY DESCRIPTION

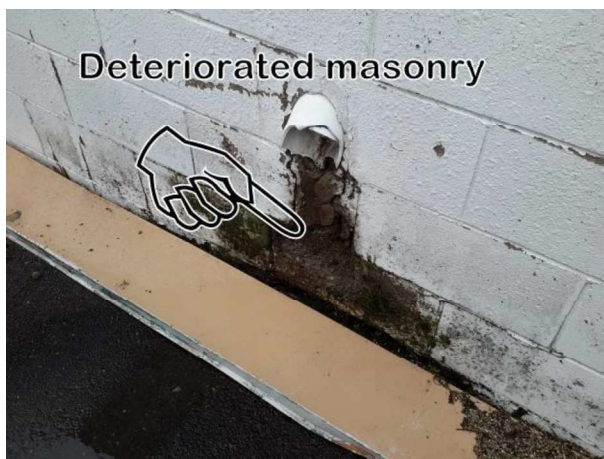
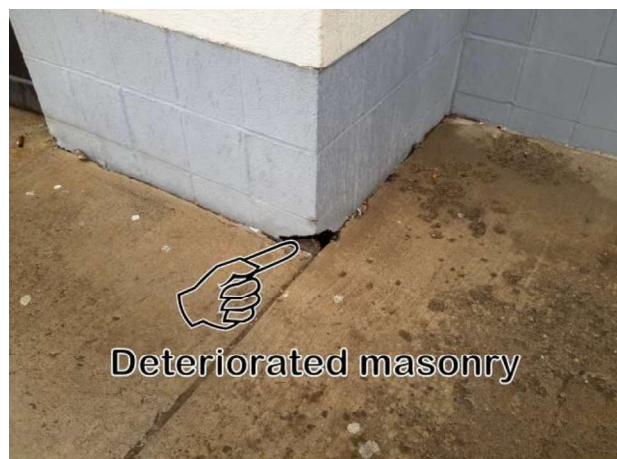
As regards basement moisture penetration we offer the following: It is our policy to include in every report a statement regarding apparent basement moisture penetration. This building does not have a basement, but it is still important to keep excess water away from the building. Where possible, the parking areas should slope away from the building. Also, roof drains should direct water away from the building. We found areas where drainage is substandard, and this has caused localized deterioration of the adjacent blockwork on the exterior of the building. Repair is needed in these areas.

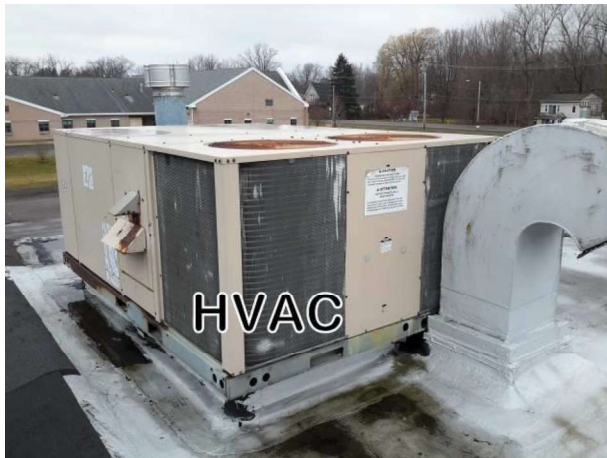
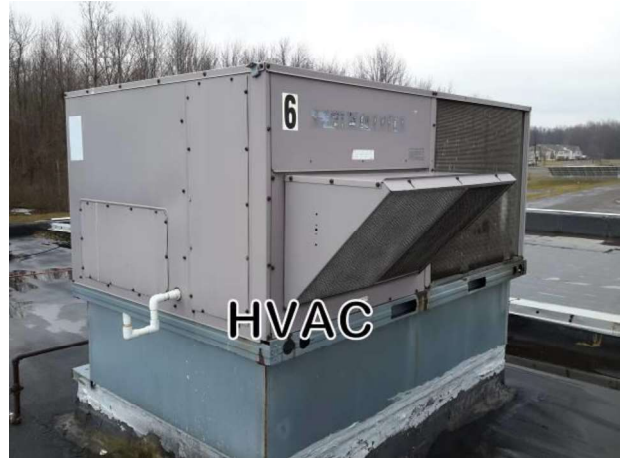
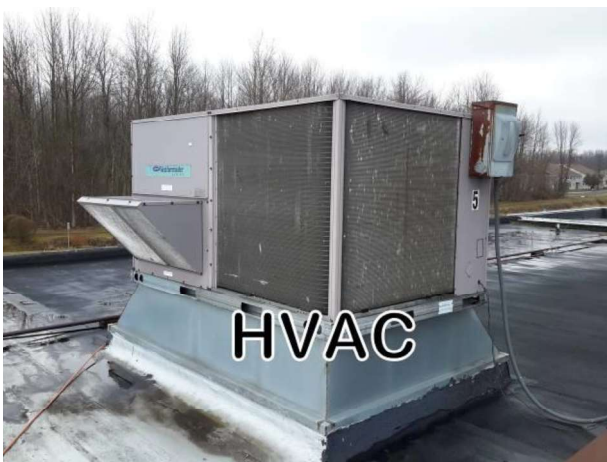
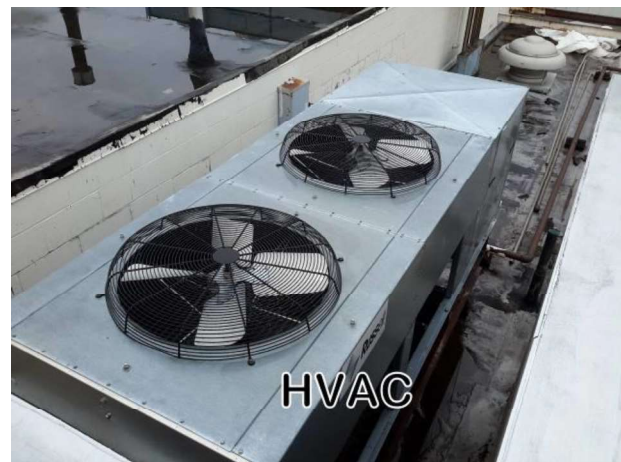
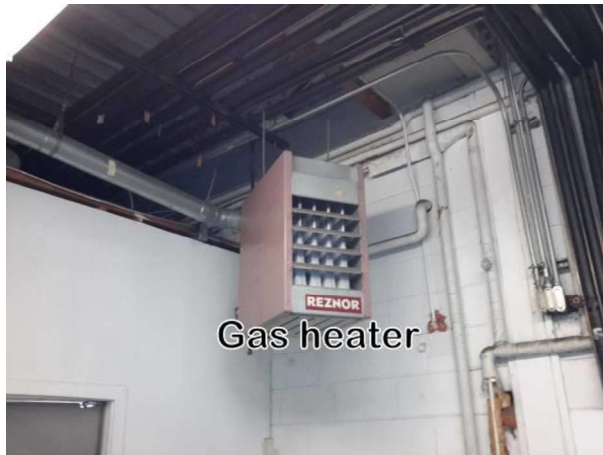
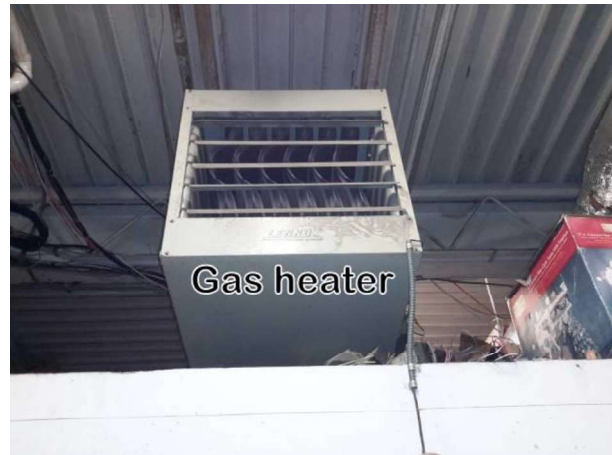
The heating units are located throughout the various sections of the building. The main heating units are rooftop units. The vast majority of this equipment is old and we did not find evidence of routine servicing. Three of the rooftop units are apparently over 20-years old. There are also gas-fired furnaces hung from the ceilings in the office and warehouse areas of the grocery store. These units are also older.

We would strongly recommend complete cleaning and servicing of the HVAC equipment by a reputable contractor at this time (prior to closing). This is an important step since it would help to provide you with some assurance that the equipment is functioning properly at this time. You should also understand that replacement of much of this equipment will probably be necessary in the near-term. This cost must be properly budgeted.

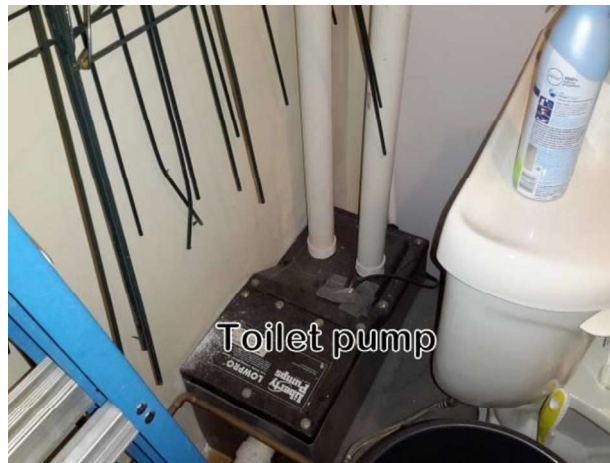
Toilet pump

There is a pump for the toilet at the rear of the flower shop. The pump was tested and it was found to be operable.

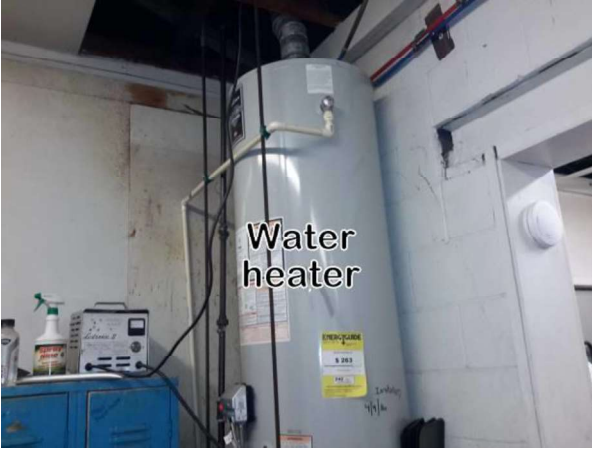
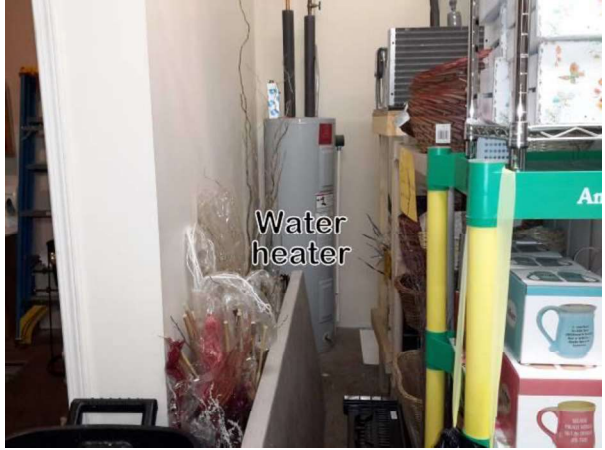
We found two water heaters in the building. They were in operation at the time of inspection. One of the water heaters could not be directly accessed. The other (near the butcher area of the grocery store) is relatively young in age.

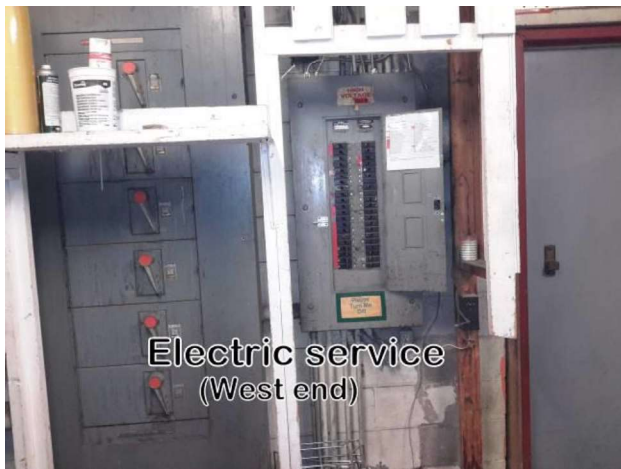
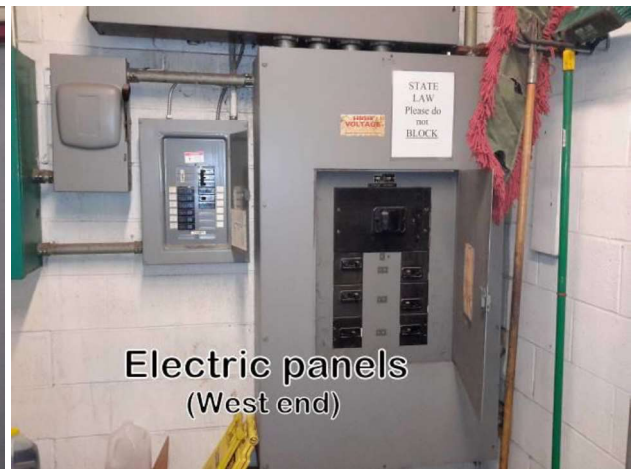
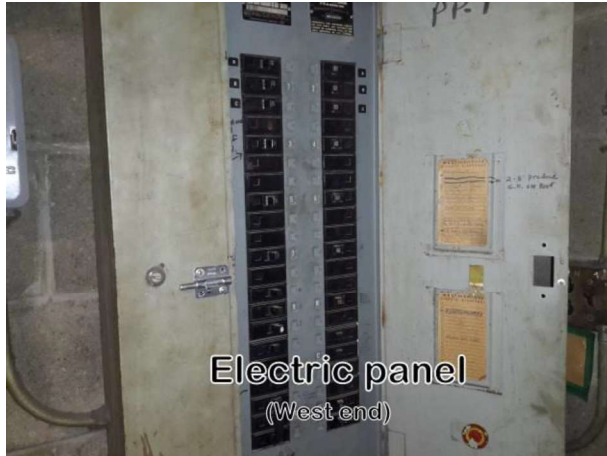
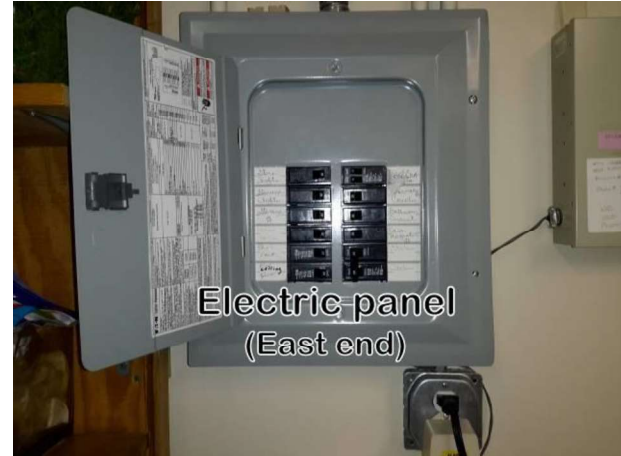
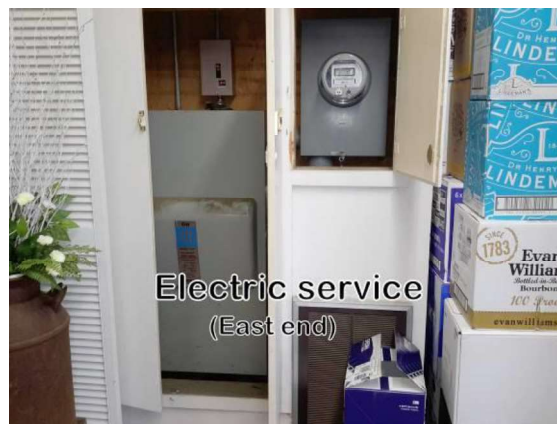
The electrical power entering these premises consists of a 4-wire, three-phase service. We could not determine the exact capacity of this service since the main service entry is not directly accessible. However, there may be approximately 1,200 amperes of capacity. This would be considered an adequate amount to serve this building as it now stands.

Many of the electric panels and components are old. You may find the justification or need to modernize the service and replace various panels and components in the coming years. Many of the panels are near the end of their anticipated service life, and most electricians would strongly recommend replacement. This must be anticipated.

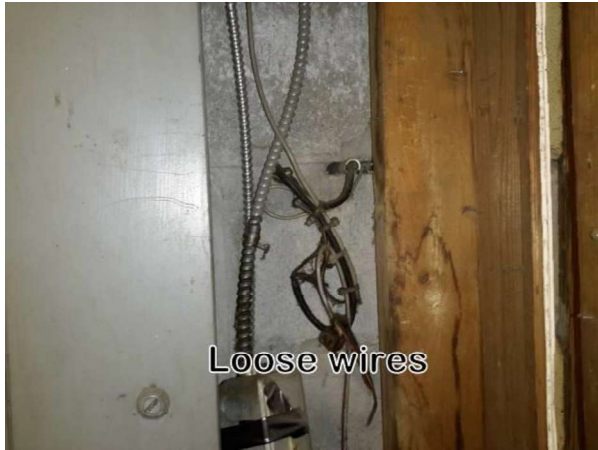
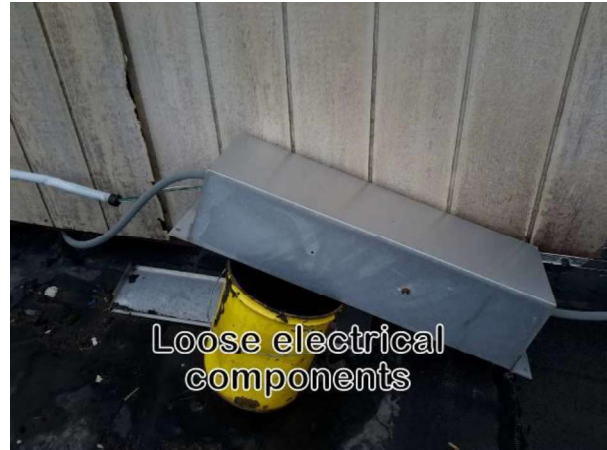
We found a few scattered areas where miscellaneous electrical repairs are needed. In the interest of safety, all wiring connections and terminations should be enclosed in a covered junction box, fixtures and wires should be secured and protected, etc.

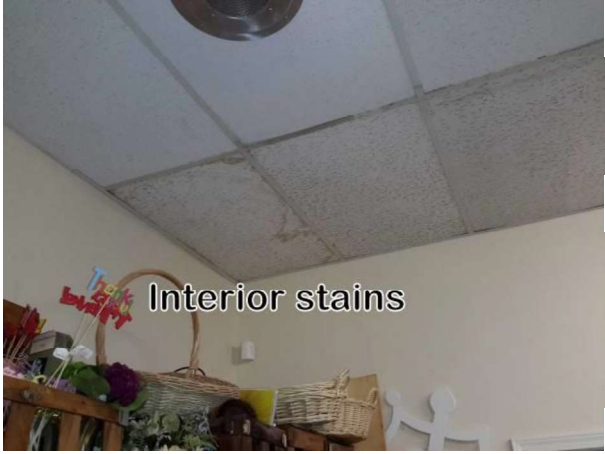
There are many damaged and stained areas on the ceiling surfaces. Please see the exterior portion of this report for further information regarding the roof. Ceiling stains can also be due to leakage in any piping above the ceiling. Active plumbing leaks were not found. These areas should be kept under observation over time.

Interior stains

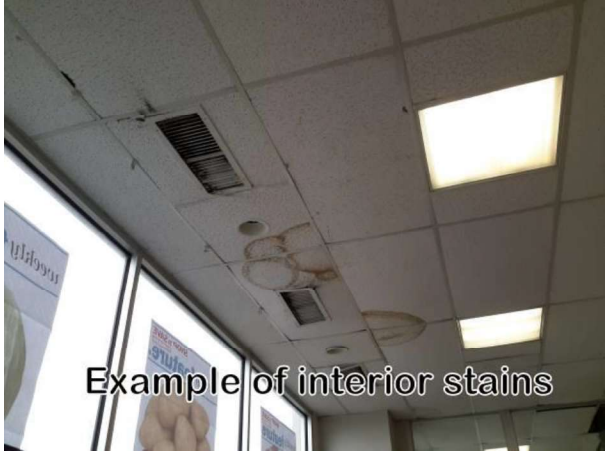
Example of interior stains

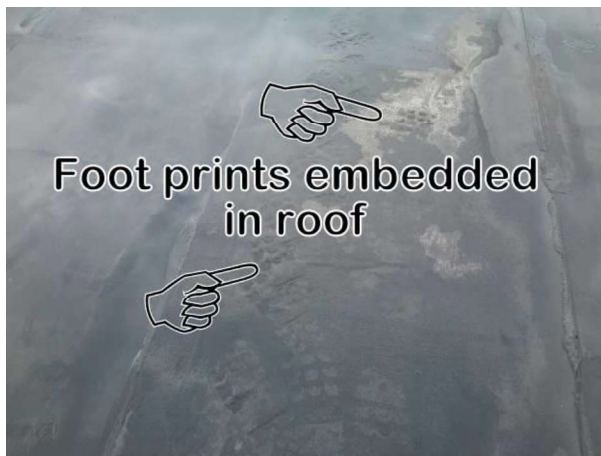
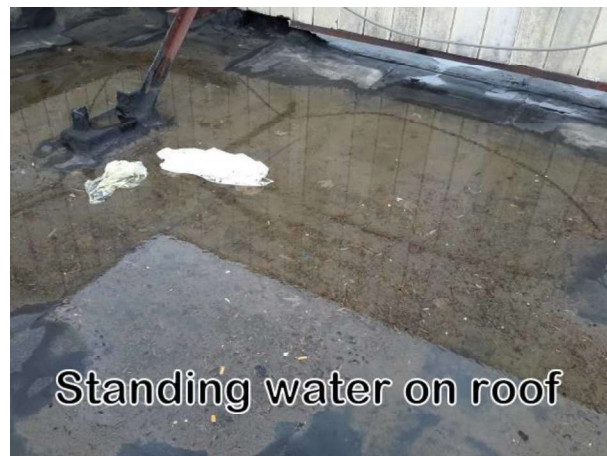
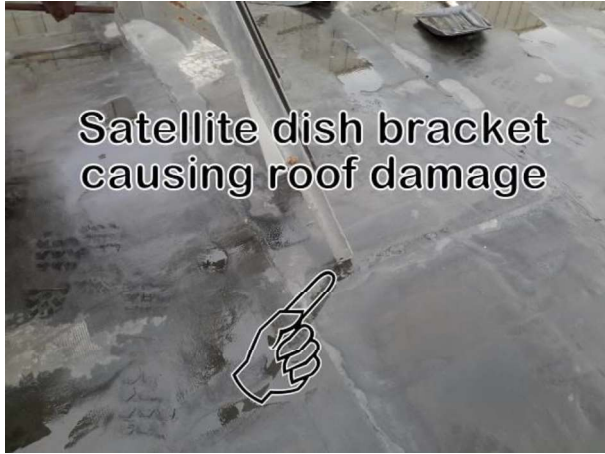
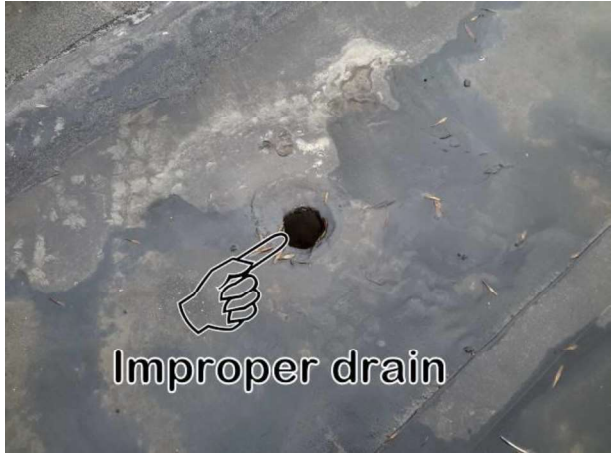
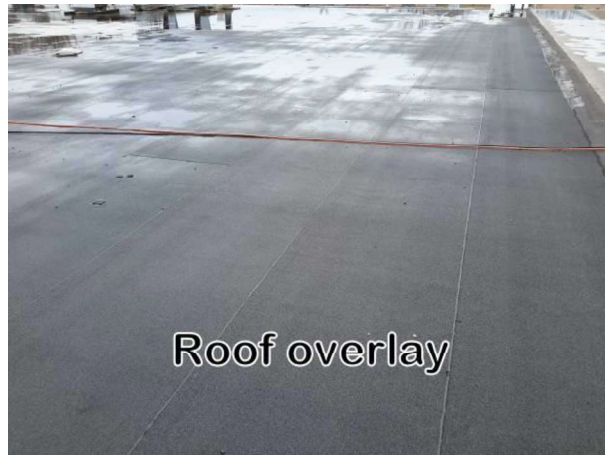
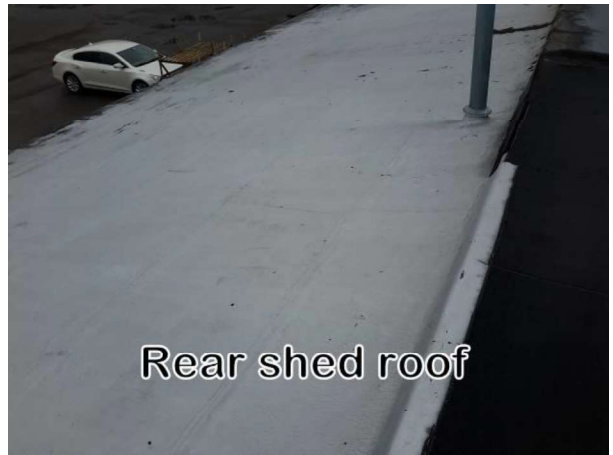
- Most modified bitumen roofs are intended to be coated. The coating protects the roofing from the ultraviolet rays of the sun. In this case, there are areas that were not coated, and there are areas where the coating is noticeably worn or loose.

- In some areas, the roofing was overheated when it was installed. This is based on the footprints imbedded in the roofing. This compromises the integrity of the roofing.

- It is apparent that there has been a patchwork approach to roof maintenance. Various areas have been patched or repaired over the years, but it consists of simply installing additional roofing over the top of previous layers.

- There are a few soft spots in the roof, and there are areas where the seams of the roofing are loose. This was even found to be the case in the newer sections.

- There are areas where re-flashing is needed.
- We found puddles or various areas of standing water on the roof. Although this is not entirely unusual, these types of roofs are not intended to hold water for any extended period of time.

- Roof drainage is substandard. Some of the drains are simply inverted pipe boots, rather than scupper-type drains with screens or grates.
- It was reported that sections of the roof are younger in age, and the seller indicated that portions of the roof may have been installed less than one year ago. In some respects, these repairs are substandard.

Based on the above, we strongly question the integrity and future serviceability of this roof. As the owner of this building you must anticipate at least some degree of ongoing roof maintenance as time passes. This approach can help to avoid very significant one-time expenses, but it does require frequent repairs that are eventually costly.

Otherwise, you must anticipate the need to replace the roof in the not too distant future. This can be a very costly endeavor. The exact cost can depend upon the number of layers of roofing, whether complete reinsulating of the roof system is found to be necessary, whether asbestos is found in the roof system, etc. You must budget for this significant expense.

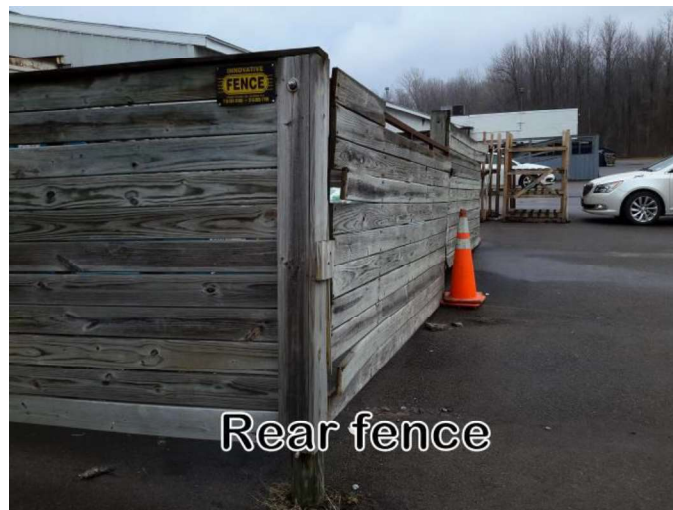
The fence surrounding the trash area is in need of repair.

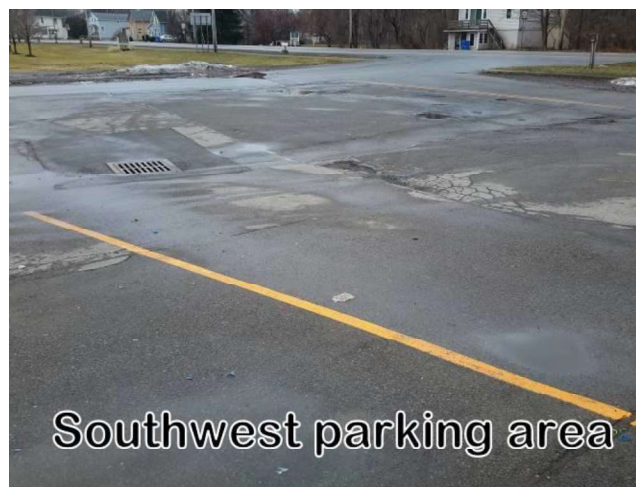
The asphalt parking areas around the building vary in condition. There are areas that are worn and cracked. You must anticipate the need for some degree of ongoing maintenance.
