Inspection:

Date: February 15, 2017

Property: 1 Sample Road
Address: Small Town, NY

Inspector: **Thomas D. Wurzer, P. E.**

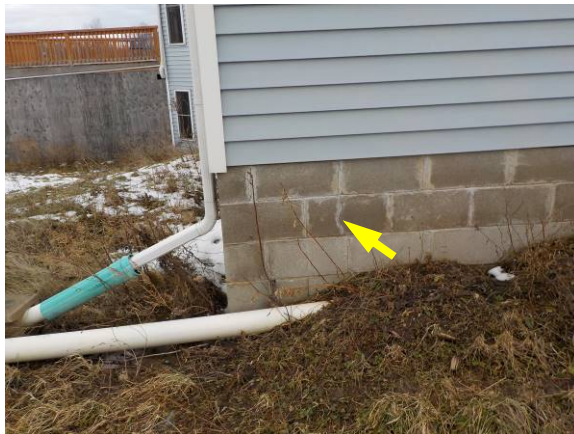
We noted hairline cracks in the masonry block foundations of the garage at the left rear corner outdoors. This is probably due to initial settlement, and this does not appear to be severe. No related corrective actions are considered necessary at this time.

Minor cracks were found at this corner of the garage foundation

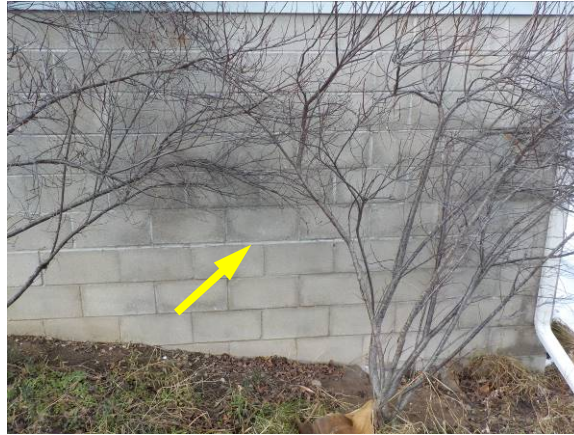
Outdoors, along the right exterior foundation wall, we noted horizontal mortar joints between blocks that are wider than others. This could be a condition that existed since the time of original construction, or these joints might have been patched after some initial settlement. In any case, we did not find open cracks or indications of recent movement and the walls are in serviceable condition. Keeping roof and surface runoff directed away from foundations can minimize the chances of future settlement and cracking.

Wider mortar joint on right side of house

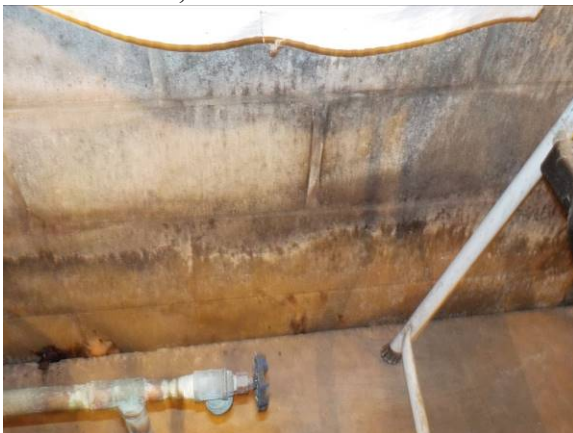
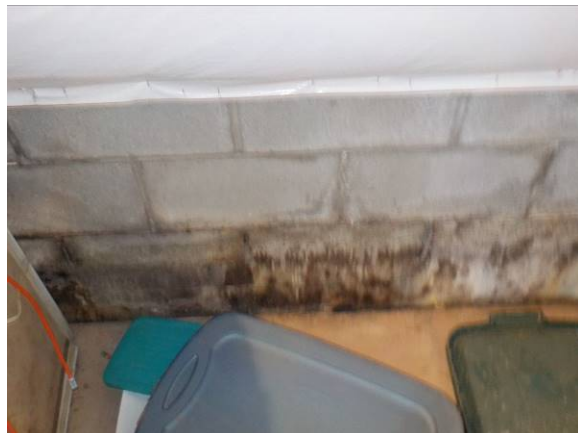
Seepage and water penetration at front corner wall areas of the basement

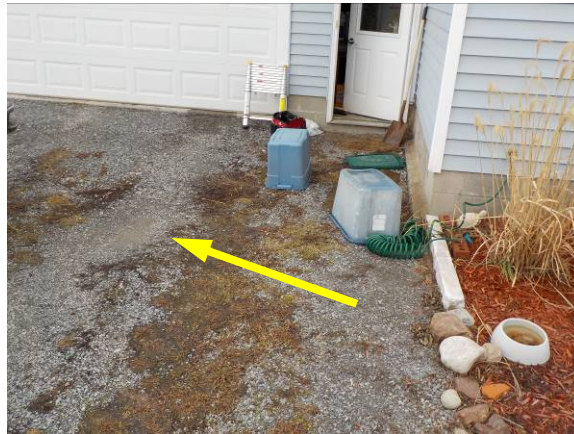
Outside the left front corner of the house, the dirt and stone driveway has some low areas where water likely collects. This is probably the primary contributor to moisture seepage near this area in the basement. The driveway should be improved with a proper drainage swale in front of the garage to direct water away from the house, away from the garage, and towards the left side of the garage. One could incorporate underdrainage piping and/or a trench drain as part of this work.

Low spot in driveway near house

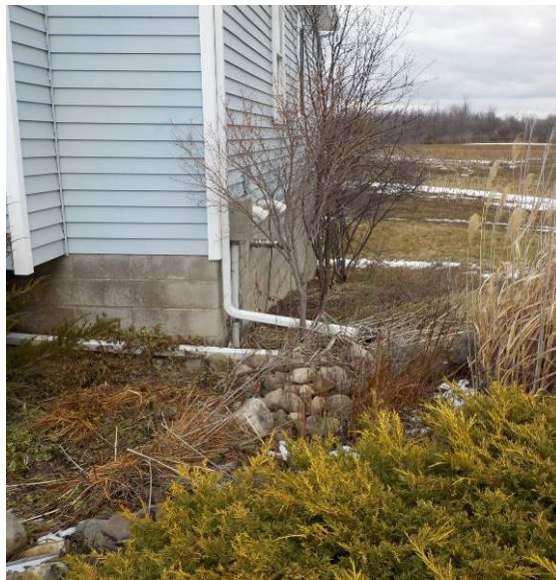
Poor grading on right side of house

On the right side of the house, significant grading improvements are recommended to pitch the ground away from the house better. Further, the gutter downspouts towards the right front corner can be directed away better to minimize water accumulation at this corner. Other landscaping and exterior grading improvements could be made around the house to minimize water penetration as well, such as along the rear of the house.

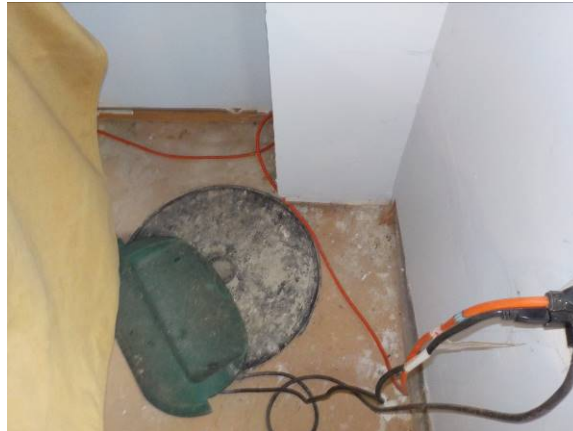
Sump pump location

control moisture that enters through the walls. The sump pump was briefly tested and found to be operable.

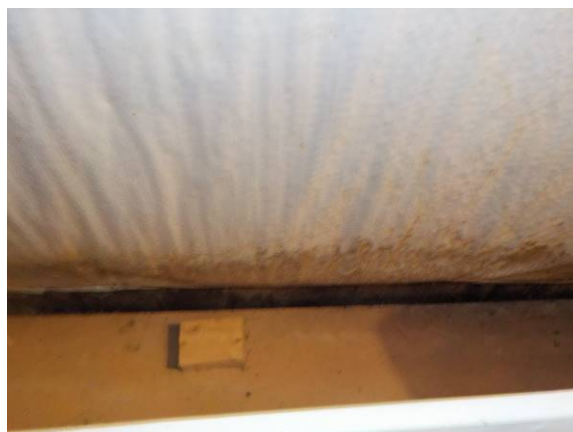
We noted some locations on the right side of the basement where wall insulation has gotten wet. Improving the exterior grading should help to prevent this, and any insulation that is saturated should be trimmed and removed. Saturated insulation is ineffective.

Damp insulation on right side of basement

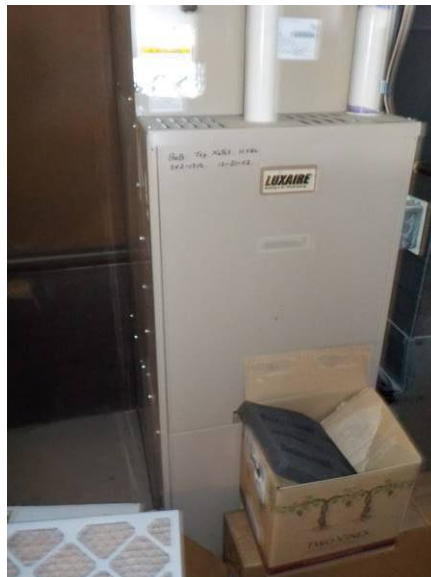
Furnace

Primary heat for the house is provided by a high efficiency propane-fired forced air furnace that was briefly tested and found to be functional. The thermostat for this is located in the main hallway of the bedroom wing.

Heating units of this type should be cleaned, serviced and inspected yearly as a preventive maintenance measure and as a safety precaution. This cleaning and servicing should include the motor, blower, filter, and a thorough evaluation of the heat exchanger. If the owner cannot provide evidence of professional cleaning and servicing within the last year, then we strongly recommend such servicing prior to closing. This will serve as a means of better evaluation. The furnace is original from 2002 and is approximately 15 years old.

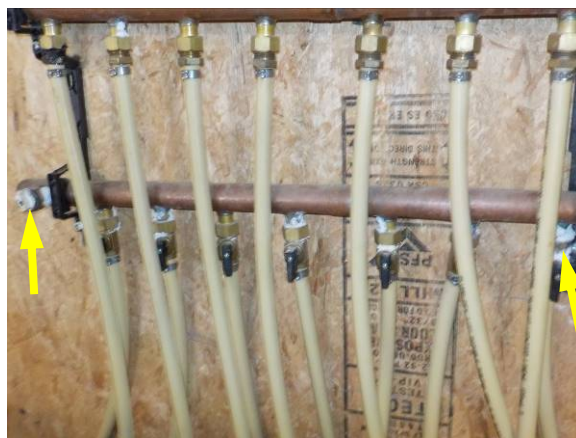
We noted significant corrosion on manifold piping of the radiant heating system, and related cleaning is recommended. If any leaks are found, repairs would be required. A missing temperature gauge should be replaced for this system and the compression tank is rusty and should be checked by a heating contractor.

Corrosion on piping manifold for radiant floor

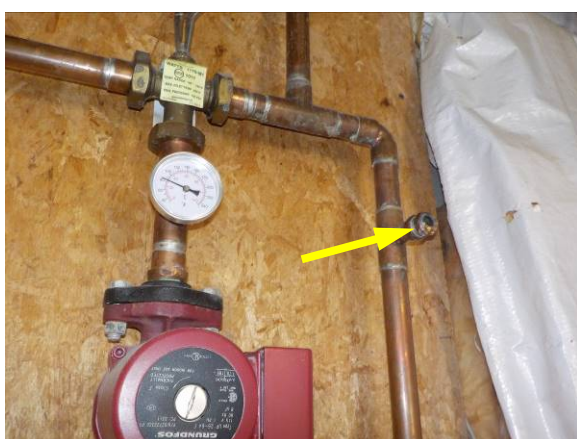
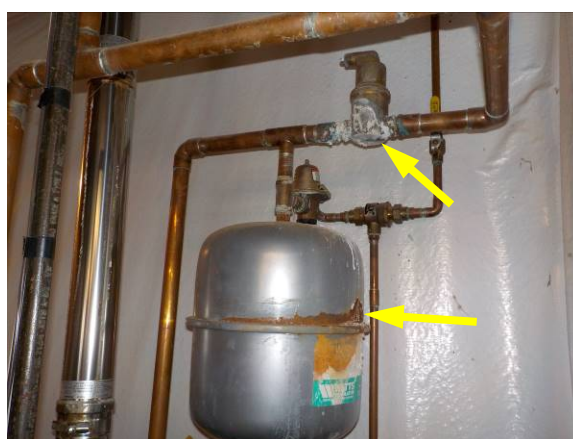
Missing temperature gauge and corroded air vent and corroded expansion tank

The boiler for the radiant system does not appear to have been cleaned and serviced professionally for quite some time. We strongly recommend that this be done by a qualified contractor at this time, and this can provide a more conclusive evaluation of the overall system and the boiler. We suspect that the boiler is original to the house.

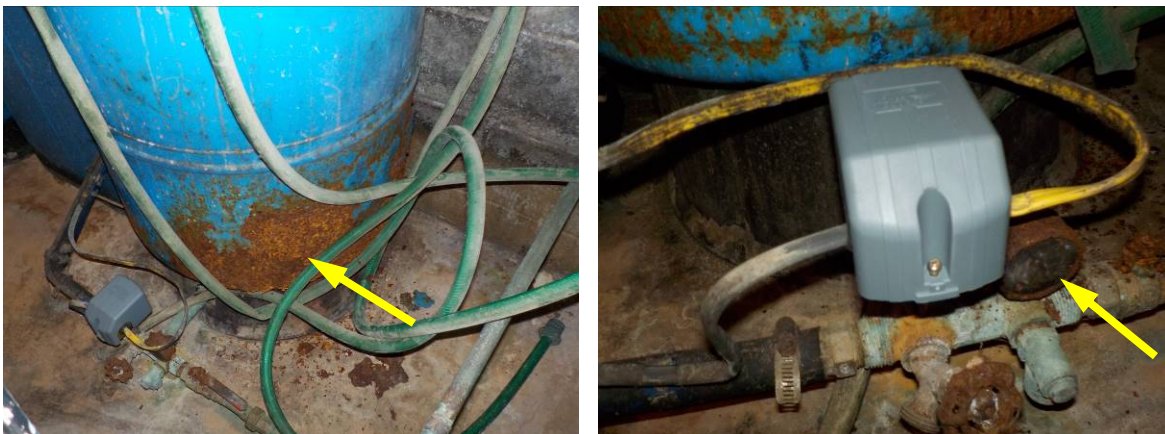
The compression tank for the well pump system is heavily rusted and replacement is recommended. A pressure gauge near the pressure switch should be replaced.

Rusty compression tank and damaged pressure gauge of well system

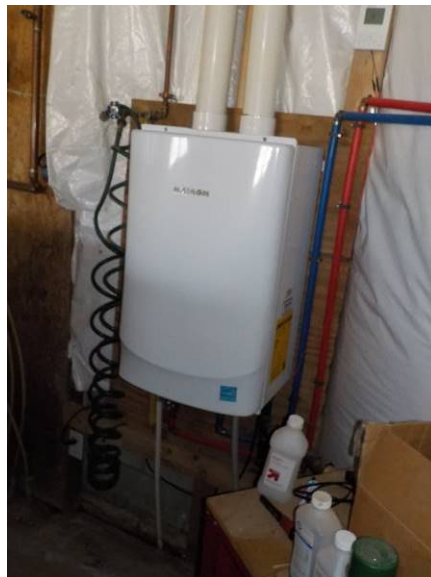
Water heater

The on-demand water heater was functioning at the time of inspection. We suspect that this is approximately eight years old, but the exact age is unknown. This should have adequate capacity for the house. One should be aware that it can take a relatively long time for hot water to get to plumbing fixtures with this type of water heater as compared to a standard water heater. Some people find this inconvenient.

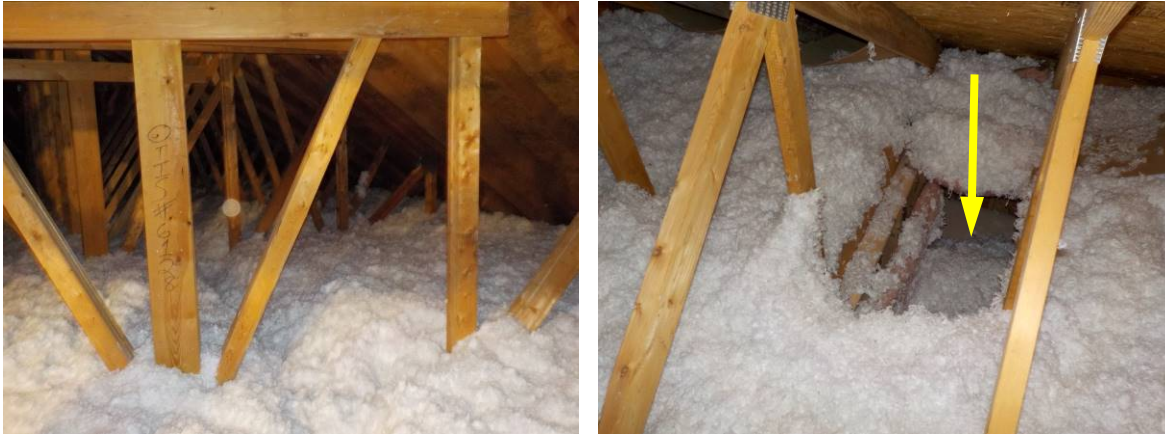
Over the front bathroom shower the insulation has fallen out of place and this should be properly replaced to reduce heat loss. One should also maintain an insulated attic-side cover for the pulldown stairs of the attic to reduce heat loss. There is a storage platform in the attic. There are likely lesser amounts of insulation underneath the platform as compared to other areas of the attic. If one will not use this for storage, more insulation could be installed.

Attic and missing insulation over front shower

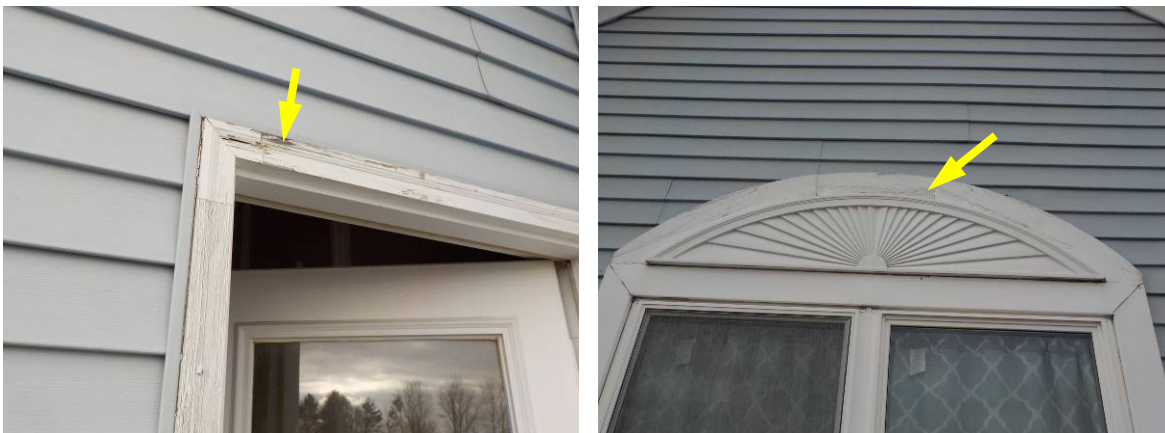
The exterior walls and siding mostly appeared to be serviceable. We found some minor cosmetic damage and vinyl siding pieces could be replaced if a suitable match can be found. Maintenance to the exterior wood trim has been deferred and related painting maintenance is recommended. Any deteriorated trim found should be replaced at the same time.

Weathered trim with peeling paint

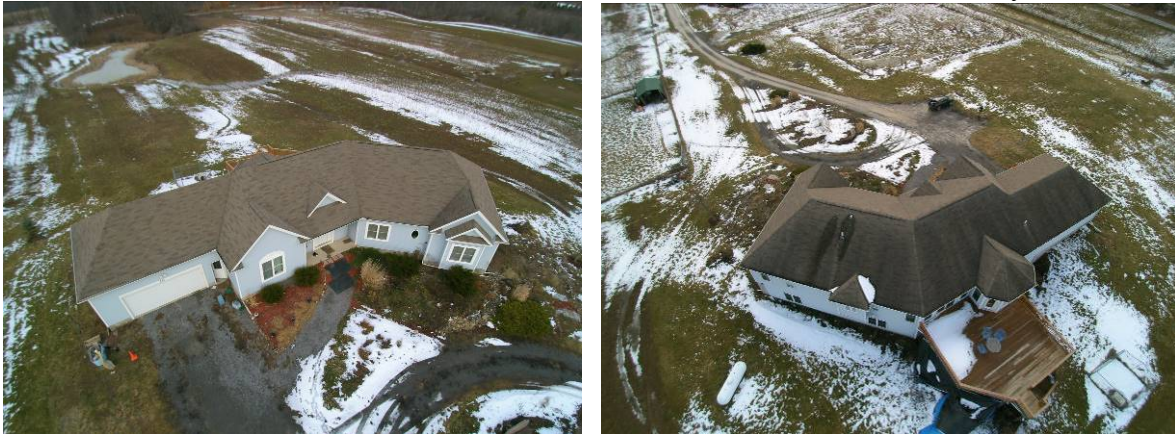
The roofs were inspected from the ground and with the aid of a “drone”. The asphalt shingle roofs are likely original from 2002, making them 15 years of age. The average expected life of a roof of this type is typically published as 20 years. Therefore, the roofs should be considered at least in the latter half of their average expected life and they could be in the later years of their life. Please be aware that a few areas were snow covered and could not be directly viewed.

With any roof, regardless of age, minor leakage should be expected from time to time. This can occur along the edges of the roof, at joints between different roof surfaces, house walls, roof penetrations and around the chimney. Normally, these conditions are relatively easily repaired. Roofing contractors often recommend complete resurfacing when only a repair is needed. If such a recommendation should be made, we suggest that you obtain independent opinions before undertaking any work.

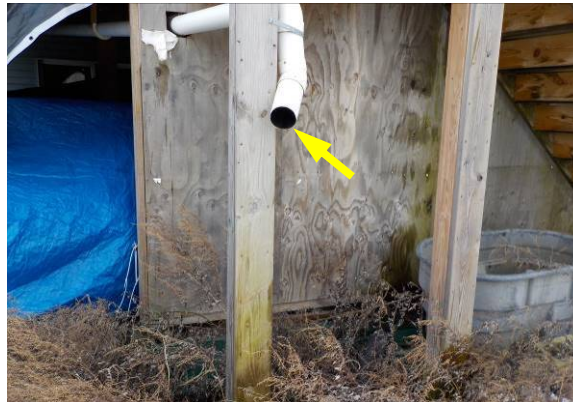
The PVC drainage pipes utilized for downspouts that run underneath the deck are leaking in a few areas and repairs are recommended when weather permits. The end of these pipes should be extended further away from the decks as well.

Extend gutter drainpipe away better

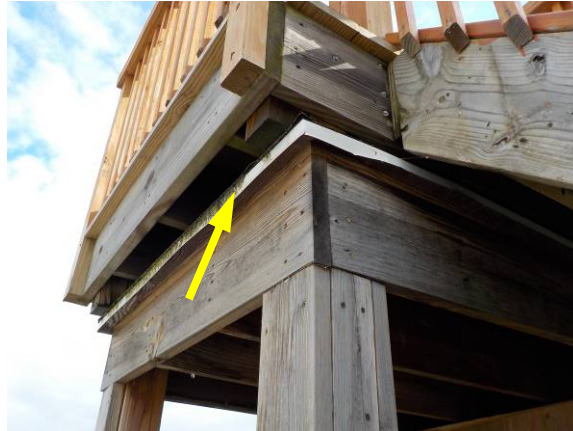
Roof under deck

There is some type of roof underneath the deck. Although we did not find evidence of active leakage, roofs in such areas can be problematic, since access is difficult to obtain if any repairs are required in the future. You may eventually wish to completely remove this roof assembly, at least partially from beneath or completely if replacing wood decking with synthetic decking in the future.
