Building Inspection Report

Inspection Date: 02/26/2016

Prepared By:
Napa Valley Home
Inspections
28 Blossom Court West
Napa, Ca. 94558

Report Number: 20161124

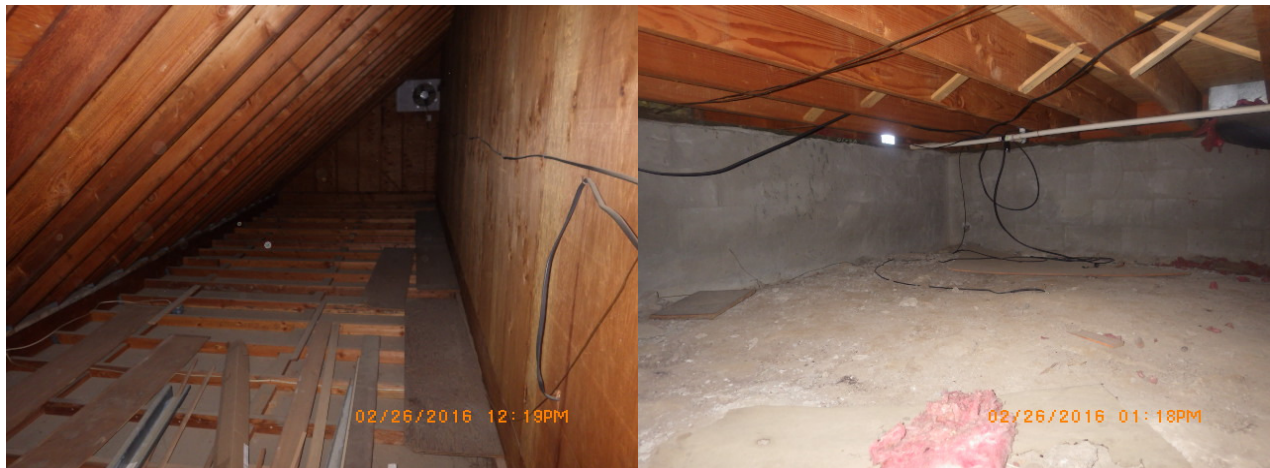
Typical minor flaws were detected in the structural components of the building. Simpson ties need further review.

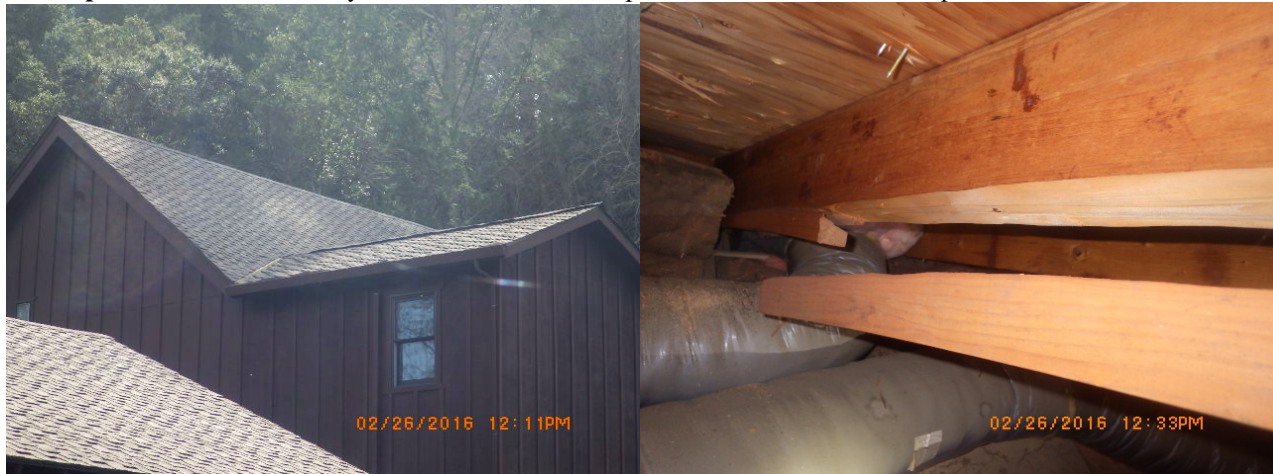
No visible sign of deflection in the roof from the exterior, attic interior shows one damaged rafter that should be repaired.

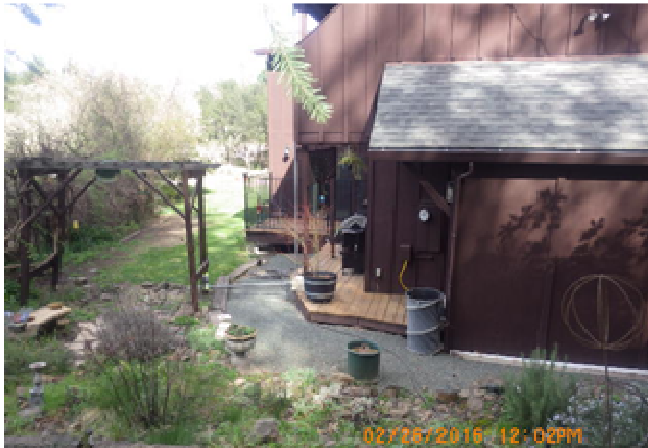
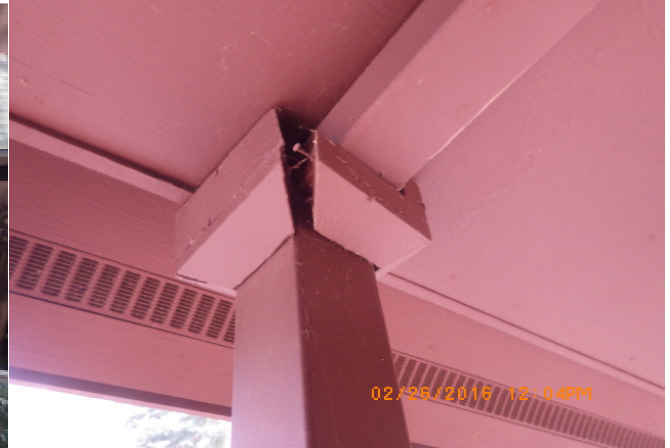
Drainage appears to move water from the foundation walls. Movement in the support posts could be reviewed by a contractor

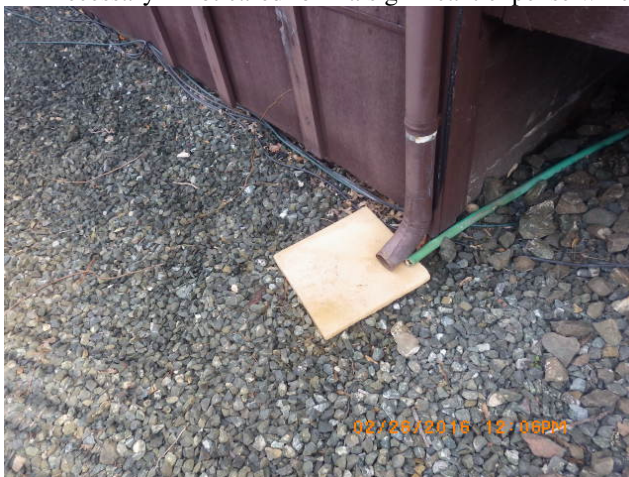
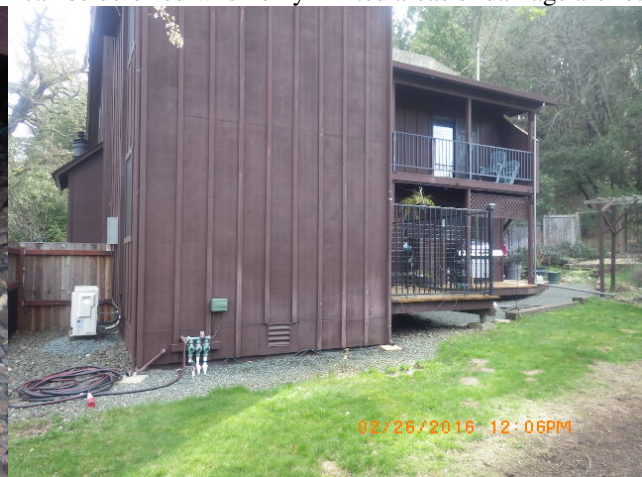
Avoid any wood soil contact, 4 inch clearance recommended. Various support posts were installed with steel deck screws.

- **Monitor, Repair:** The construction of the metalwork for the decks is not compliant to “Simpson Ties” standard procedures for fasteners; screws used rather than galvanized nails. Repairs may be needed; consult a contractor.

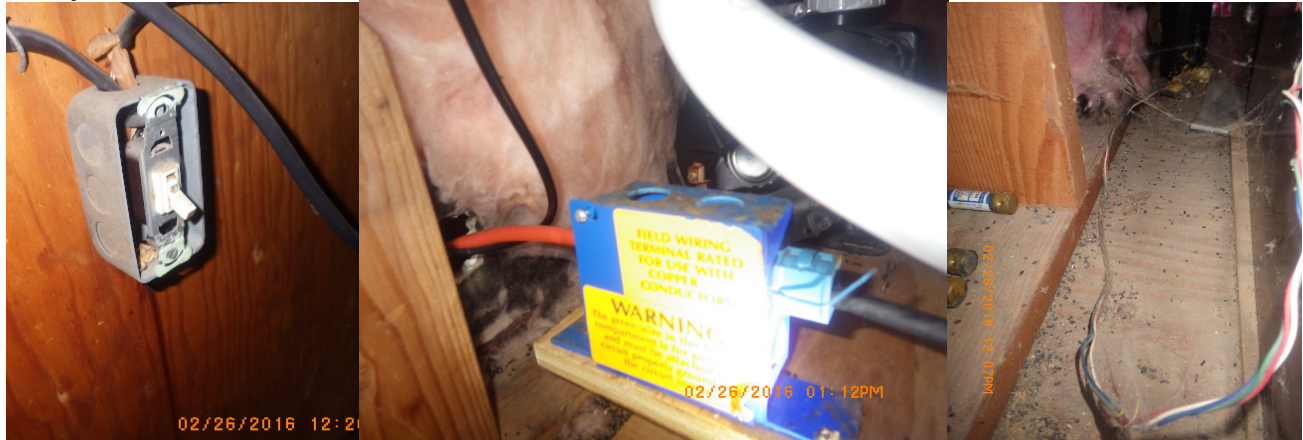
- **Repair:** Loose wiring in the attic & crawl space should be secured.
- **Repair:** Missing outlet cover plates should be replaced to avoid a shock hazard. Abandoned circuits should terminate in a junction box with a cover.
