Building Inspection Report

Napa, CA

Inspection Date: 1/27/2016

Report Number: 20161118

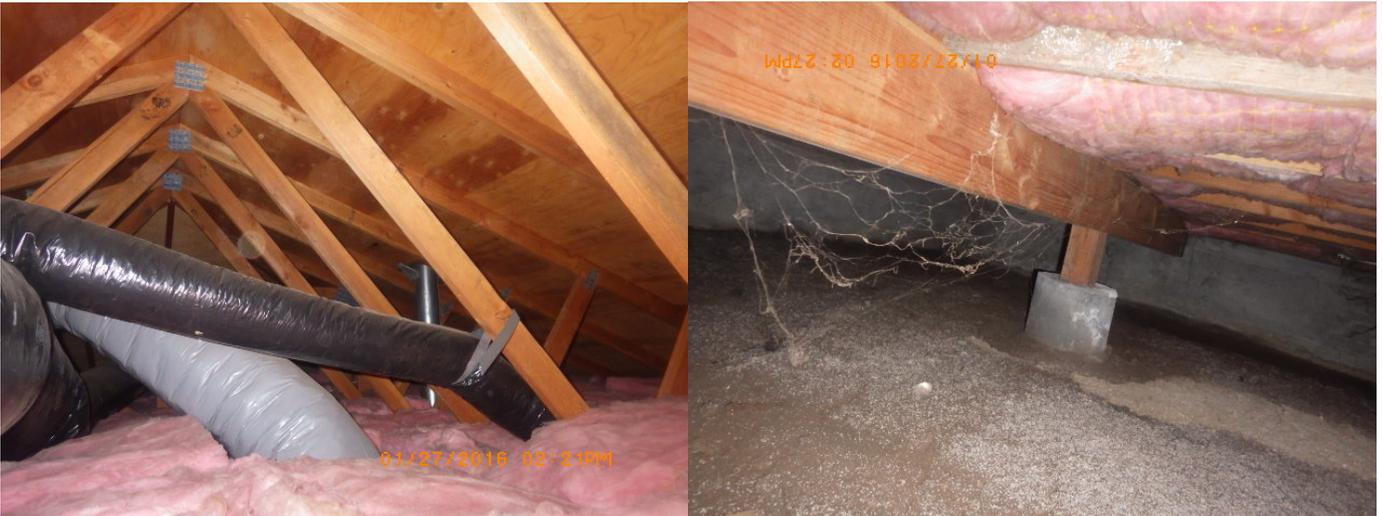
The inspection did not discover evidence of substantial structural movement.

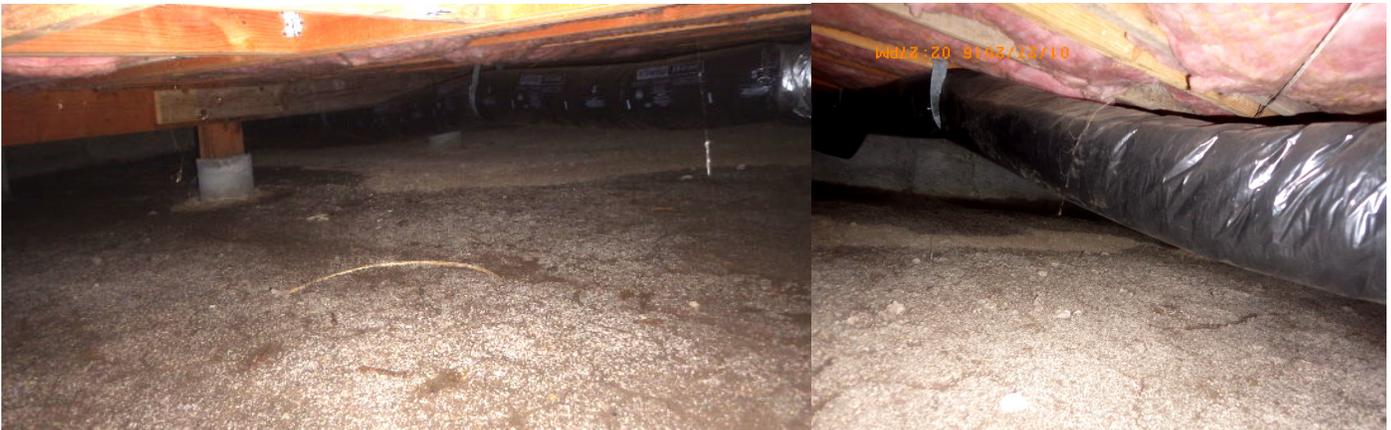
- **Monitor:** There is evidence of past water in the crawl space. Wet crawl spaces risk building damage from rot and insects and can cause interior mold or mildew. This condition may vary seasonally and/or with precipitation intensity. Roof and lot drainage repairs or improvements should be addressed as a first step to controlling water in the crawl space (see Exterior and/or Roof). This condition should then be monitored to determine if additional, potentially costly measures are necessary to protect the building interior from water and moisture damage.

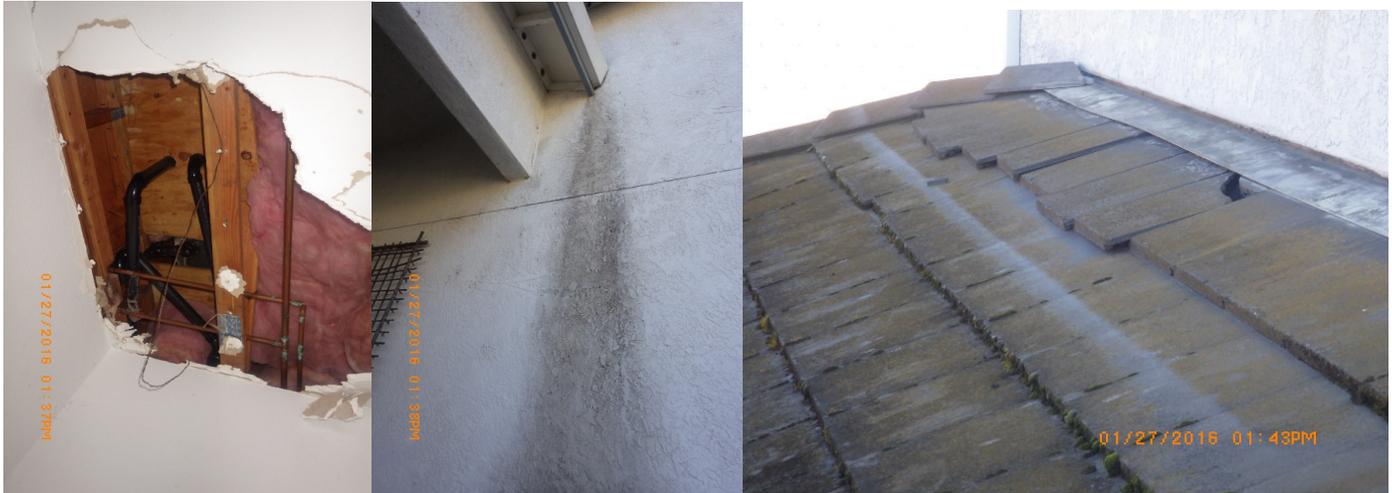
- **Repair:** Substantial evidence of roof leaks was observed. Please refer to the Roofing section of the report for recommendations.

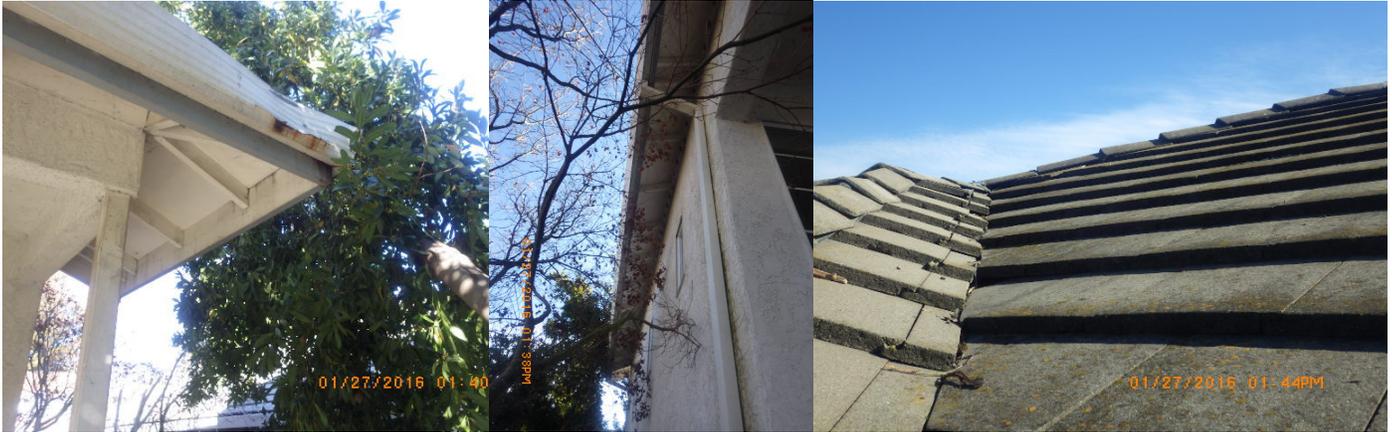
Damaged gutters in many areas.

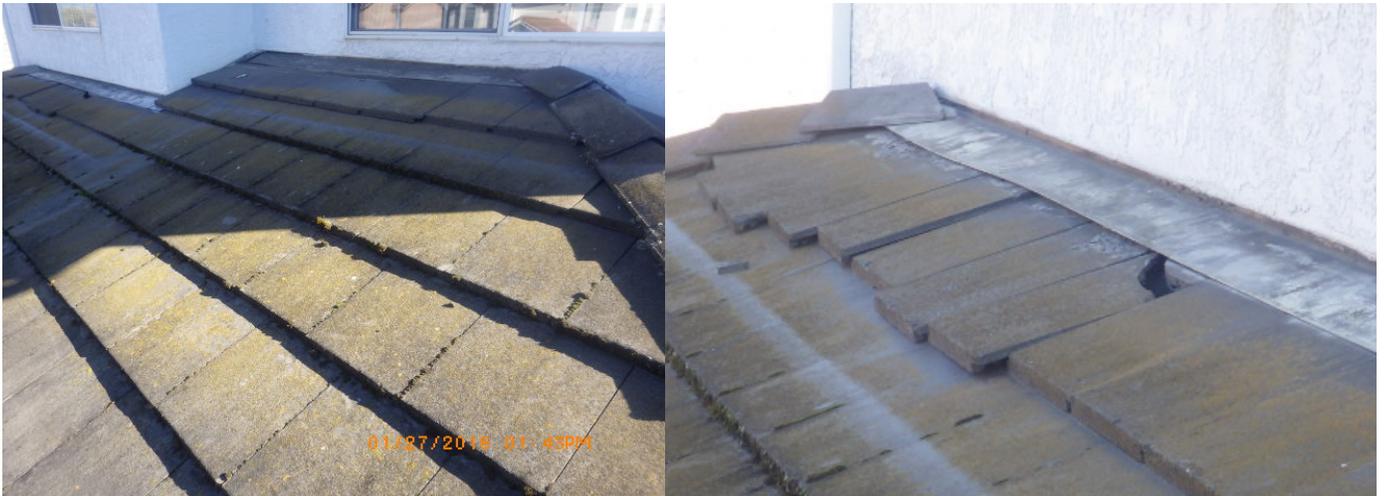
- **Monitor:** The roofing material is mostly in good condition. However the installation workmanship was poor in some areas. While this does not pose a need for replacement, it risks leaks and reduced roof sheathing life. Repairs are needed asap.
- **Monitor:** The flashing should be carefully monitored. Skylight flashings are extremely vulnerable to leakage.
- **Repair:** The metal chimney should be cleaned to help assure safe and functional operation.

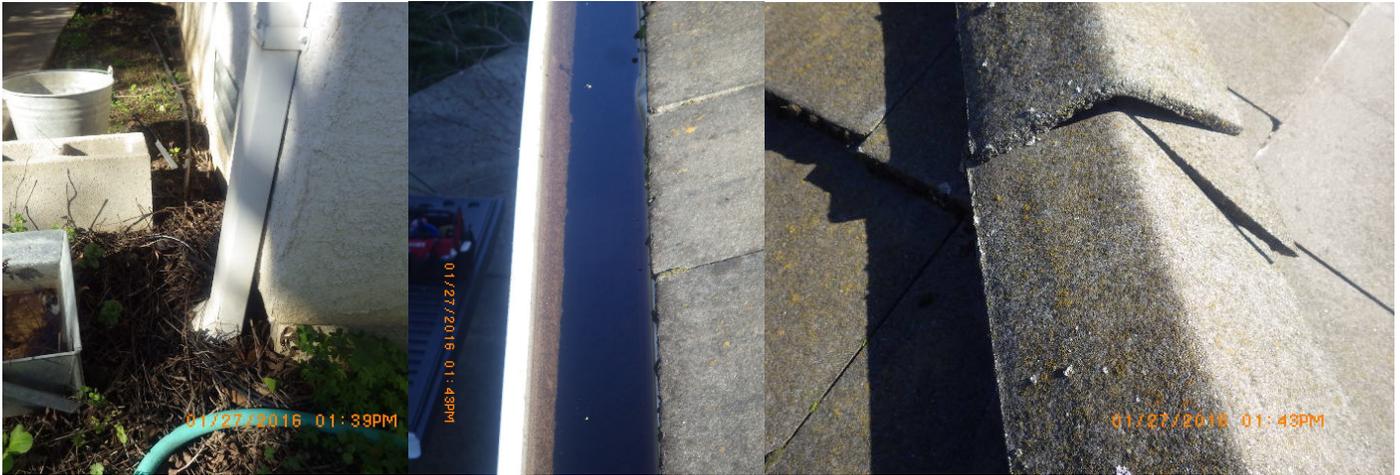
- **Repair:** The gutters require cleaning to avoid spilling roof runoff around the building – a potential source of water entry or water damage.
- **Repair:** Damaged gutters should be repaired or replaced as necessary to avoid spilling roof runoff around the building – a potential source of water entry or water damage.

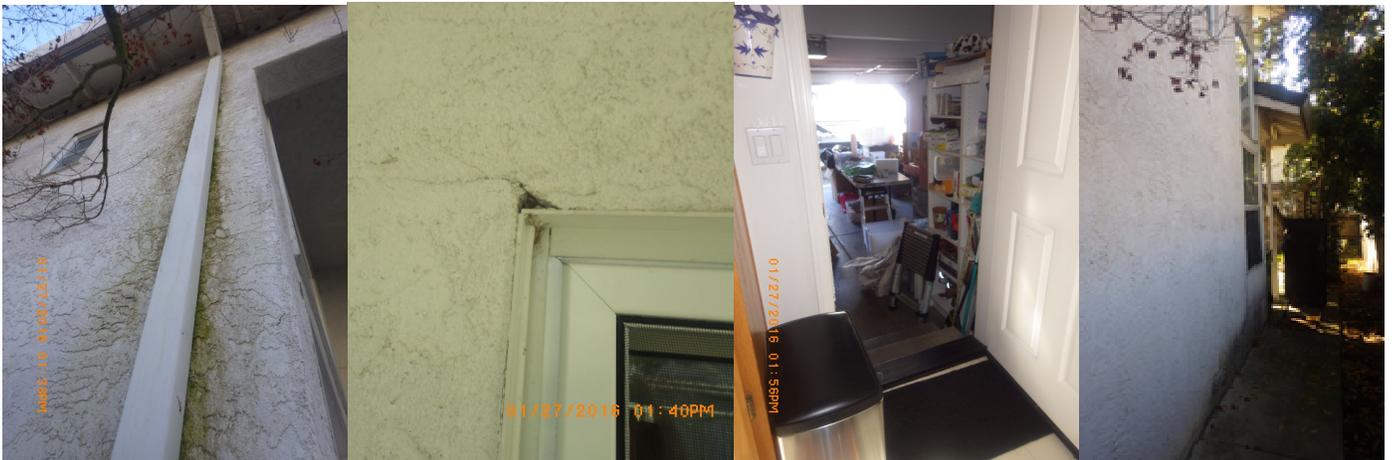
The exterior of the home has not been well maintained. Repairs are needed.

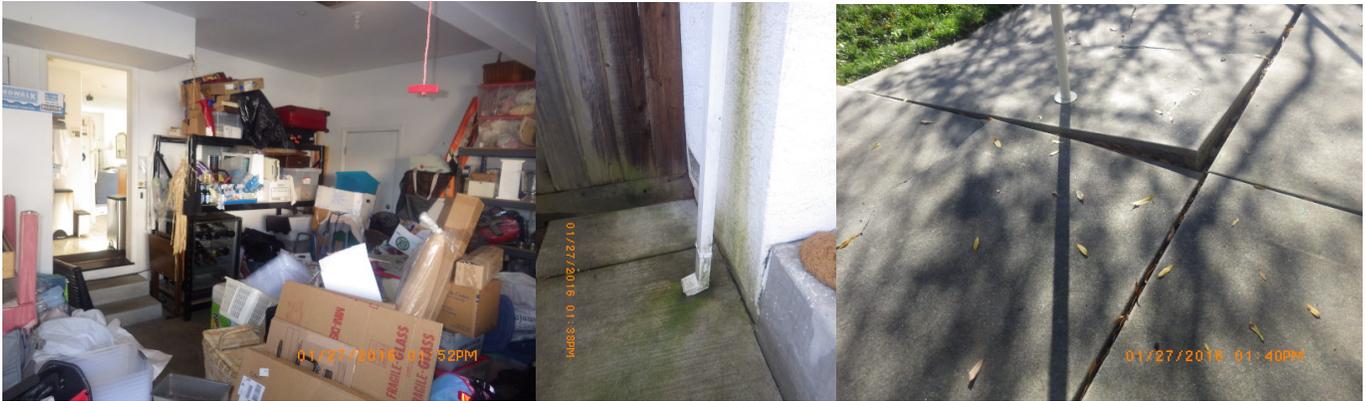
- **Repair, Safety Issue:** The overhead garage door requires adjustment for easy and safe operation.
- **Repair, Safety Issue:** The walls and ceilings of the attached garages should be well sealed where they abut the interior of a house. This reduces the potential of toxic automobile gases entering the house. Openings should be sealed for your protection.
- **Possible Major Concern, Repair, Safety Issue:** Proper fire separation between the garage and house proper is recommended.
- **Repair, Safety Issue:** The door between the house and garage should be weather-stripped and fitted with an automatic closer. This will reduce the potential of toxic automobile gases entering the house.

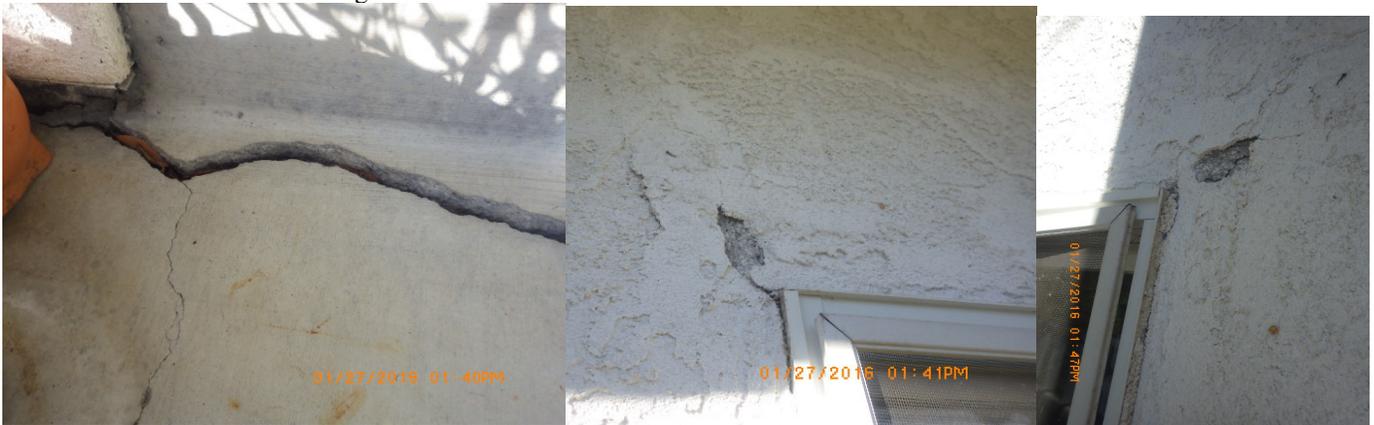
- **Major Concern, Repair:** The grading should be improved to promote the flow of storm water away from the house. This can often be accomplished by the addition or re-grading of top soil. The ground should slope away from the house at a rate of one inch per foot for at least the first ten feet. At least eight (8) inches of clearance should be maintained between soil level and the bottom of exterior wall siding.

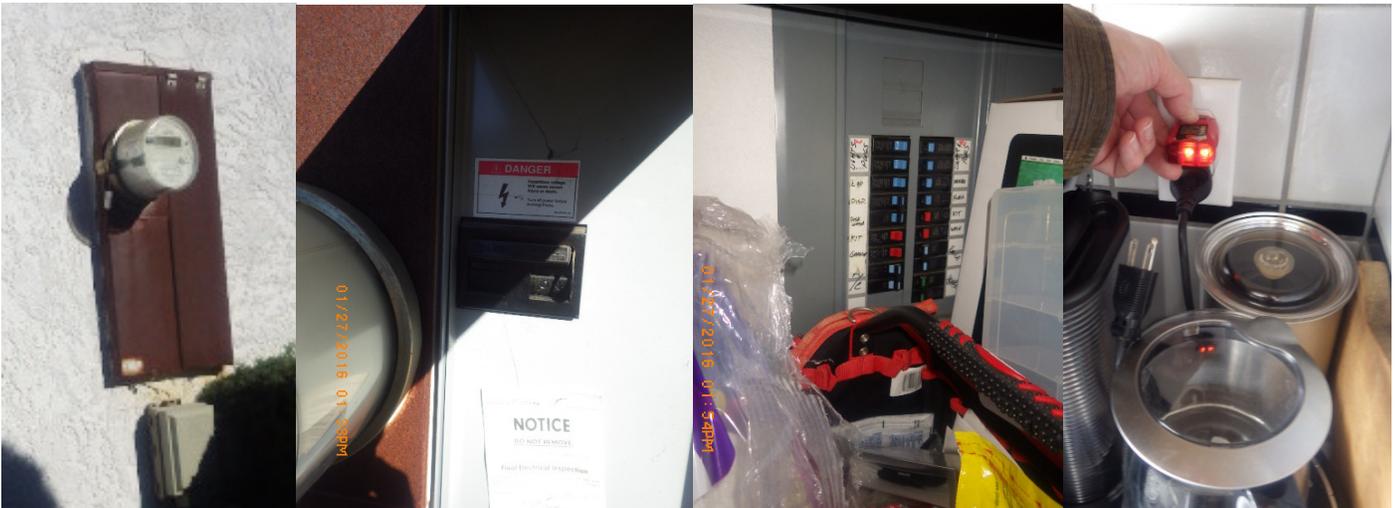
The size of the electrical service is sufficient for typical single family needs.

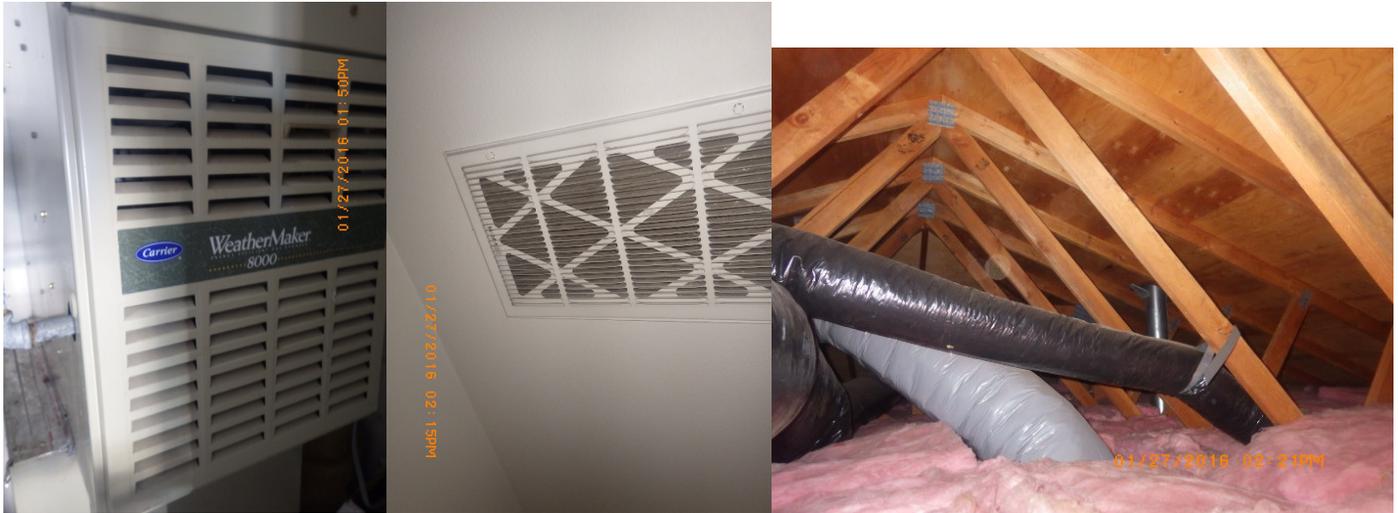
The heating system has not been regularly maintained.

- **Repair:** The dirty air filter should be replaced.
- **Repair:** The heating system requires service. This should be a regular maintenance item to assure safe, reliable heat.

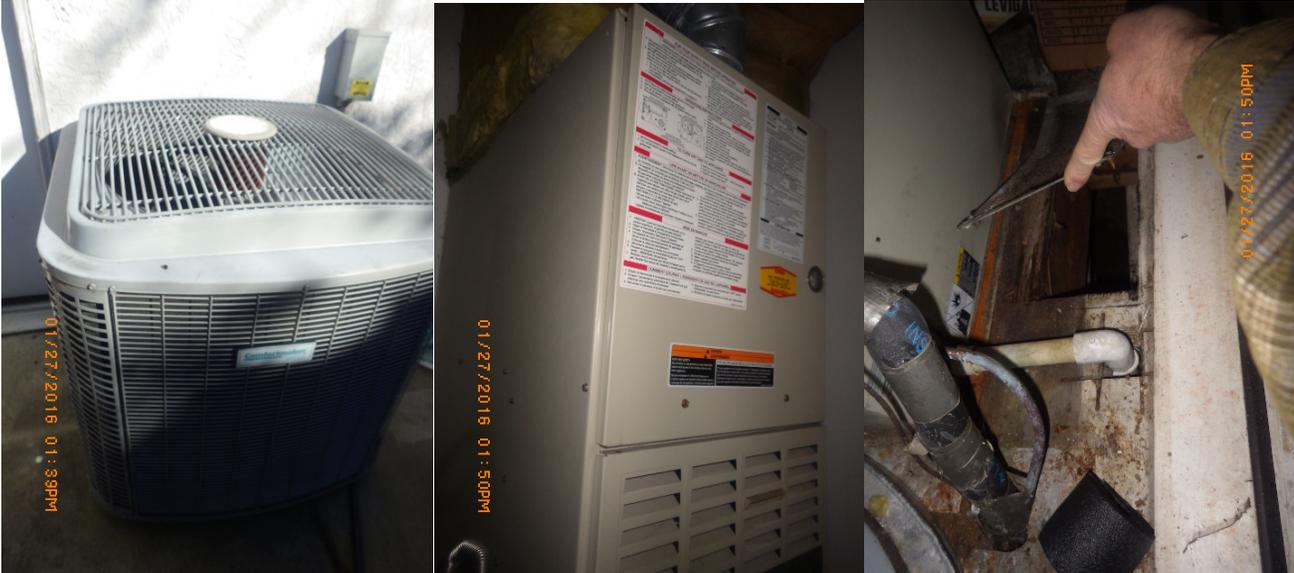
- The air conditioning system may require servicing in the spring to verify optimal performance. Air conditioners cannot be safely tested when the ambient temperature is below 60 degrees F. This system has not been regularly maintained.

- **Repair:** The outdoor unit of the air conditioning system requires cleaning.
- **Repair:** The air conditioning system requires servicing.

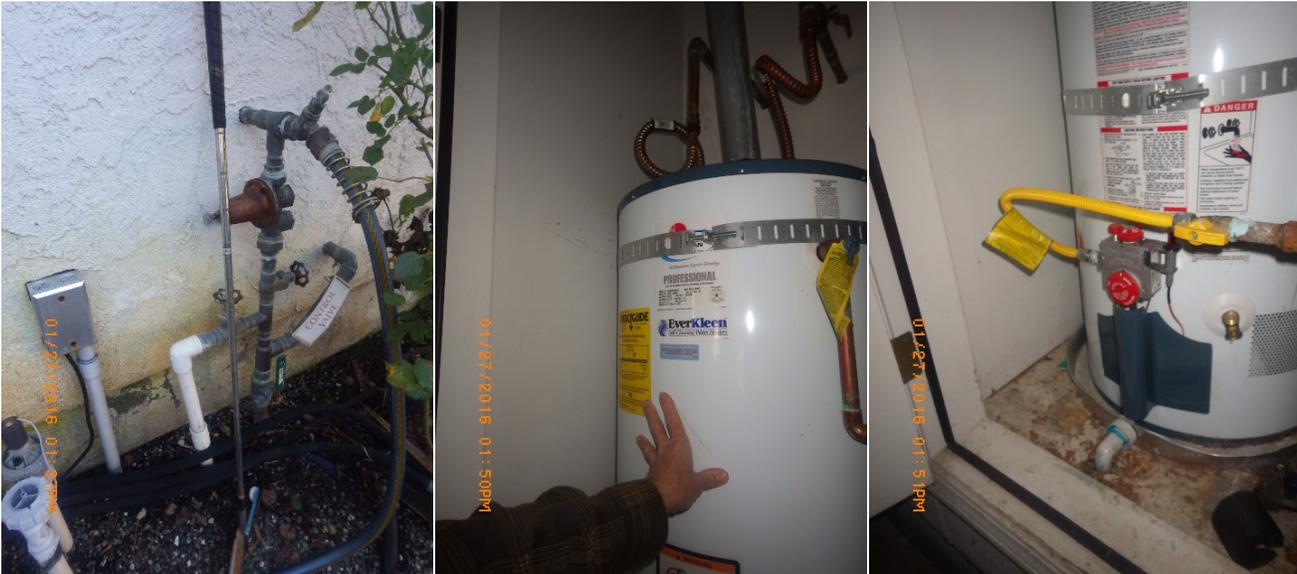
- **Deferred Cost Item:** Water heaters have a typical life expectancy of 7 to 12 years. The existing unit is approaching this age range. One cannot predict with certainty when replacement will become necessary. **This tank is not strapped properly.**
