Building Inspection Report

Inspection Date:02/24/2016
Prepared For:

Prepared By:
Napa Valley Home Inspections
28 Blossom Court West
Napa, Ca. 94558

Report Number:20161123
Inspector:Dean Alm

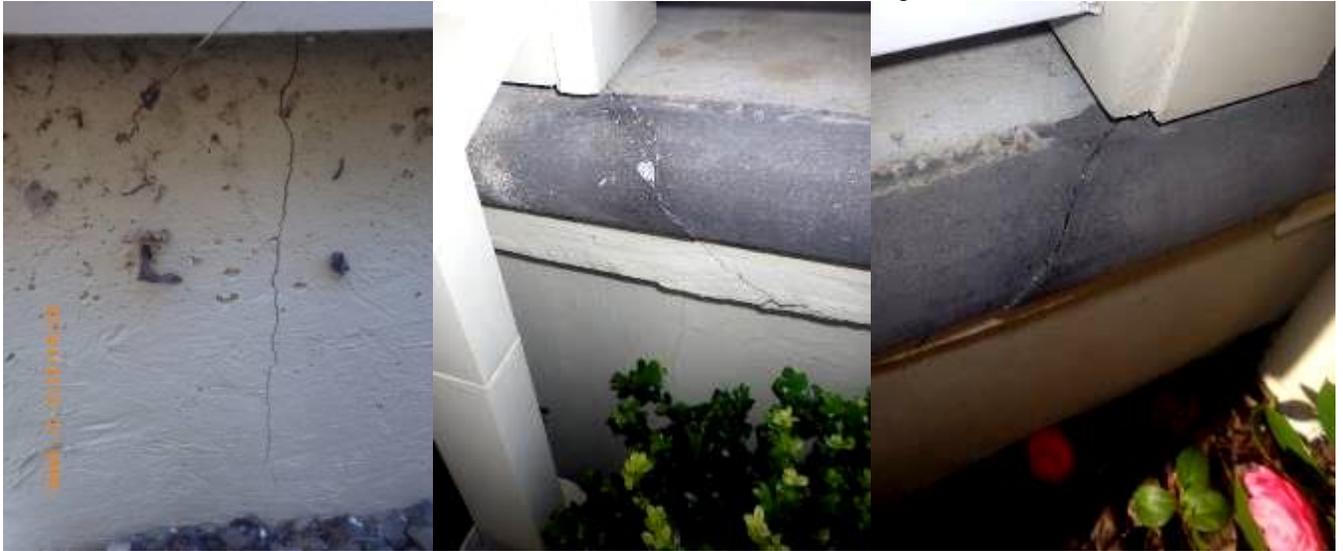
- **Monitor:** Minor hairline settlement cracks were observed in the foundation walls. This implies that some shrinkage has likely occurred. Cracks of this type should be watched for any sign of additional movement. In the absence of any sign of ongoing movement, repair should not be necessary.
- **Monitor:** Larger than typical 1/4-inch front deck settlement cracking was observed. The amount of movement which has occurred is not likely to have caused other damage to the structure but this area should be monitored. If additional movement occurs, more costly repairs might be necessary. The rate of movement cannot be predicted during a one-time inspection. These cracks may need sealing on the exterior to prevent moisture penetration.

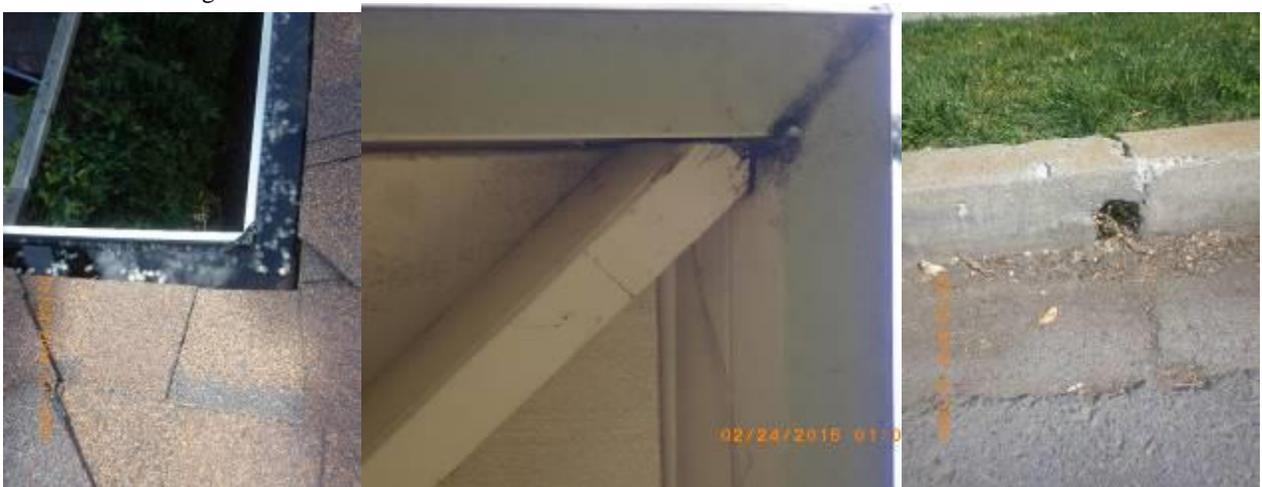
- **Repair:** The gutters require cleaning to avoid spilling roof runoff around the building – a potential source of water entry or water damage.

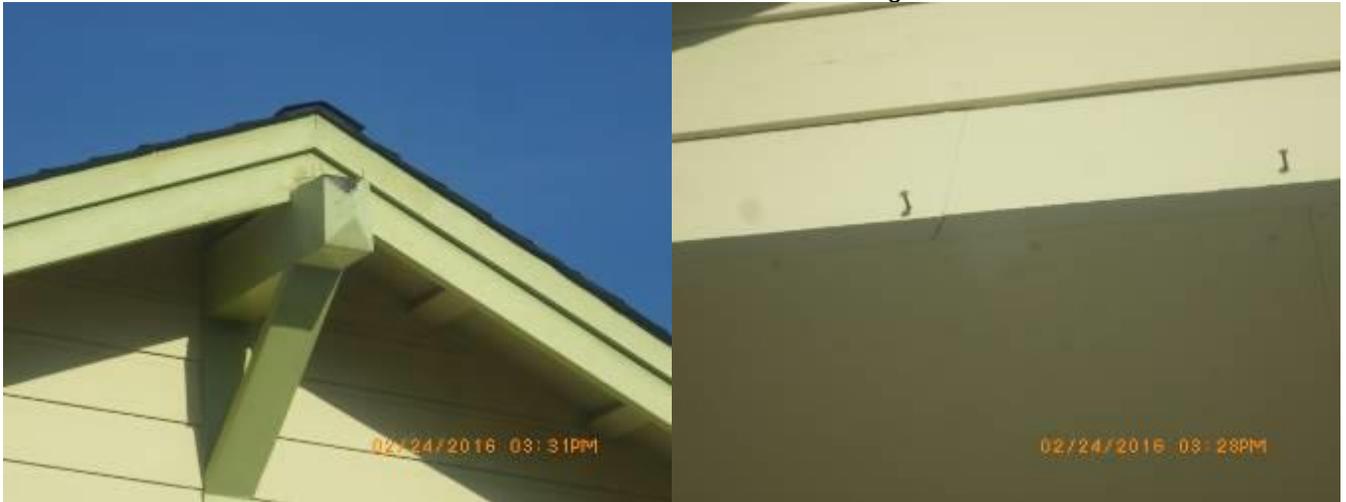
- **Major Concern, Repair:** The grading should be improved to promote the flow of storm water away from the house. This can often be accomplished by the addition or re-grading of clay at the perimeter. The ground should slope away from the house at a rate of one inch per foot for at least the first four feet. At least six (6) inches of clearance should be maintained between soil level and the bottom of exterior wall stucco.

Paint the tops of the craftsman accents (or use metalflashings) Remove all screws, repair penetrations.

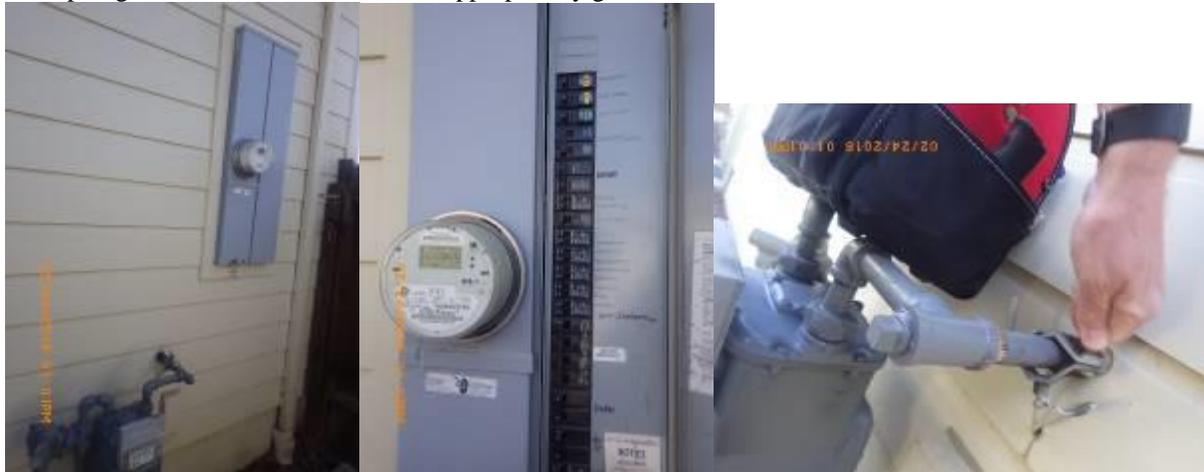
- **Repair:** The main distribution panel does not appear to be properly grounded/bonded. This should be investigated.
- **Smoke Detectors**
- **Repair:** It is suspected that the batteries in the smoke detectors are defunct. This should be investigated twice a year.
- **Safety Issue:** One arc fault circuit interrupter (GFCI) outlet did not respond correctly to testing during the inspection. This breaker should be replaced.

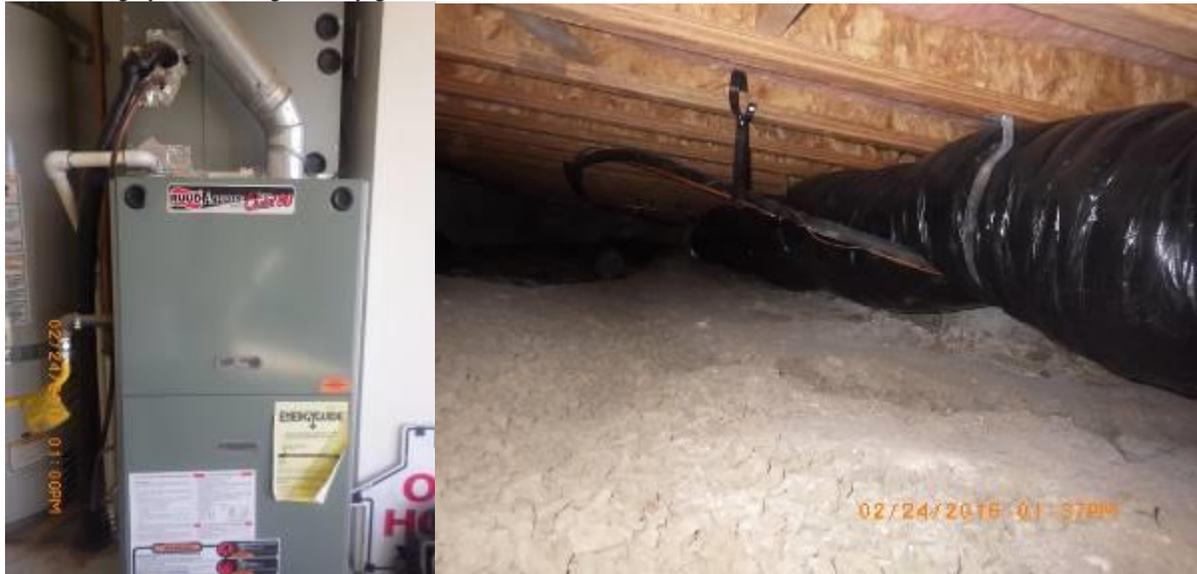
- **Repair:** The heating system requires cleaning & service. This should be a regular maintenance item to assure safe, reliable heat. Ask for service records and warranty info.
- **Monitor:** The dirty air filter should be replaced seasonally.

- **Repair, Safety Issue:** There is insufficient clearance between the exhaust flue and possible combustible materials (insulation). *This could be a fire hazard.* This condition should be checked by a qualified heating technician.

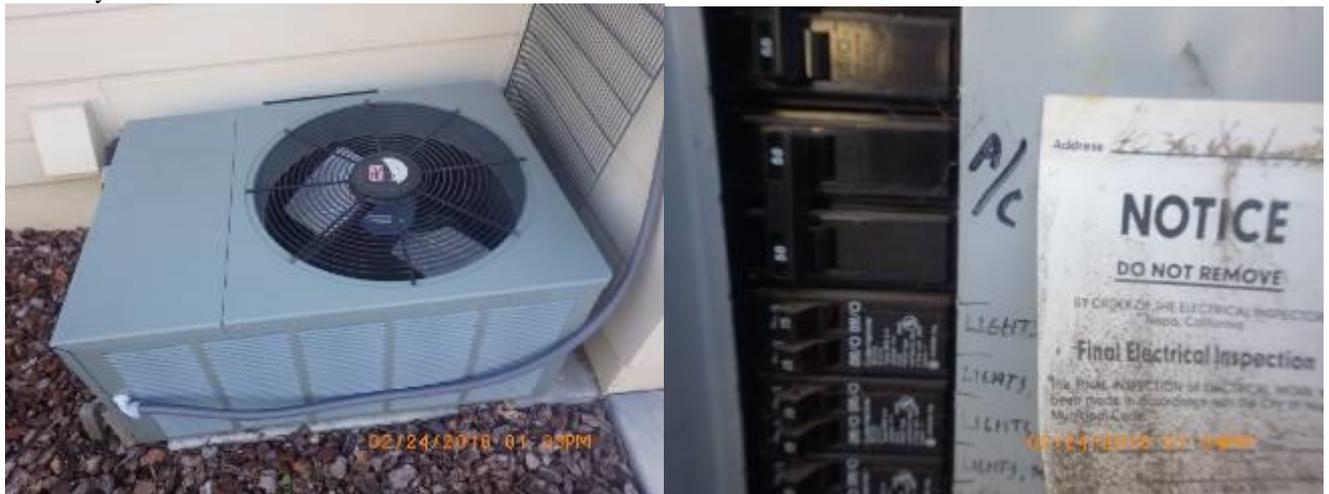
The breaker for the AC unit is oversized for the unit; max 35 amp breaker; 50amp breaker.

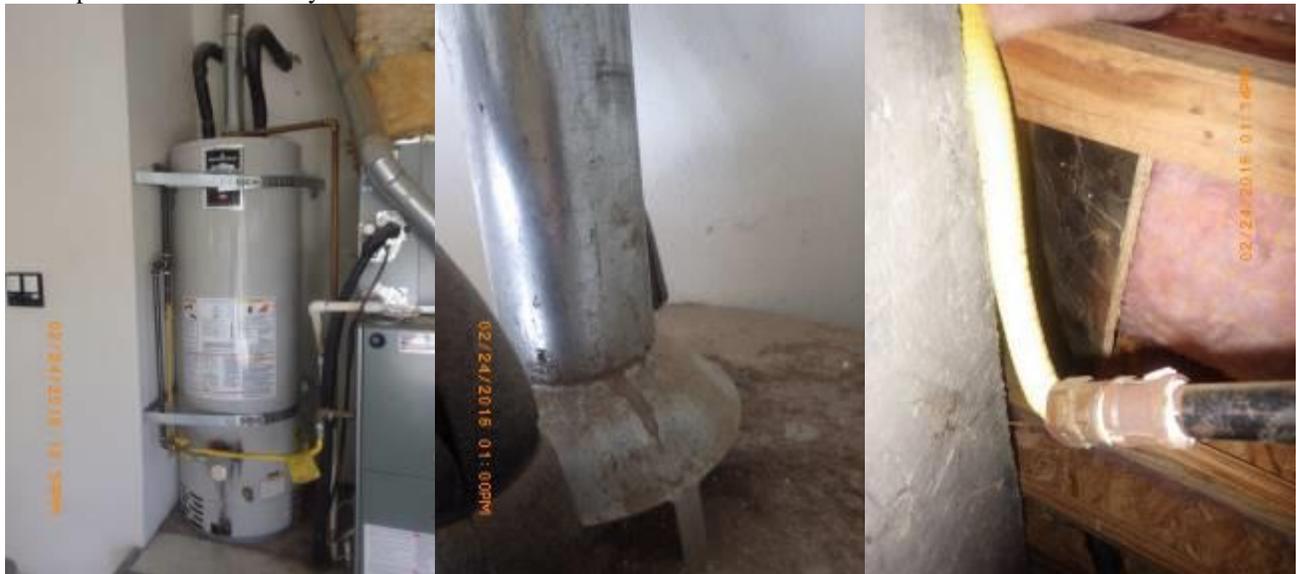
- **Repair:** For enhanced safety, it is recommended that the connections of the water heater venting system be improved. Missing screws. Upper strap should be 1/3rd of the tank down from the top.
- **Repair Safety Issue:** There is a gas line in the crawl space that rubs against the foundation and the floor joists. The line could get pinched and begin to leak gas, This is a serious hazard, repair asap.

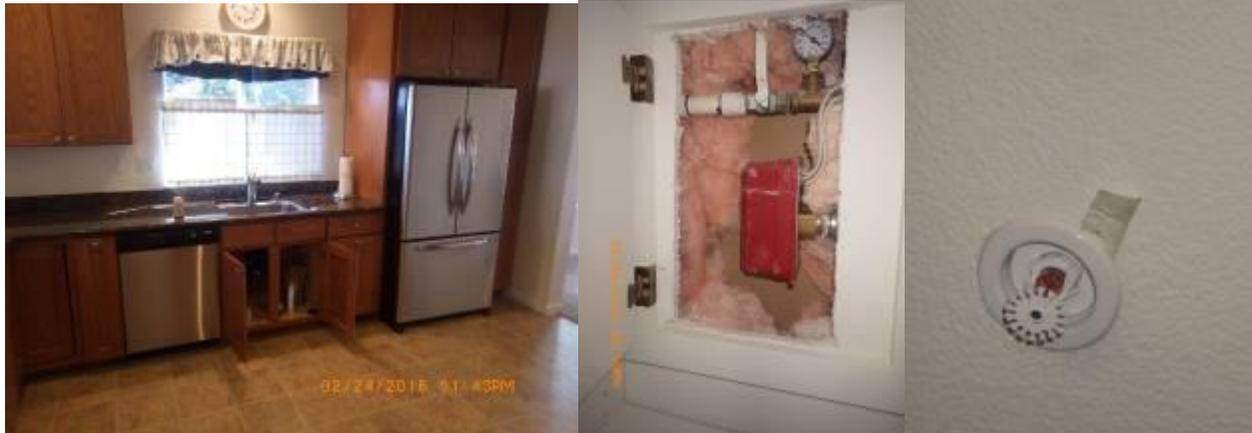
Fire sprinklers should be tested periodically by a qualified tech.
