Rugby Model Engineering Society Limited

Safety Investigation Report 01/2017

Passenger train derailment and coach overturn at birthday party event, 8th April 2017

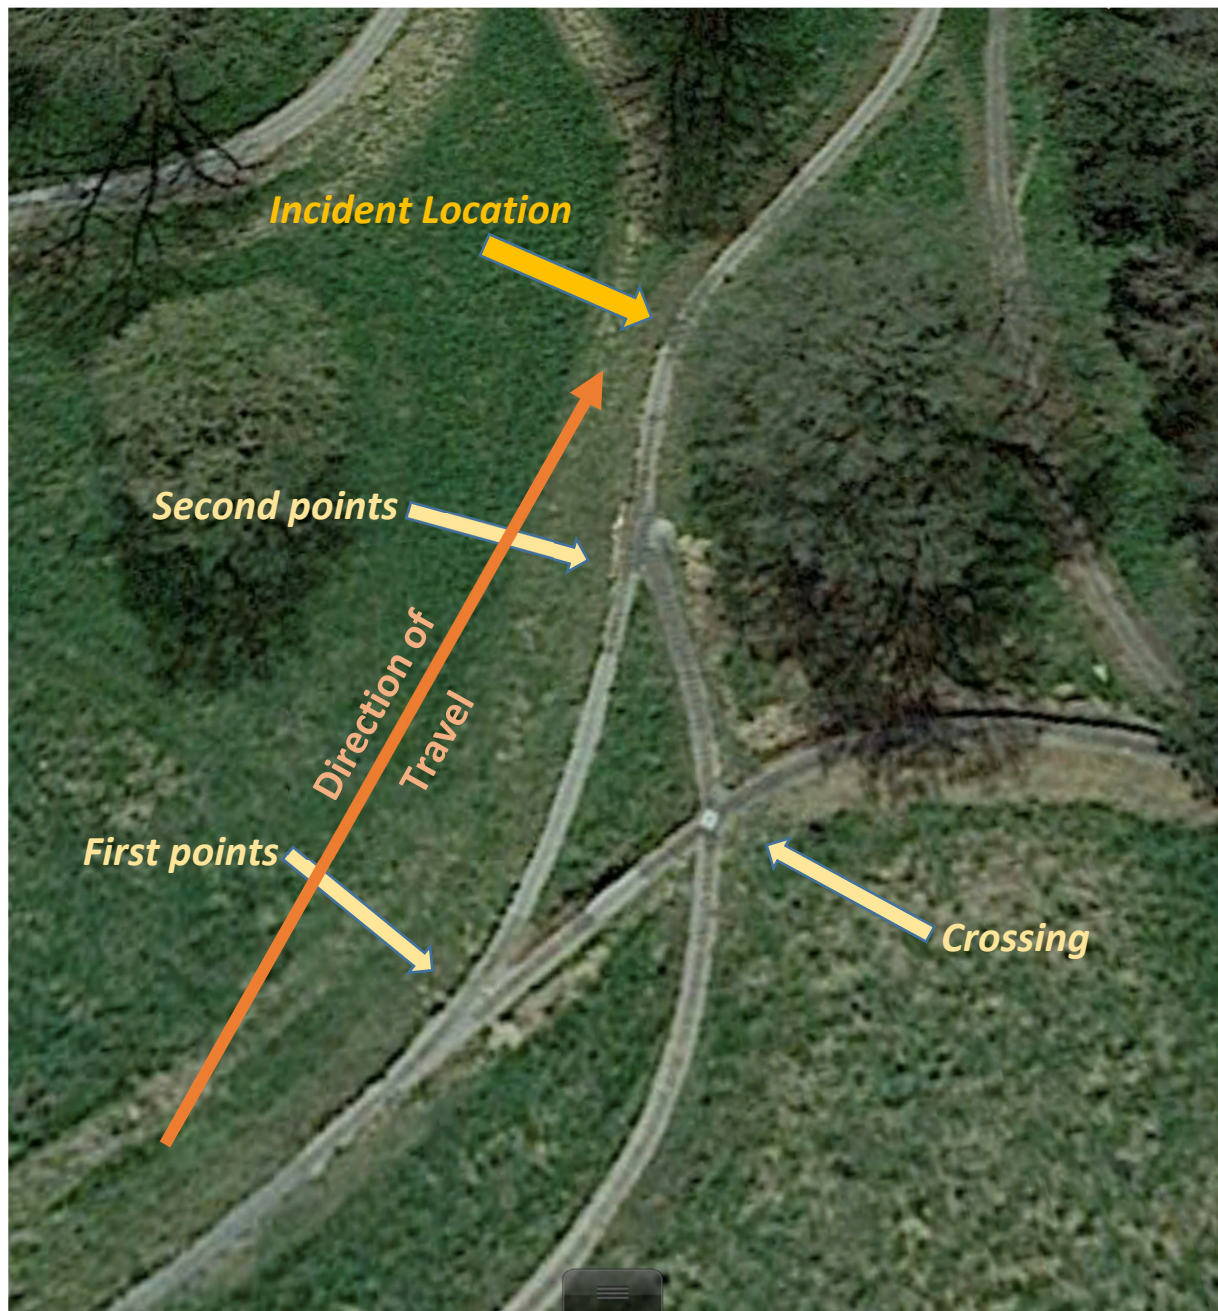
Figure 2: The Crossover Complex where the incident occurred

This incident occurred on a section of the track laid in the Autumn of 2016 known locally as the "crossover complex" adjacent to the proposed new station (see Figure 1) and designed to permit trains to enter or leave the station in either direction using different routes. The complex consisted of two sets of points and a crossing (see Figure 2). At the time of the incident the two sets of points were physically locked to permit operation only on the route selected for the event and the crossing was not used.

The complex was near the highest point of the layout and was approached via a series of curves on a climbing gradient and left by a further series of curves on a descending gradient. The incident occurred on the first, right hand, curve after the second set of points.

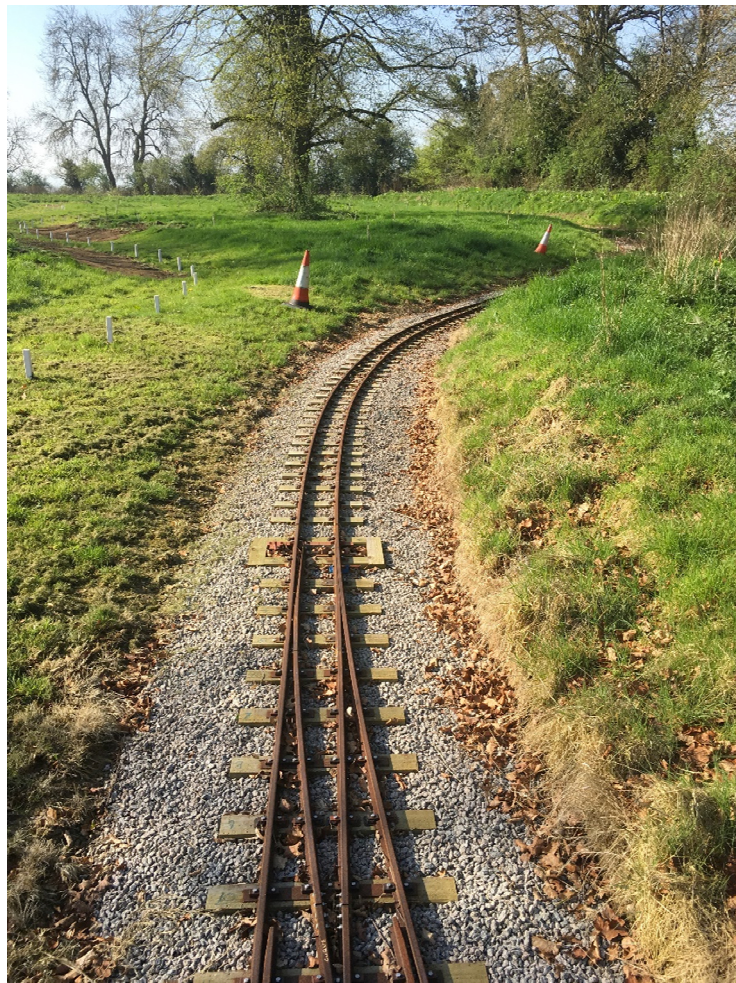
Figure 5: Track at the incident site. Coach 108 overturned between the cones.

During the site inspection, the radius of the curve where the coach overturned was found to be 50 Feet (15.2 metres).

In the “crossover complex” the priority was to get the correct relationship between the two sets of points and the crossing. The track was then connected to the complex but the tight curve from the end of the second set of points was not picked up at the time.

- a) RMES has imposed a temporary speed limit of 4 MPH through the “crossover complex” to be re-assessed following track repairs and easement of the curve;
- b) RMES has commenced a review of first-aid provision at public events.

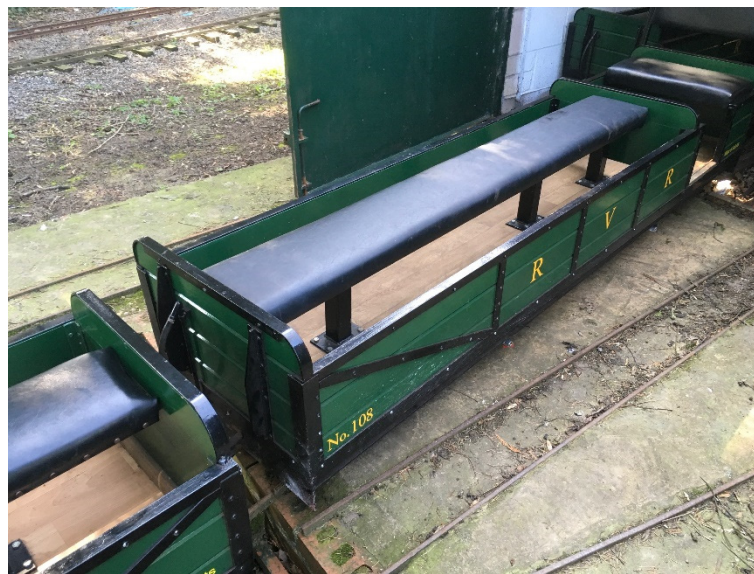
Figure 6: Coach 108 pictured during post incident inspection.

The coach that overturned, No. 108, was found to weigh 211 Kg and the centre of gravity estimated to be 350mm above the railhead. The seat height was 440mm above railhead level.

Post incident inspection of both coaches involved showed no defects that might have affected the stability of the vehicle and only superficial damage caused by the incident.

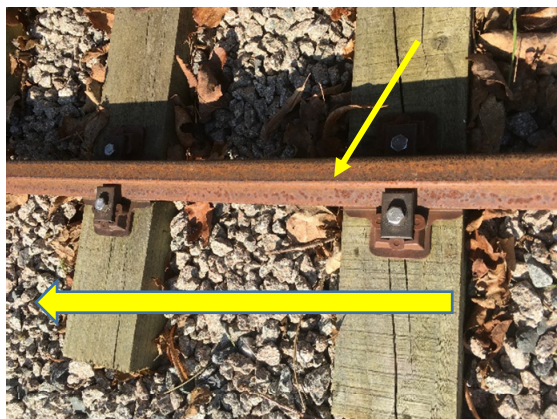
Figure 8: Witness mark on outside edge of left rail. Arrow shows direction of travel.

At approximately 6.2 metres from the end of the second set of points there was a light witness mark on the outer edge of the left rail. This continued for 2 metres and suggests that a vehicle had transferred its weight to the outer edge.

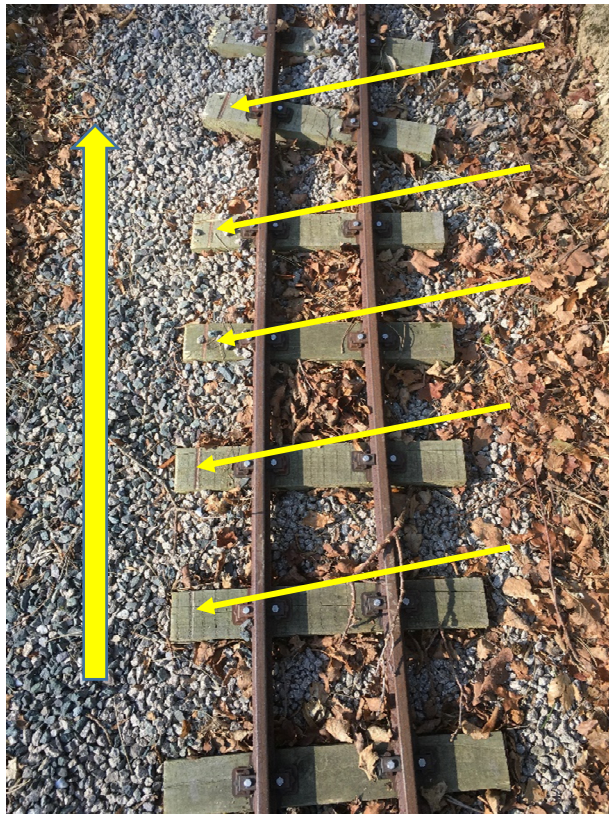
Figure 9: Witness marks on left end of sleepers

At 8.5 metres from the end of the second set of points there were witness marks of something striking the top of the sleepers with increasing force. At first this was thought to have been caused by a derailed wheel but later tests showed that it was more likely the front vacuum release valve and/or the lowest point of the coach underframe. This continued for approximately 1.2 metres after which the sleepers started to be displaced by either the front crossmember of the coach or the front bogie.

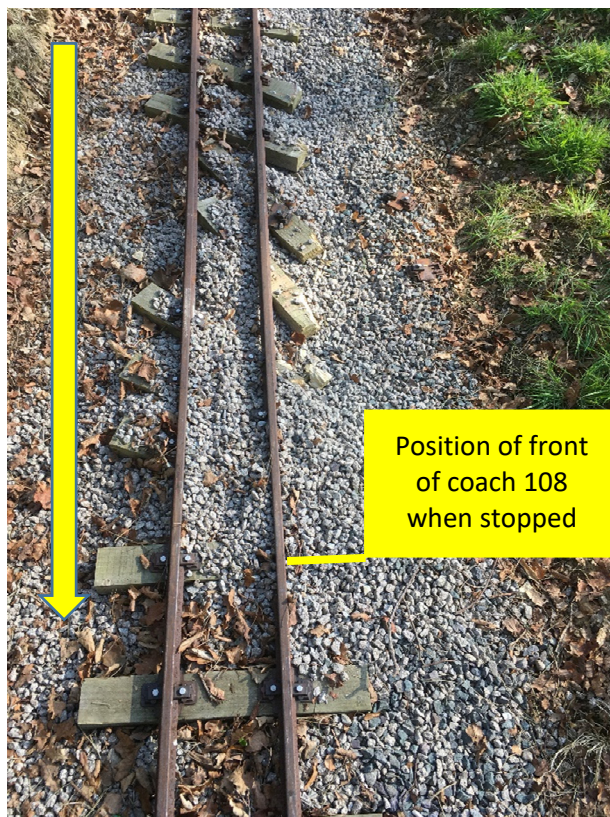
Figure 10: Displaced sleepers and ballast

The track was severely disrupted over approximately 3 metres with sleepers and ballast displaced.

Once the sleepers were being struck and displaced the train quickly stopped with its front edge 11.5 metres from the end of the second set of points and resting on its side against the shallow embankment to the left of the track.
