Broken Head Quarry

Enforceable Undertaking Progress Report

Report #1 – August 2018

Environmental Monitoring Report

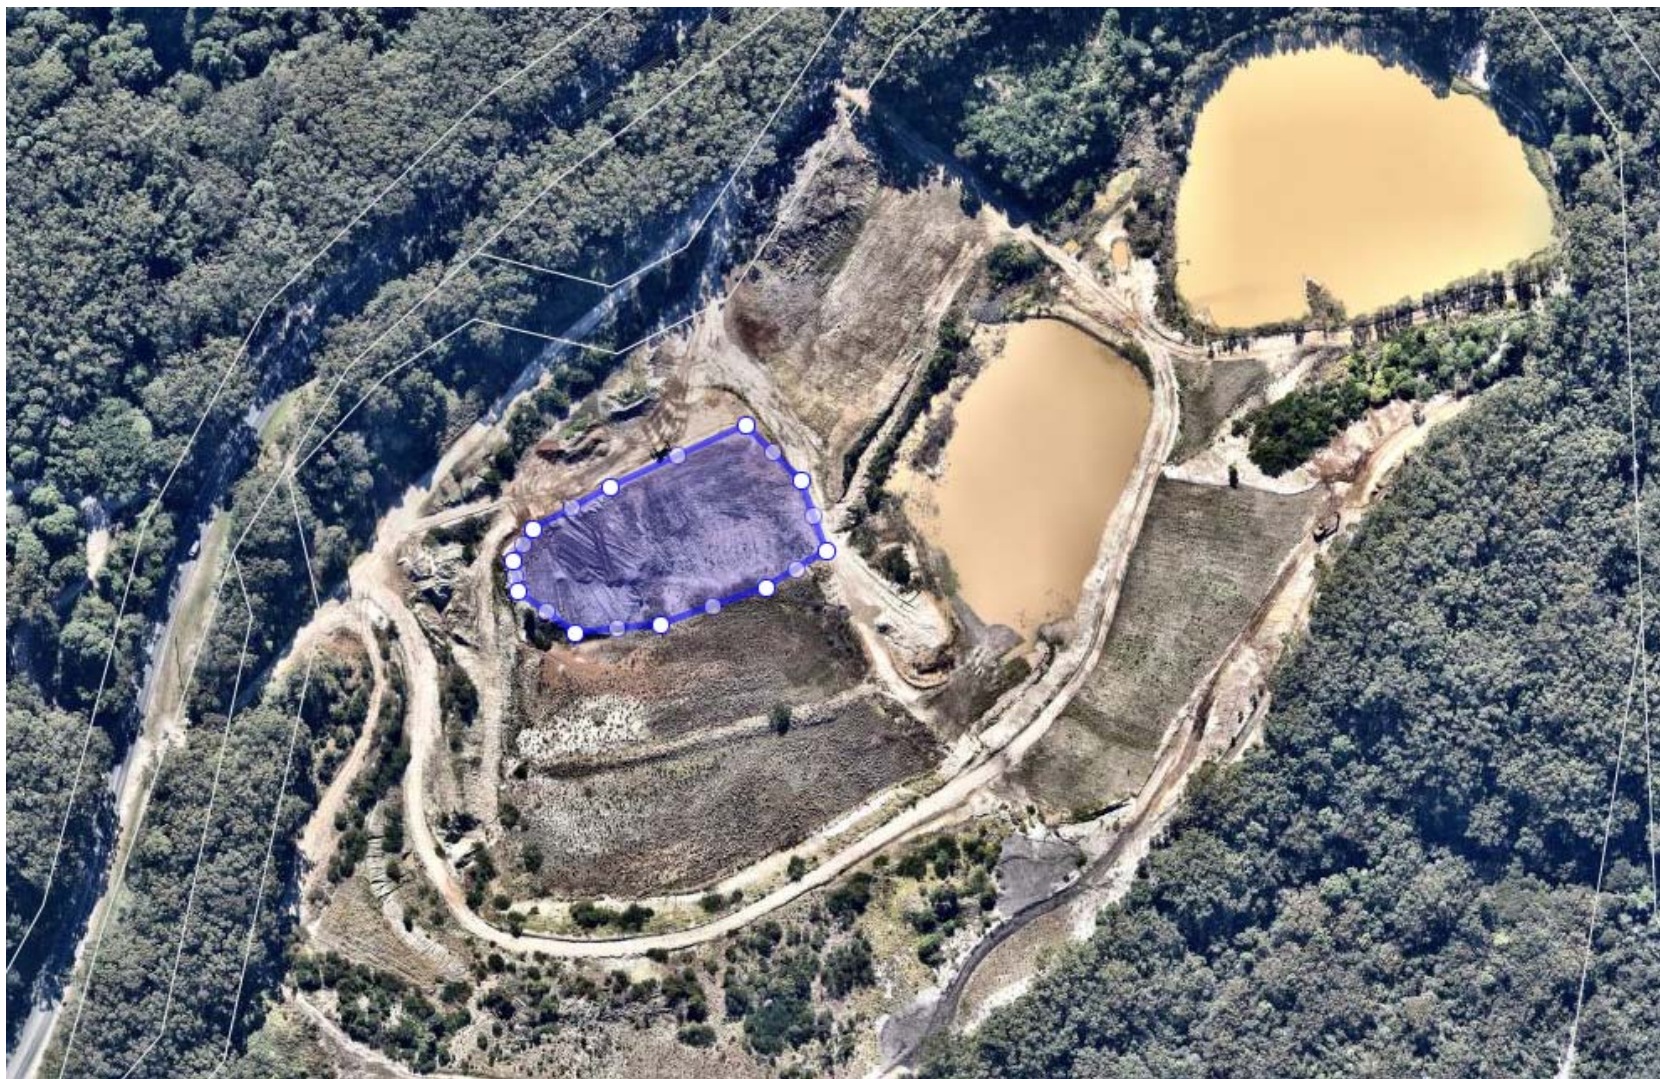
Figure 1 - Eastside Batters

- Finalisation of batter placement, topsoiling and track rolling in the following area on the Eastside:

The following areas shown in Figure 1 - Eastside Batters, Figure 2 - Eastside Batters and Drain and Figure 3 - Eastside Reshaped Batter were hand seeded with grass following completion of the final landform and water cart irrigated.

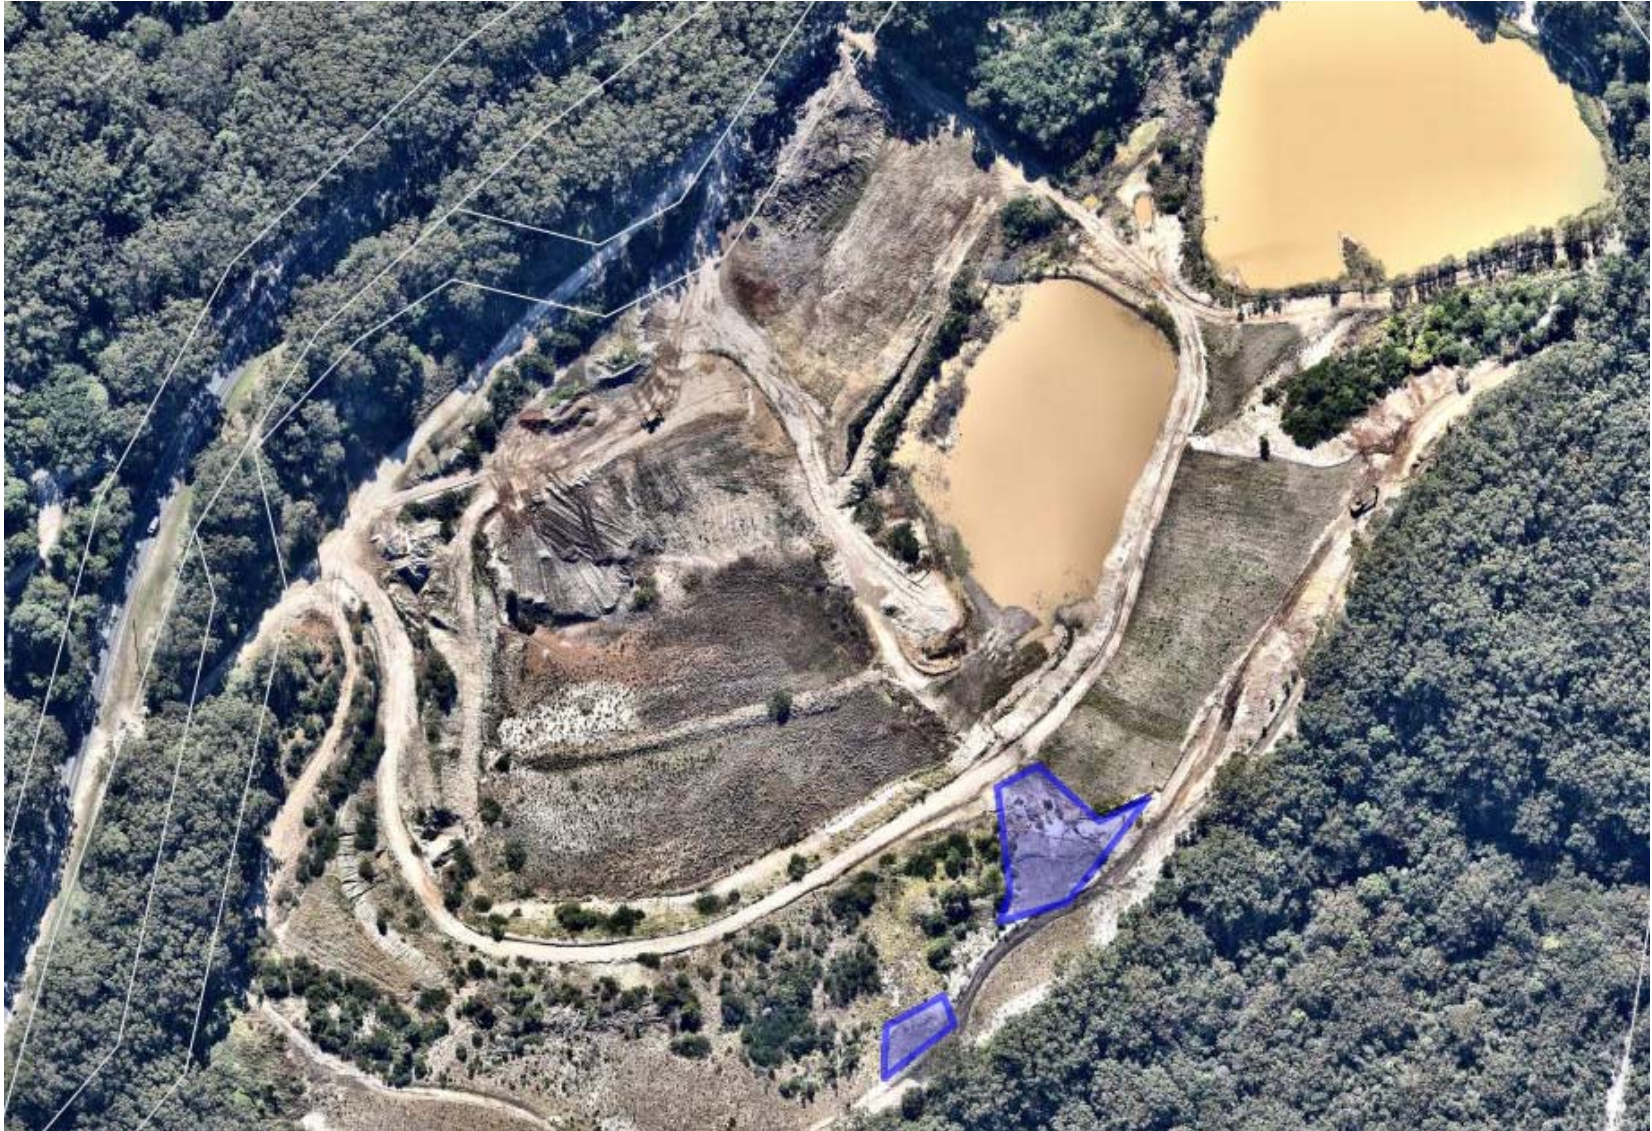
Figure 2 - Eastside Batters and Drain

- finalisation of batter reshaping and topsoiling and drain formation in the following area on the Eastside:

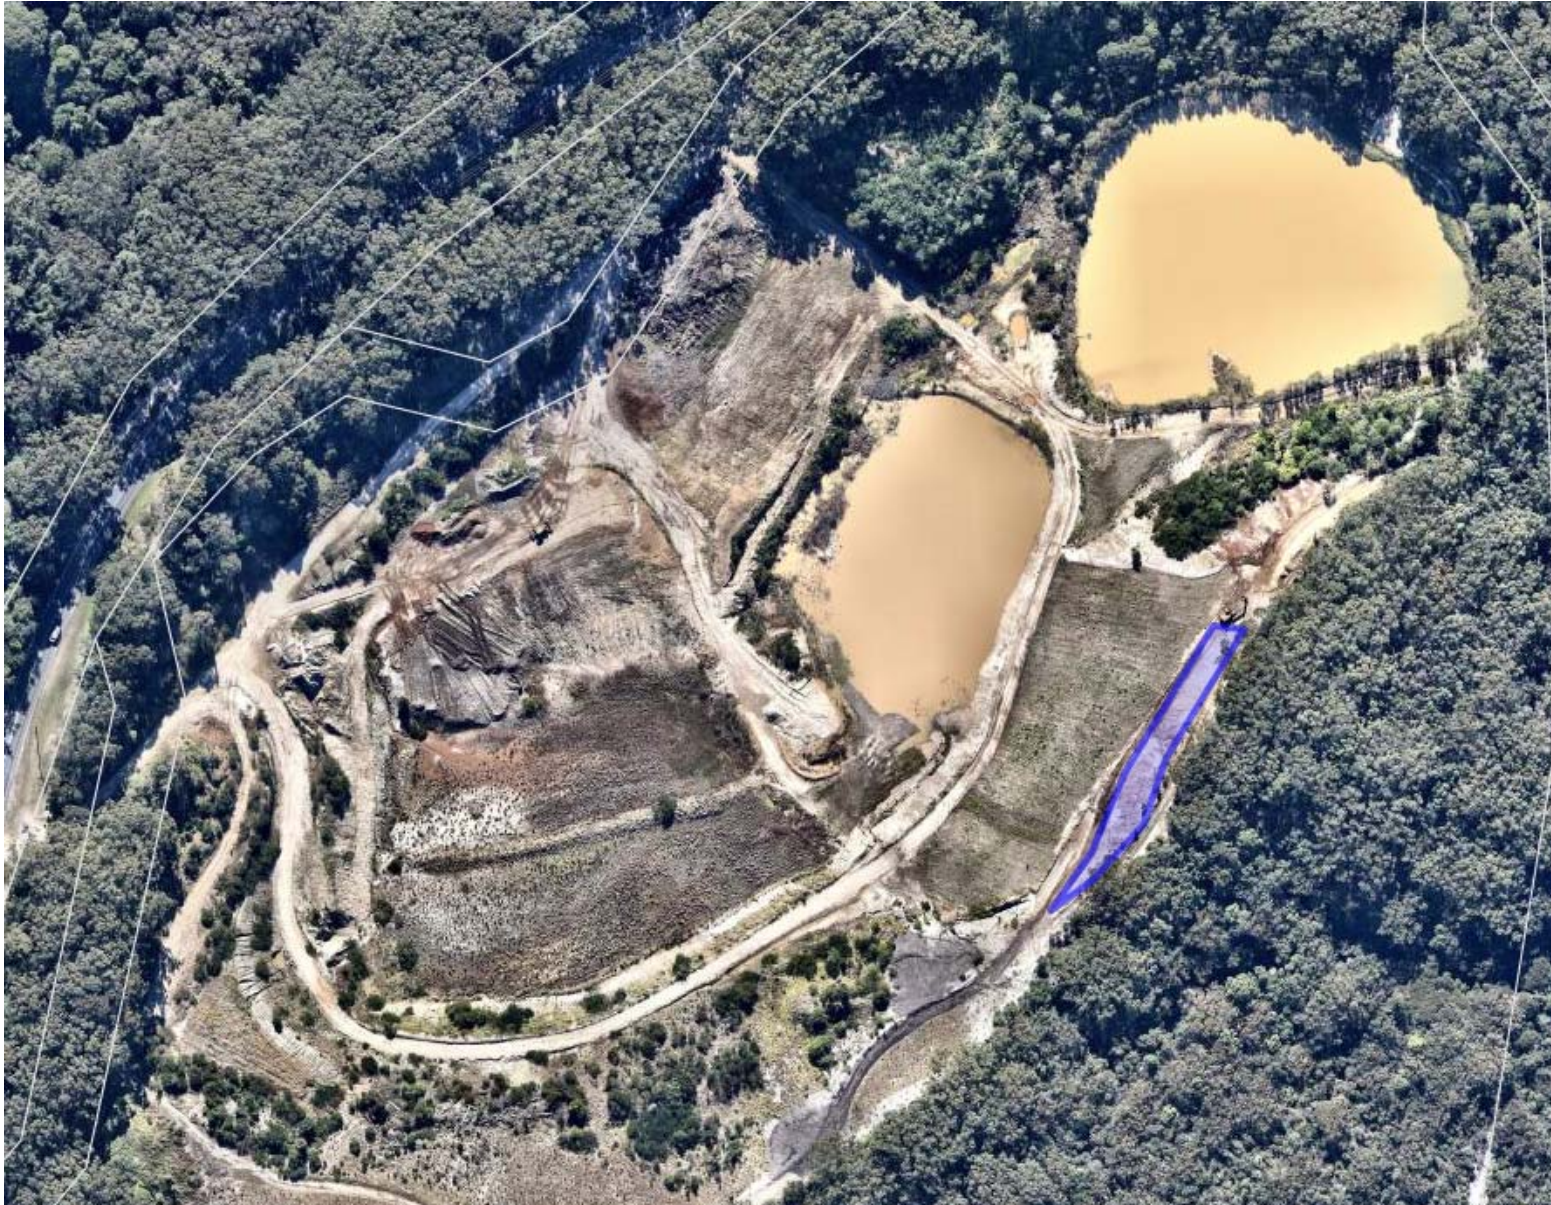
Figure 3 - Eastside Reshaped Batter

- batter reshaping and placement in Area 2 on the Rehabilitation Works Plans and Specifications as shown below:

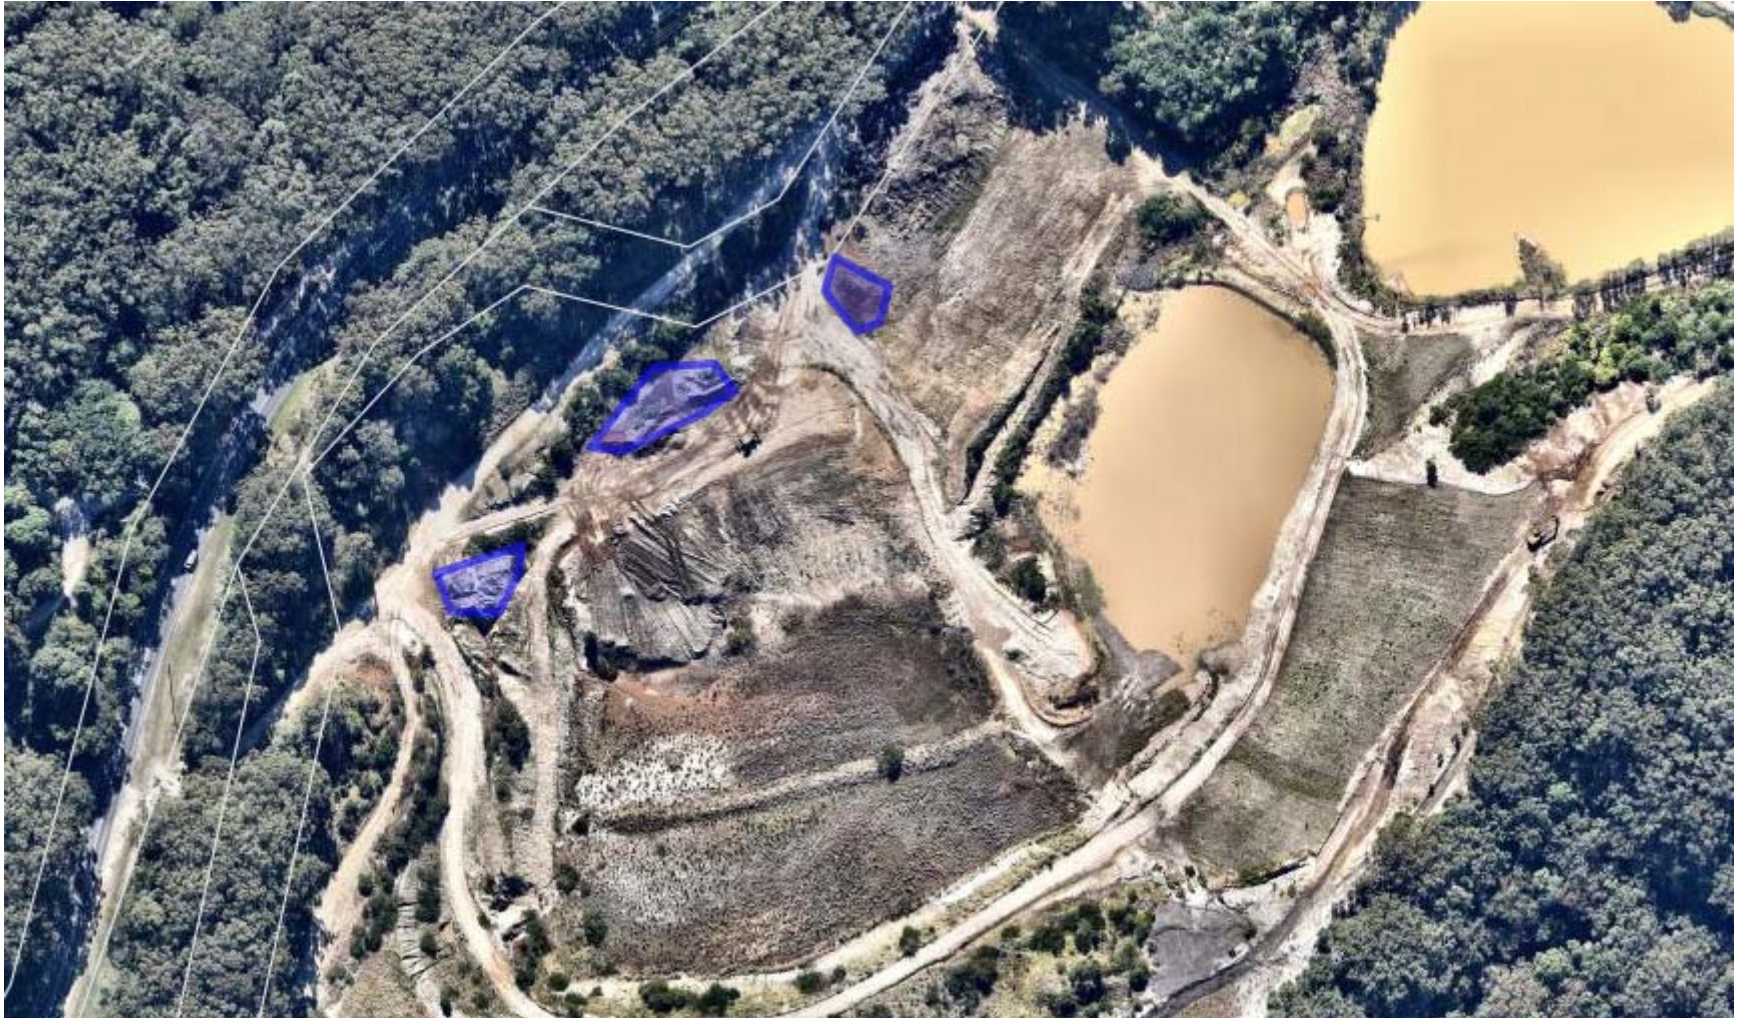
Figure 4 - Stockpile Removal

- rebuilding of the drain crossing the road east of Sediment Pond No 1 on the Eastside to channel runoff into Sediment Pond No 1 without erosion of the road, and some re-profiling of the road (in the area below that shown in Figure 2 - Eastside Batters and Drain:
- removal of material stockpiles formerly located in the following areas on the Eastside:

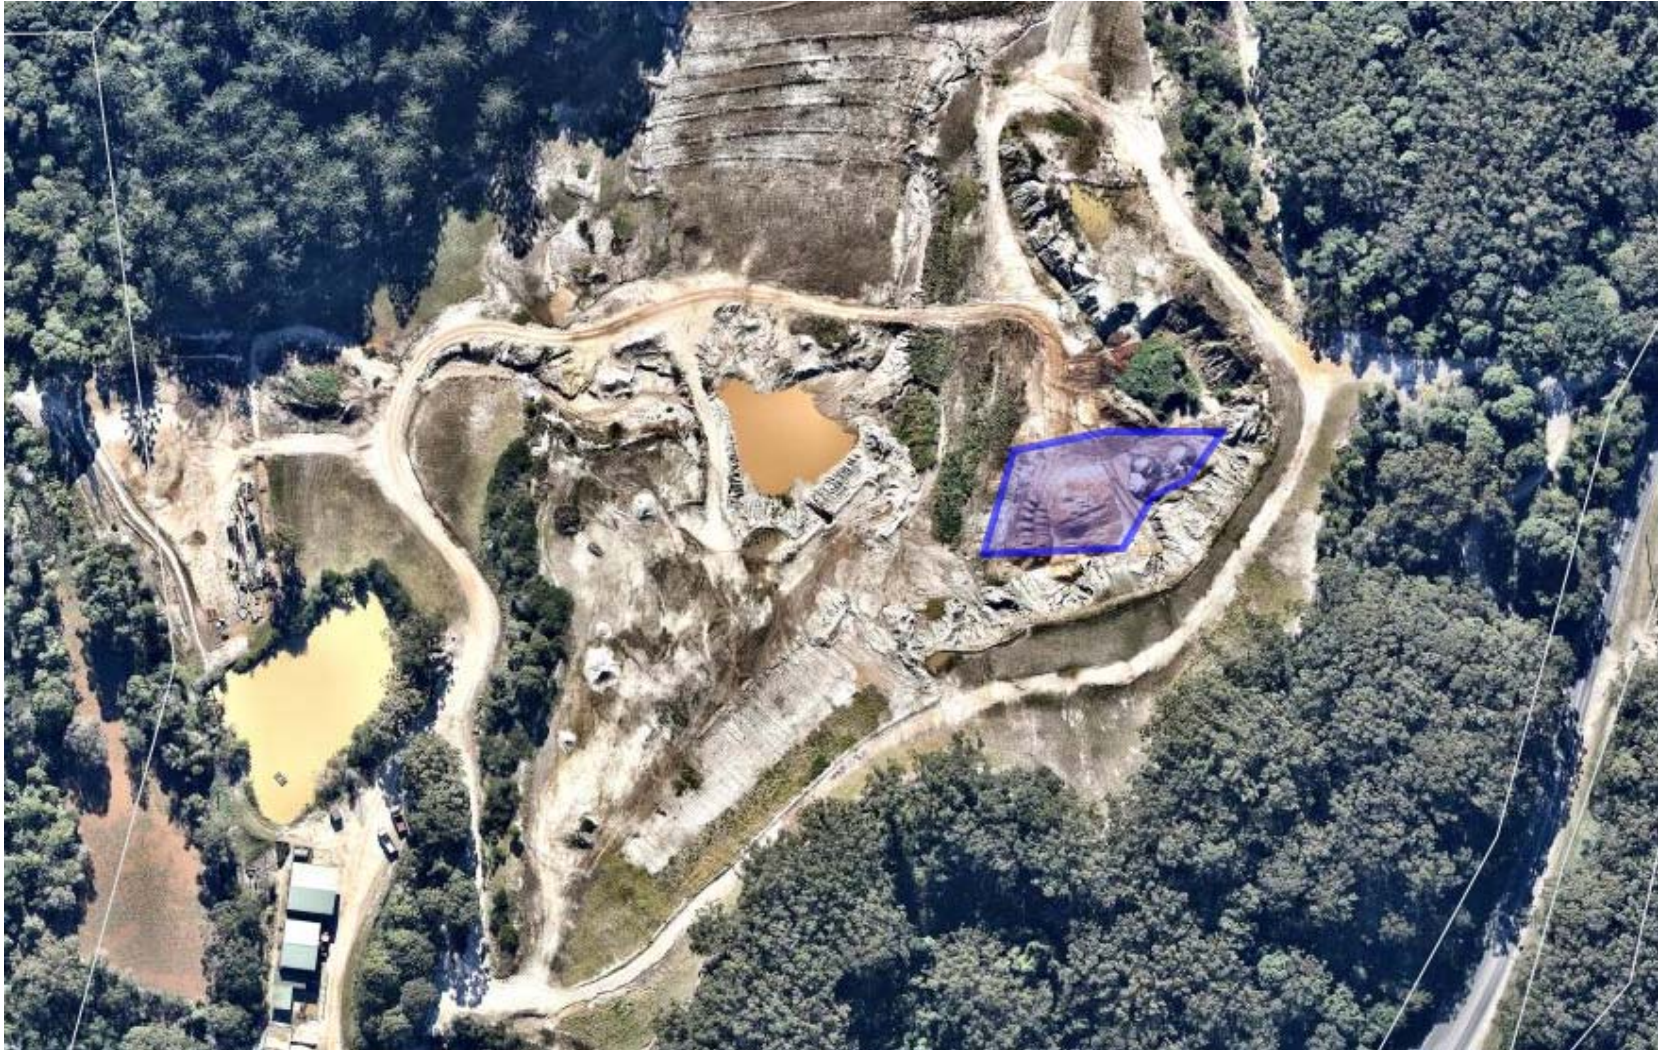
Figure 5 - Westside Fill Area

- receipt of clean fill and temporary placement in the large fill receipt areas in the following location on the Westside:

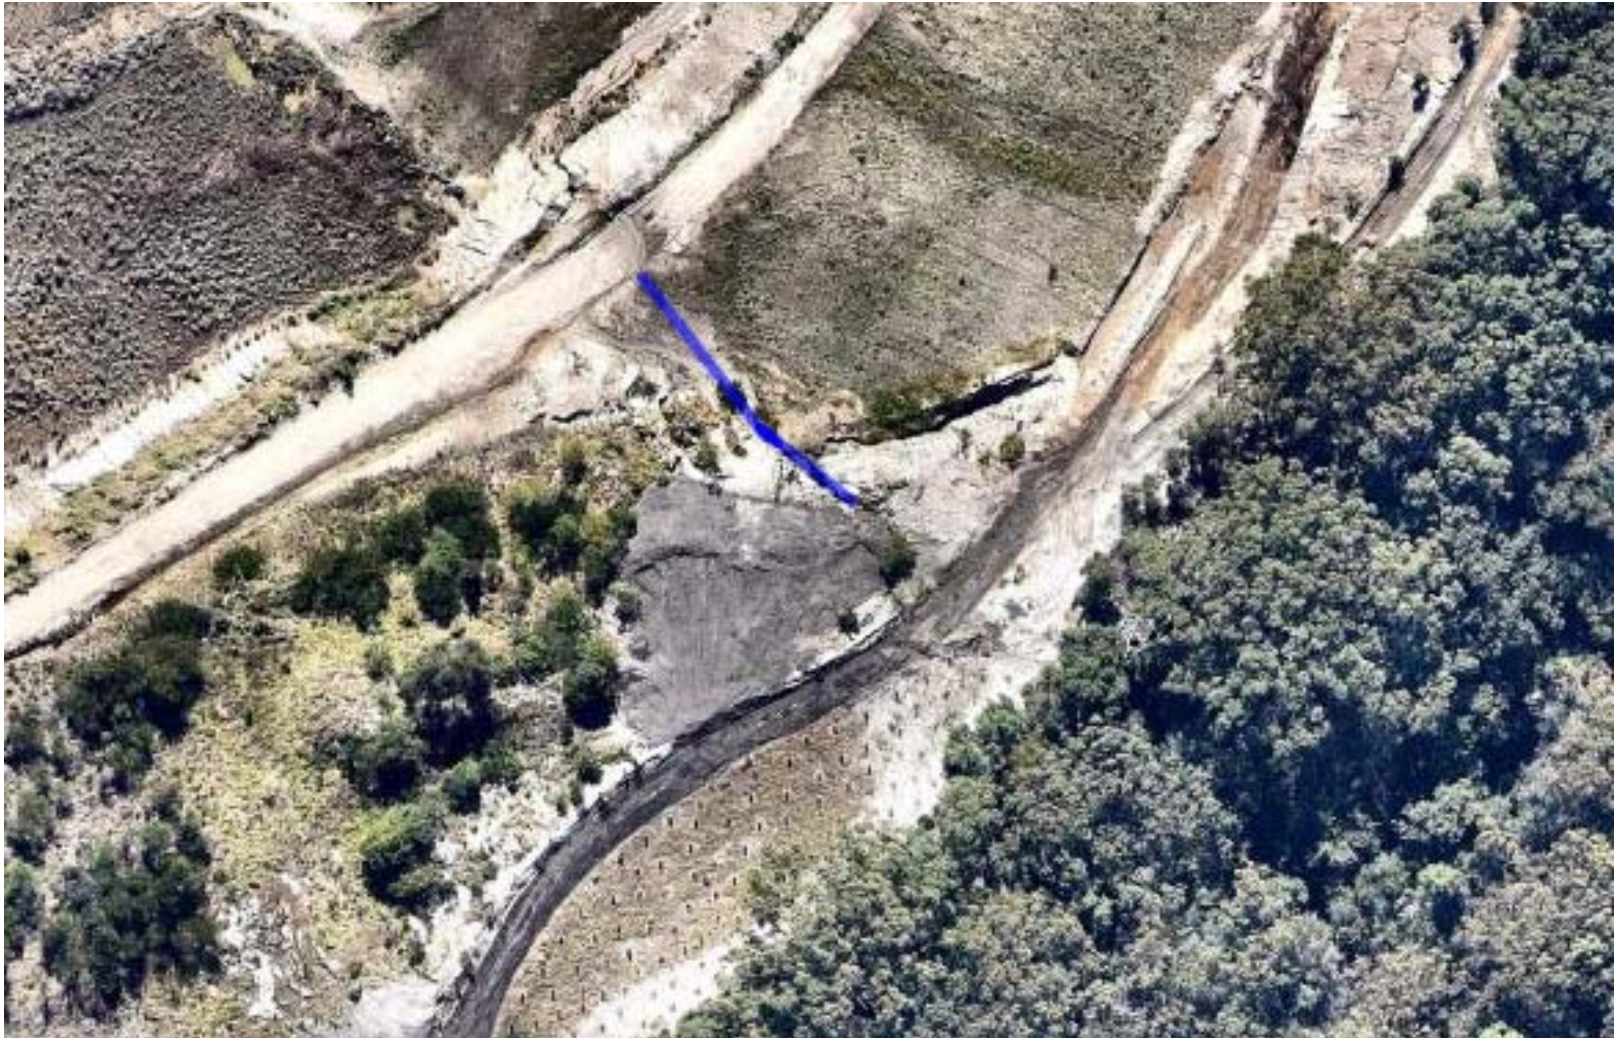
Figure 6 - Eastside Drain Location

- On 31 August 2018 a new drain in the following location of the eastside was installed:

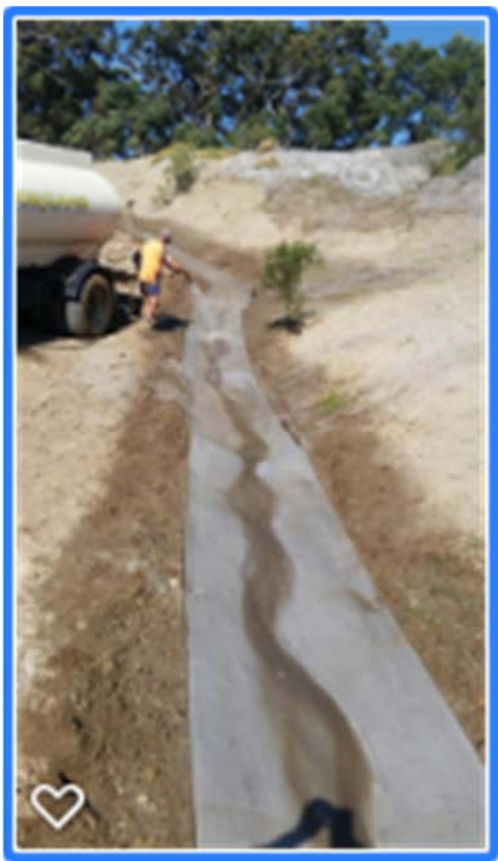
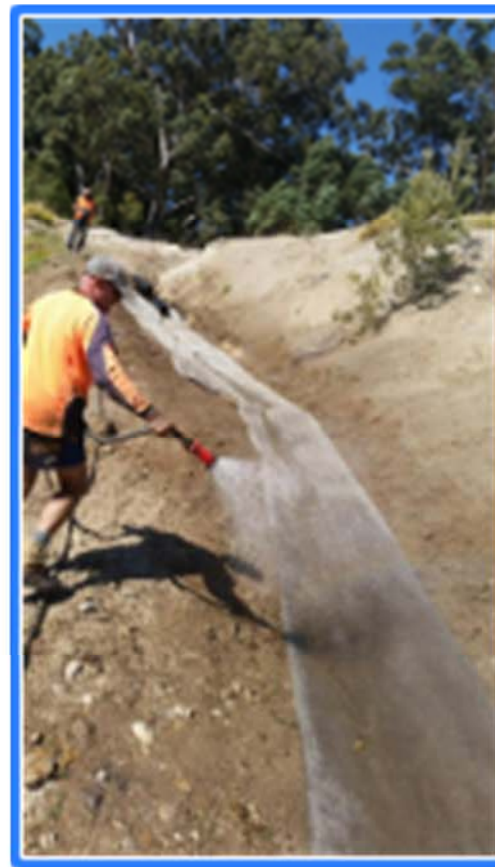
Figure 7 - Eastside Drain Installation

- An order was placed for 100 lineal metres of “concrete canvas” drain lining material to enable urgent drain formation and lining of the new east side drain (located between areas 2 and 5a on the Rehabilitation Works Plans and Specifications) in anticipation of heavy rainfall in the forthcoming week. Arrangements made for additional staff and equipment to be on hand to apply the product. This product was installed on 31 August and is reported on below.

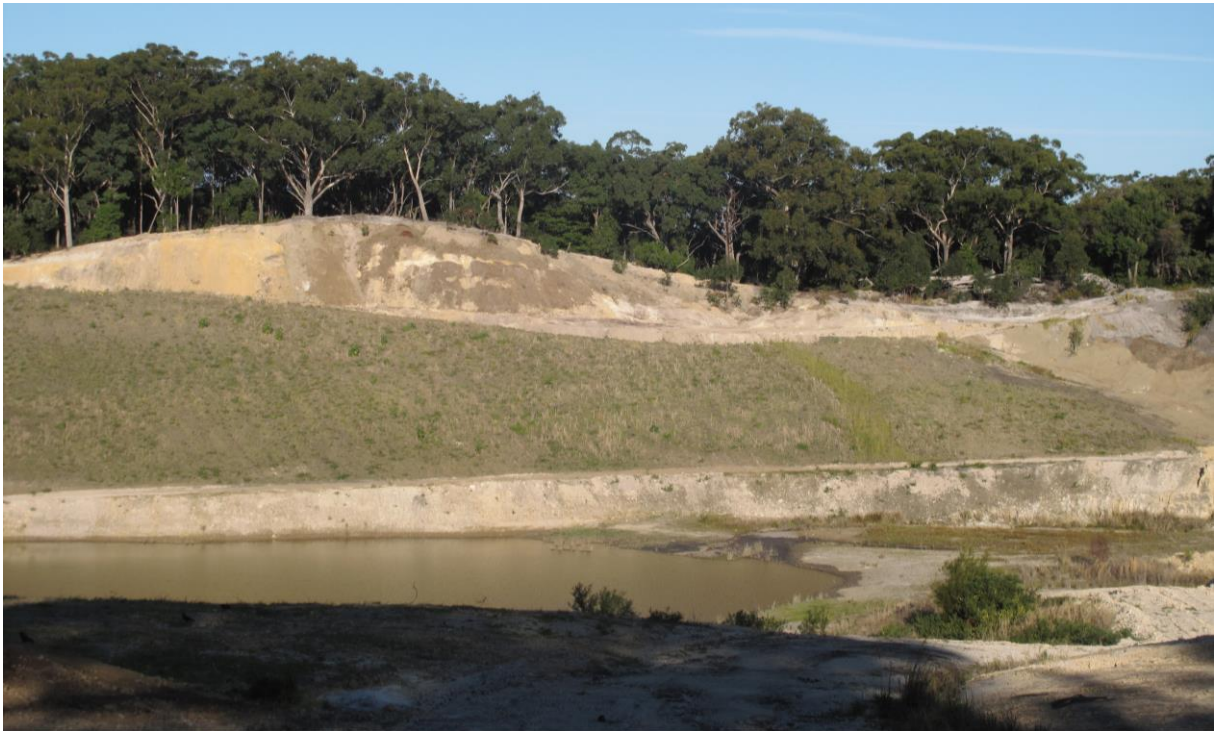
Since the previous monitoring event additional reprofiling has been undertaken in some areas with steep quarry faces reshaped to form gentler, albeit still relatively steep, slopes. The majority of exposed unvegetated areas on both sides of the quarry were recently hydromulched with a grass seed mix to stabilise soils and provide vegetative cover.

PLATE 1 RECENTLY HYDROMULCHED HILLSLOPE IN THE EQS

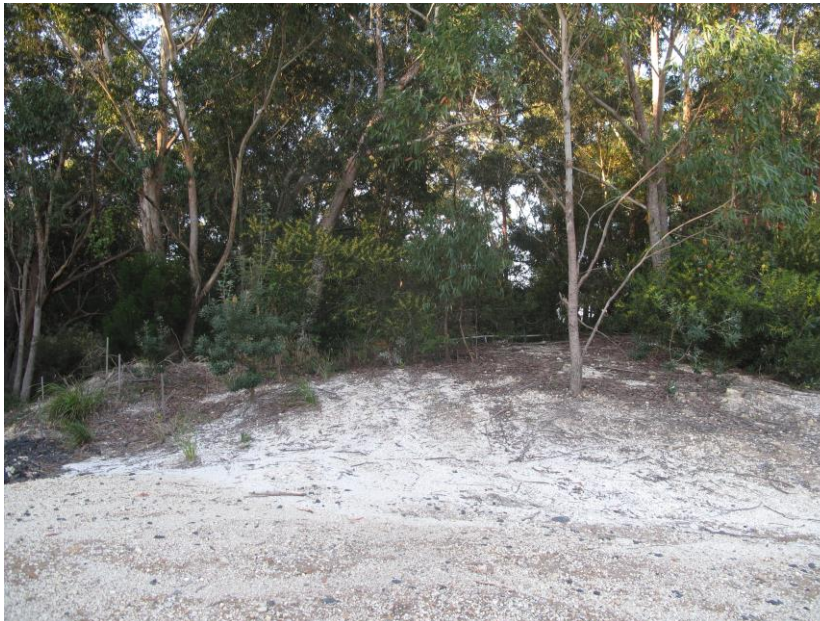
PLATE 5: Development of vegetation cover on exposed stony hillside, Area RE1, Aug 2018

Plantings on the stony hillside continue to develop slowly and there is some leaf litter buildup. Although there is little natural recruitment in these difficult conditions, a number of planted trees are very well established with Blackbutt, Turpentine, Coast banksia and Blackwood wattle forming an open canopy. Conditions will improve as leaf litter and organic material continues to build up.

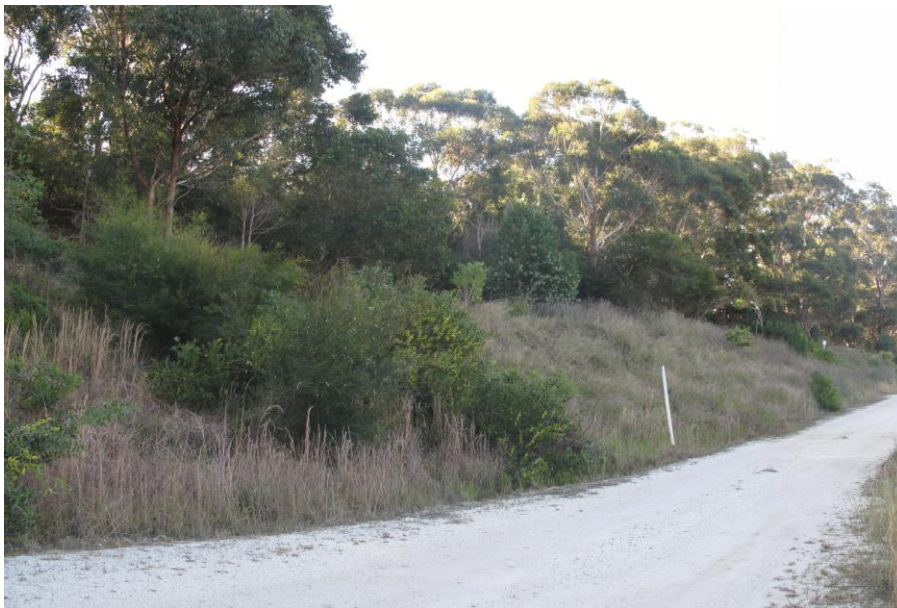
PLATE 7:
Rehabilitation
area RE2,
Aug 2018

Gaps should be planted with suitable species able to cope with harsh conditions which this slope is exposed to. Suitable species include Sweet pittosporum, Cheese tree, Coast banksia, Persoonia, Narrow-leaved wattle, eucalypts and Brush box.

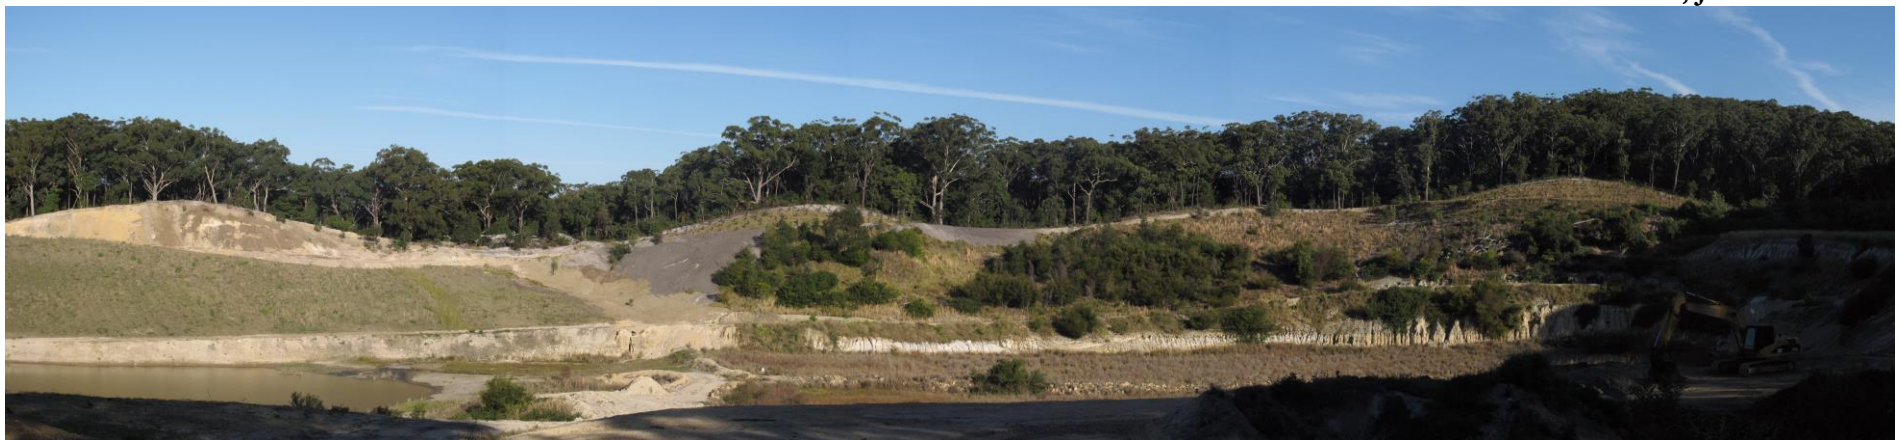
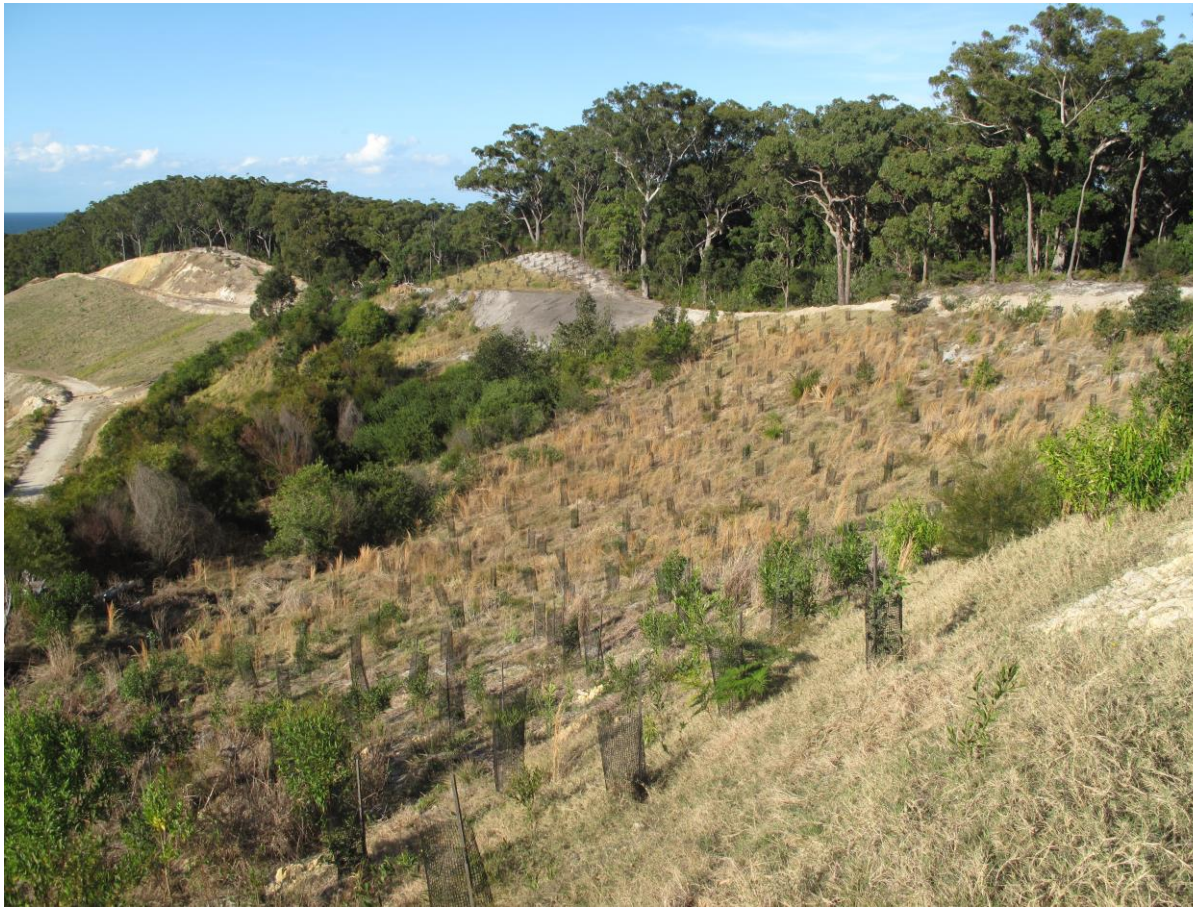
PLATE 9 REHABILITATION AREA RE3, AUG 2018

PLATE 10: Area RE3, August 2018

Acacia species planted on the upper slopes in January 2018 have generally become established although there have been some losses in the dry conditions. The majority of planted specimens were alive at the time of monitoring with an estimated survival rate of about 90%. Natural recruitment has been good with Hopbush plentiful as well as Prickly moses, Narrow-leaved acacia, Satinash and Swamp hibiscus. Couch cover is helping to minimise erosion and Whiskey grass is only occasional.

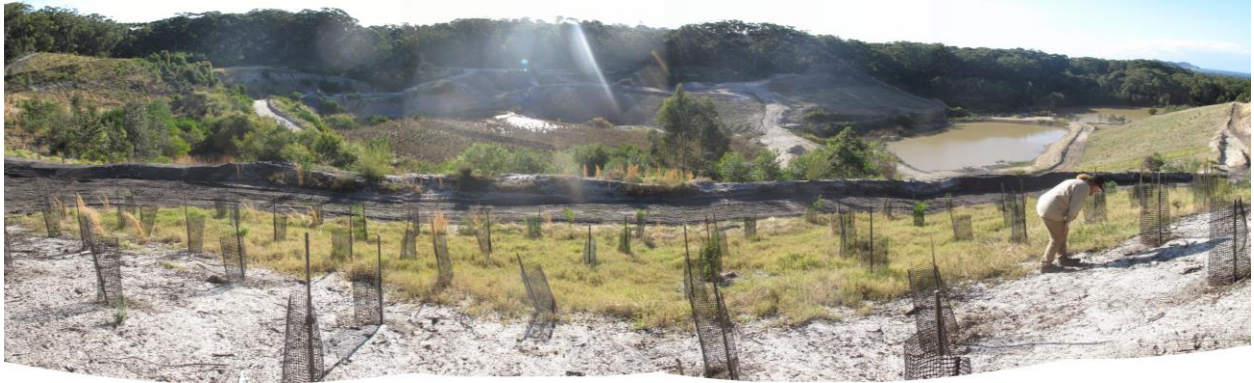
PLATE 11 REHABILITATION AREA RE4, AUGUST 2018

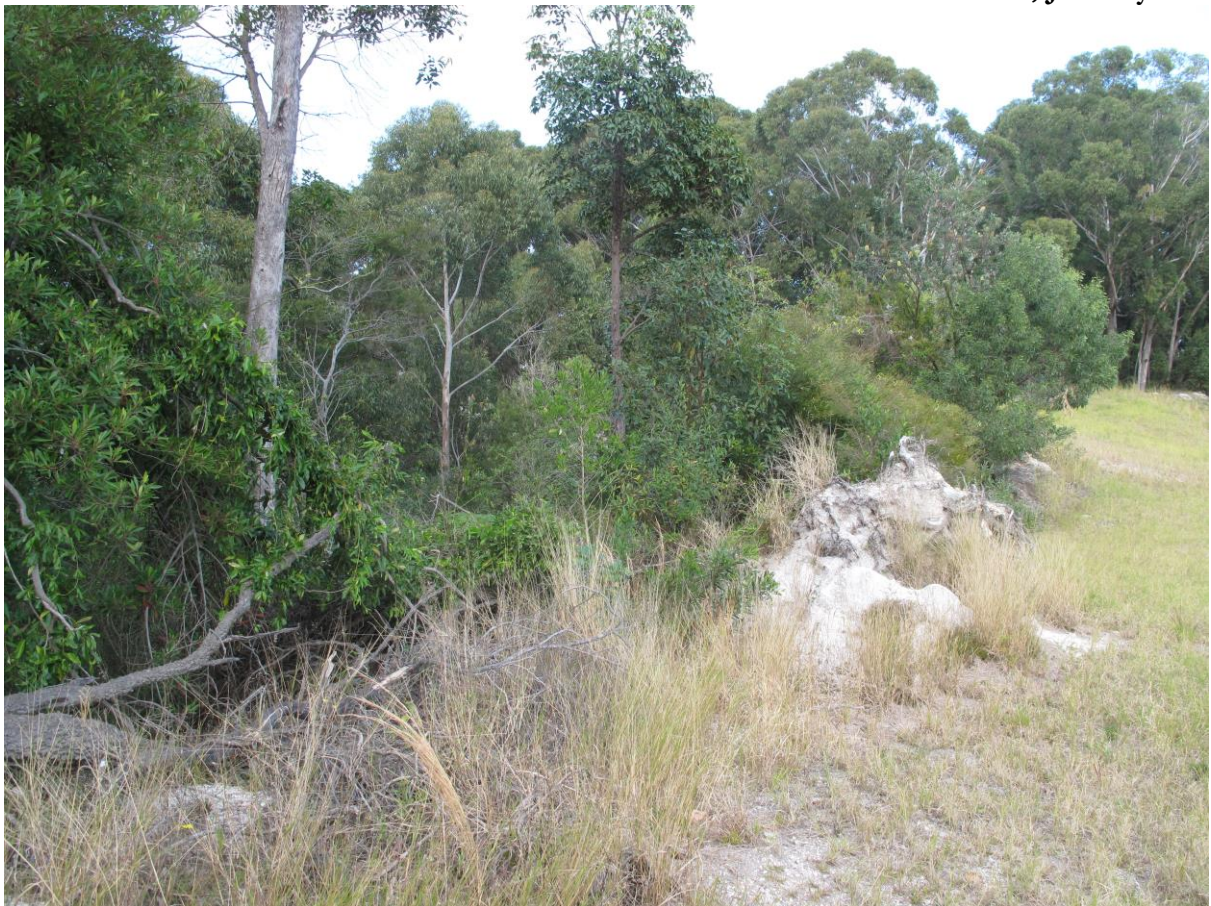
PLATE 13: Rehabilitation area RW1, August 2018

A nearby Cockspur coral tree along the road edge requires control.

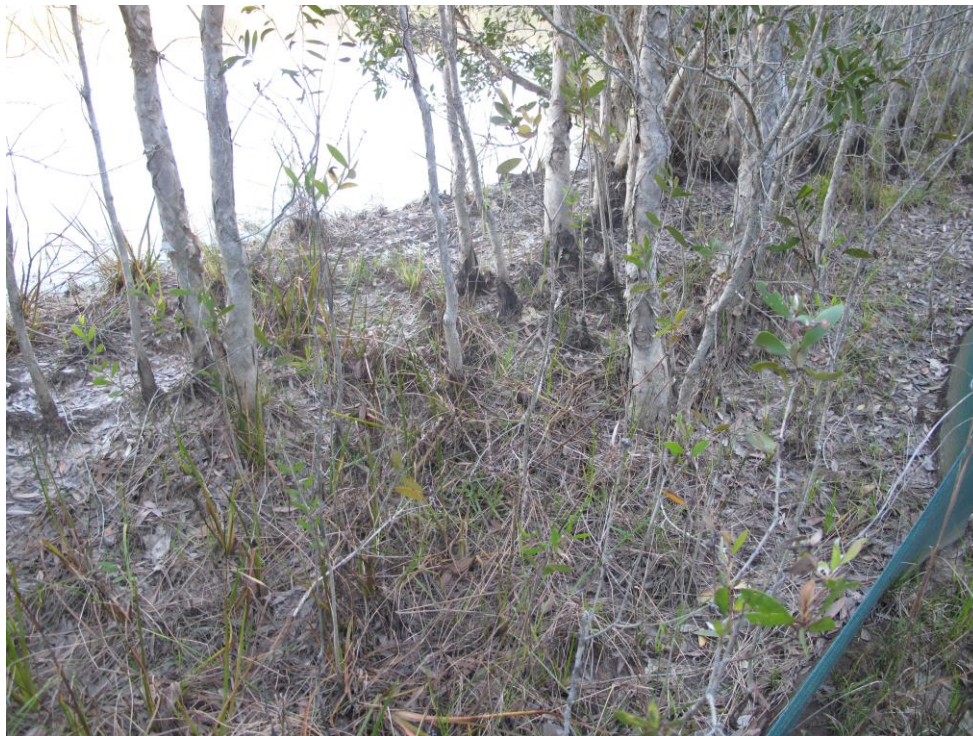
The Cane toad fence as well as the development of dense fringing vegetation around the sedimentation pond has apparently reduced the population of Cane toads which was prevalent in this area. However sections of the fence require replacement and/or repair in order to ensure the continued suppression of Cane toads at the site.

PLATE 16
Cane toad
fence around
the
sedimentation
pond EQS
requires some
repair

Growth of Swamp rice grass, sedges and rushes around the northern sedimentation pond in the EQS has suffered as a result of recent dry weather and lower water levels. Sections of the Cane toad fence that have collapsed should be repaired.

Some sections of the Cane toad control fence are in disrepair and require replacement or maintenance.
