Broken Head Quarry

Enforceable Undertaking Progress Report

Report #2 – September 2018

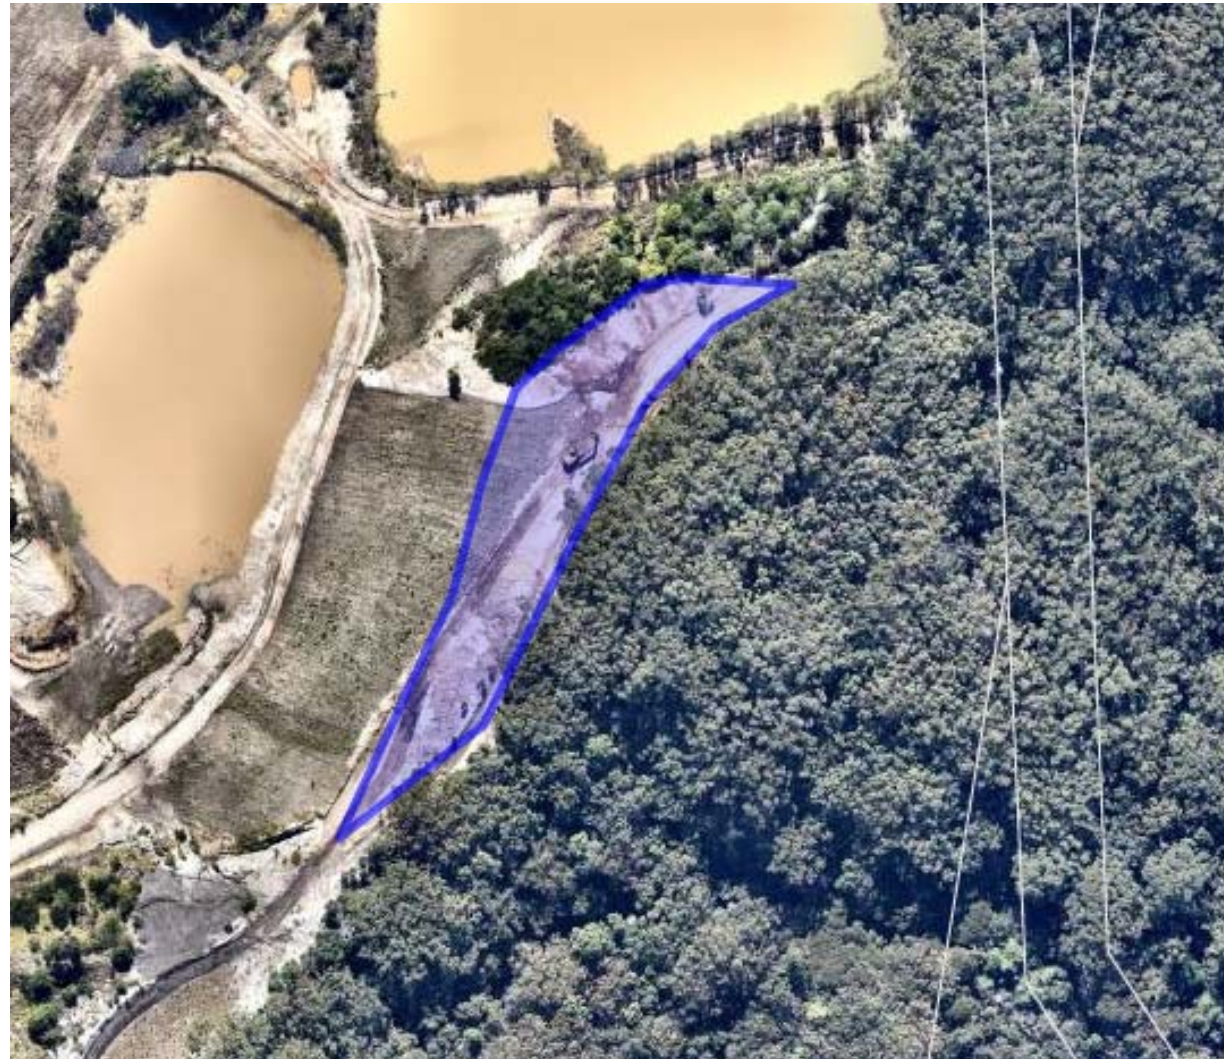
Figure 1 - Eastside fire trail and batter reforming

- Re-landforming of the fire access trails and batters in areas PZE2, PZE3, PZE4 and PZE5 to reduce batter gradient, as required by the Rehabilitation Works Plans and Specifications. Civil contractors were engaged to undertake this tricky process given the difficulty of the batter

slopes, the proximity to mature vegetation and the amount of material required to be removed. Works involved moving the lower trail west to reduce batter between the upper and lower trail, and significantly lowering the trail north of the junction, and reshaping and topsoil of batters. Some further work removing oversized bunds and drainage work is still required.

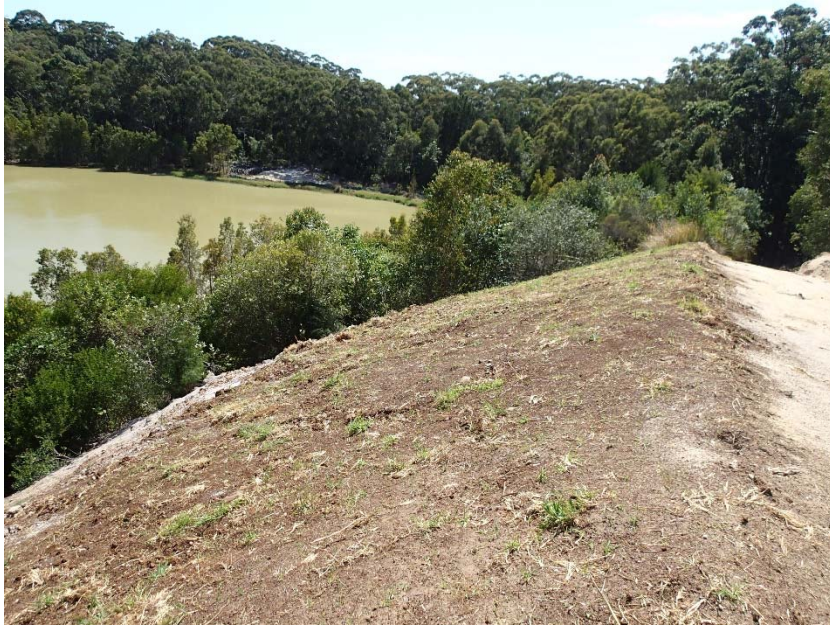
Looking North, at crest of lower trail

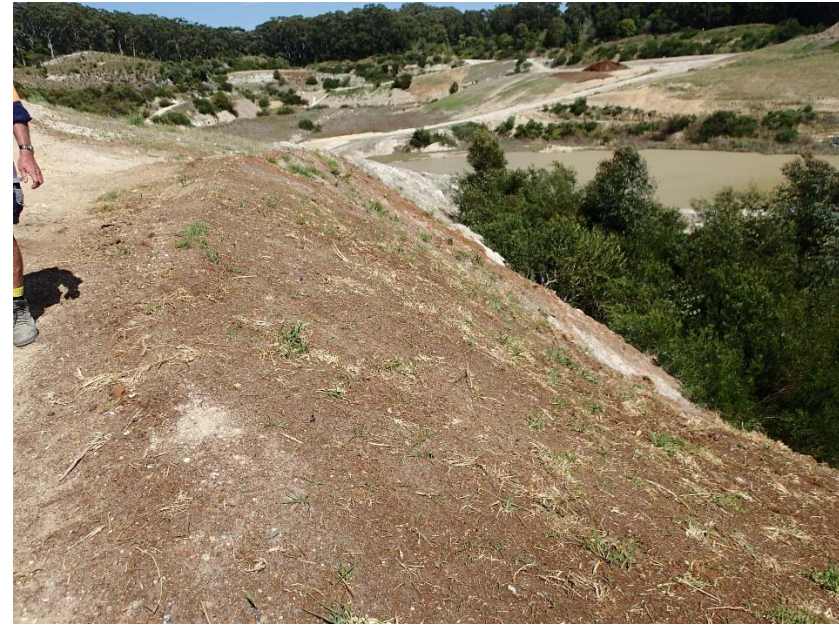
Looking South, at crest of lower trail

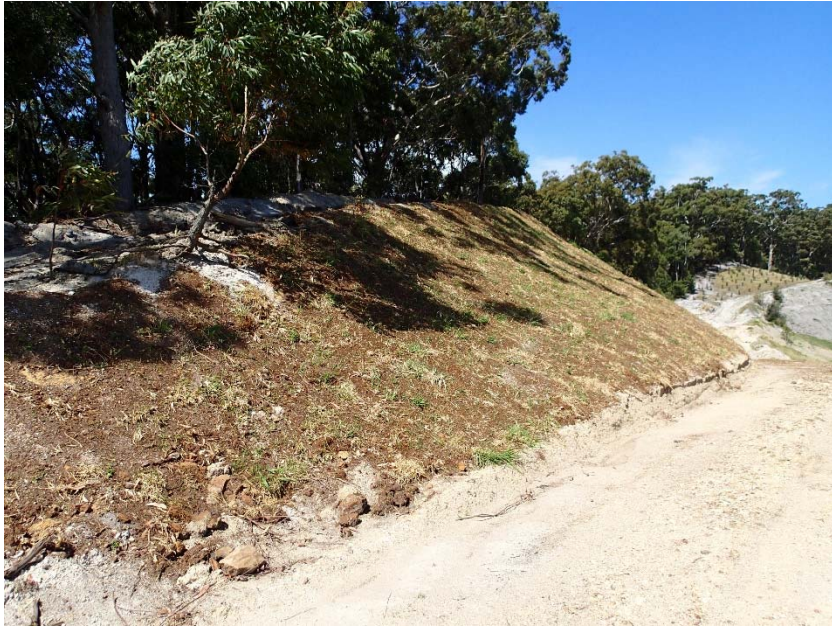
Looking South east, below junction of upper and lower trail

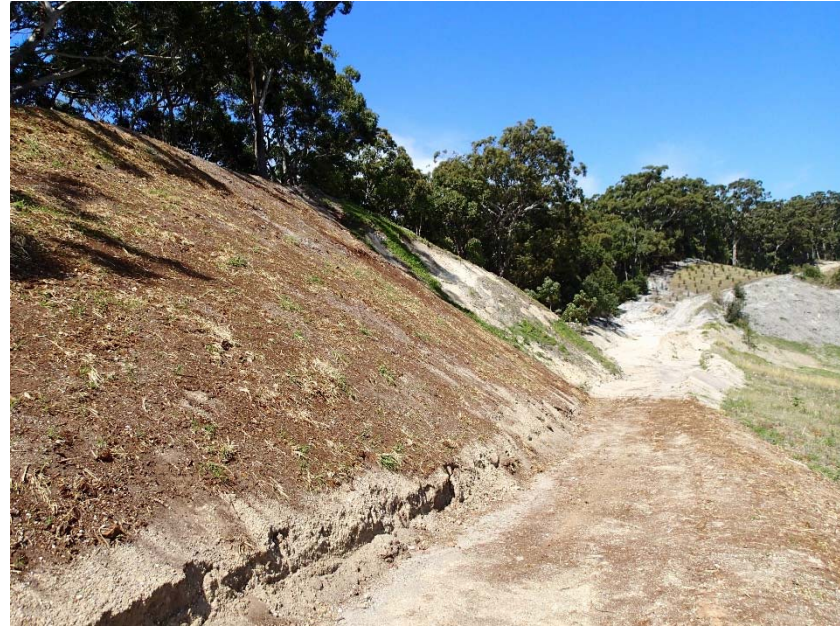
Looking South, on relocated lower trail

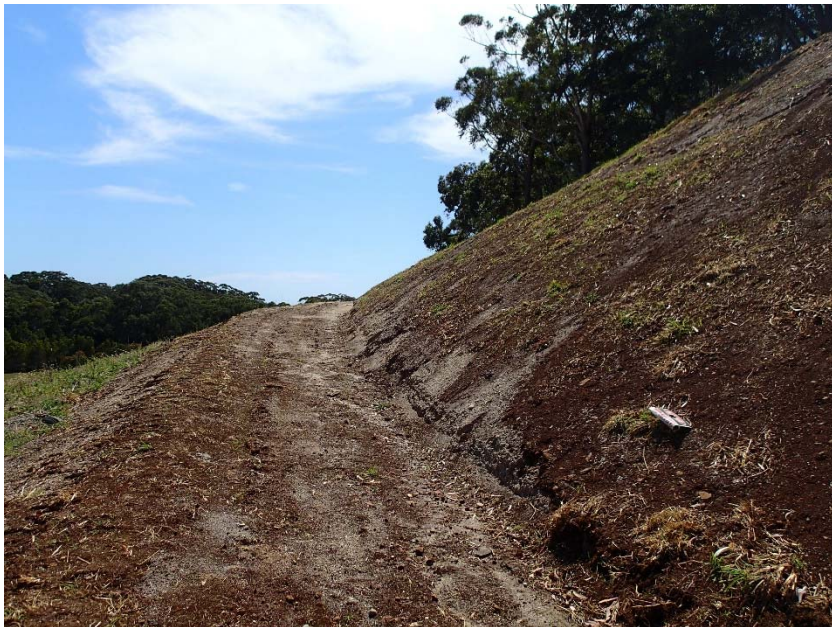
Looking North, relocated lower trail

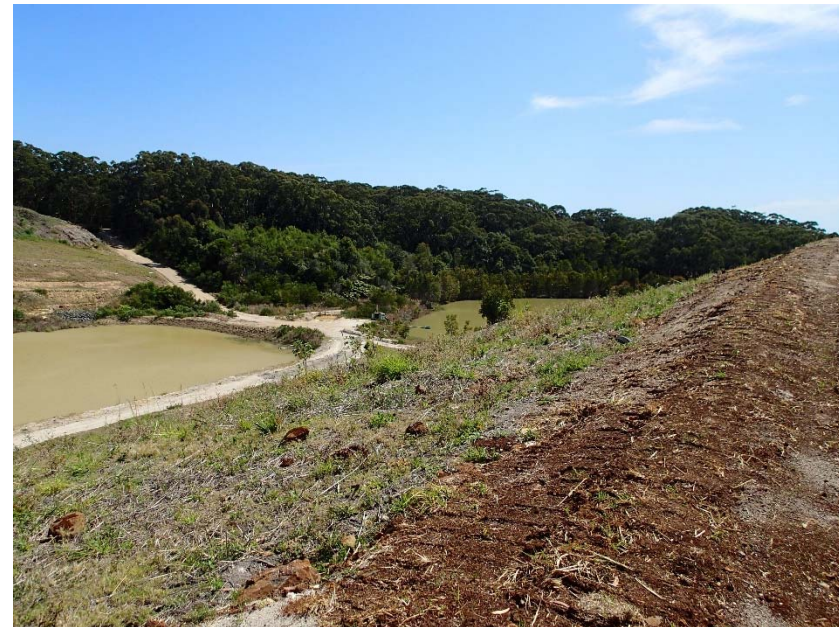
Edge of relocated lower trail – requires grassing

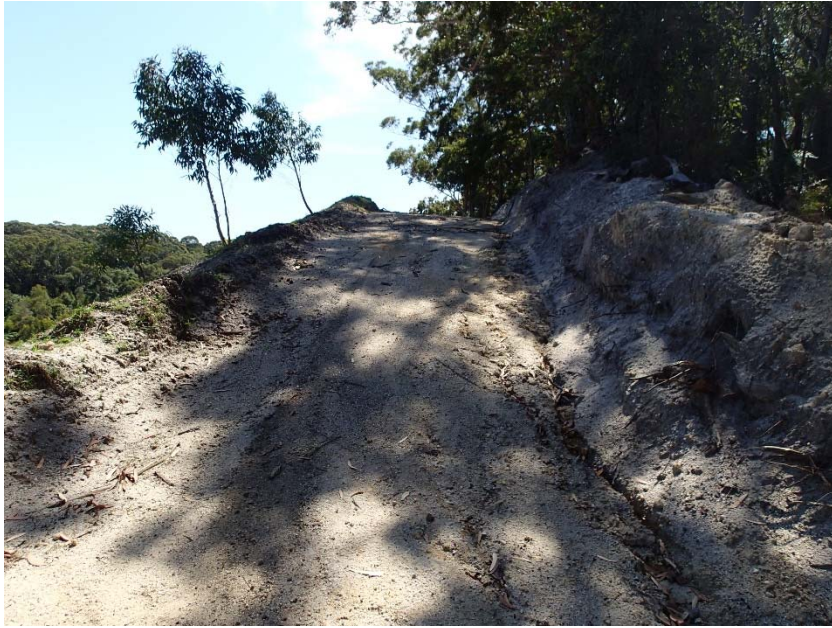
Looking North from base of upper trail

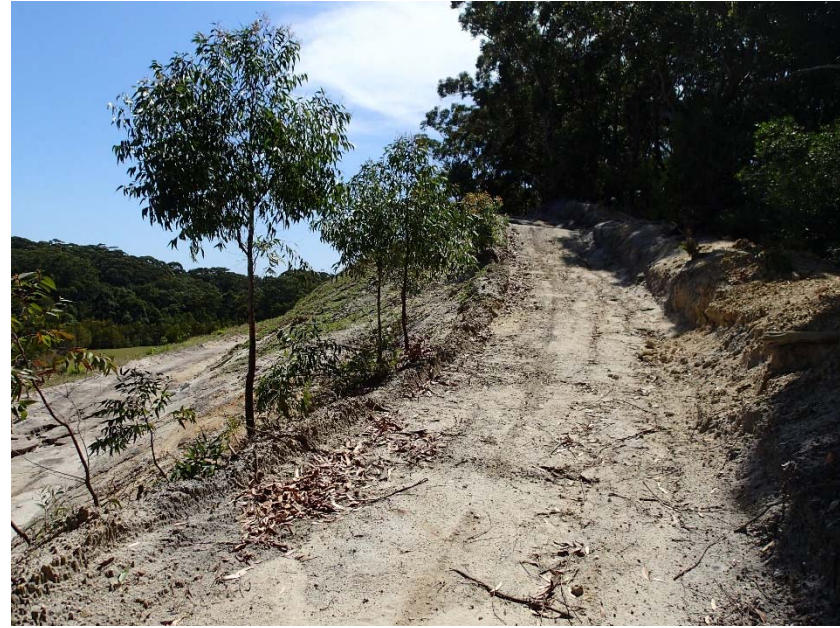
Looking North towards crest, upper trail

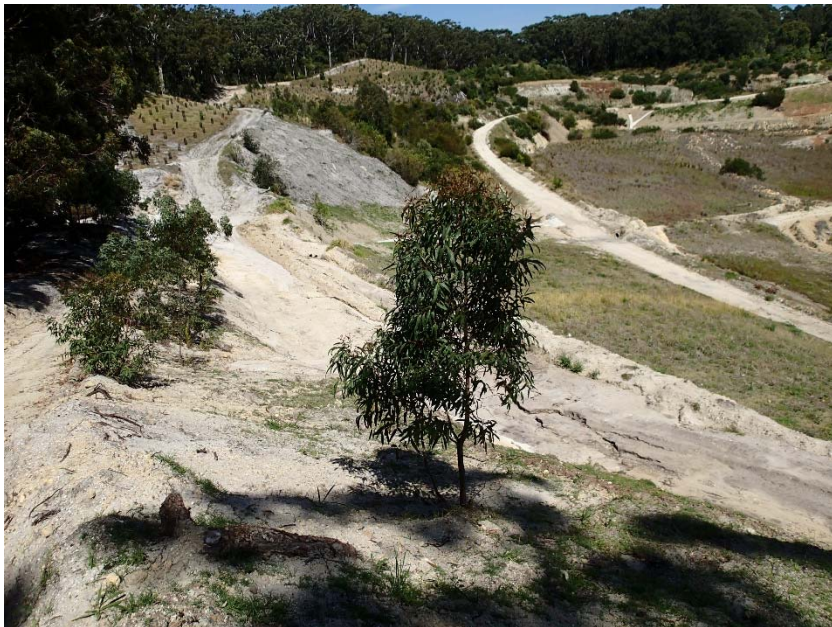
Looking South from middle of upper trail

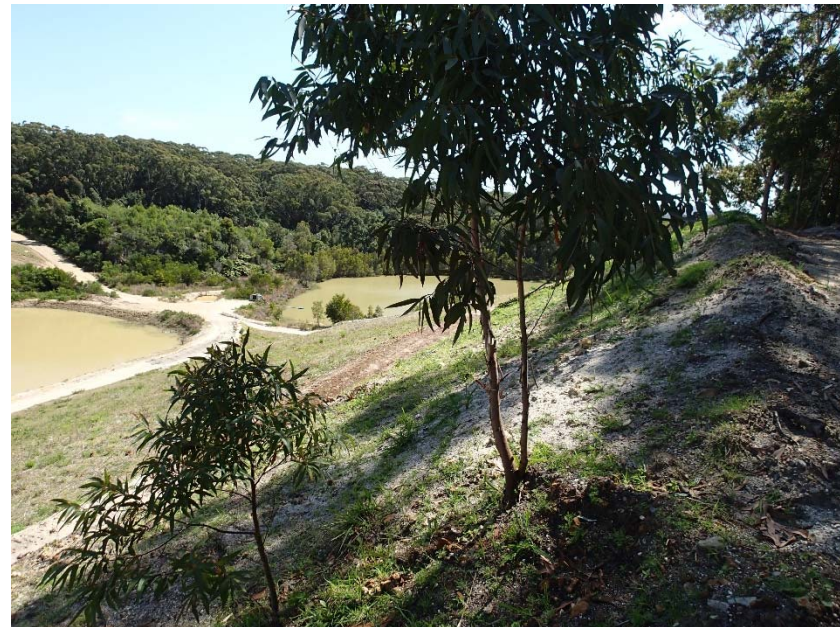
Looking North from near crest, upper trail

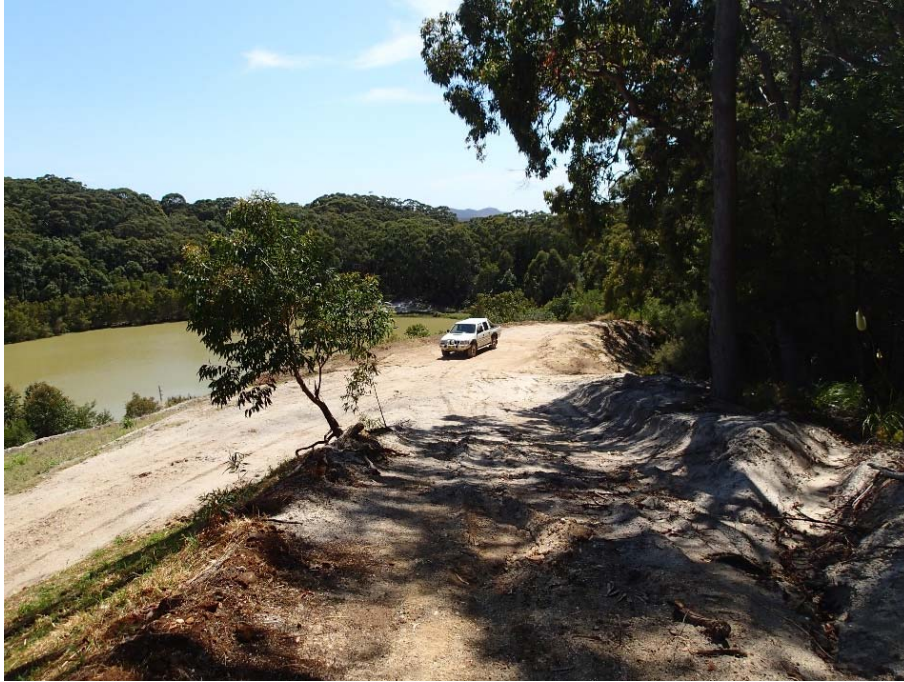
Looking North from crest of upper trail

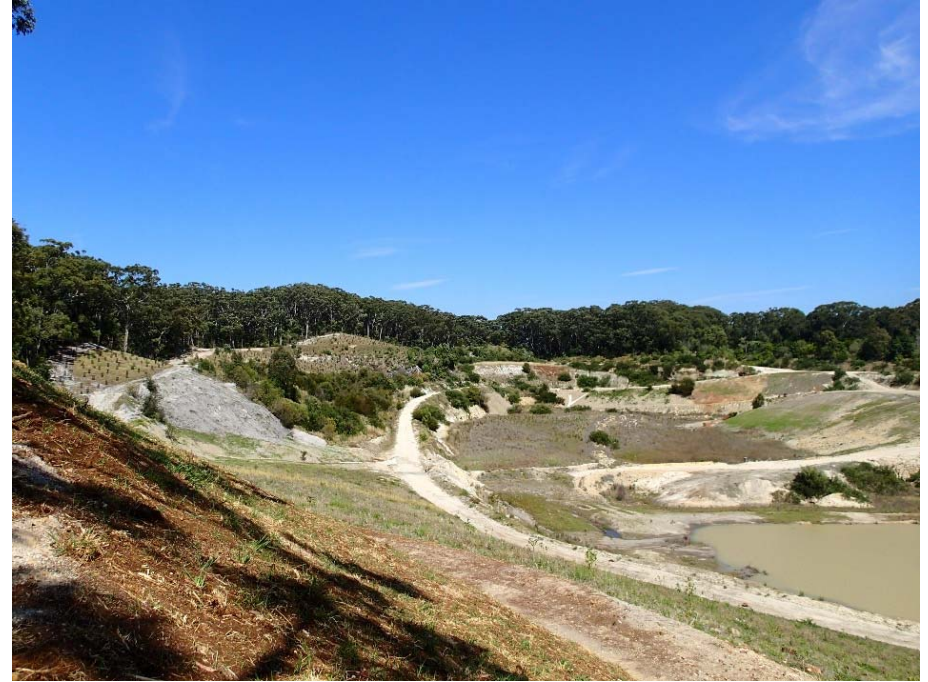
Looking South west from near junction of trails

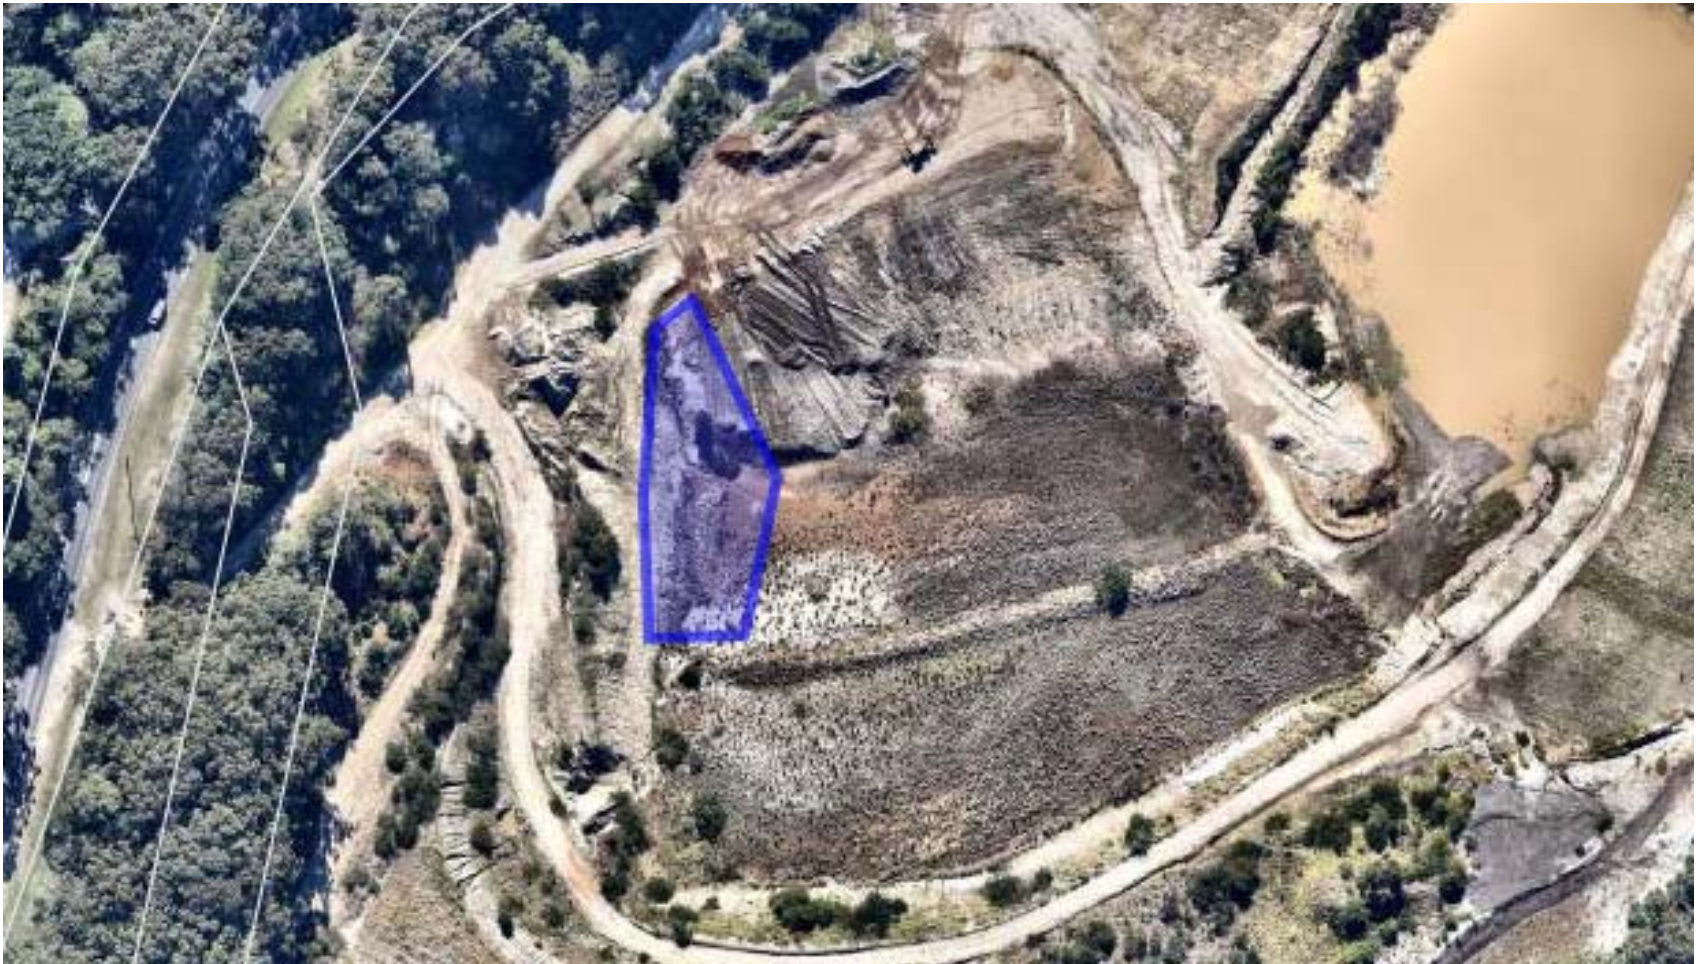
Figure 2 – Area 4 landforming and seeding

- Finalisation of batter reshaping and topsoiling in the area PZE11 (Area 4 from the Rehabilitation Works Plans and Specifications) on the Eastside. Further fill materials have been placed in this gully, track rolled and seeded topsoil applied.

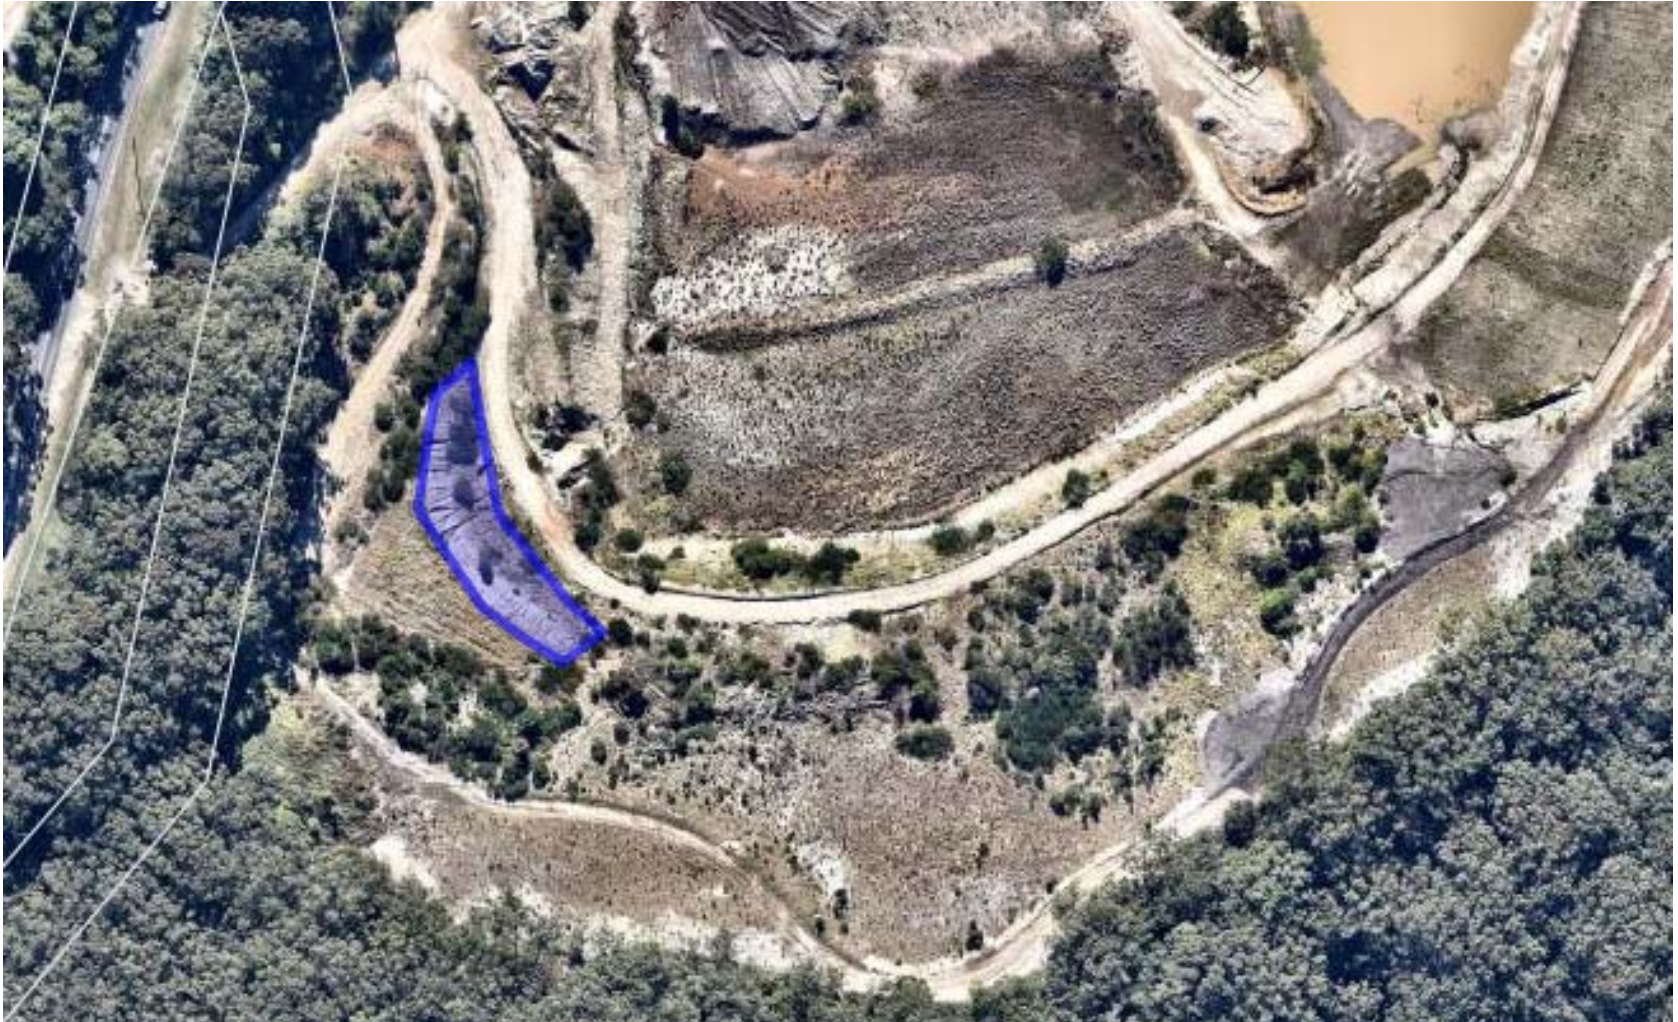
Figure 3 – Area 5b bund and erosion repair

- Bund works and batter erosion repair in Area 5b on the Rehabilitation Works Plans and Specifications as shown below. A bund has been formed at the top of the batter to contain water flows down batter and prevent further erosion. A trial emplacement of seeded topsoil to fill eroded and rilled batter was undertaken in the most affected area and is being monitored. If successful, this procedure will be repeated across the entire battered area:

PZE7	Batter below level pad. Comprises Area 5b in the Rehabilitation Works Plans and Specifications	Steeper batter showing some signs of rilling and erosion, but with a scattering of well-established shrubs. Hydromulched in January 2018 with limited grass cover established from that exercise. Bund to be constructed to stop water flowing from level pad PZE8 above. Erosion rills to be filled with seeded topsoil and plantings undertaken to assist in stabilising slope. Rehabilitation Works Plans and Specifications requires the following action: WHERE VEGETATION HAS NOT ESTABLISHED AND WHERE SURFACE RILLS HAVE FORMED REPROFILE WITH TOOTHED EXCAVATOR BUCKET {ACCESS FROM ROADWAY ABOVE OR ON SLOPE WHERE POSSIBLE). APPLY TOPSOIL THEN PROVIDE SHORT TERM COVER CROP. FINAL REHABILITATION BY PLANTING WITH APPROVED SPECIES.	Bund established during September 2018. Half of the eroded area successfully re-topsoiled during September 2018. Further topsoil emplacement and shrub plantings expected in November 2018 and December 2018.

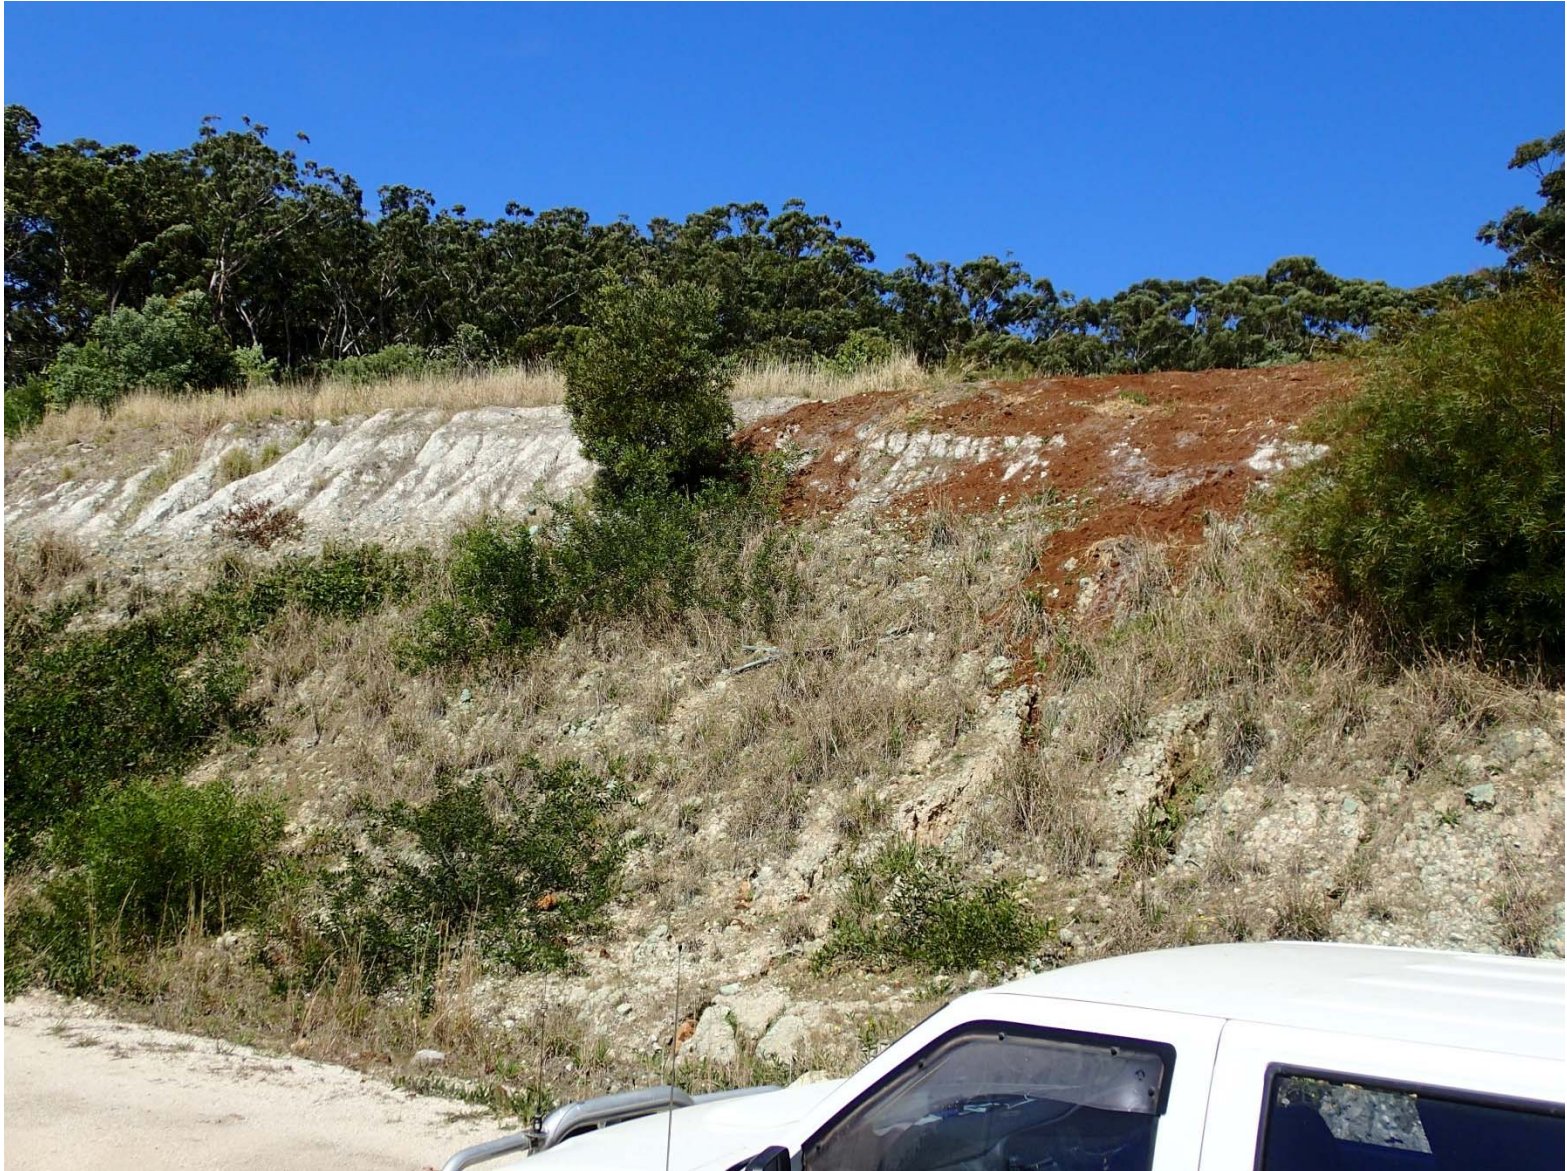
The following photo shows the works undertaken as a trial. Further eroded areas in Area 5b will require similar treatment and hydromulching and revegetation:

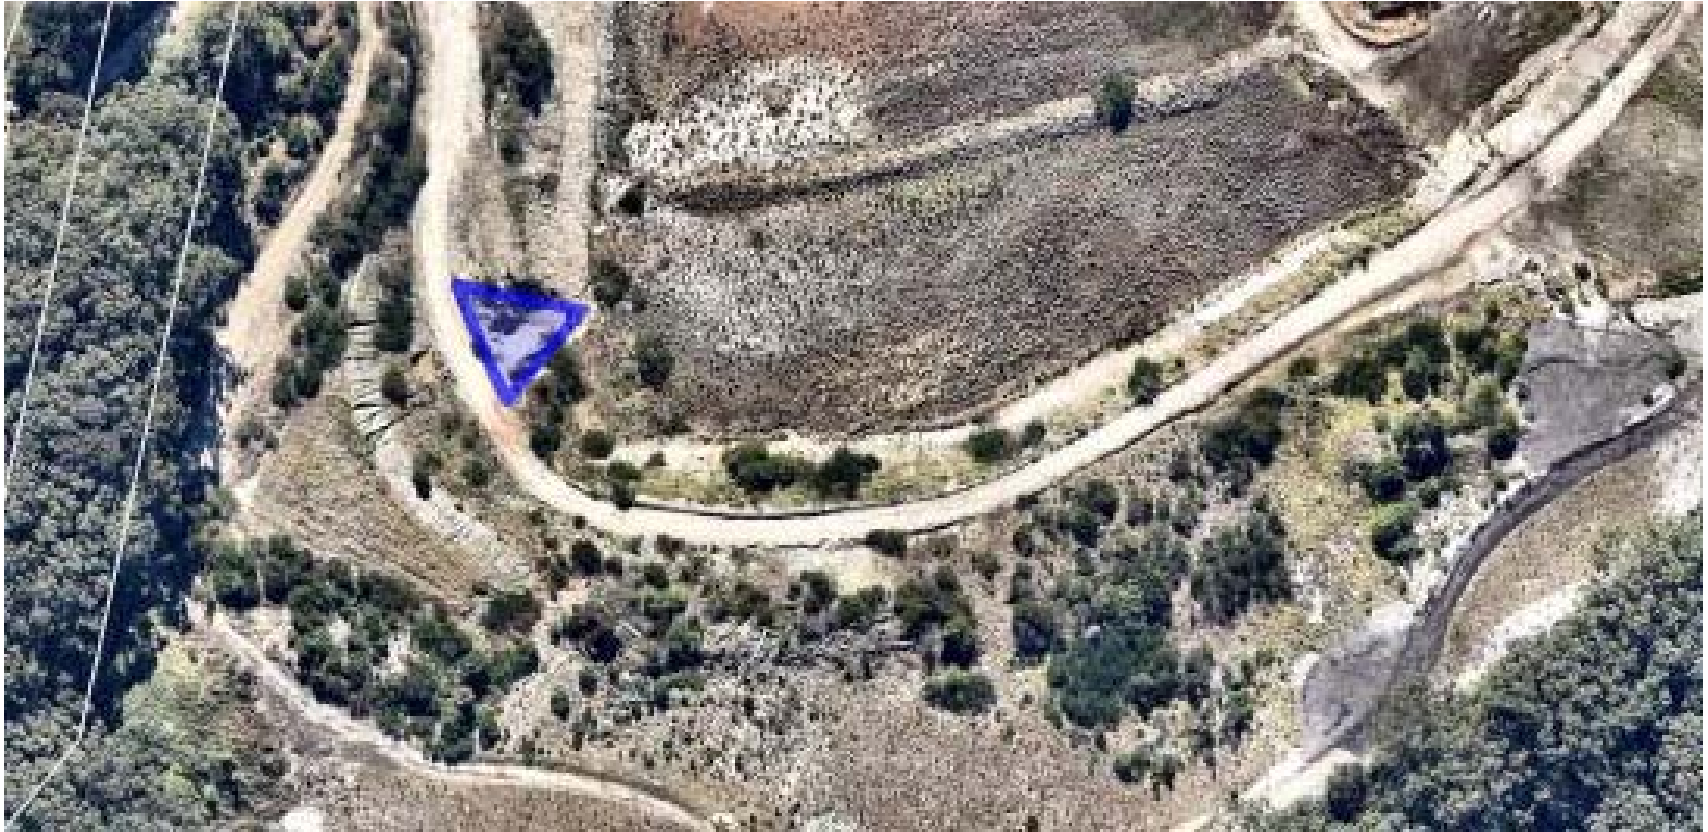
Figure 4 – Drain repair

- Repair of eroded drain area PZE10 on the Eastside. The eroded batter below a major drainage culvert was filled, covered with seeded topsoil and a drainage channel formed to take discharge from the culvert and prevent a repeat of the erosion. The formed channel was lined with concrete canvas. A second drainage channel was formed to take discharge from the road and it was also lined with concrete canvas:

PZE10	Site of concrete pipe drain from above.	Highly eroded and disturbed area. Rehabilitation of highly eroded batter and new drain to be installed, and then hydromulched and revegetated.	Area filled with fill sand and seeded topsoil during September 2018. Concrete canvas drain installed to take discharge from concrete pipe in September 2018. Performance observed during recent rainfall and observed to perform well, future erosion eliminated. Area to be hydromulched in October 2018 or November 2018 and planted with shrubs selected by Mark Free. Planting expected to be completed by December 2018.
PZE11	Batter area. Comprises Area 4 in the Rehabilitation Works Plans and Specifications	Partially completed batter, awaiting further fill material and topsoil. Rehabilitation Works Plans and Specifications requires the following action: EXTEND BATTER WEST AND SOUTH TO PROVIDE MAXIMUM 50% BATTER SLOPES DOWN FROM ROAD. BATTER TO BE TRACK ROLLED,	Further fill emplacement undertaken and seeded topsoil spread during September 2018. Now being monitored for drainage performance and erosion. Area to be planted with shrubs selected by Mark Free.

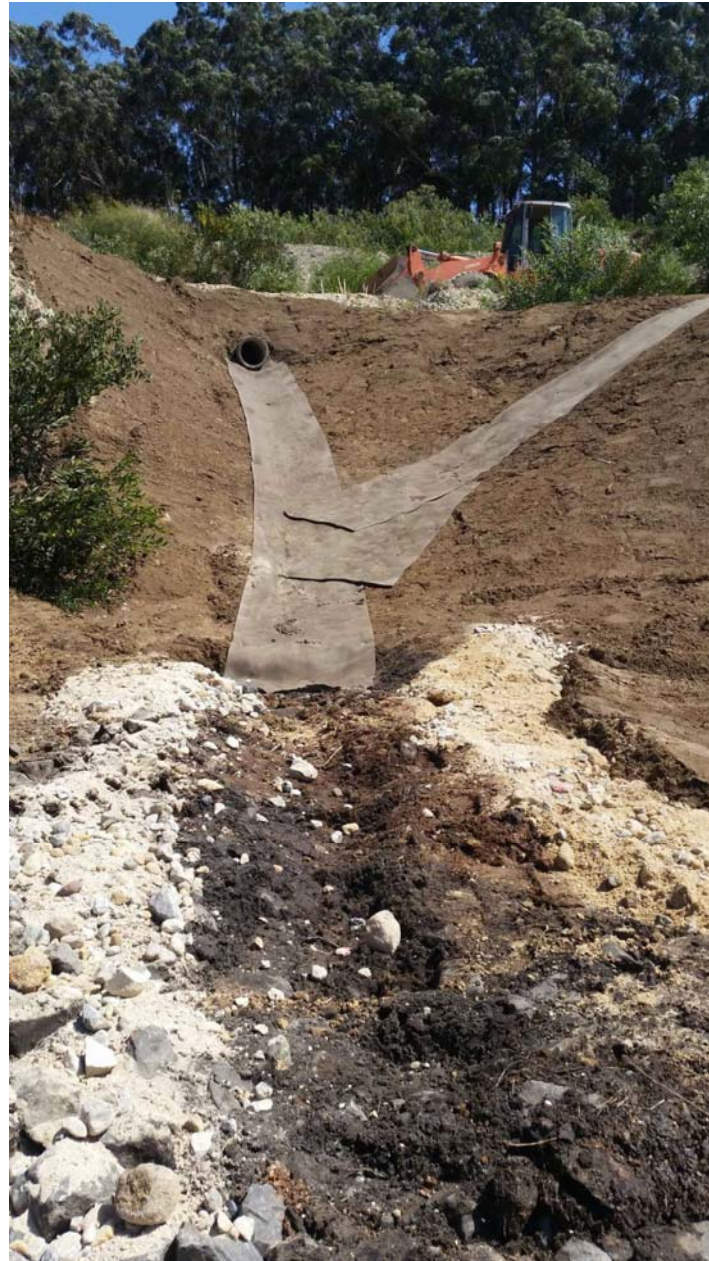
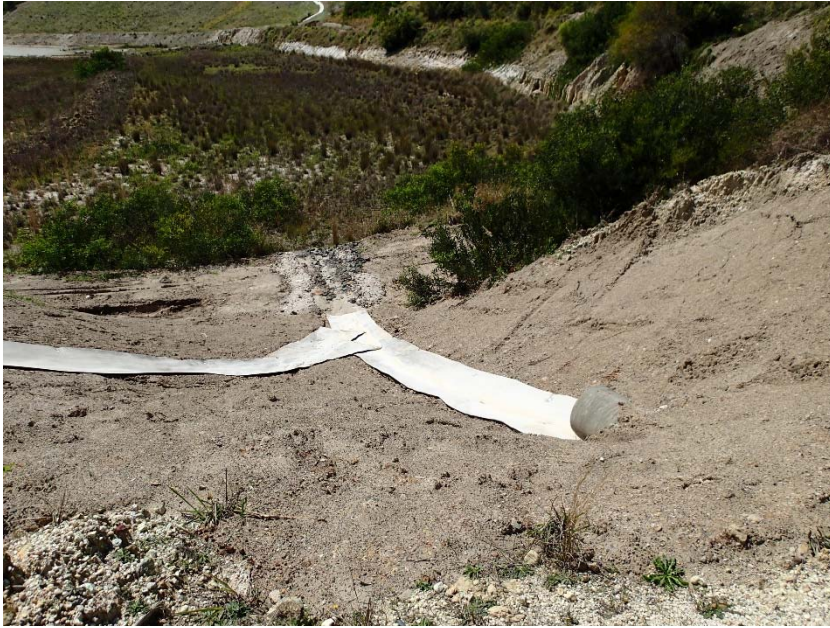
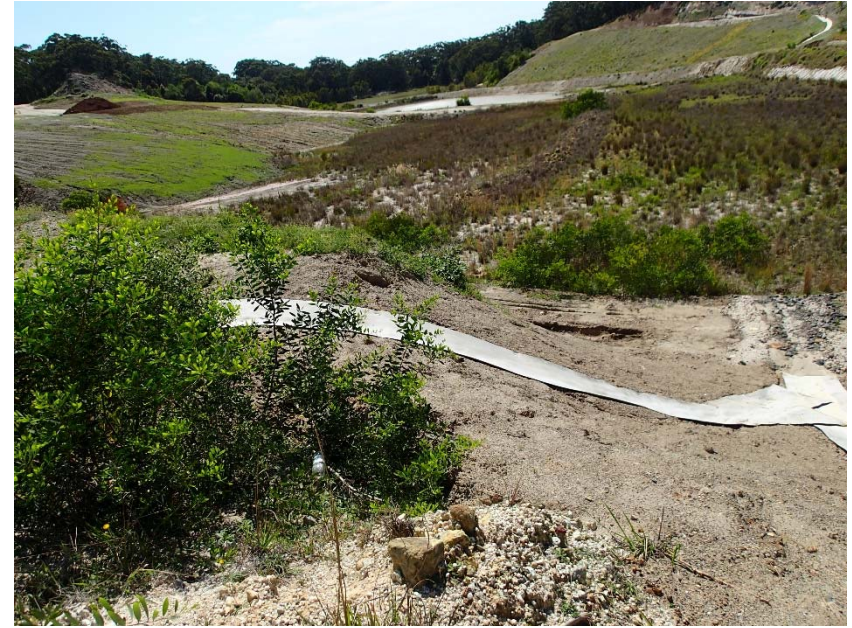
The following photos show the works undertaken:

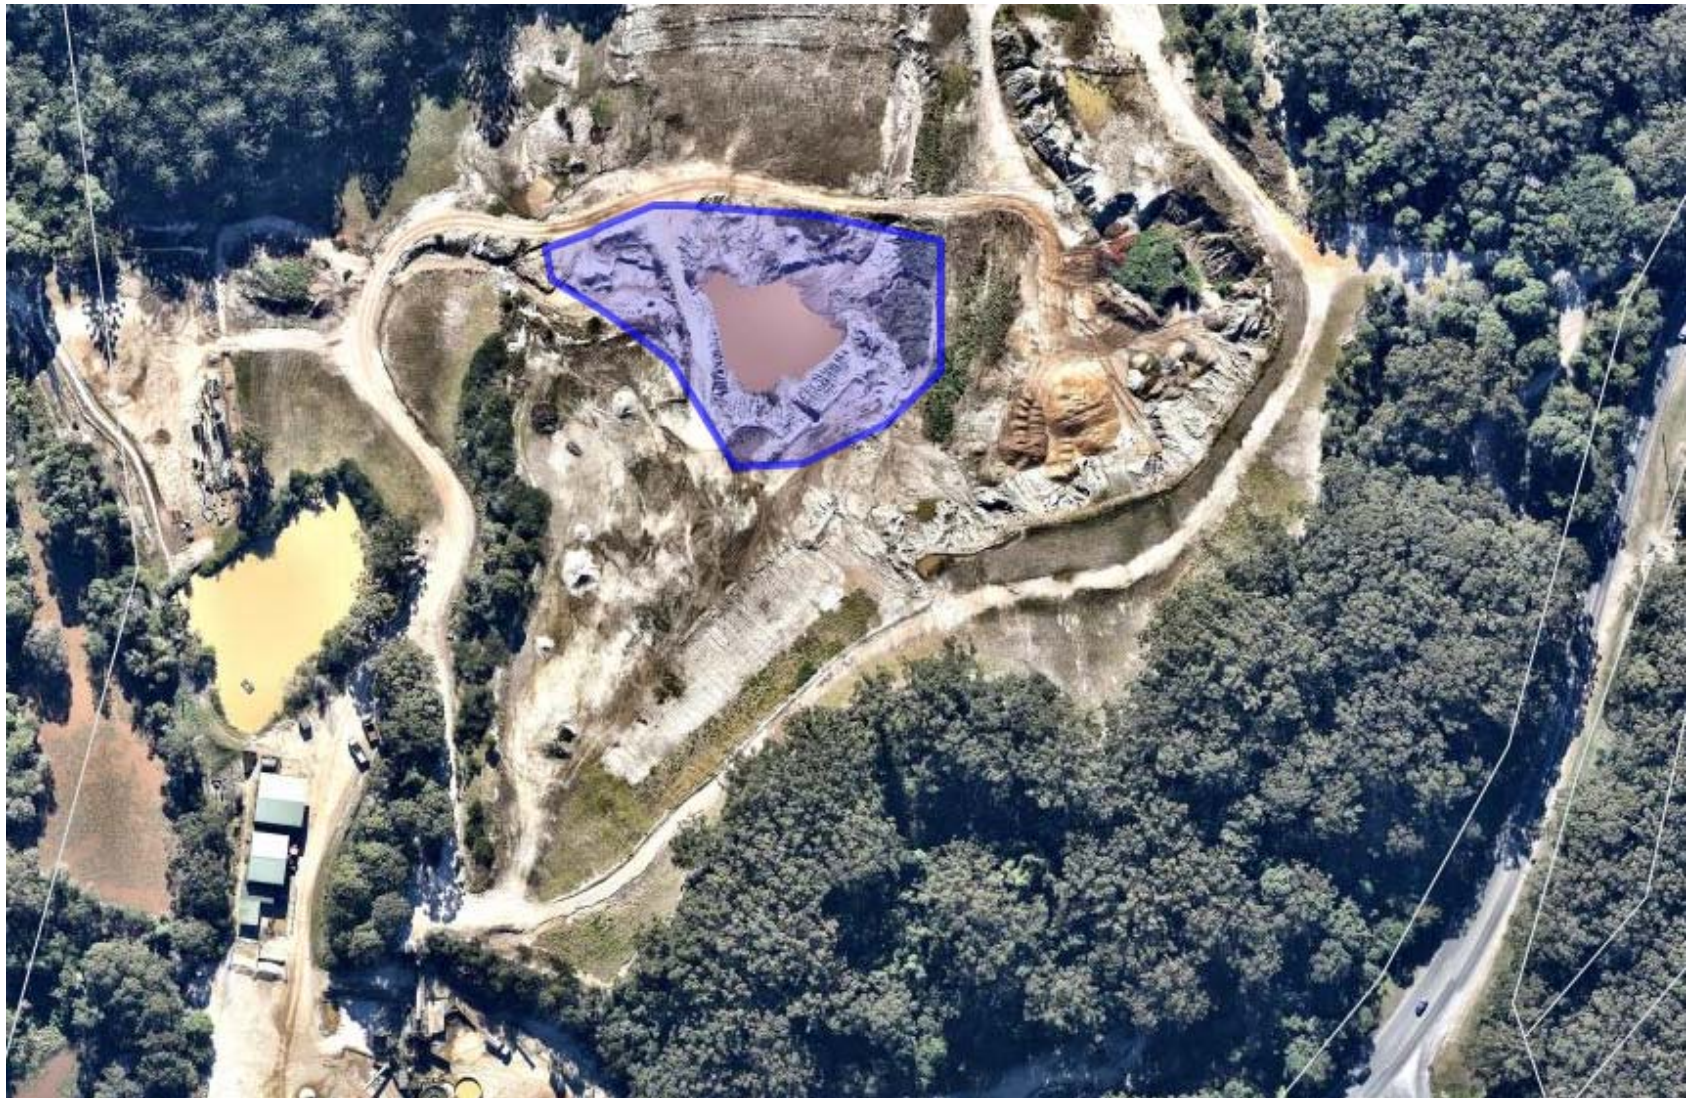
Figure 5 - Westside Central Dam Area

- Preparation works have been undertaken for the creation of the new Central Dam on the Westside. This involved the deployment of civil contractors once the fire trail reforming works were complete. Works were very involved and are described further below. The dam wall had not been commenced as at the end of September 2018.

- excavating the dam wall site and keying in to lateral cliff;
- excavation of channels for sub-dam drainage pipes;
- specifying and ordering of pipes and valves;
- excavation of dam and removal of old silt, causeway and culvert;
- reforming and topsoiling of dam banks, including Area 12 in the Rehabilitation Works Plans and Specifications;
- enlargement of wetland area adjacent to site of new dam wall; and
- creation of temporary emplacement site for excavated mud and silt for drying before being used for fill in the main fill emplacement area, PZW21

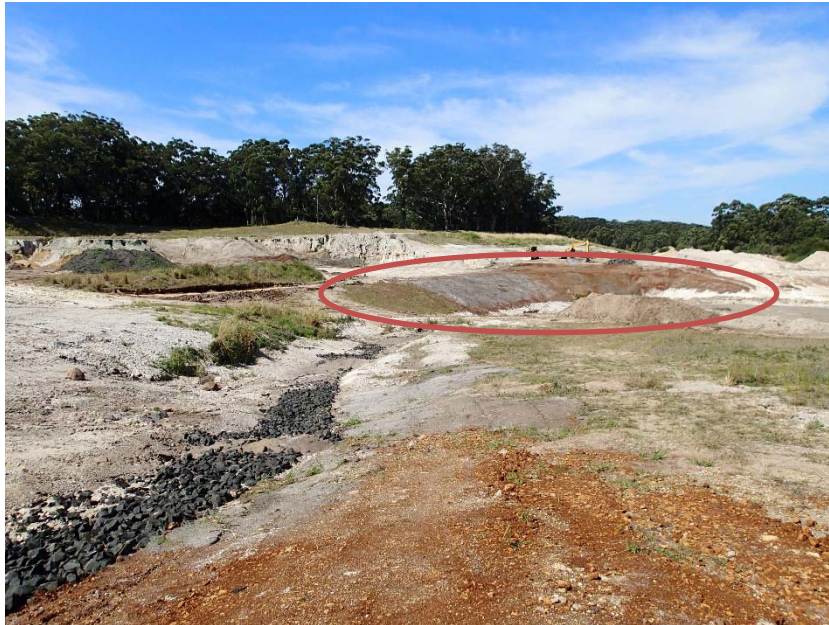
Reformed dam banks (Area 12) circled

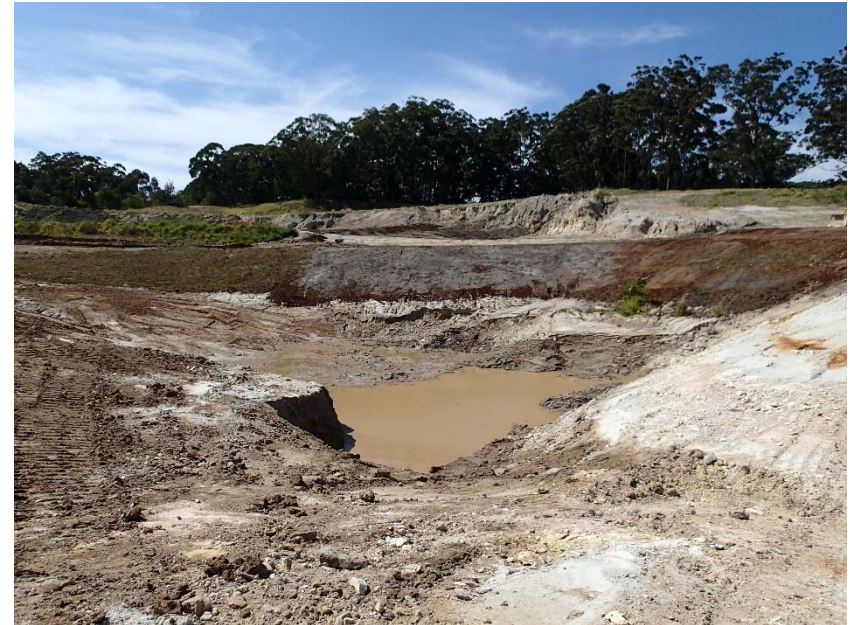
Excavated dam and reformed dam banks (taken from dam wall site)

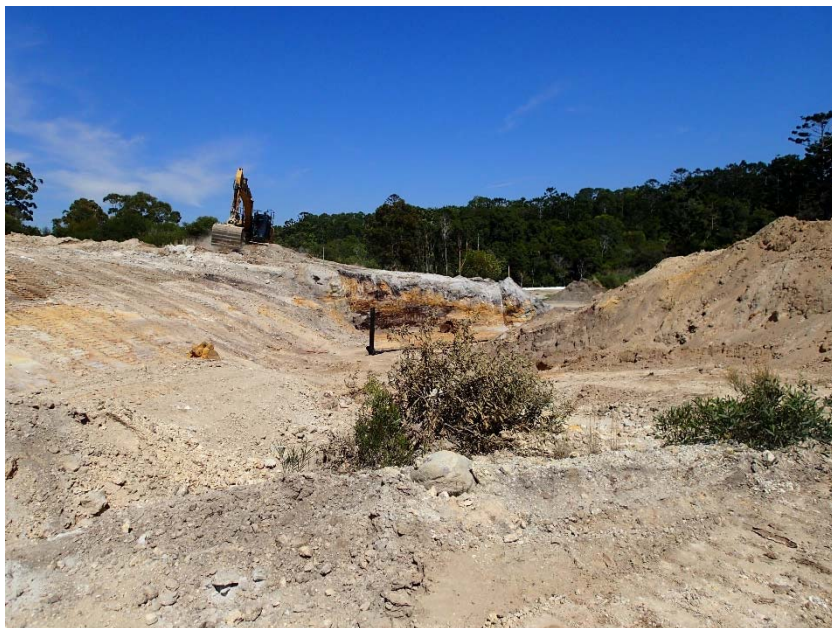
Looking towards site of dam wall

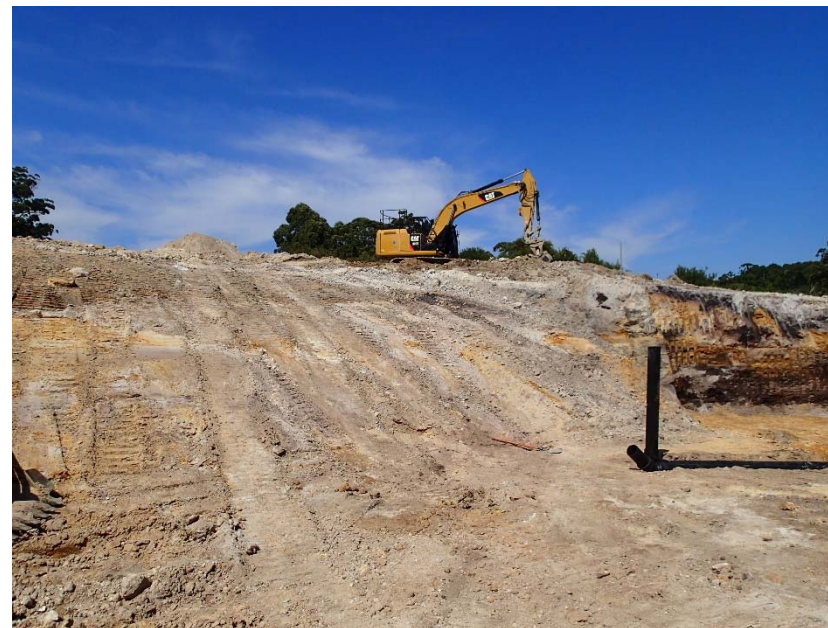
Removed causeway and culvert and dam wall keyed area
