Broken Head Quarry

Enforceable Undertaking Progress Report

Report #2 – September 2018

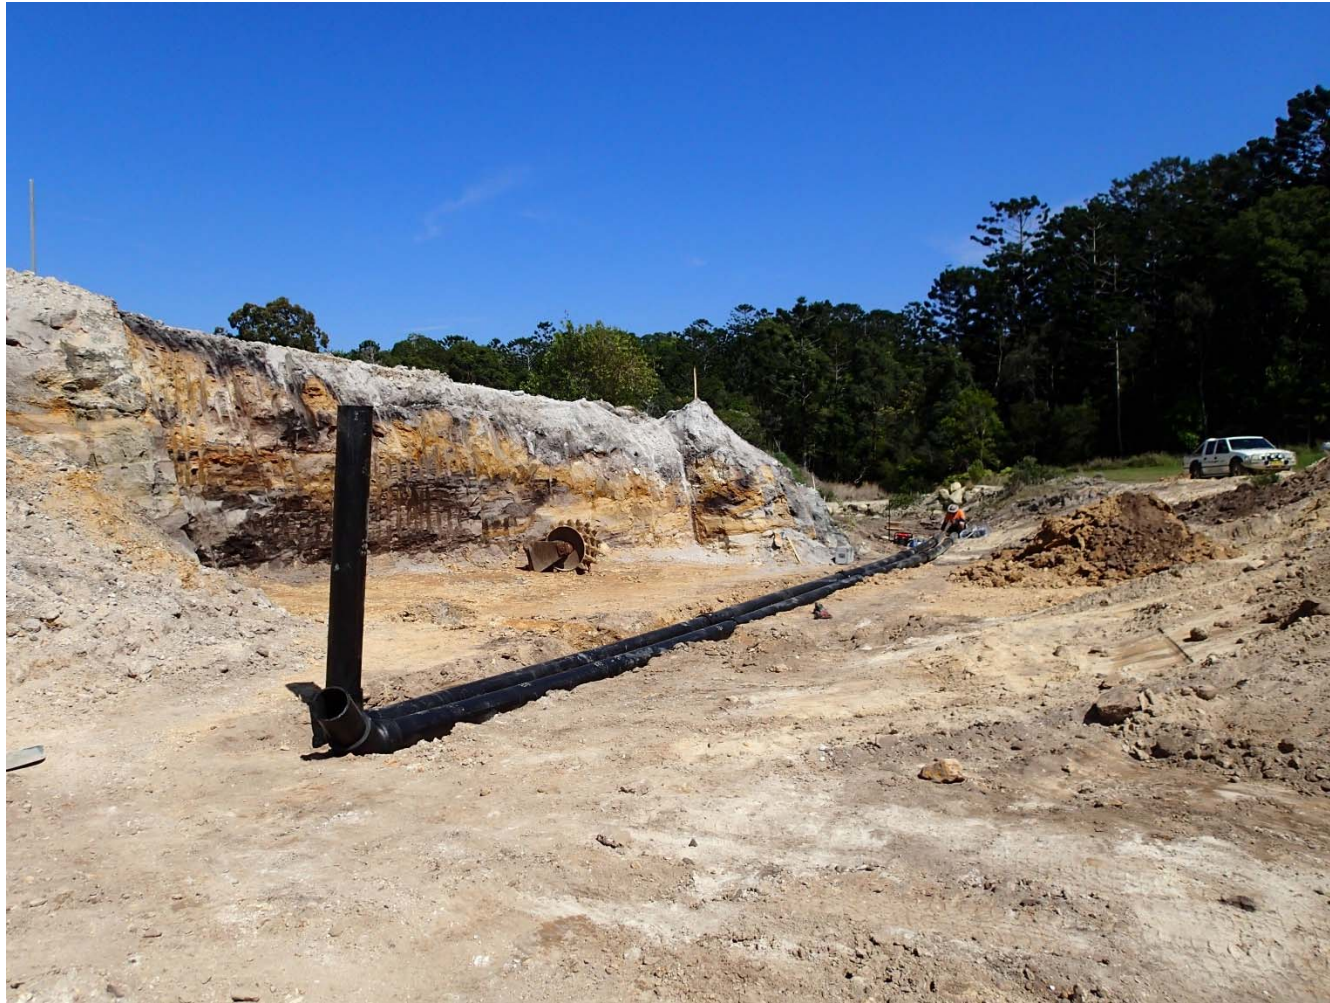
Site of dam wall with drainage pipes installed

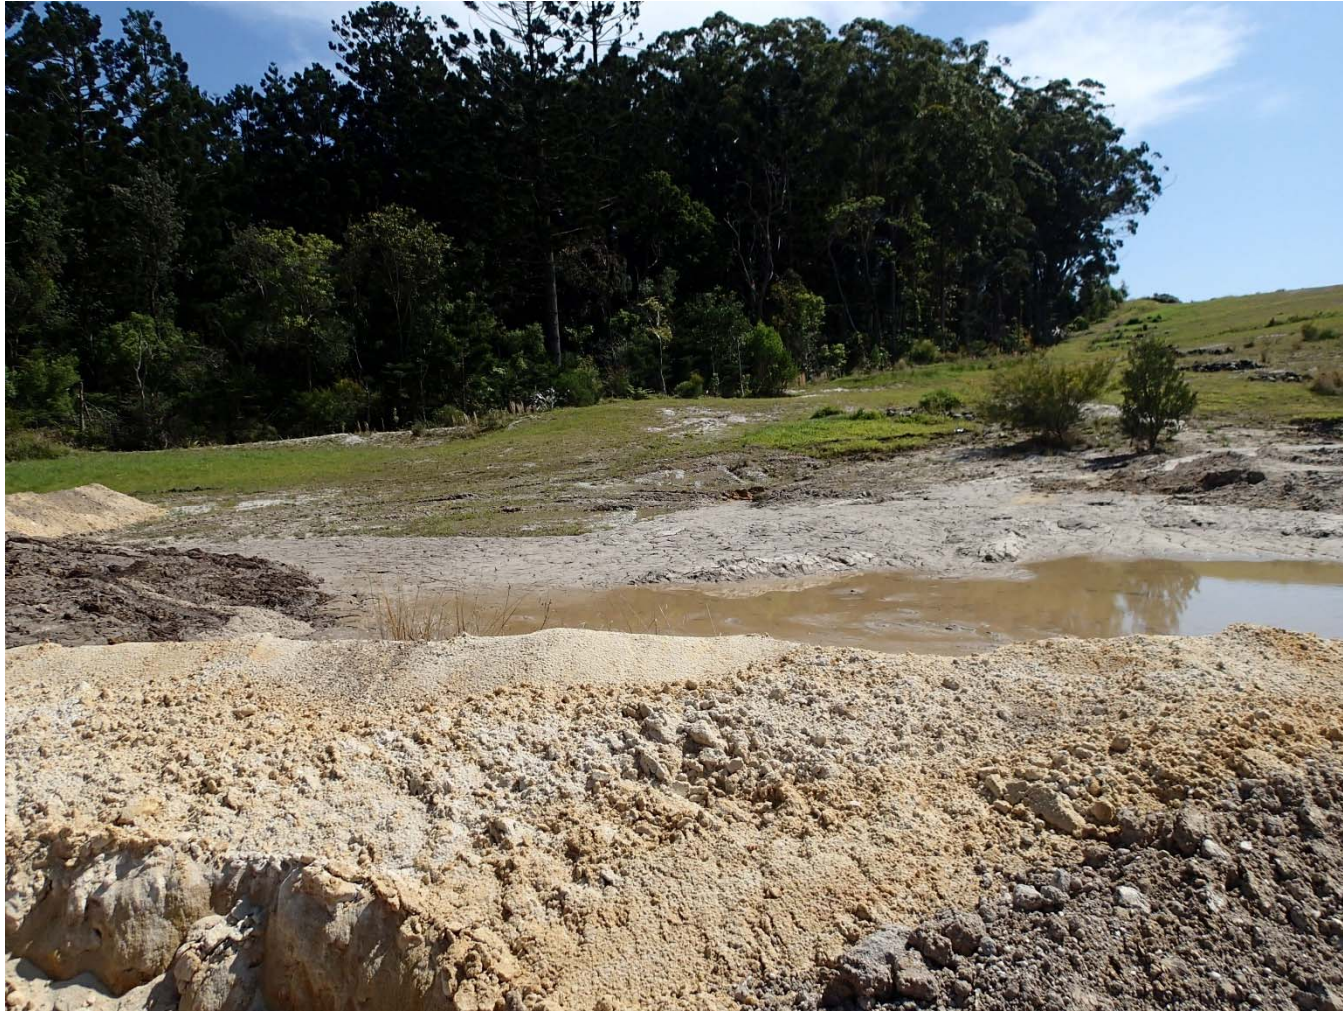
Site of enlarged wetland area

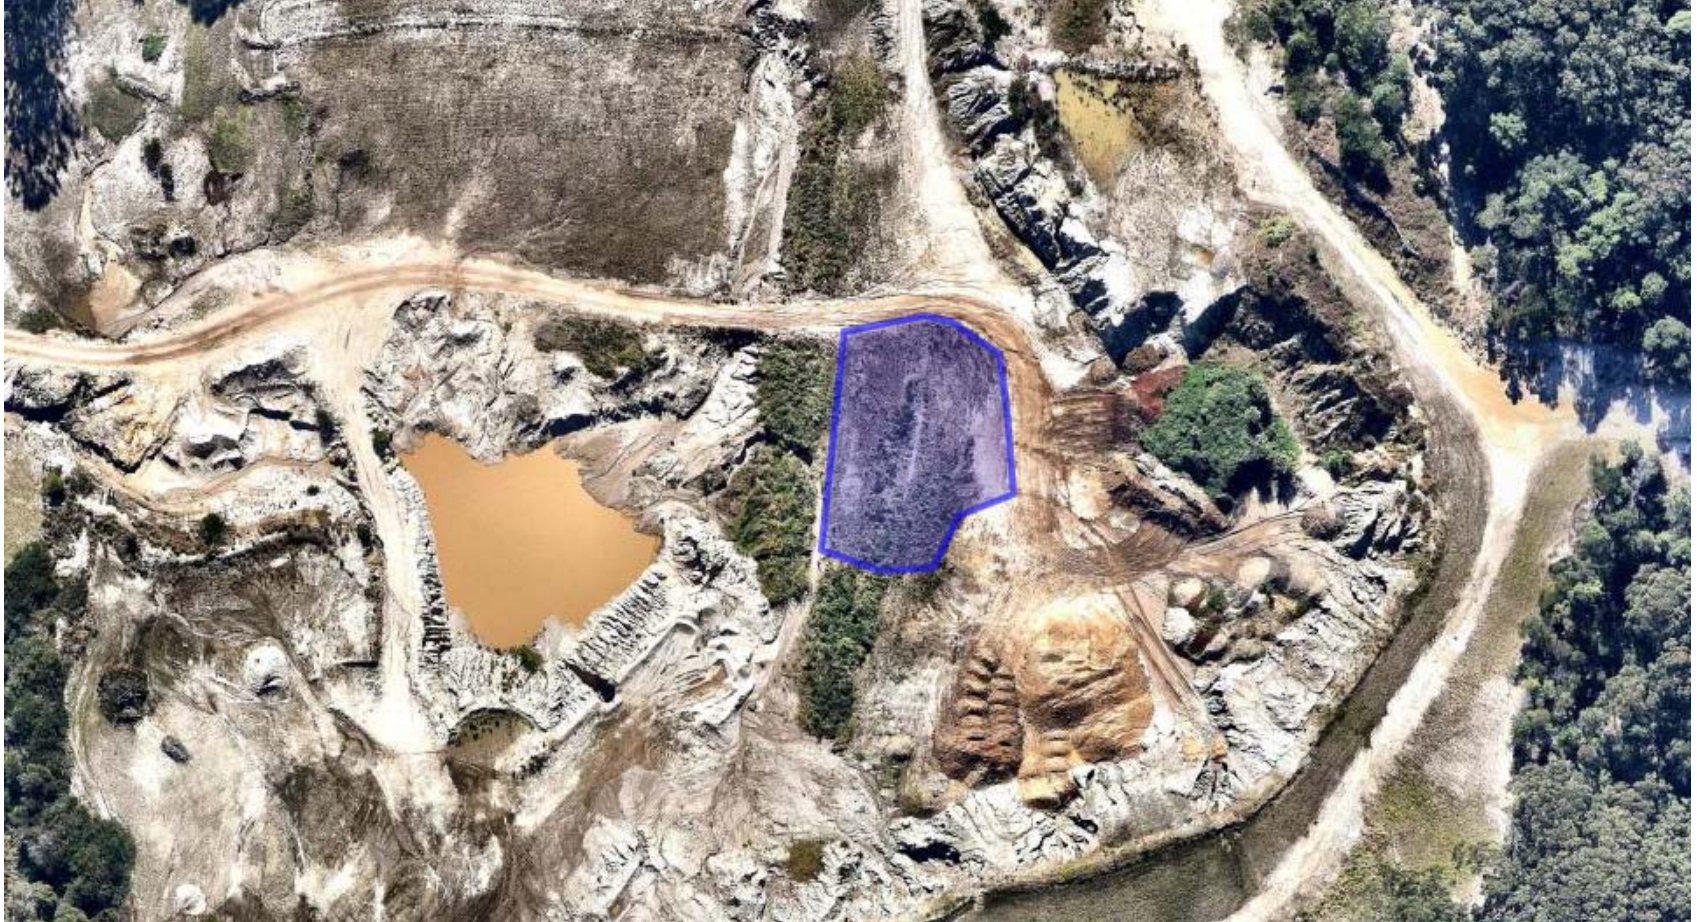
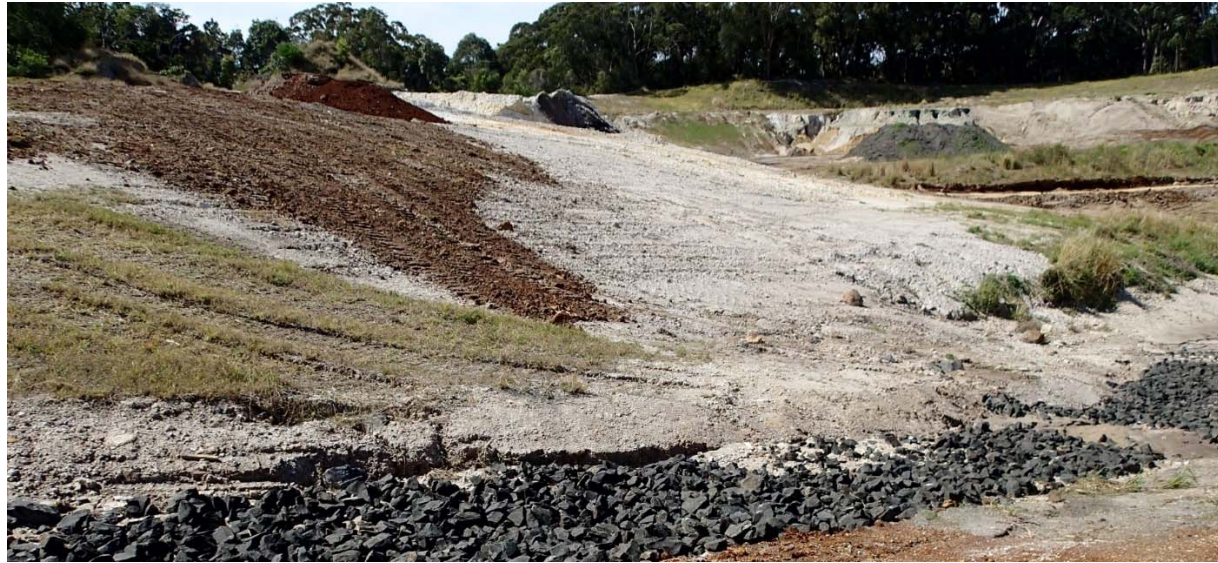
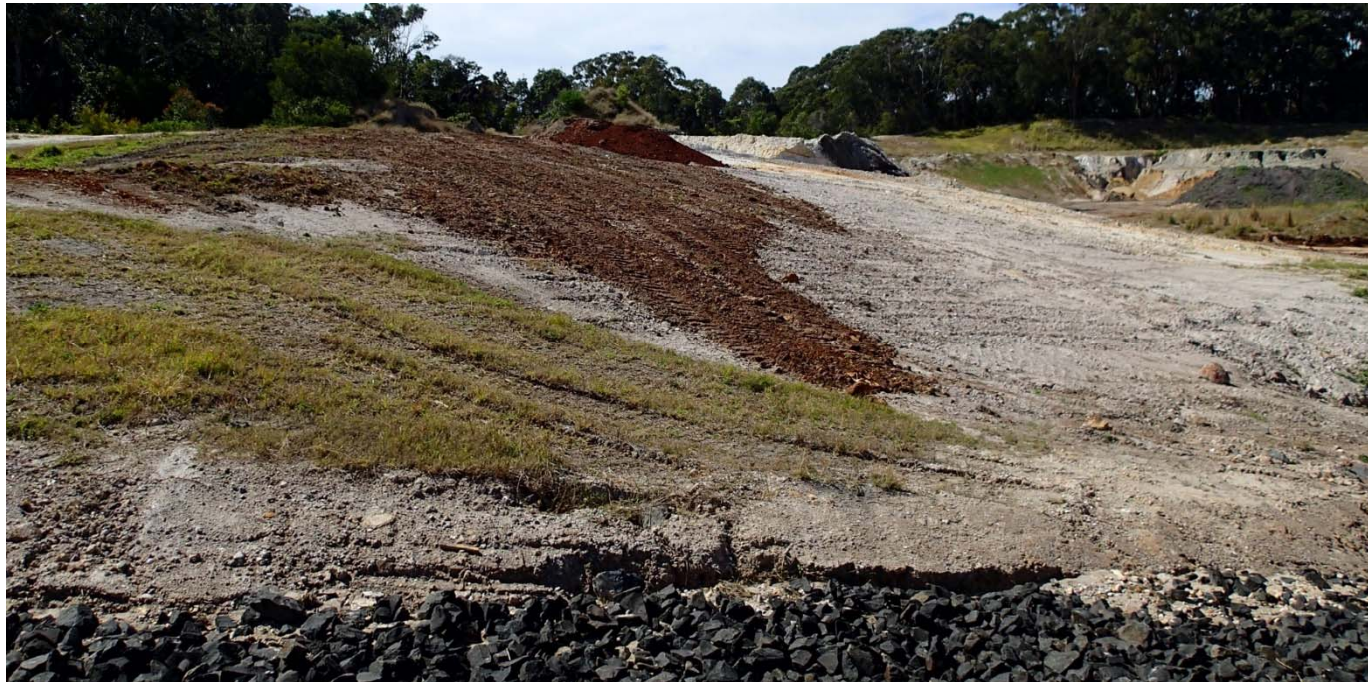
Figure 6 - Westside Batter works

- The steep batter in area PZW11 was removed, battered to a shallow gradient, track rolled and topsoiled:

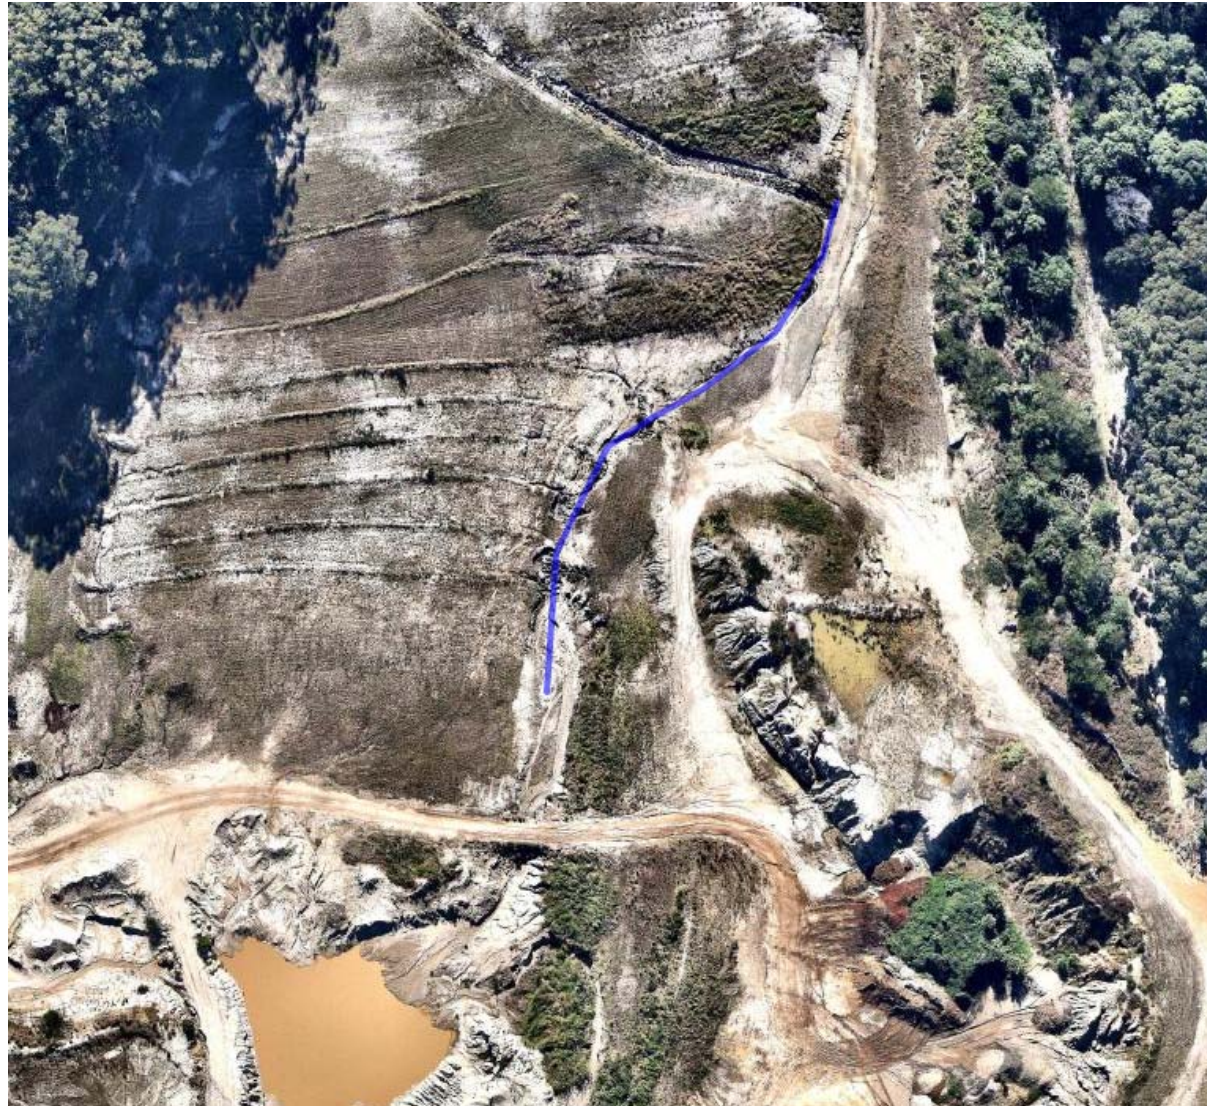
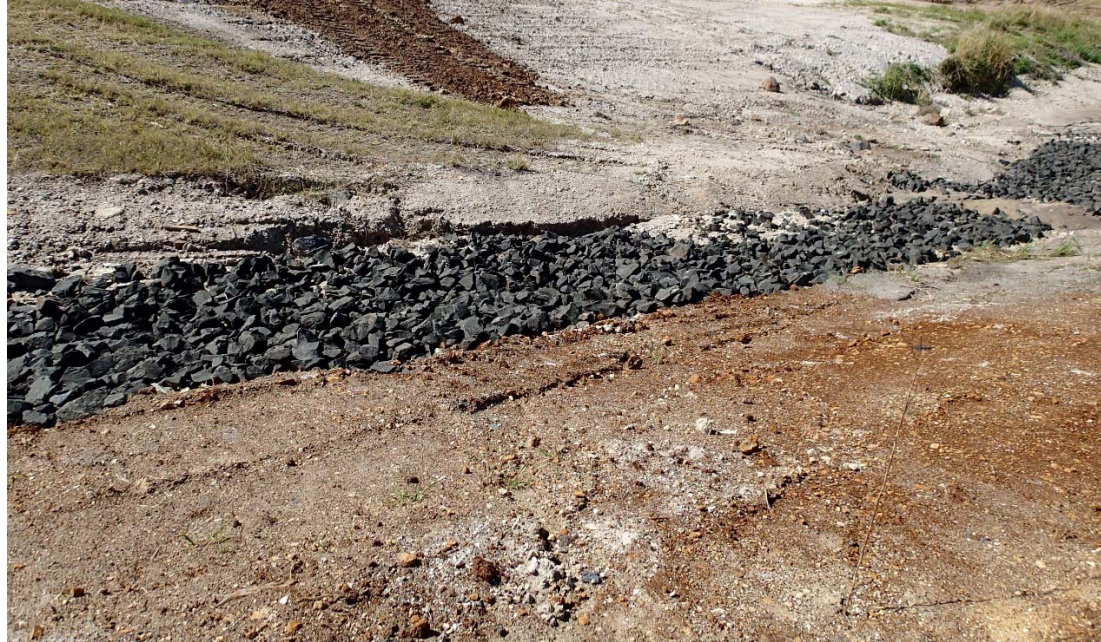
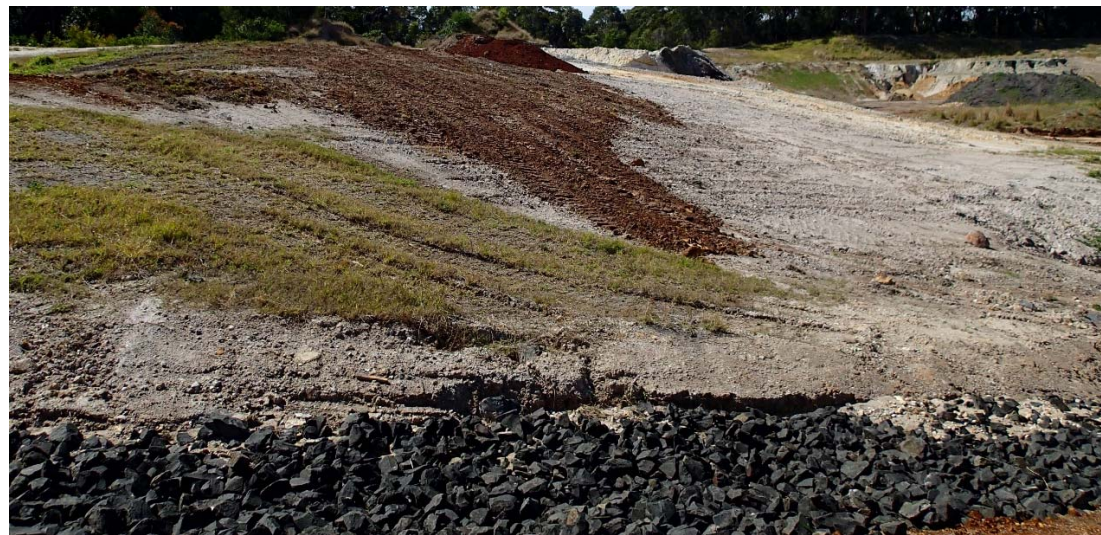
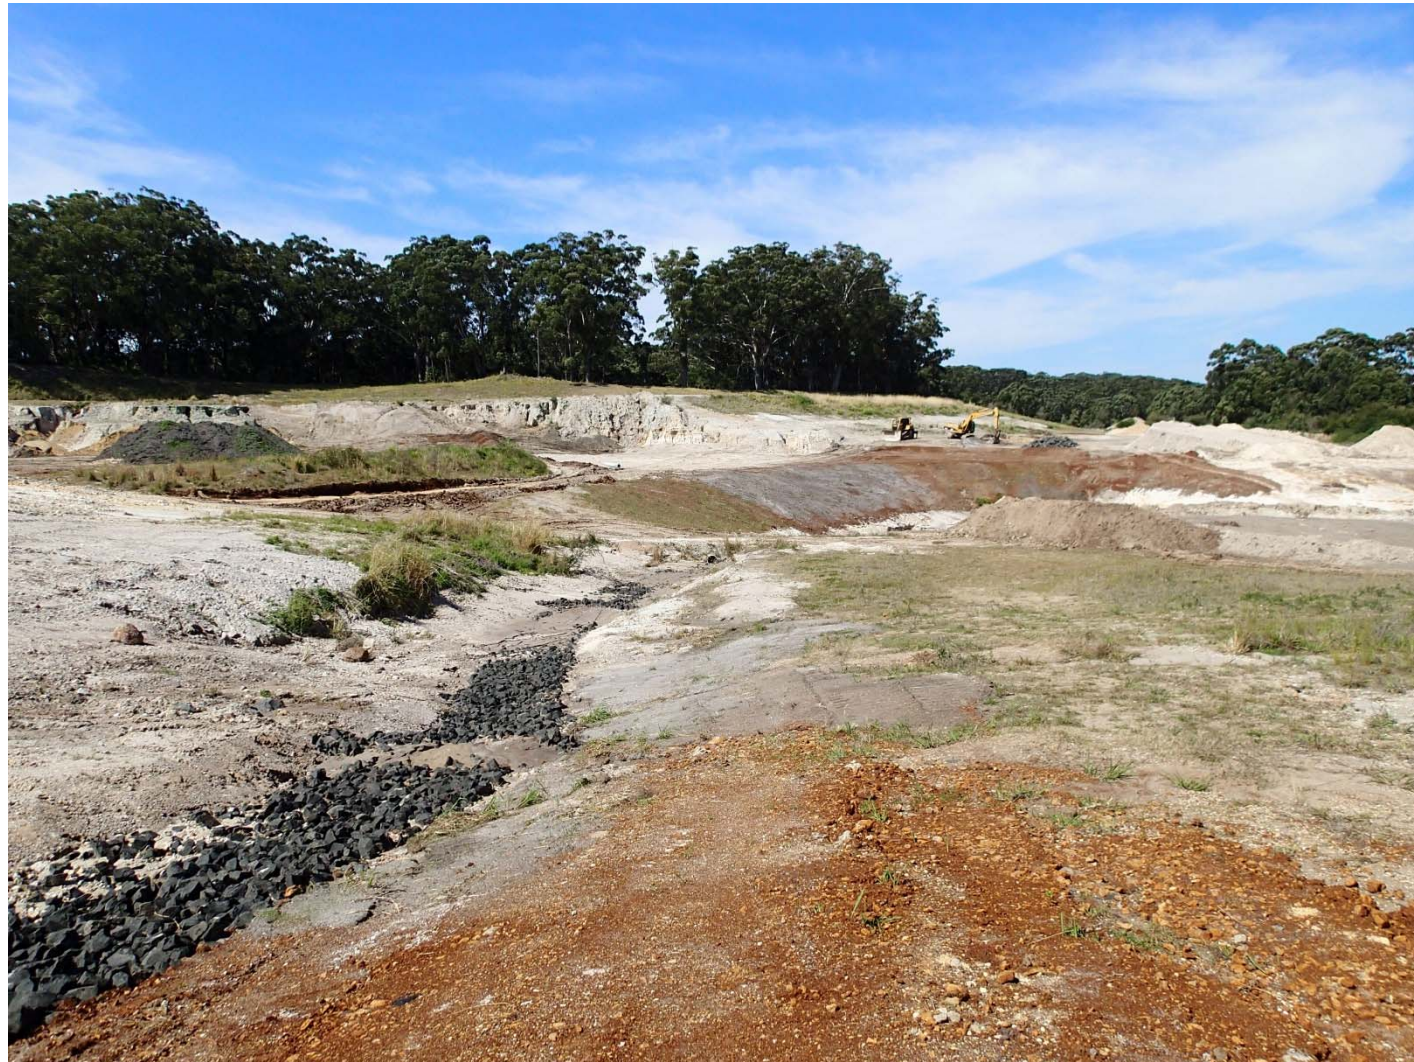
Figure 7 - Westside Upper Drain reforming

- Westside drain from northern pad to Central Dam (Area 11 on the Rehabilitation Works Plans and Specifications) has been re-formed and rock-lined. Further work closer to the Central Dam will be undertaken once the dam is complete:

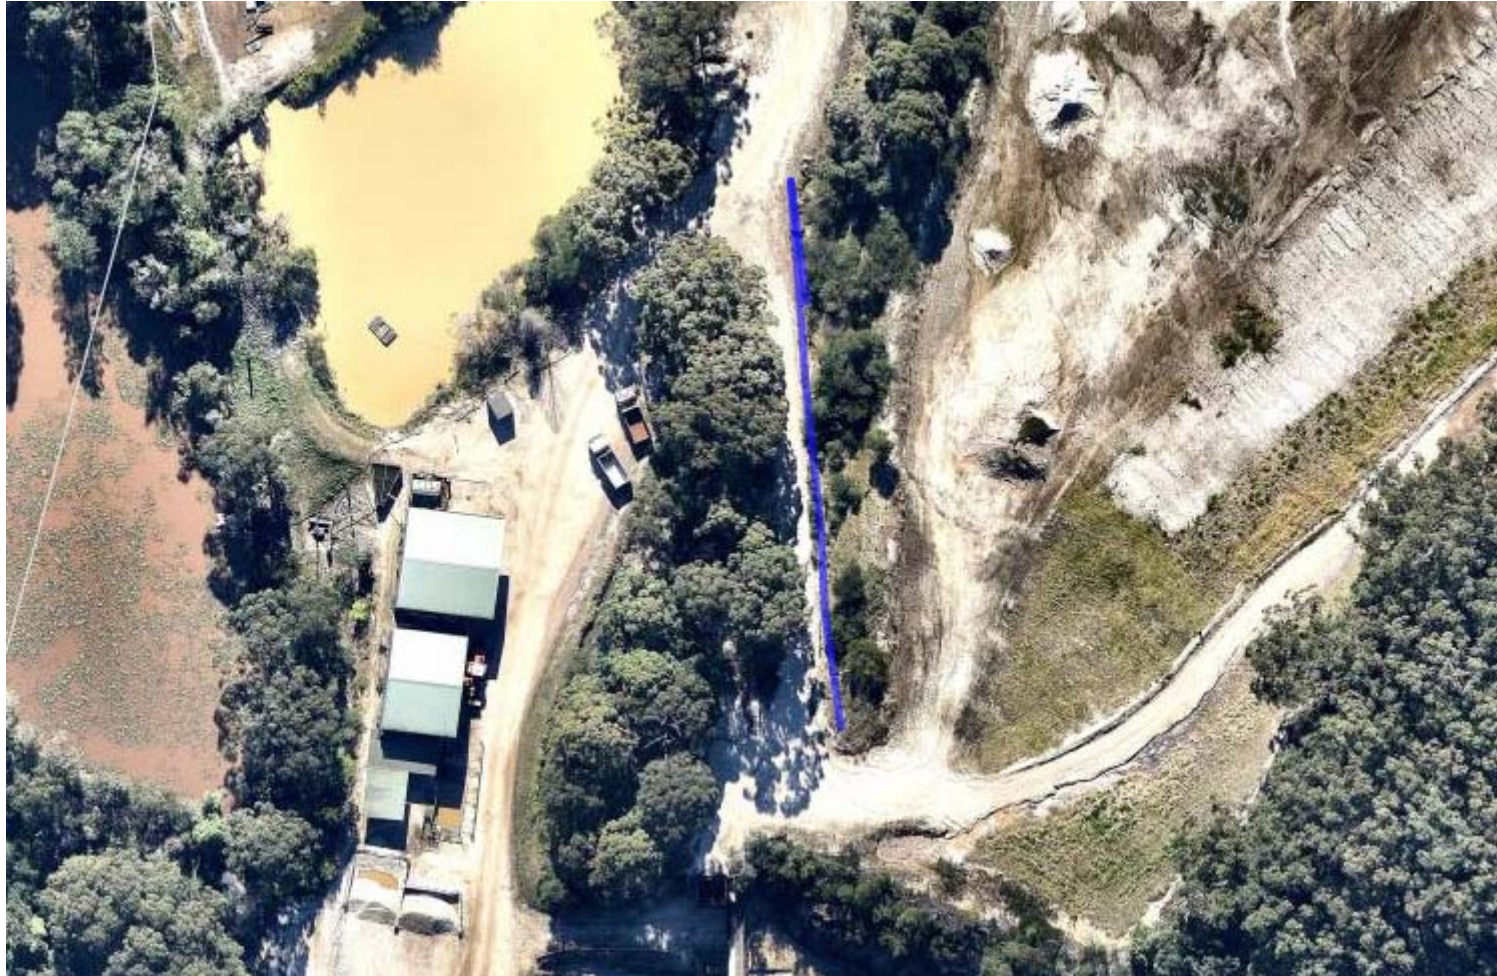
Figure 8 - Westside Middle Drain concrete lined

- Westside drain from central pad to the proximity of the Process Pond concrete lined and rocked:

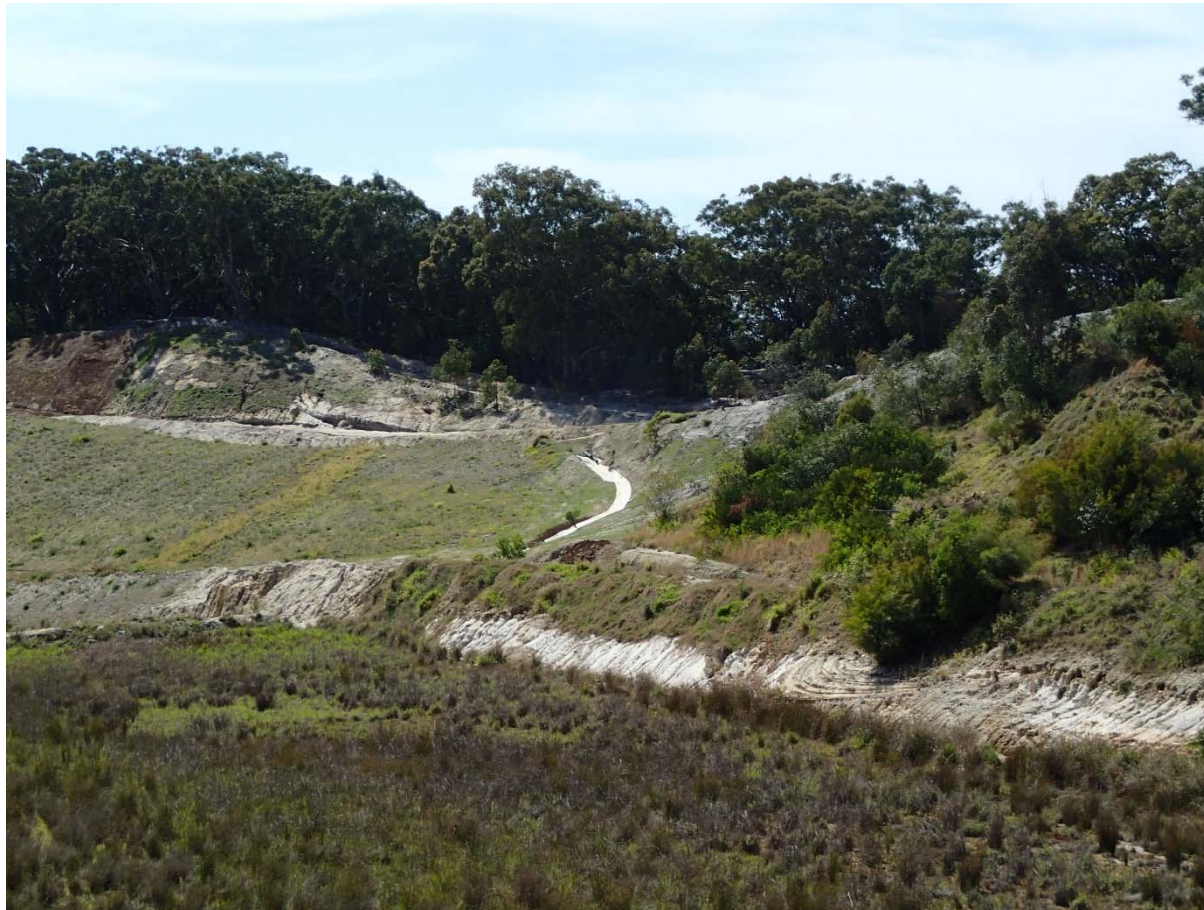
Areas PZE4, PZE5, PZE6, PZE9 and PZE13

Areas topsoiled and seeded in the past few months have struggled with low rainfall and have required water cart irrigation, but this has been with limited success. Heavier rainfalls experienced in September has assisted in the striking of seed and the seeded areas are looking good at present, as demonstrated by the photos preceding in this report and the following photos:
