Broken Head Quarry

Enforceable Undertaking Progress Report

Report #5 – December 2018

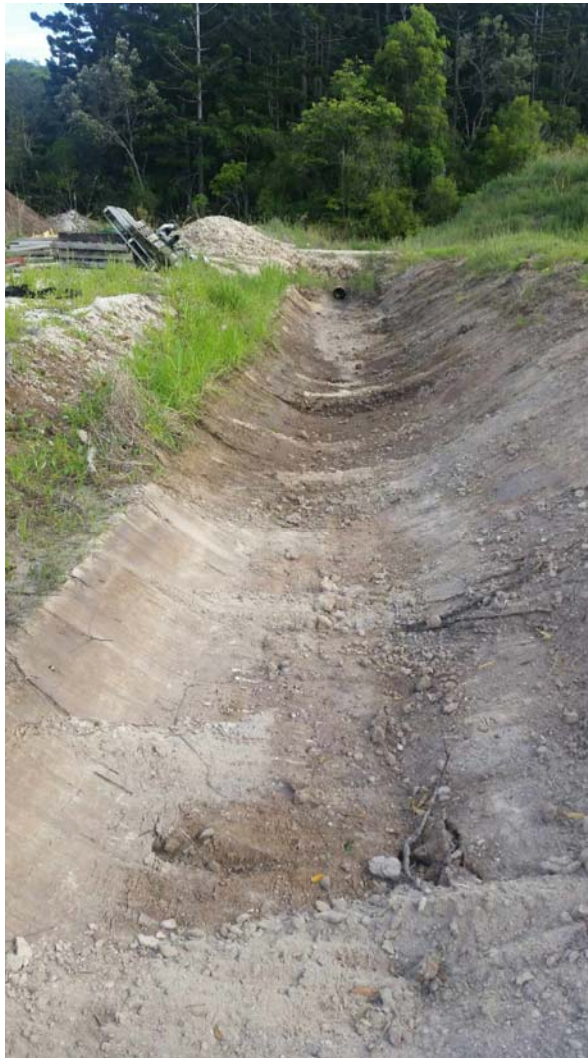
Drain clearance and upgrade works were undertaken during the month, particularly on the Cut-off drain, which had become heavily silted, including due to the construction of the Central Dam.

**Figure 1 – Cleared cut off drain from close to entry point to Process Pond, looking northwest**

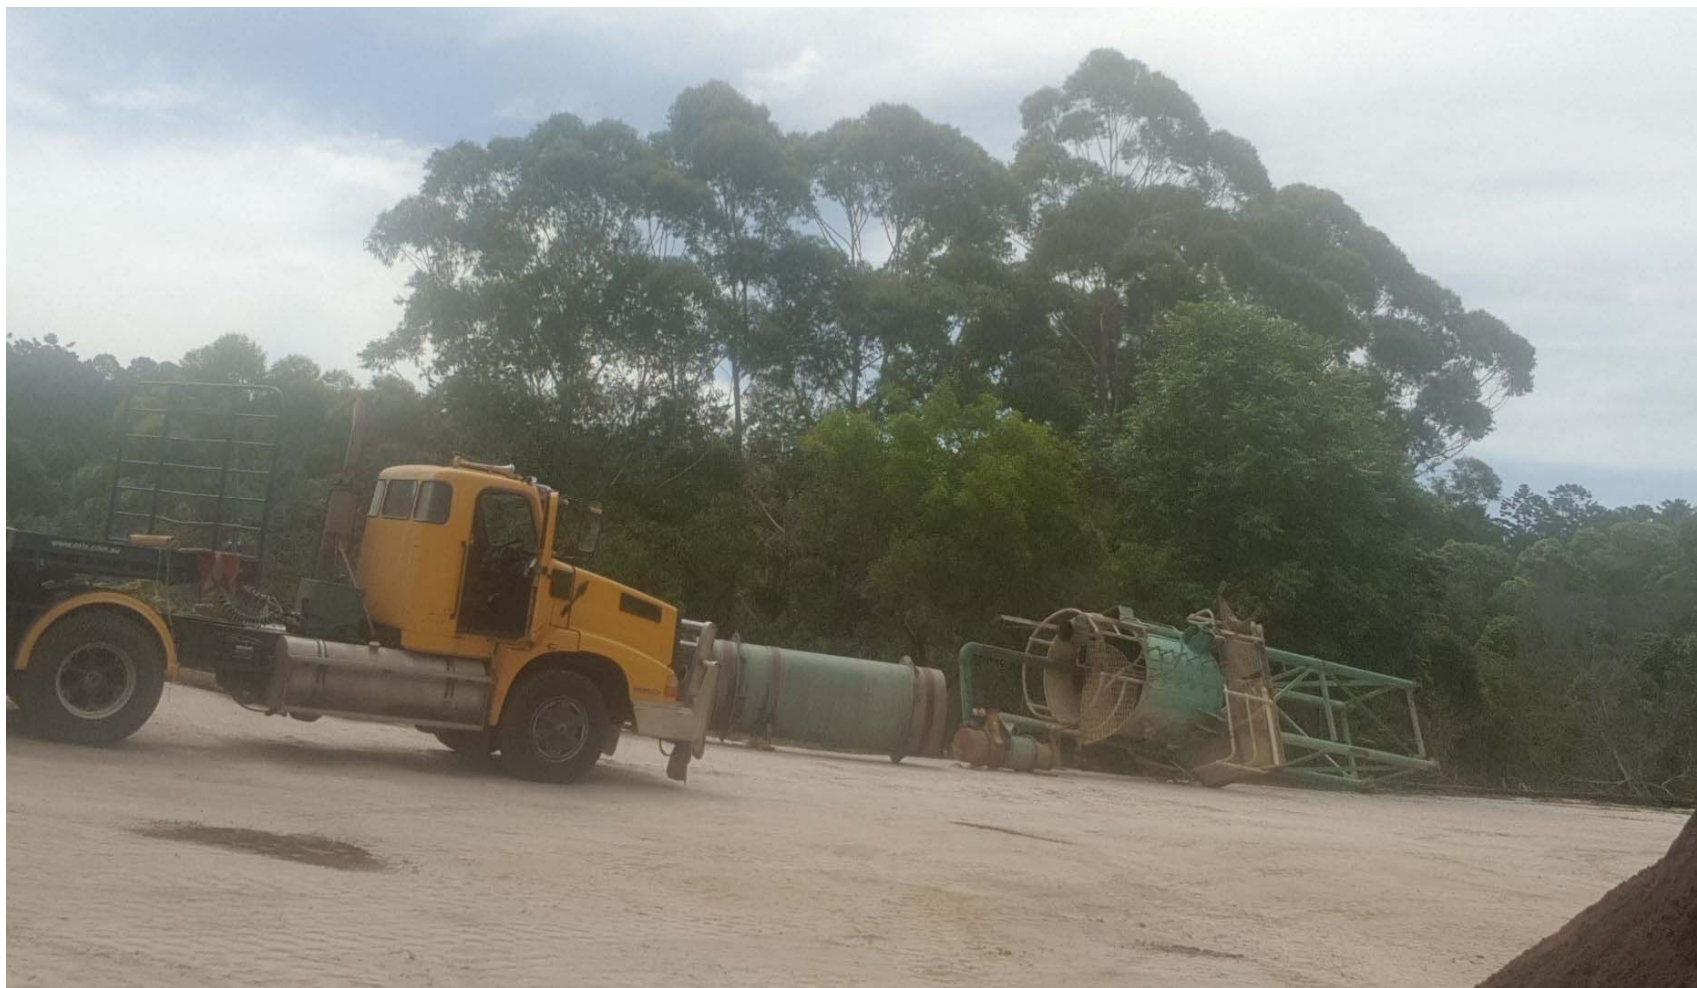
**Figure 2 – Cyclones and trommel removed, awaiting loading onto flatbed semi-trailer**

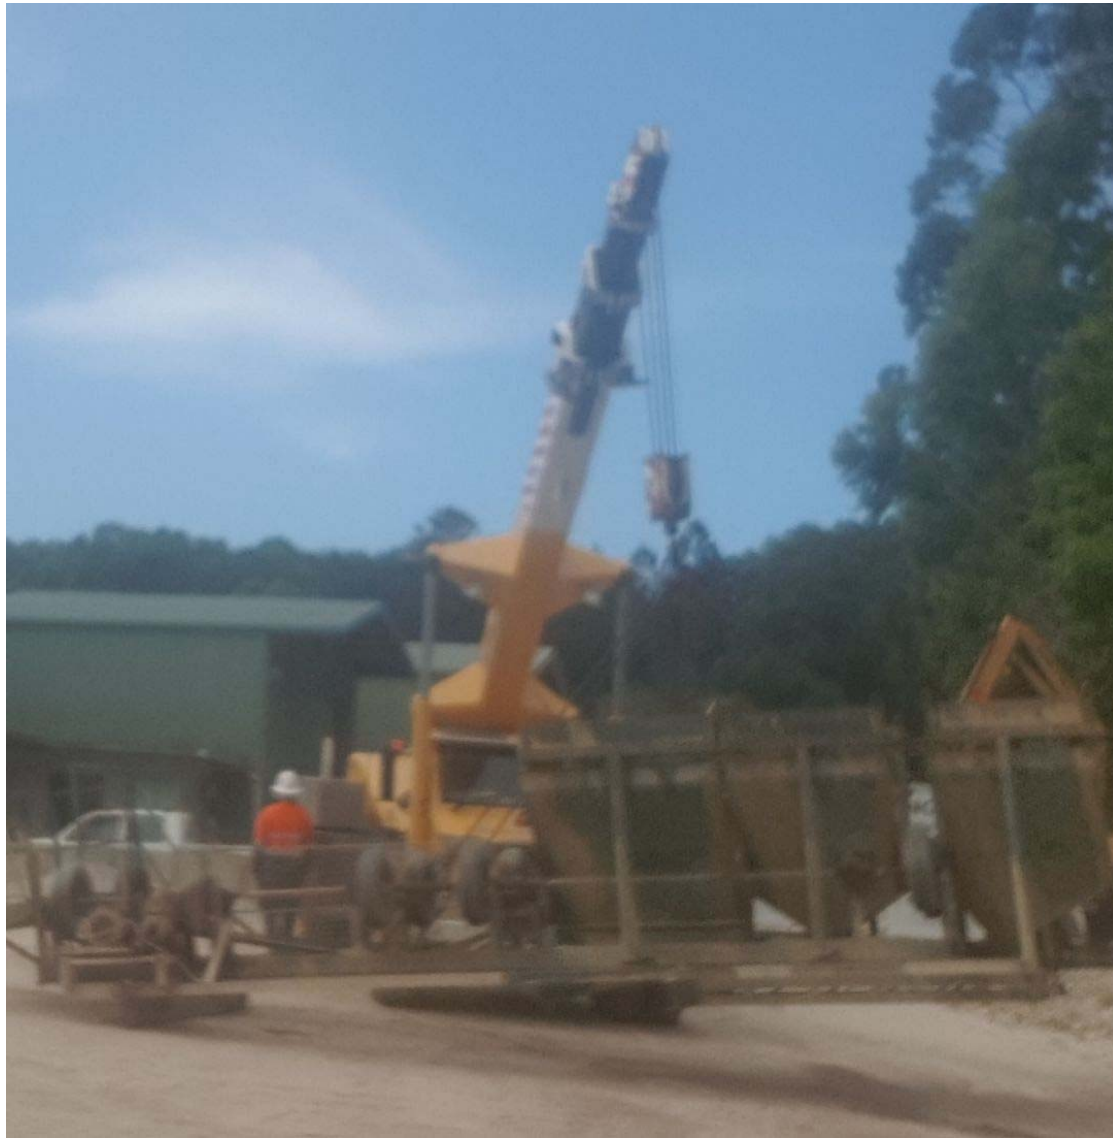
**Figure 3 – Trommel screen sorting hoppers removal**

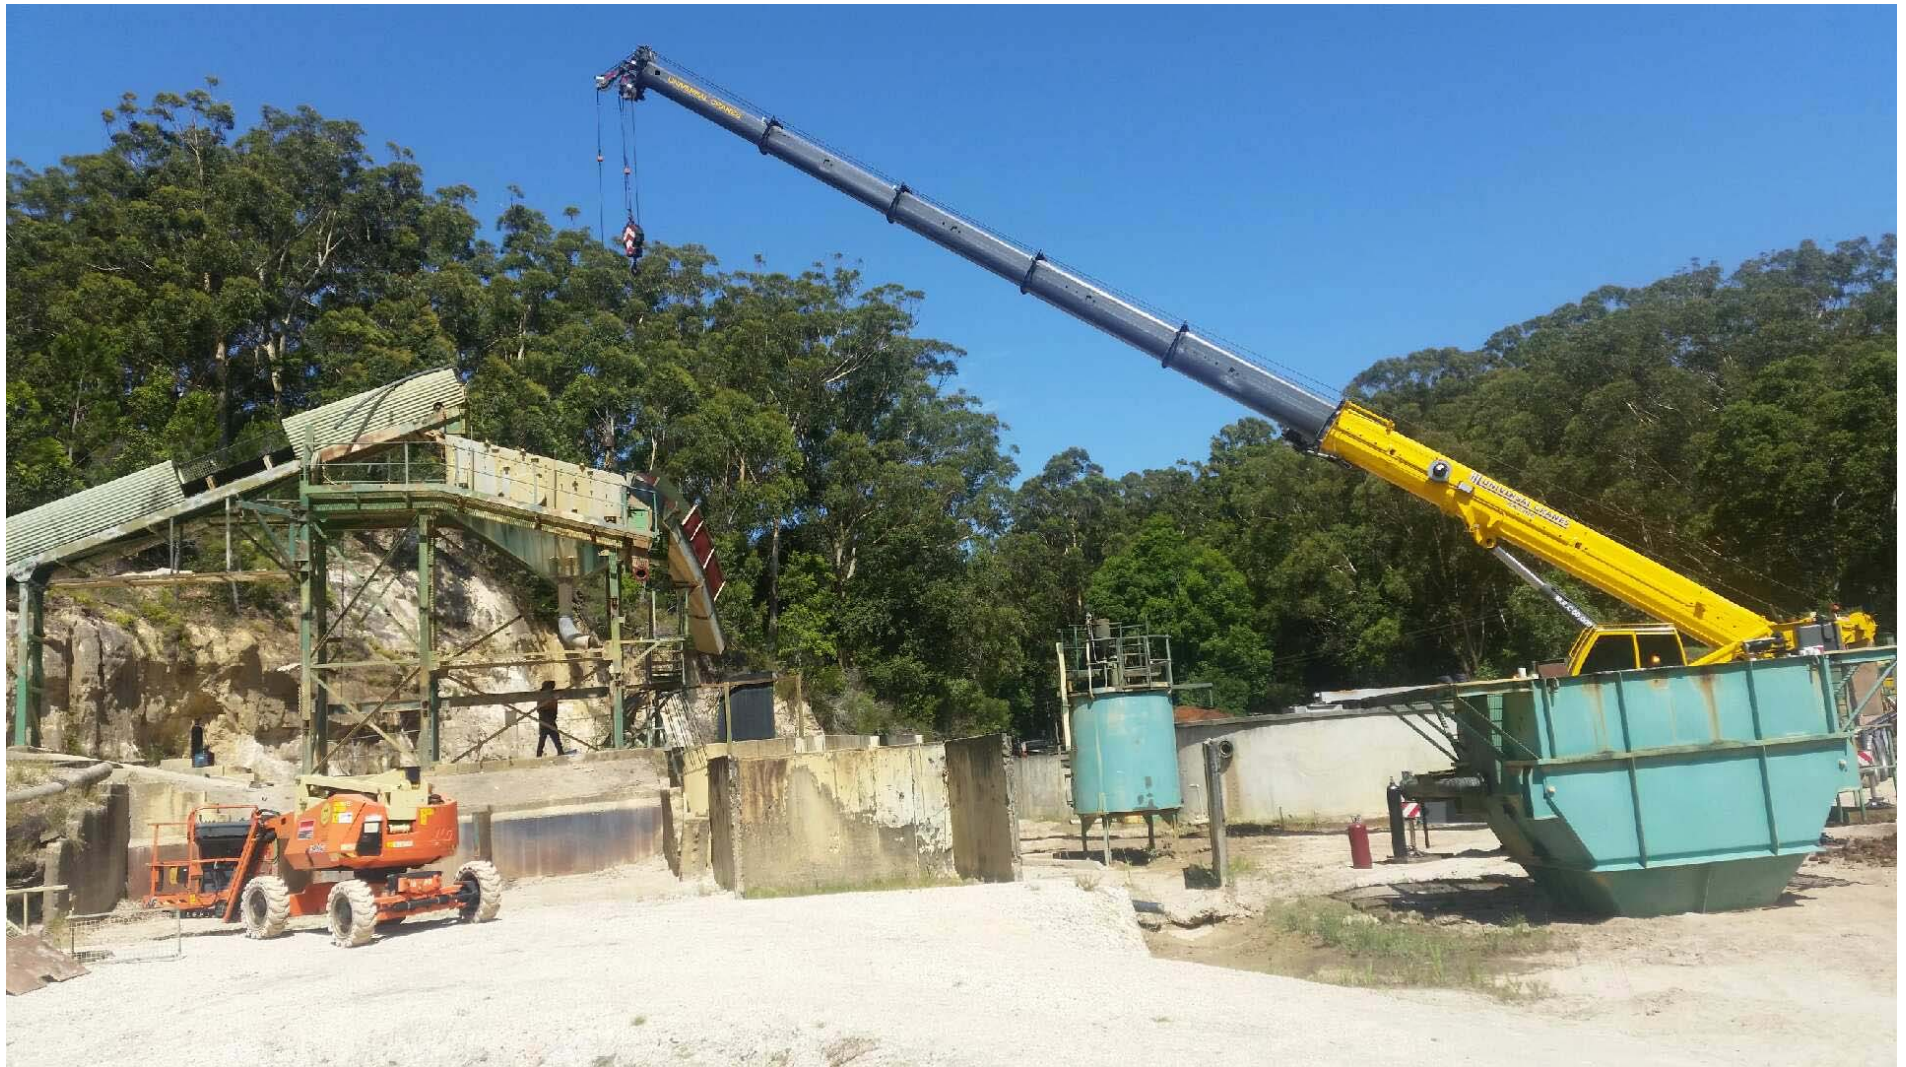
**Figure 4 – Trommel, hoppers and cyclones removed, preparing to remove conveyor assembly, shaker deck and screen**

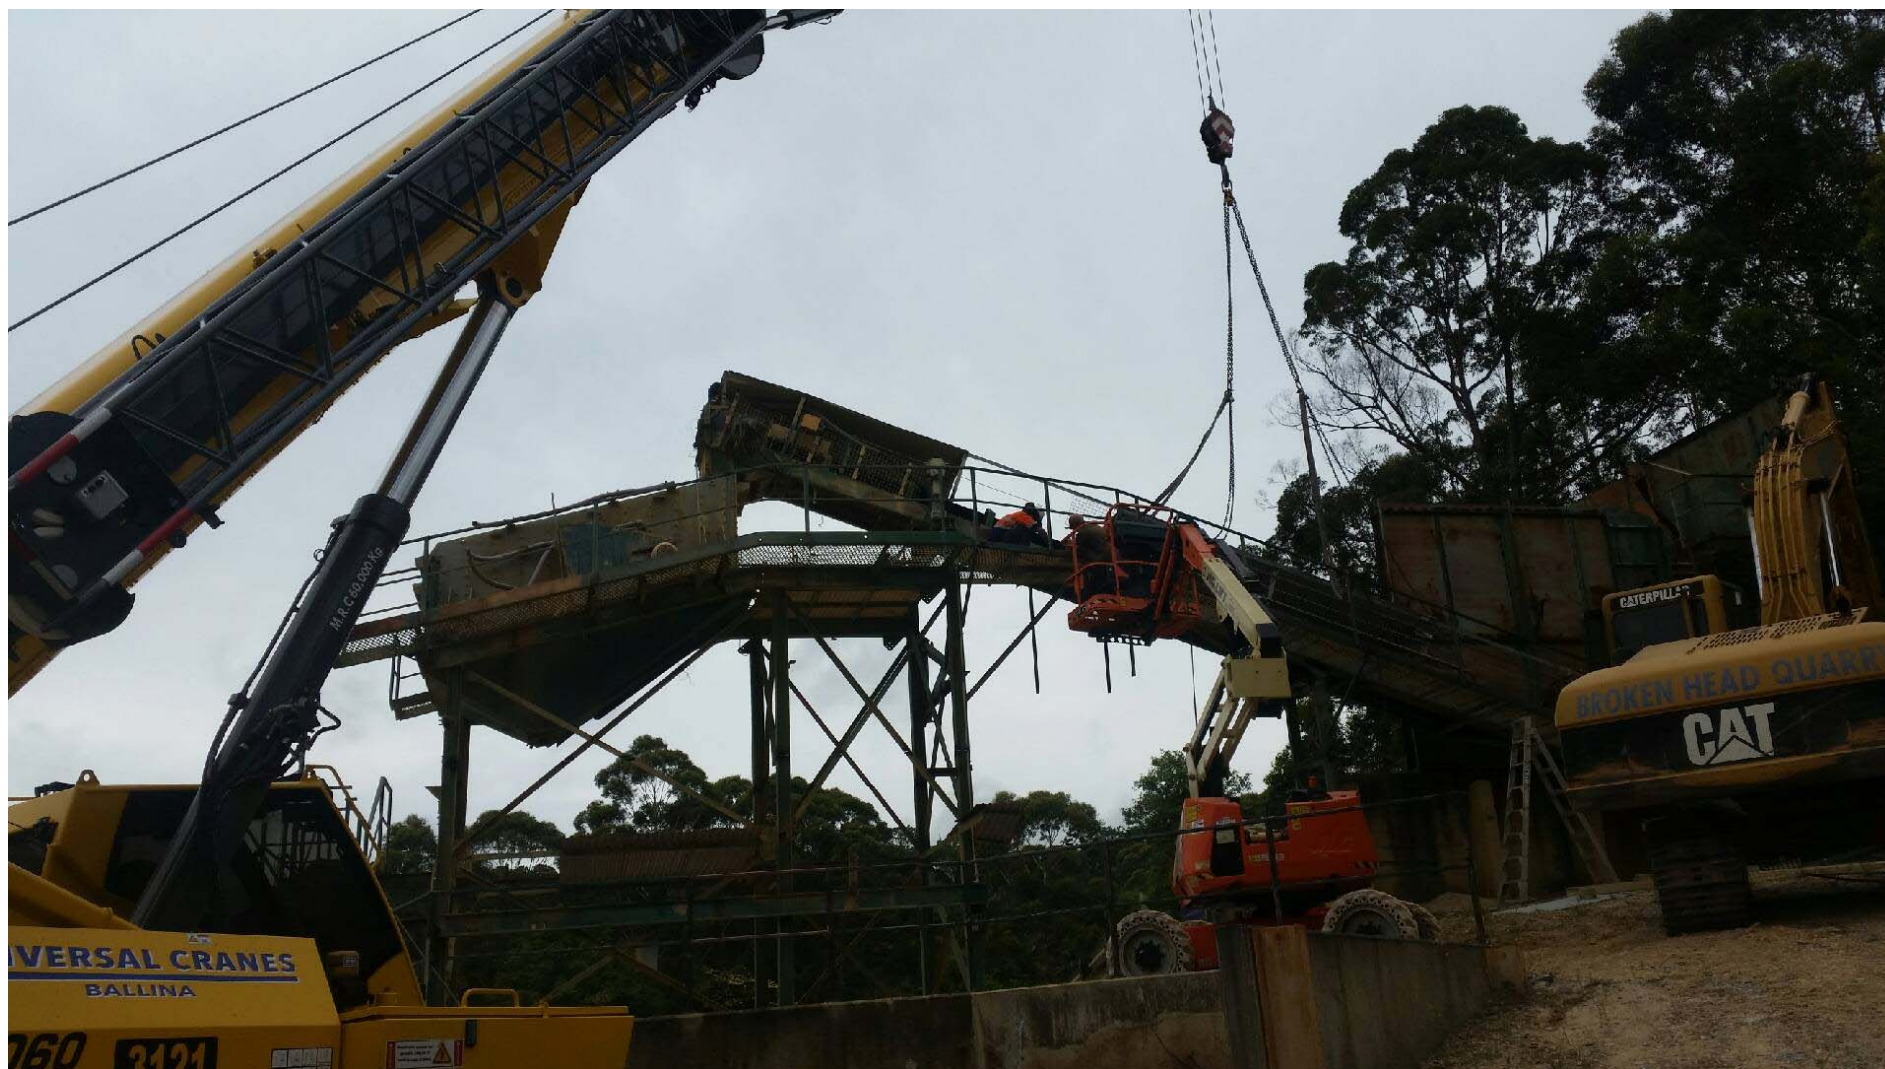
**Figure 5 – Preparing to remove conveyor assembly**

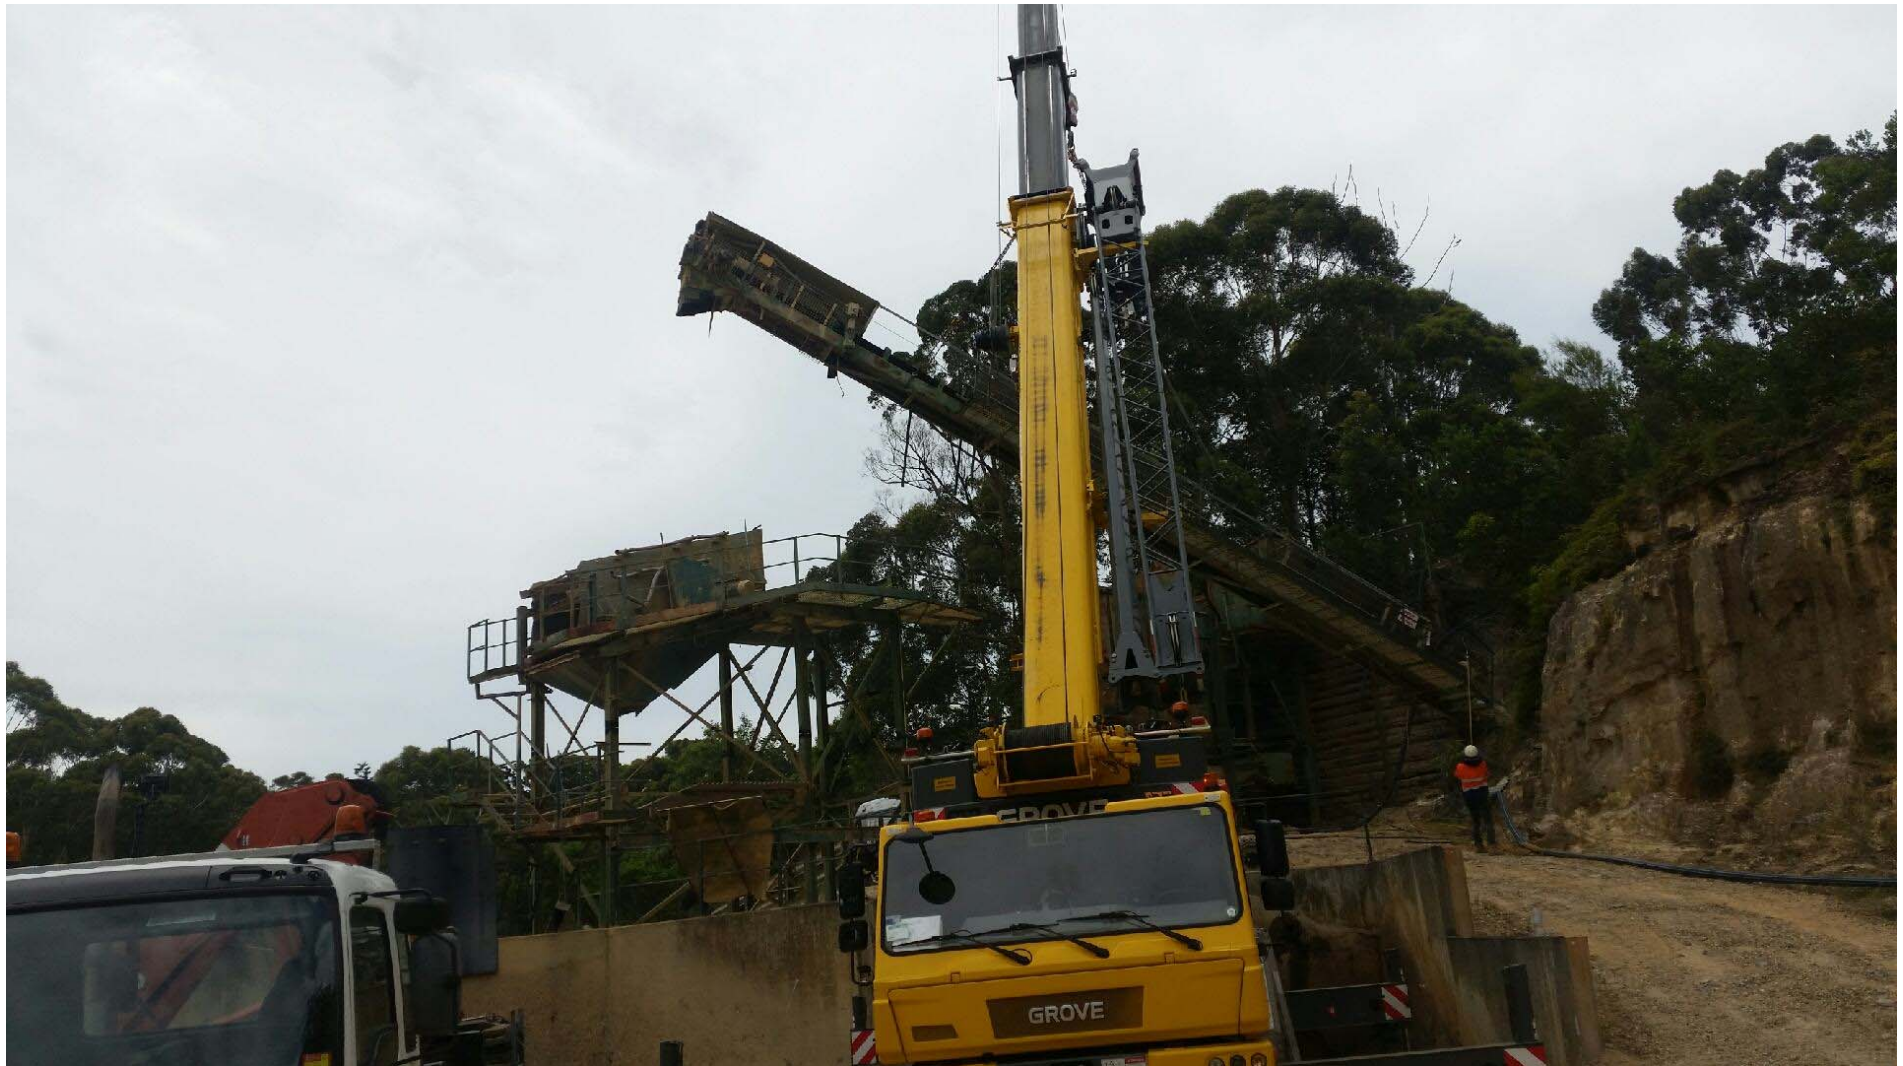
**Figure 6 – Conveyor assembly removal**

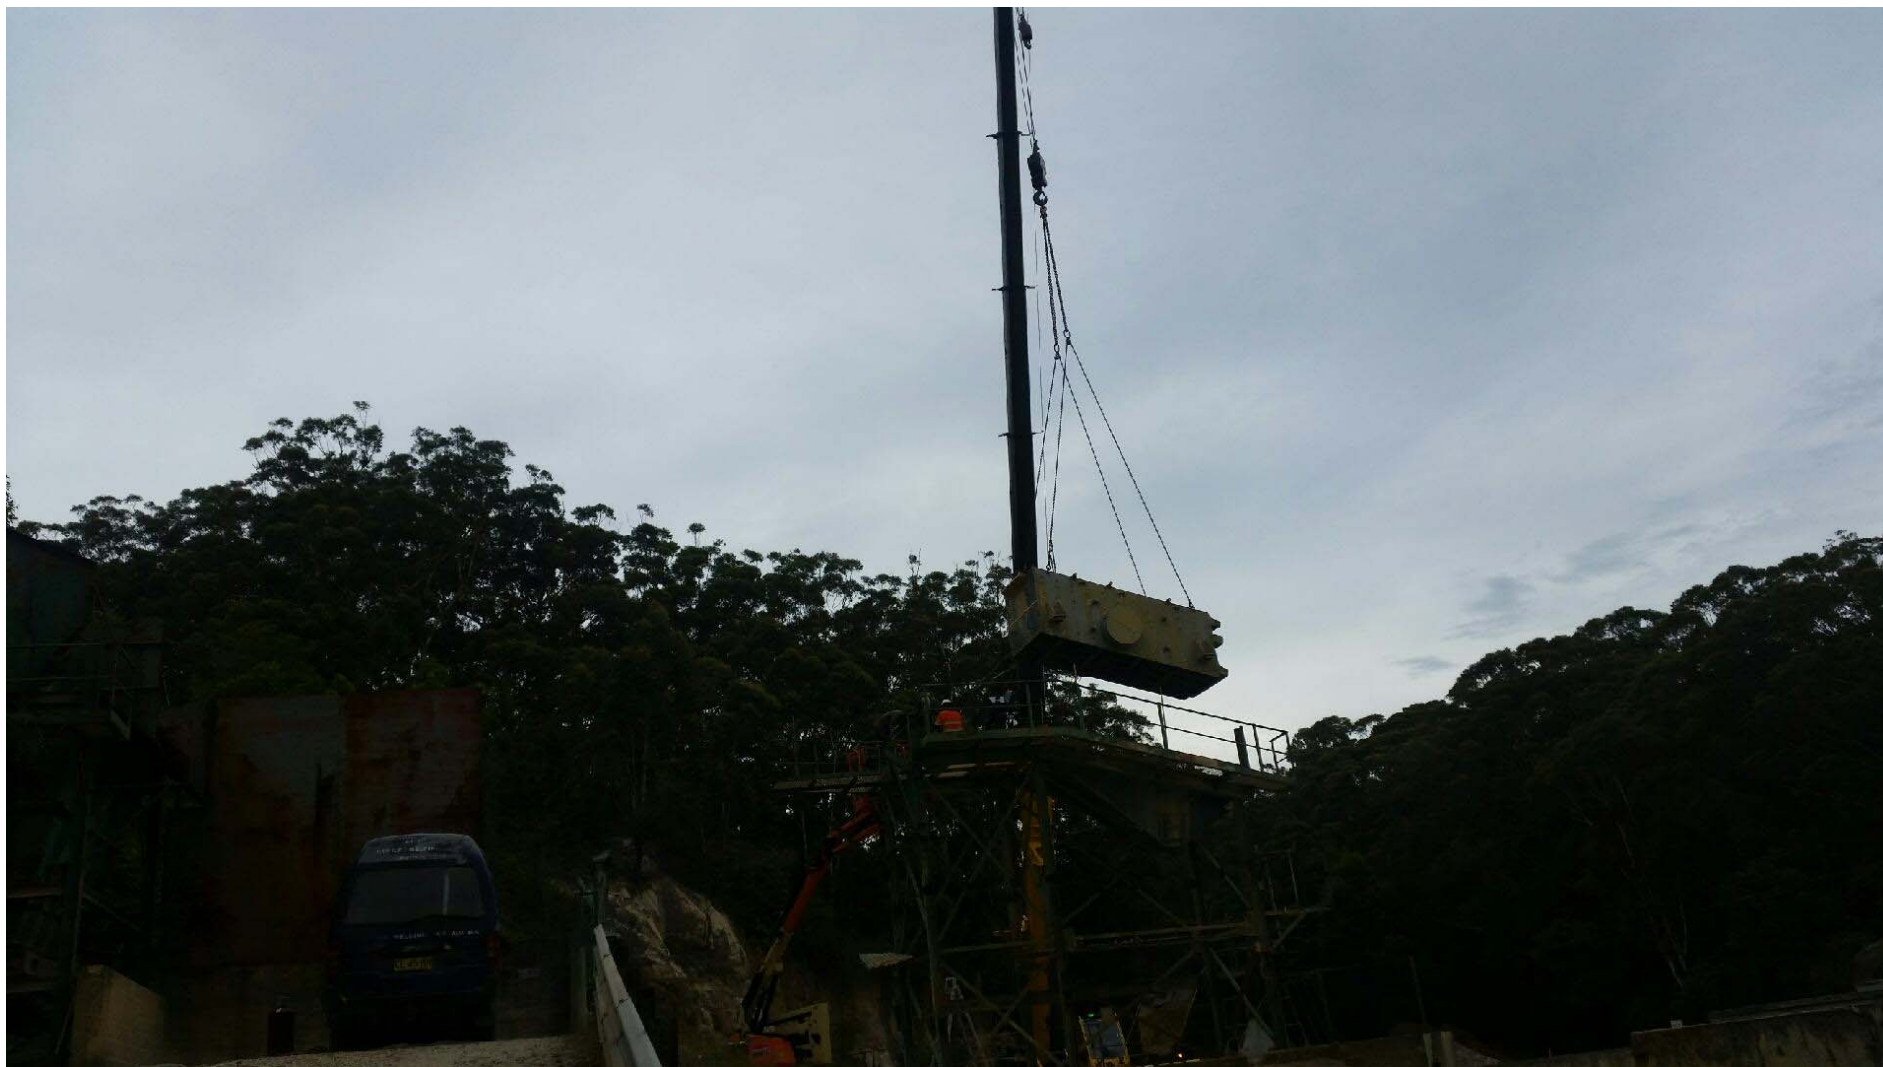
**Figure 7 – Shaker deck removal**

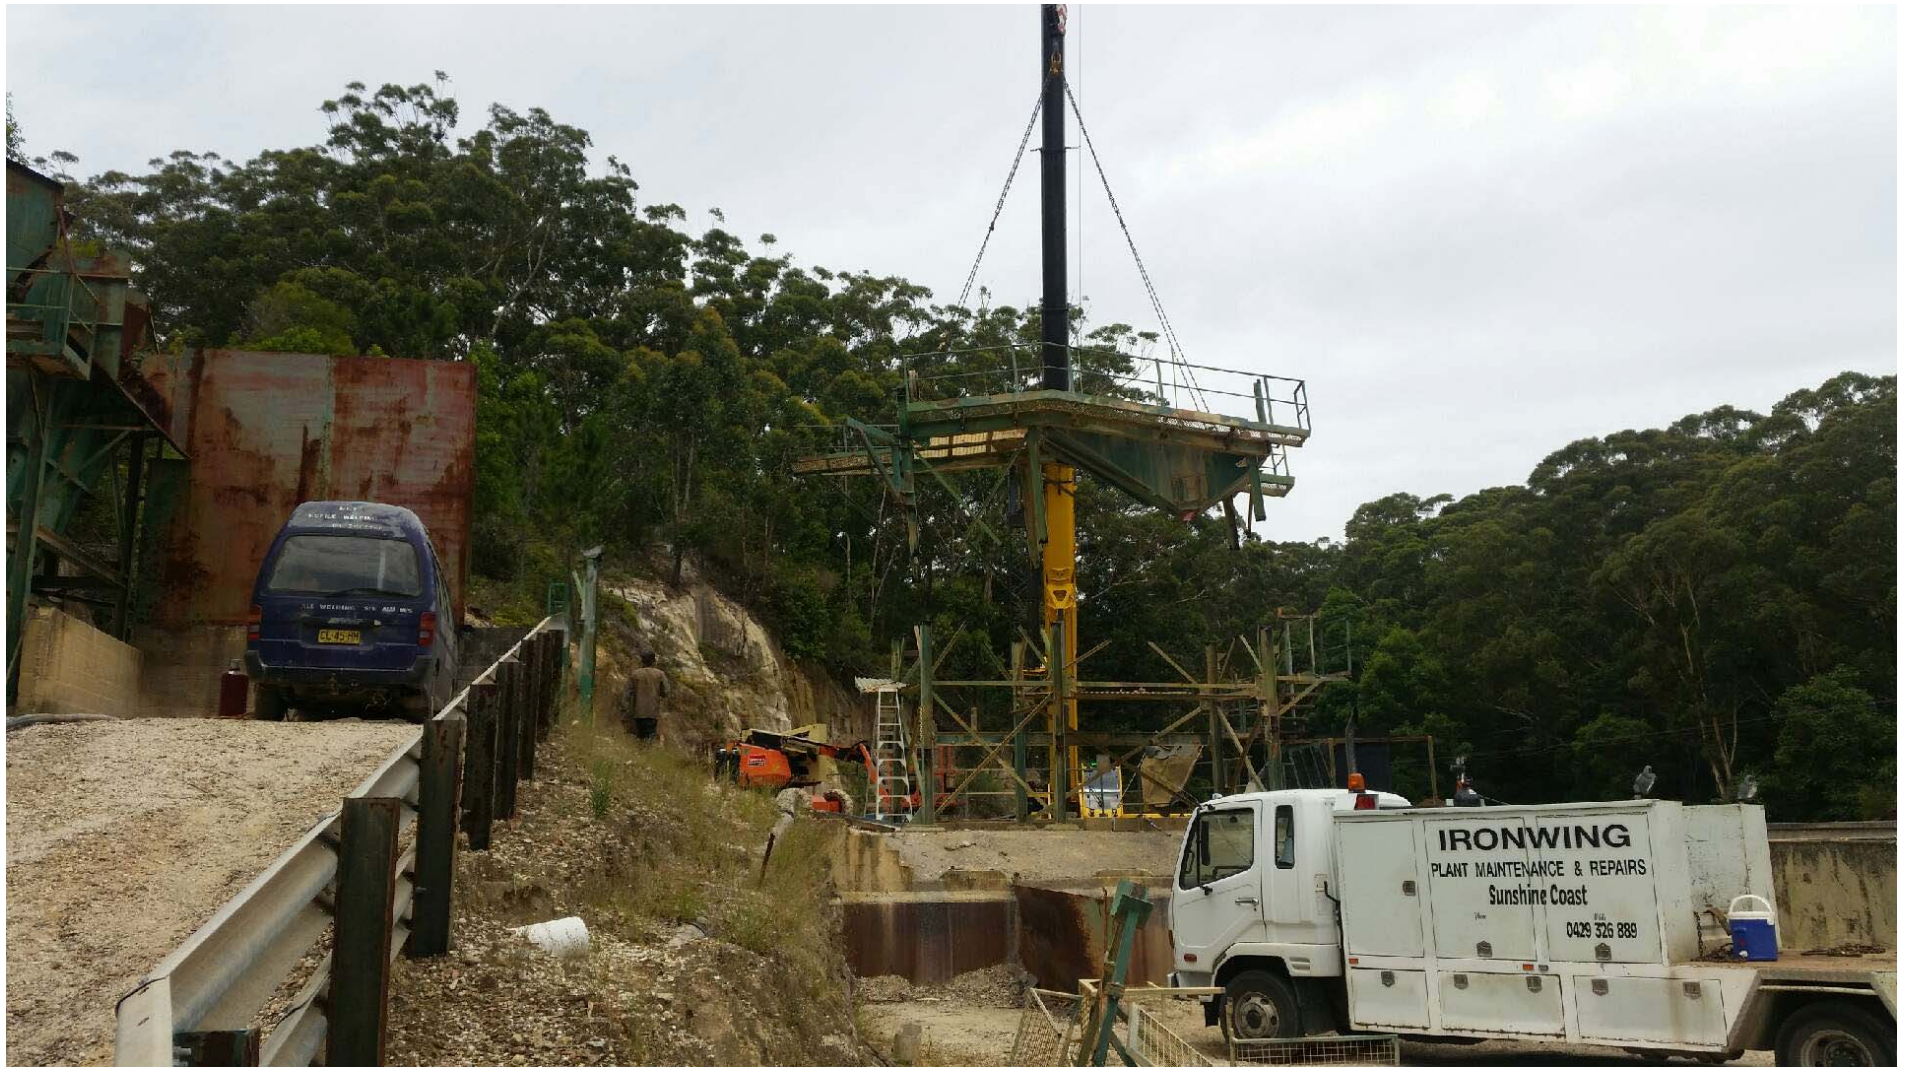
**Figure 8 – Screen and catwalk removal**

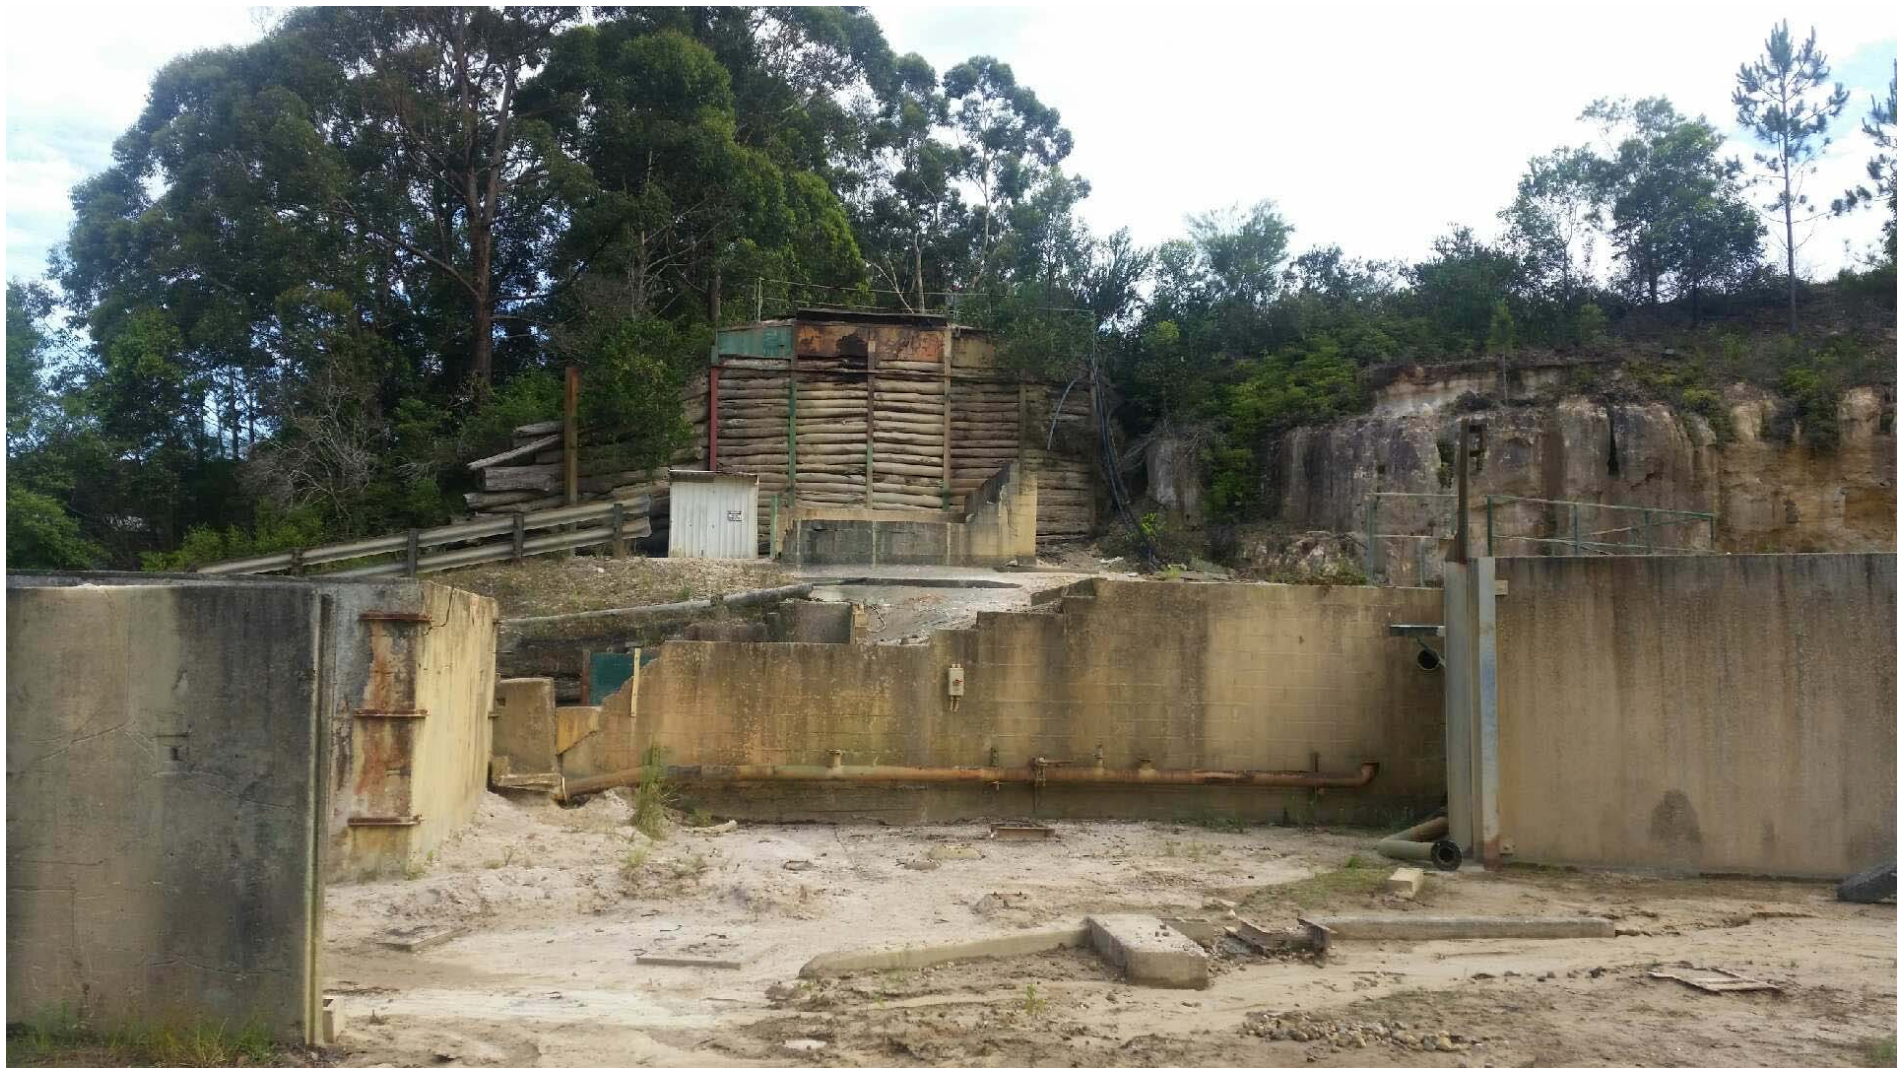
**Figure 9 – All washplant equipment removed at end of job, looking north towards drop point**

The drop point was secured with barricades for safety and further work will be done to protect this high face from danger.

Tidy up works remain to be completed, including demolition of residual concrete structures, removal of concrete blocks and other safety related works. The electrical switchboard and two water tanks will remain. The electrical switchboard still services the work shed area. The water tanks are an important part of the Quarry water storage facilities, including for filling water carts for dust suppression and irrigation.
