# Buy-Wise Inspection Services P/L

## PRE HANDOVER INSPECTION REPORT

### DEFECTS LIST

| Inspected Property Address: | Tootgarook | |

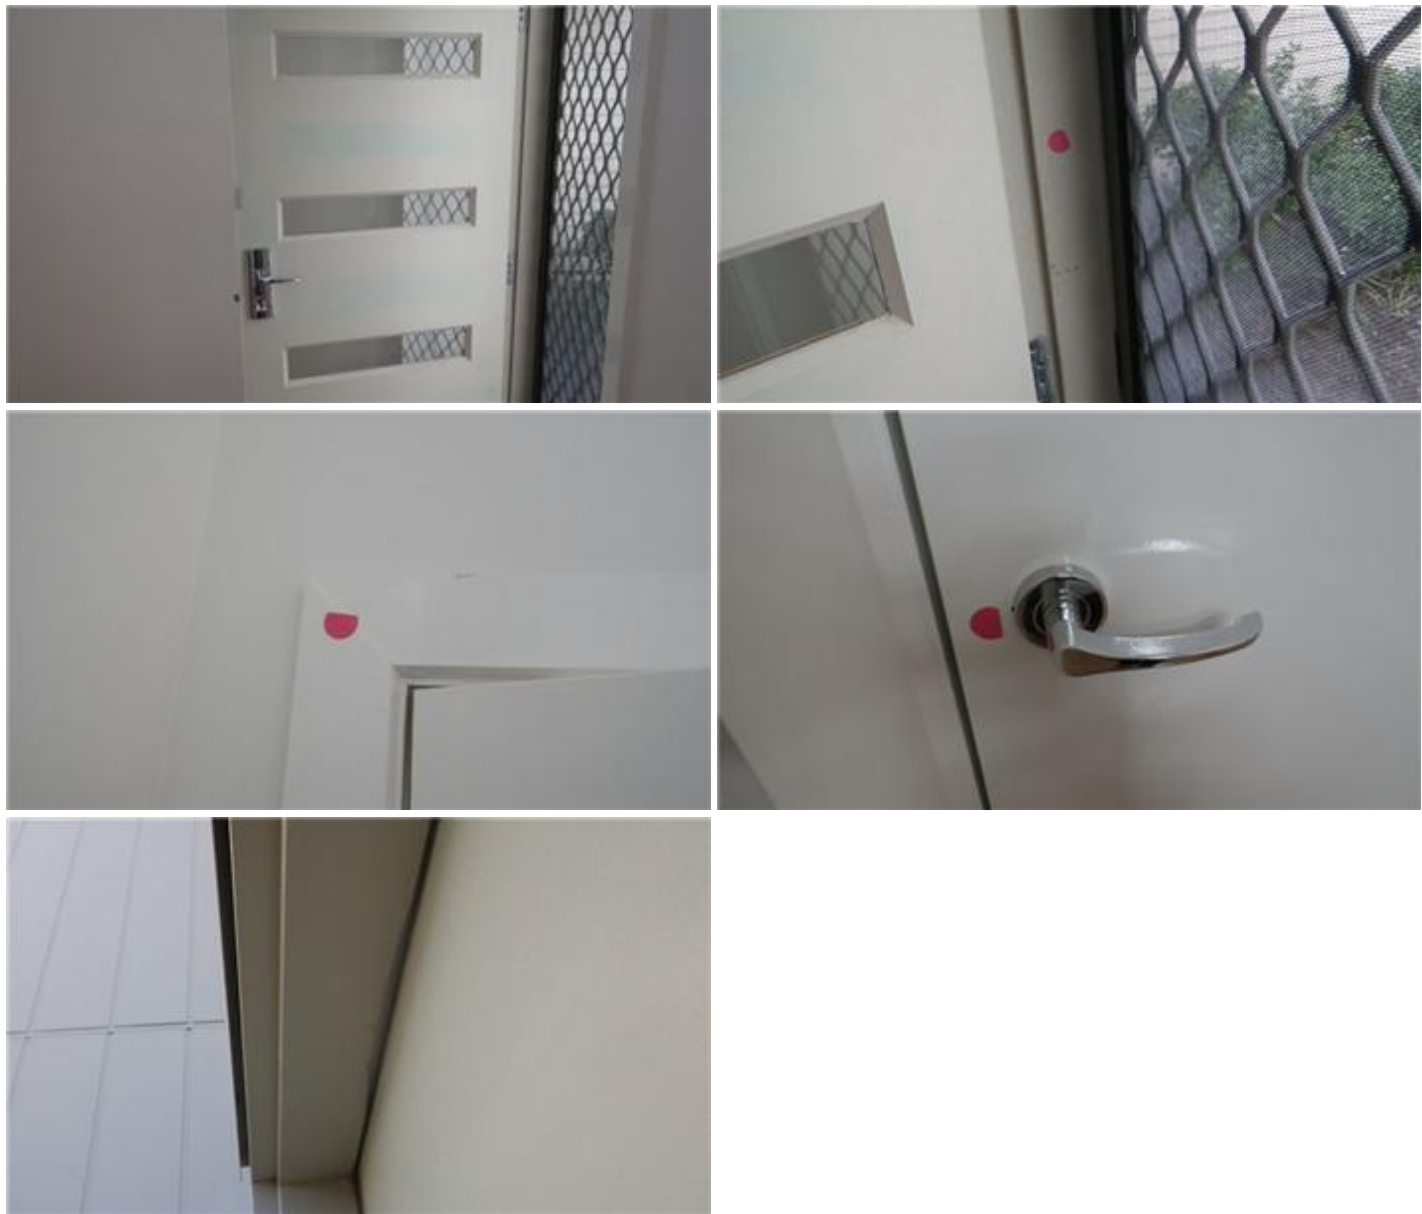
| Doors | External solid timber and glass door | Painting required to the top and bottom edges of external door, as to manufactures recommendations<br>Door and door jamb require another coat<br>Architrave mitres require sanding and painting<br>Hole noted next to handle of door under stairs<br>Section missing from door head, requires filling | Condition: Defect Noted |

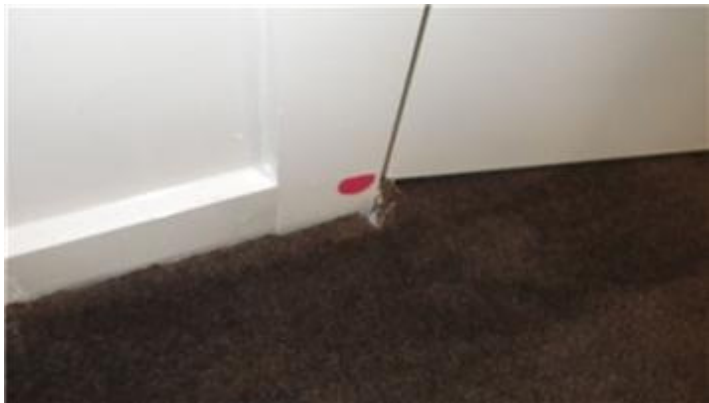
| Floors | Carpet | Carpet requires repair near cupboard door | Condition: Defect Noted |

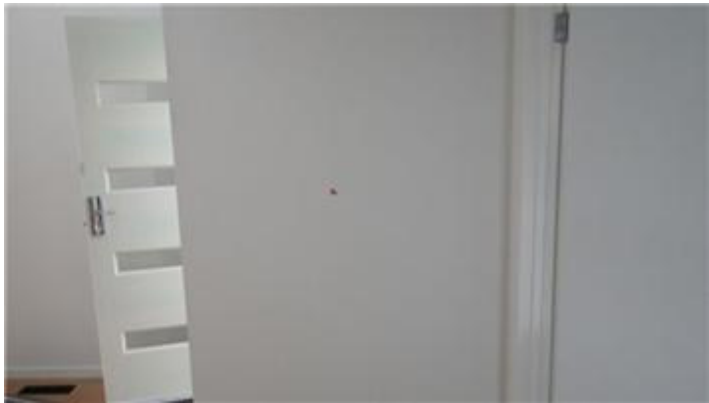
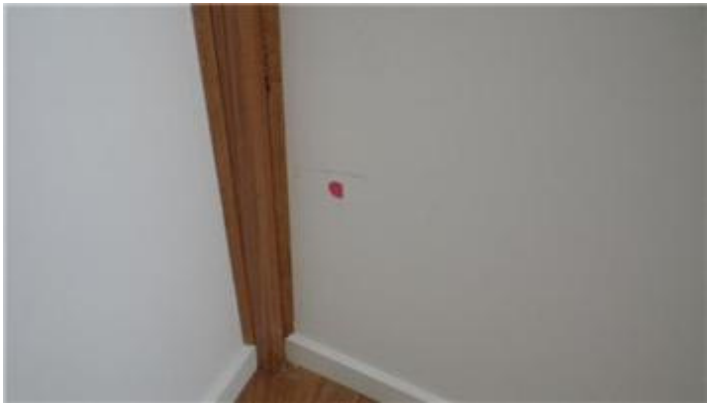
| <b>Walls</b> | Plaster | Walls require a finishing coat, they are unacceptable in their current state with marks and paint runs to most walls, also areas appear to be missing final coat | Condition: Defect Noted |

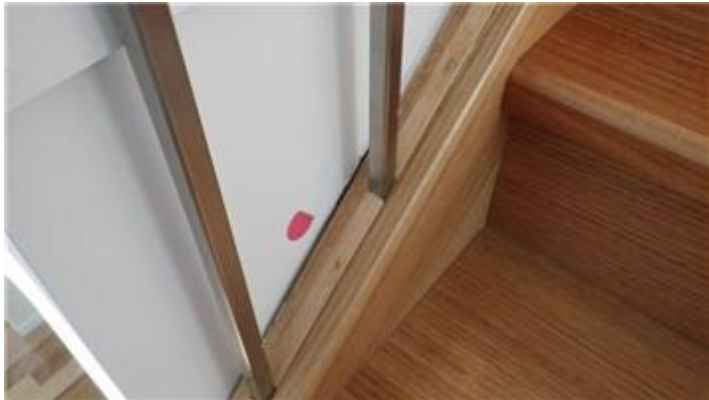
| <b>Comments</b> | Gap between stairs and wall require filling |

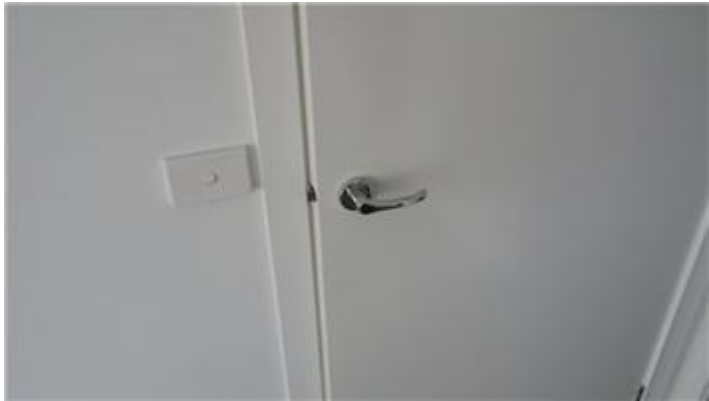
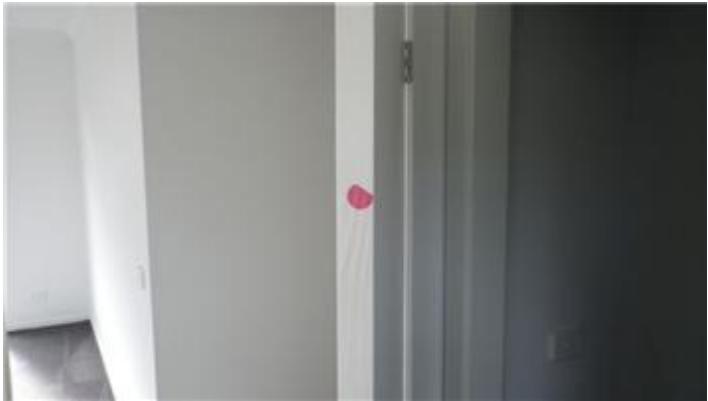
| <b>Doors</b> | Hollow core door | Door requires adjustment, binding on door jamb<br>Sanding required to edge of door | Condition: Defect Noted |

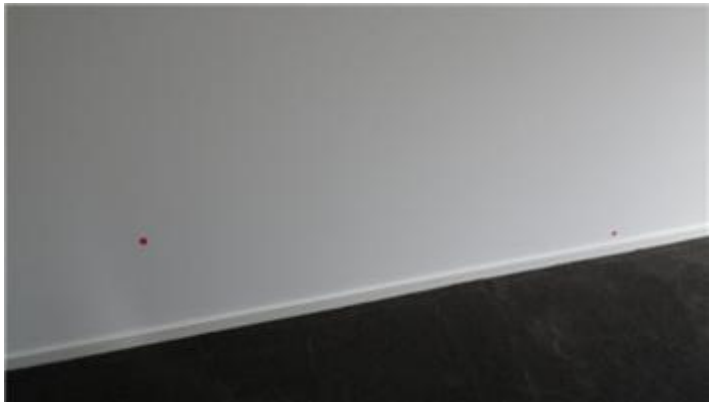
| <b>Walls</b> | Plaster | Marks noted to walls where indicated that require removal or painting<br>Paint runs noted that require sanding and touch ups | Condition: Defect Noted |

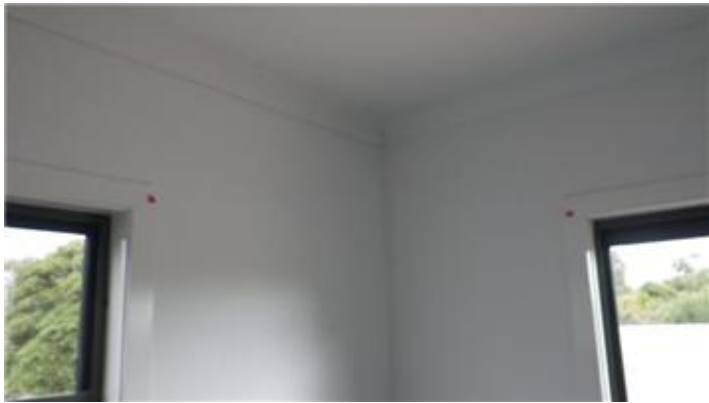
| <b>Windows</b> | Aluminium awning | Architrave mitres require sanding and painting | Condition: Defect Noted |

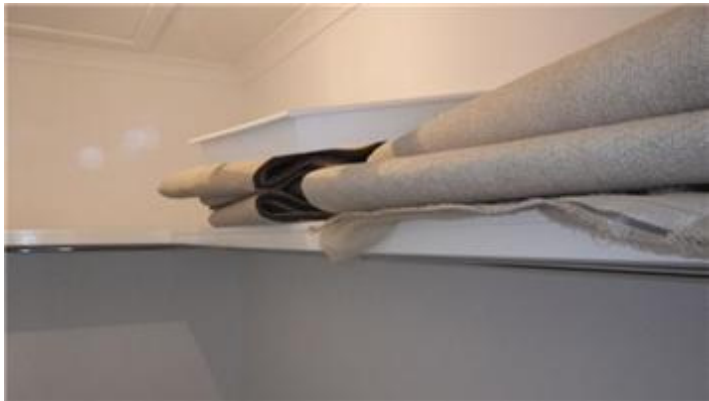
| <b>Comments</b> | Extra support required to shelf as it will bow when clothes are hung and items stacked on shelf<br>Painting required to man hole |

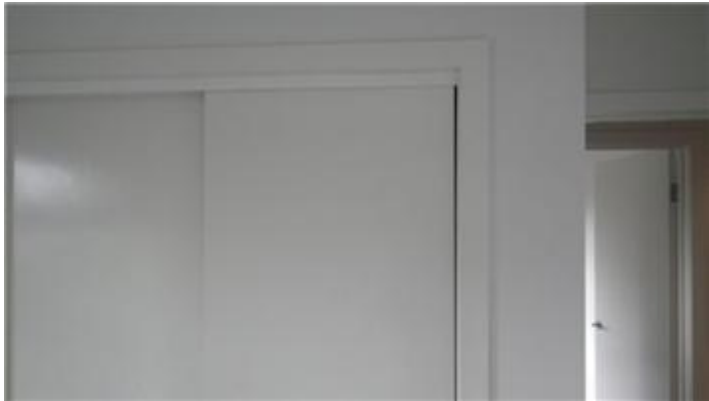
| <b>Doors</b> | Hollow core door | Robe door on right side requires adjustment | Condition: Defect Noted |

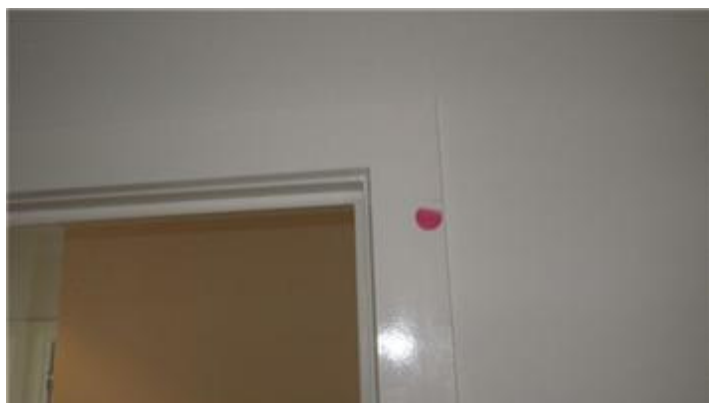
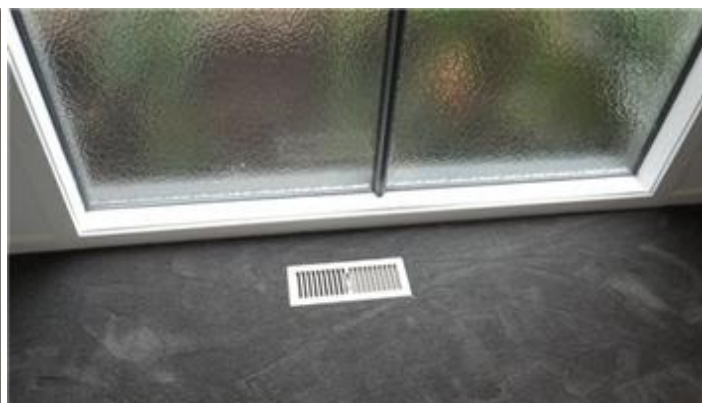
| <b>Windows</b> | Aluminium awning | Architrave mitres require sanding and painting<br>Window sill has not been installed straight, architrave requires removal and re installed after straightening | Condition: Defect Noted |

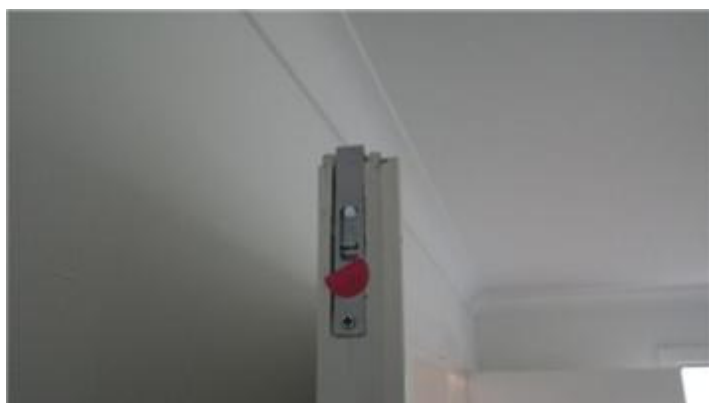
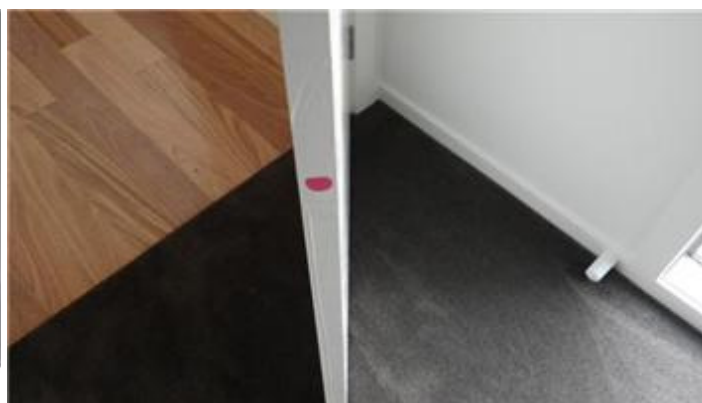
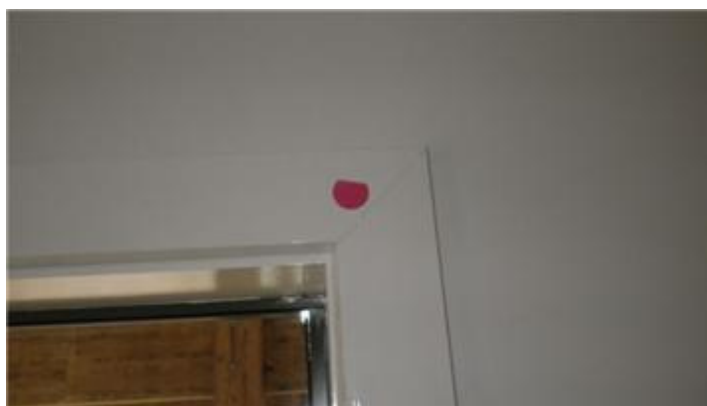
| <b>Doors</b> | Hollow core doors | Gaps noted around flush bolt that require filling<br>Edge of door requires sanding and painting<br>Door and window architrave mitres require sanding and painting | Condition: Defect Noted |

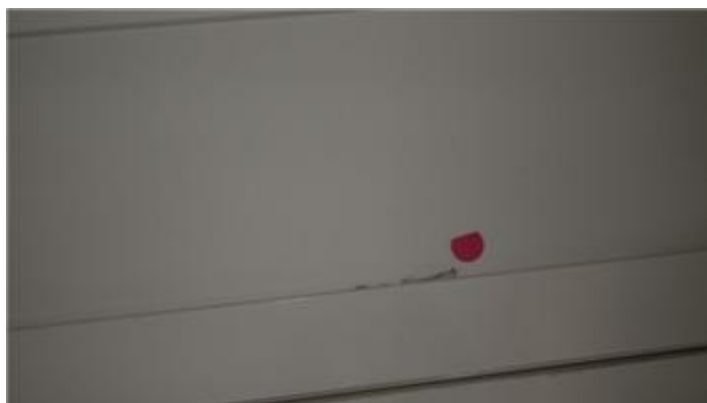
| <b>Walls</b> | Plaster | Marks noted to walls where indicated that require removal or painting<br>Paint runs noted that require sanding and touch ups<br>Hole requires filling and painting above double doors | Condition: Defect Noted |

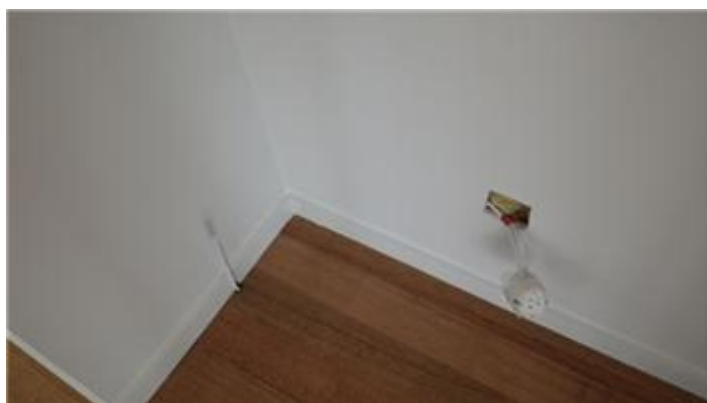
| <b>Comments</b> | Power point not finished off, gas pipe provided to this location | | |

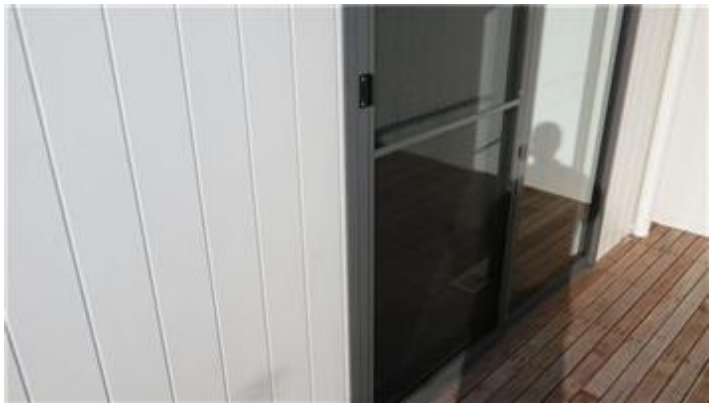
| <b>Doors</b> | External aluminium sliding doors | Door frames dont appear to be secured to wall framing adequately as there was a lot of movement<br>Futher fixing required | Condition: Defect Noted |

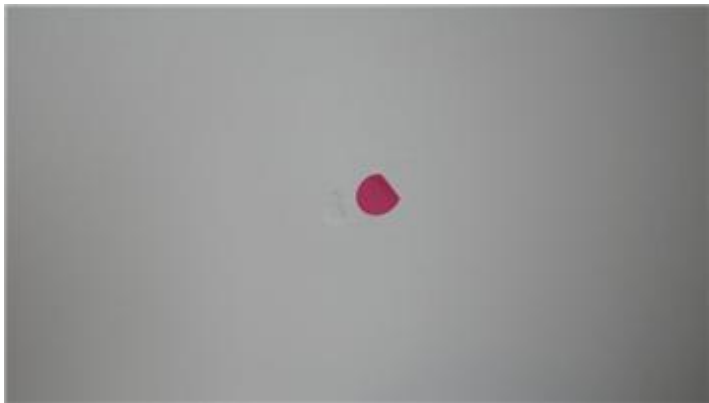
| <b>Walls</b> | Plaster | Marks noted to walls where indicated that require removal or painting<br>Paint runs noted that require sanding and touch ups | Condition: Defect Noted |

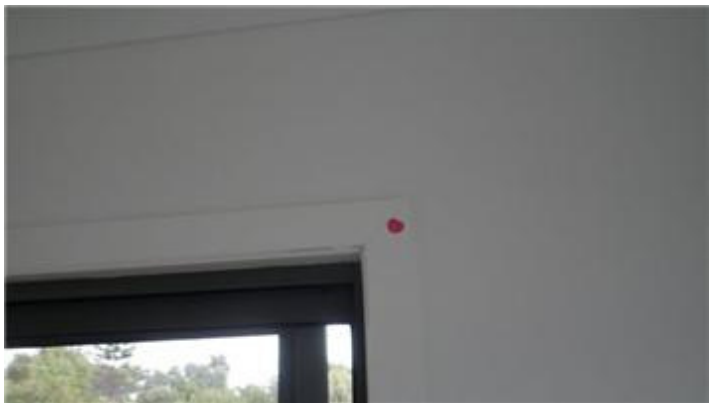
| <b>Windows</b> | Aluminium awning | Architrave mitres require sanding and painting | Condition: Defect Noted |

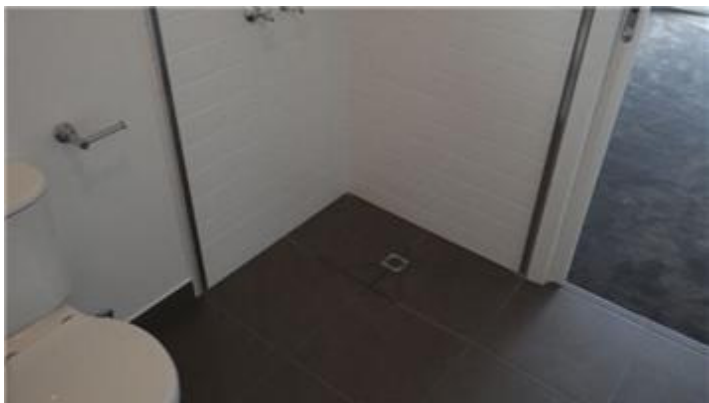
| <b>Shower Screen</b> | None noted | Not installed yet | Condition: Defect Noted |

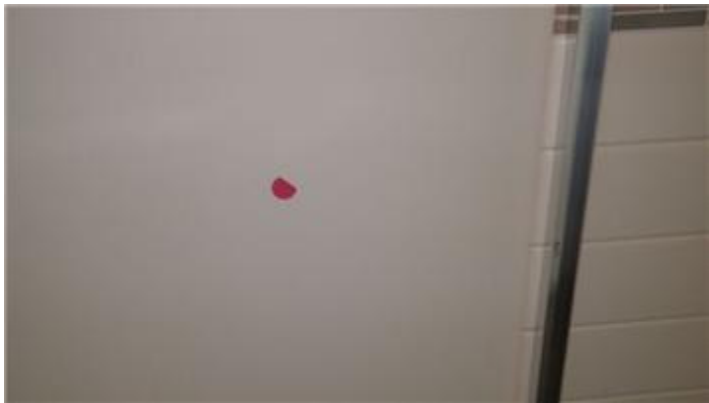
| <b>Walls</b> | Plaster | Marks noted to walls where indicated that require removal or painting<br>Paint runs noted that require sanding and touch ups | Condition: Defect Noted |

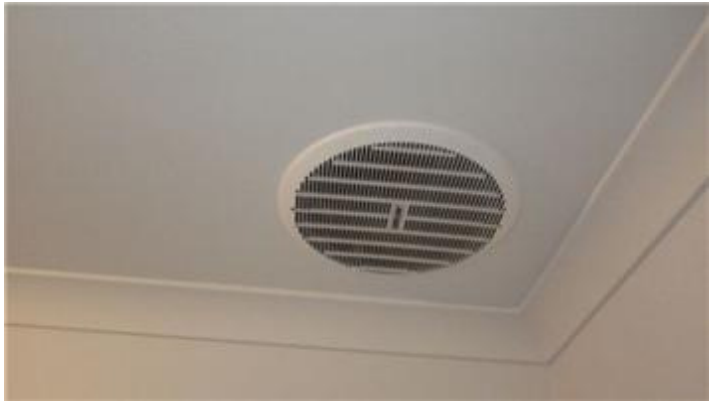
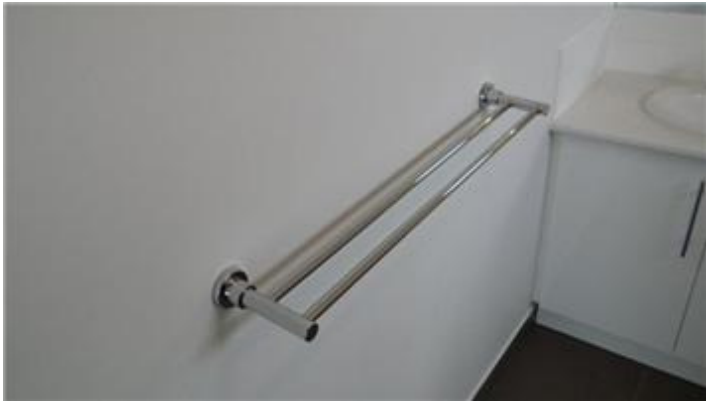
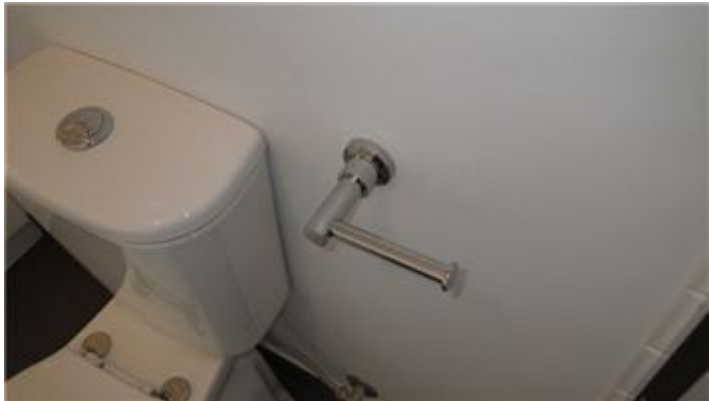
| <b>Comments</b> | Fan requires adjustment, very noisy<br>Hand rail and toilet roll holder require better fixing to wall, very loose and not installed properly |

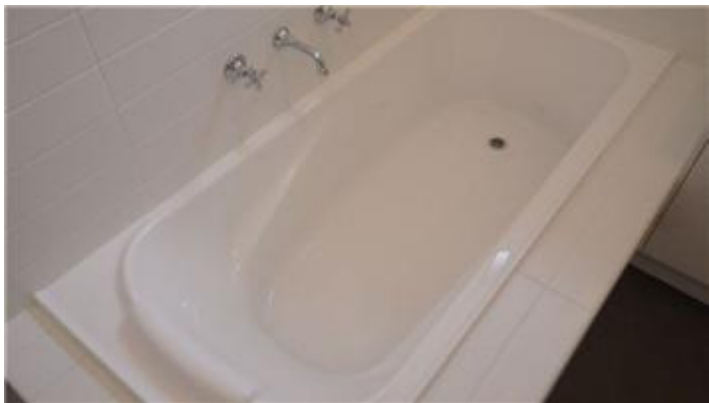
| <b>Bath</b> | Fibreglass | Bath is not supported under base, may not be to manufactures recommendations<br>All fibreglass baths should be supported at base | Condition: Defect Noted |

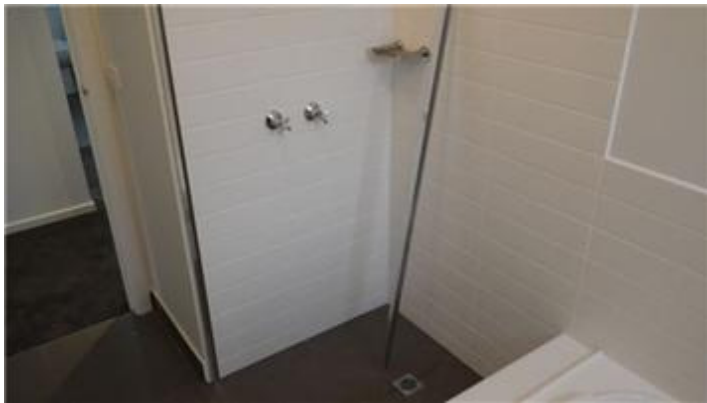
| <b>Shower Screen</b> | None noted | Not installed yet | Condition: Defect Noted |

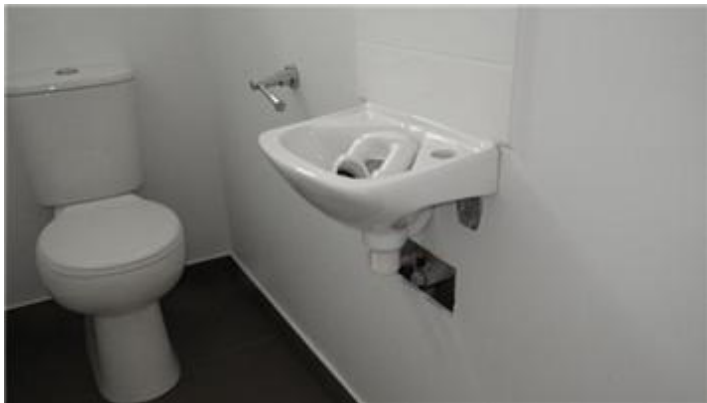
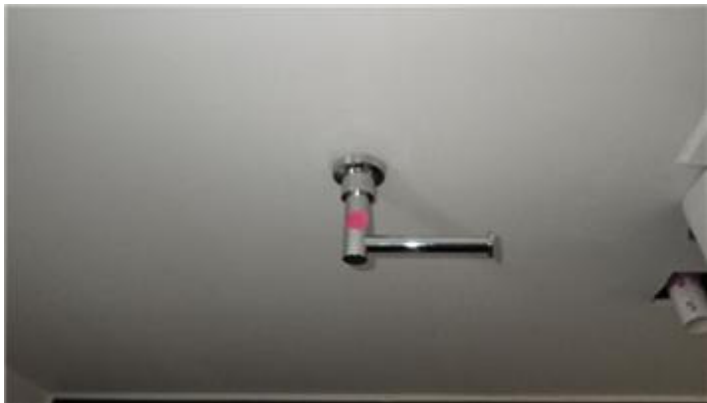
Taps and waste not fitted  
Hole noted in wall  
Toilet roll holder requires attention, not installed adequately  
Marks noted to walls where indicated that require removal or painting  
Paint runs noted that require sanding and touch ups

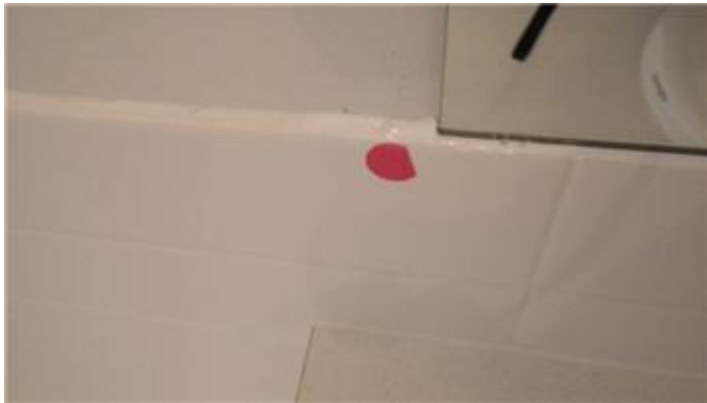
Silicon installed instead of grout to top of tiles, should be removed and matching grout installed

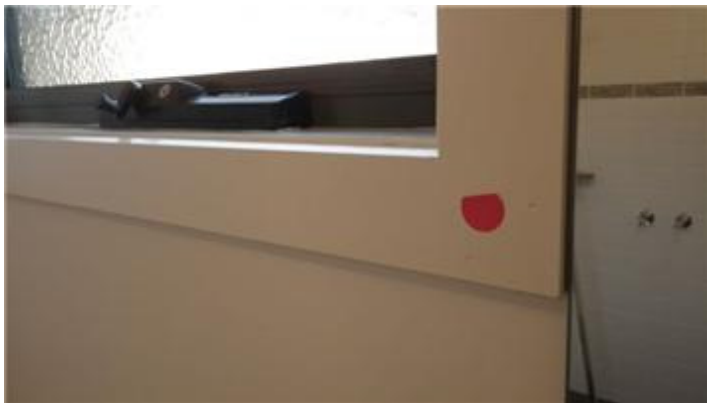
Architrave mitres require sanding and painting

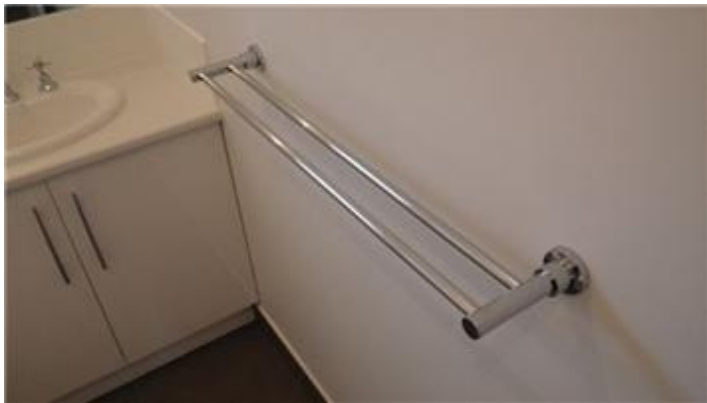
Towel rail requires attention, not installed properly to wall

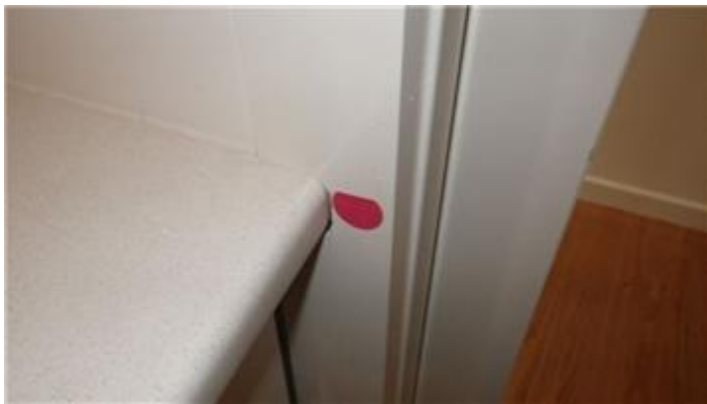
| Doors | Hollow Core door | Architrave requires filling as gap present next to bench top | Condition: Defect Noted |

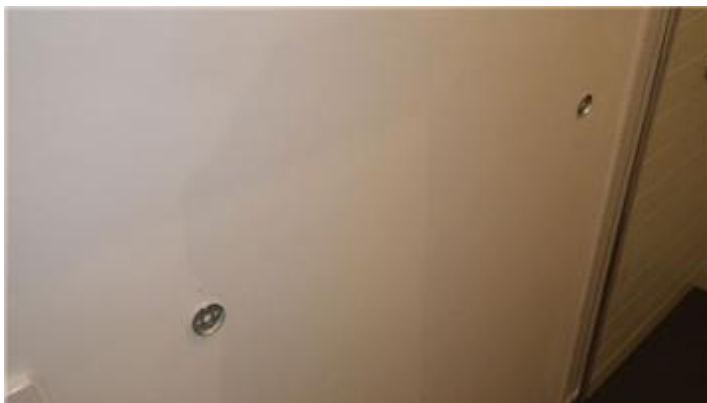
| Comments | Basin not fitted<br>Cover plate missing from power point<br>Towel rail missing |

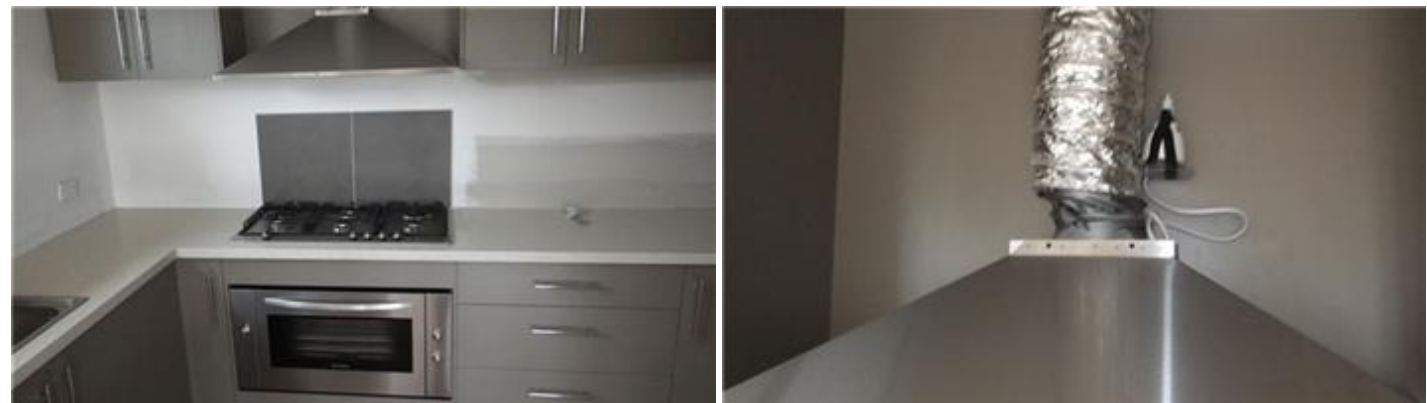
| Appliances | Electric oven, gas hotplate, rangehood, dishwasher | Appliances working<br>Rangehood not completed | Condition: Serviceable |

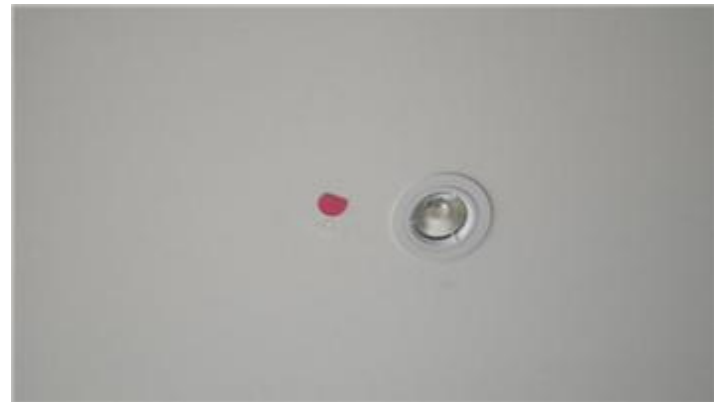
| Ceilings | Plaster | Marks noted to ceiling, painting required | Condition: Defect Noted |

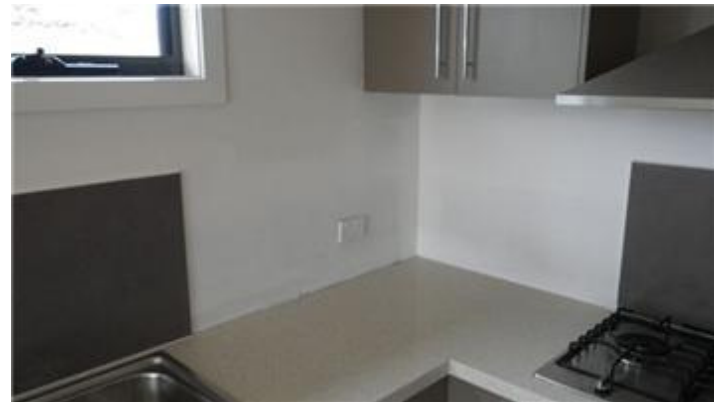
| Splashbacks | Tiled | Splash backs incomplete | Condition: N/A |

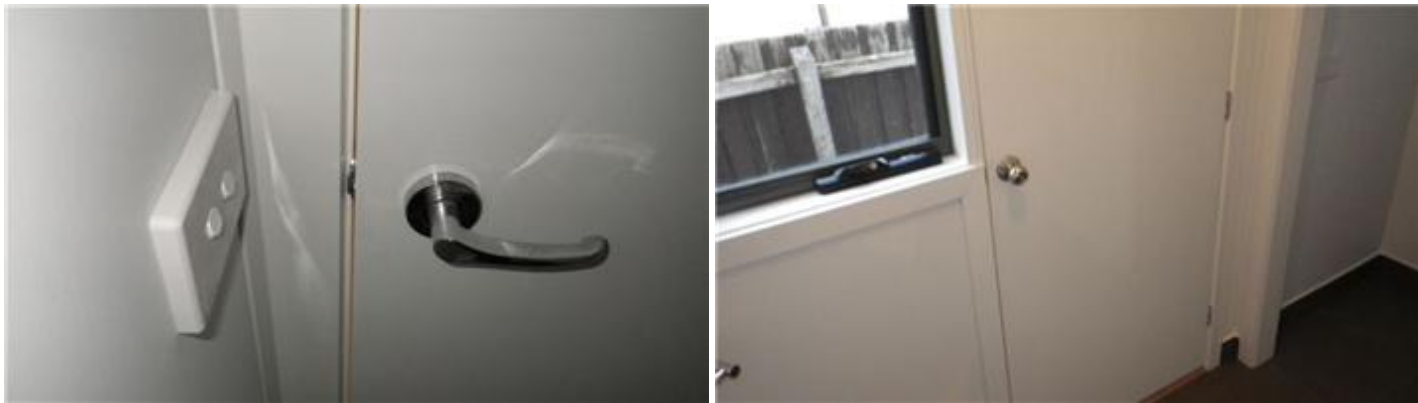
| Doors | Hollow Core door, External hollow core door | Door requires adjustment, binding on stricker plate<br>Painting required to the top and bottom edges of external door, as to manufactures recommendations<br>Architrave mitres require sanding and painting | Condition: Defect Noted |

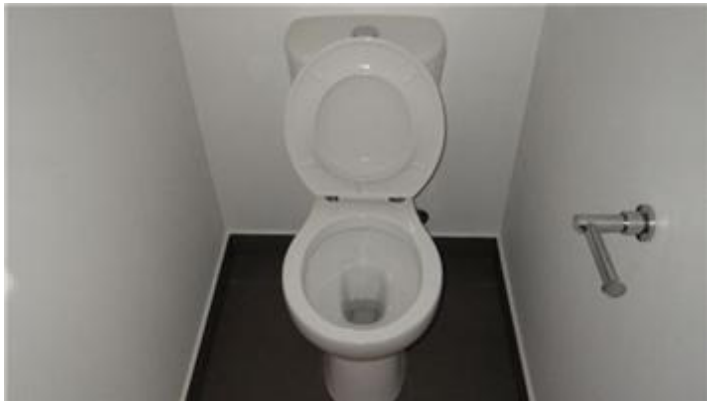
| <b>Toilet Suite</b> | Porcelain pan and plastic cistern | Cistern running continuously<br>Walls require a finishing coat, they are unacceptable in their current state with marks and paint runs to most walls, also areas appear to be missing final coat | Condition: Defect Noted |

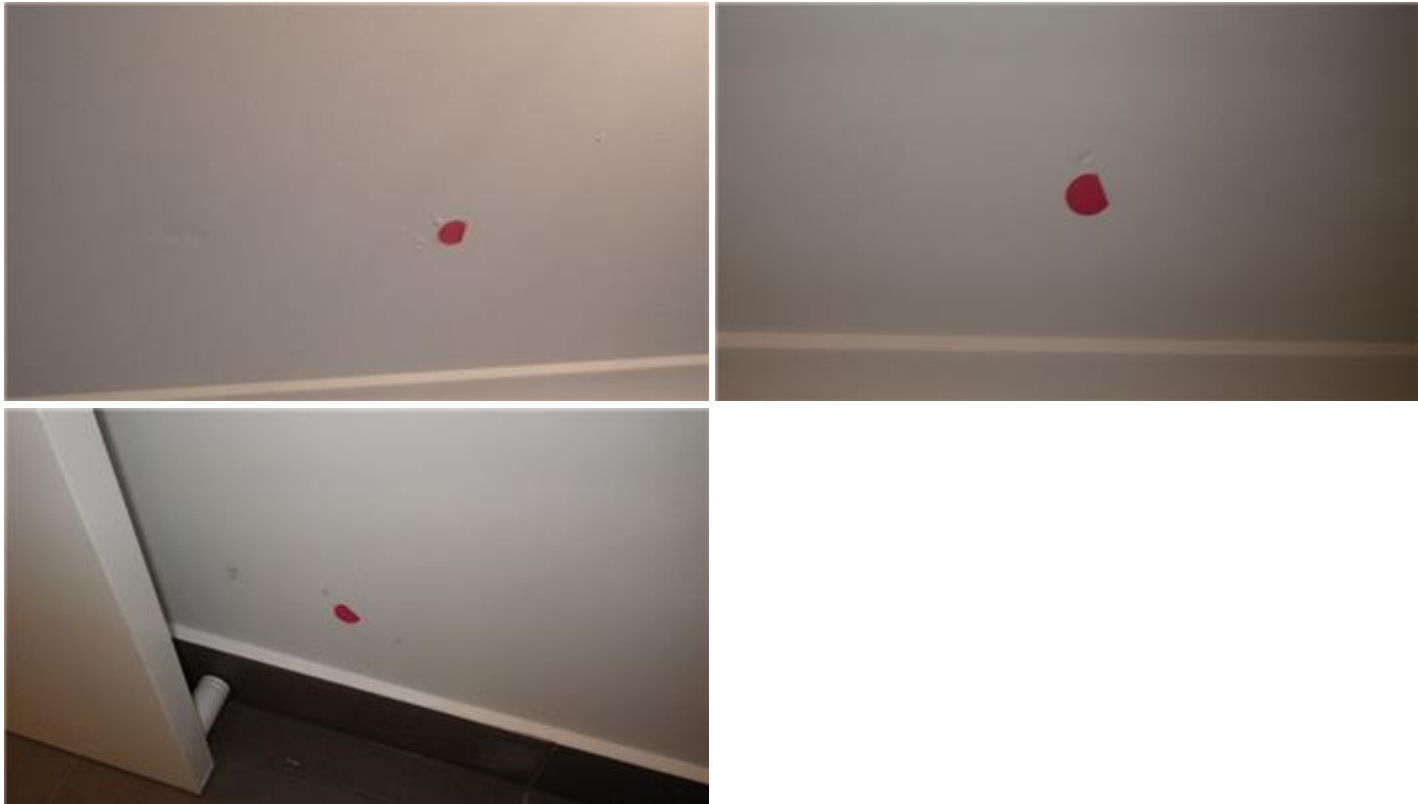
| <b>Walls</b> | Plaster | Marks noted to walls where indicated that require removal or painting<br>Paint runs noted that require sanding and touch ups | Condition: Defect Noted |

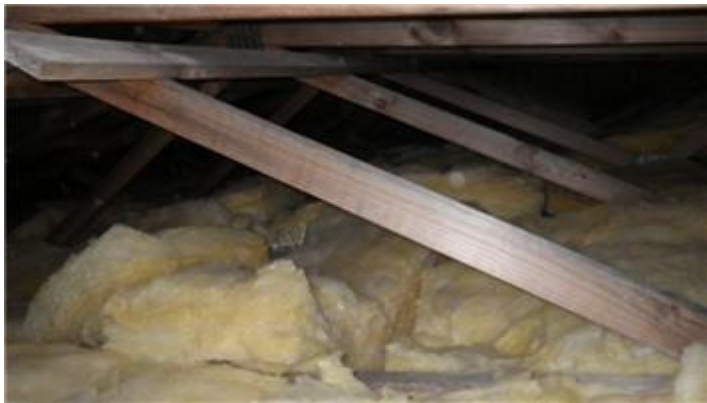
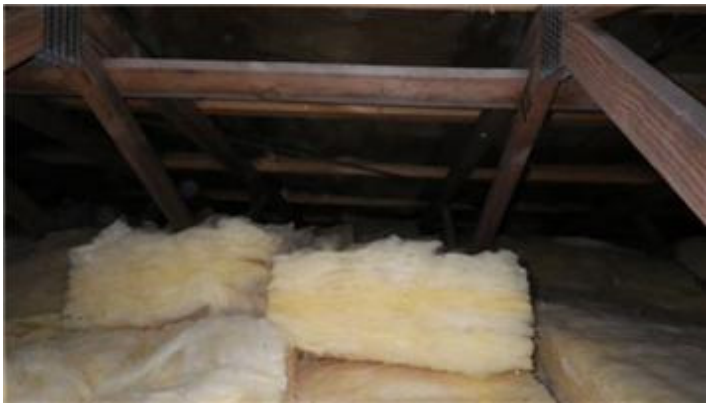
| <b>Insulation</b> | Batts on ceilings | Insulation appears to have been installed to all areas<br>Unknown to roof spaces at front due to no man hole | Condition: N/A |

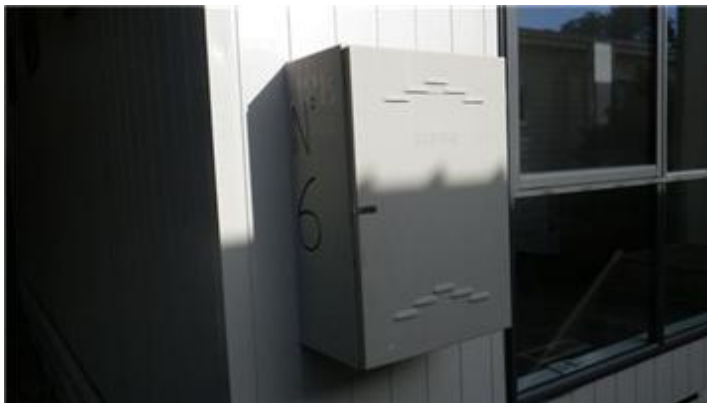
| Electrical | Residual current device (safety switch) and circuit breakers provided to meter box | Meter box requires painting | Condition: Serviceable |

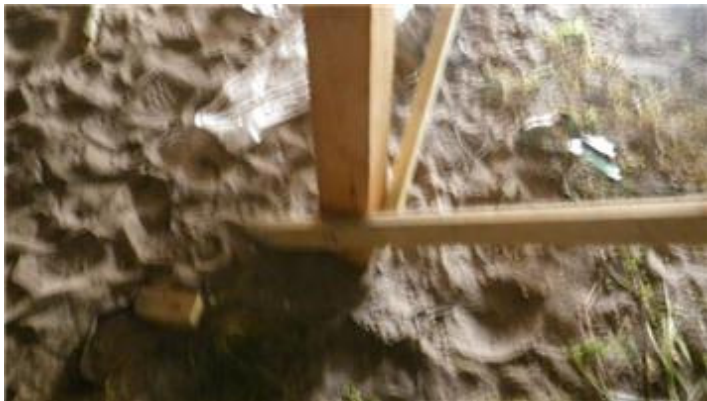
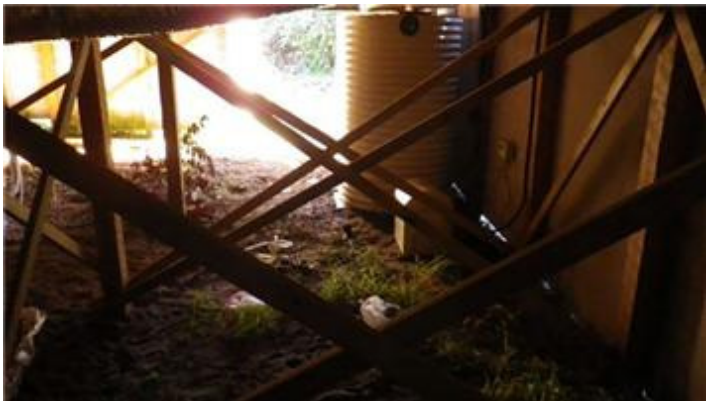
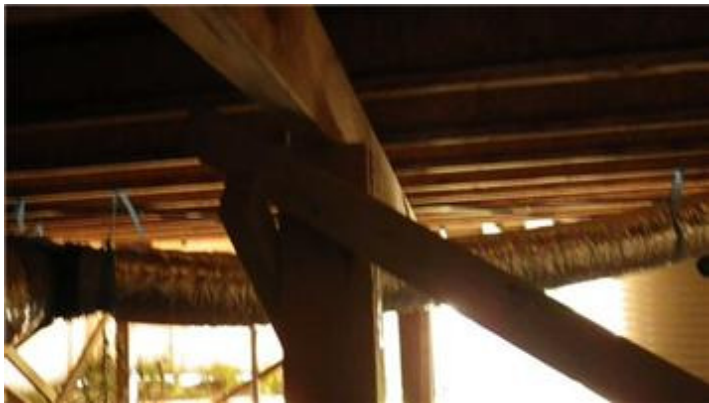
| Stumps | Concrete, Cypress pine stumps | All timber bracing that is required to stumps should be bolted with a 12mm gal bolt through timber stumps and not just nailed, this is to the building regulations<br>Computations and plans are to be checked for verification regarding stump bracing<br>All timber bracing should be cut so not in the ground | Condition: Unknown |

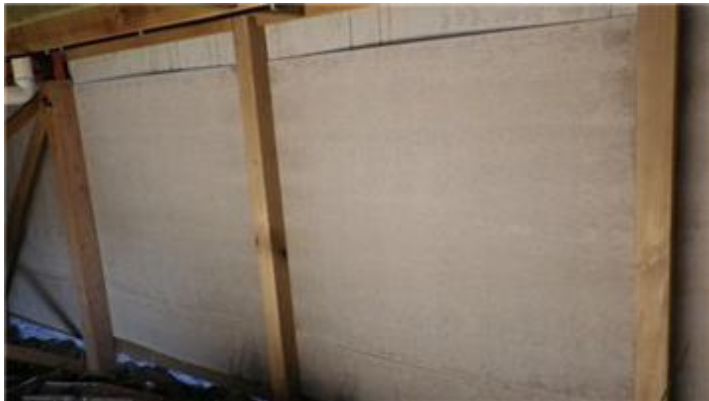
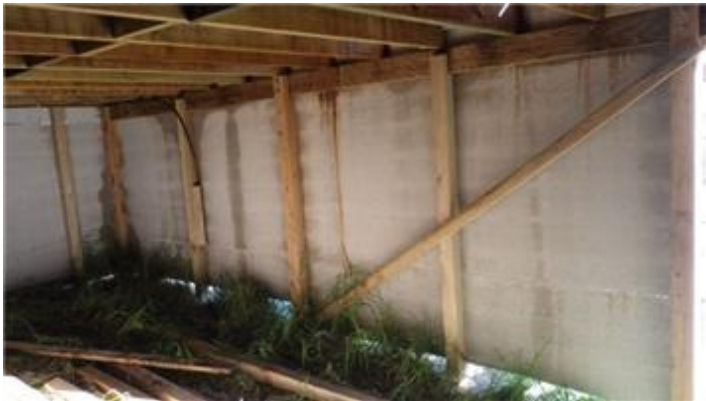
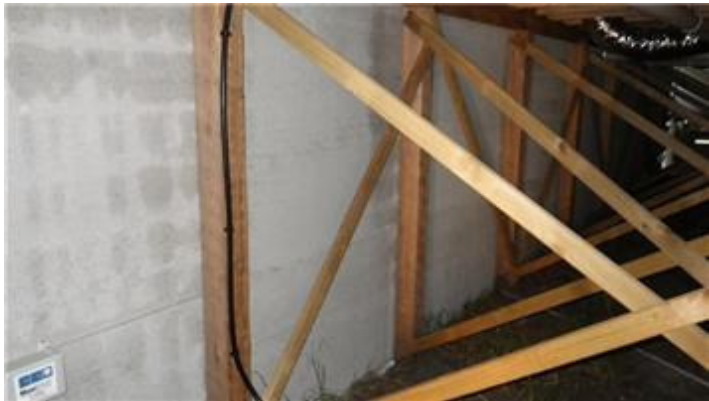
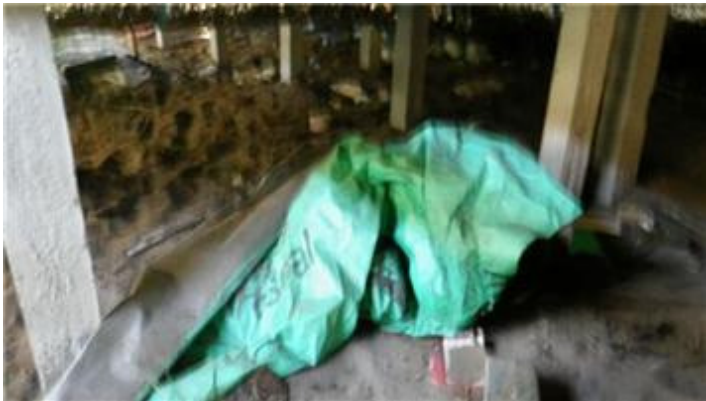
| Comments | Cement sheeting from ground to floor level around dwelling is buckling and requires timber framing to support sheeting<br>Sheeting should be nailed to treated pine 90x35<br>Debris requires removal from under floor space | Condition: Defect Noted |

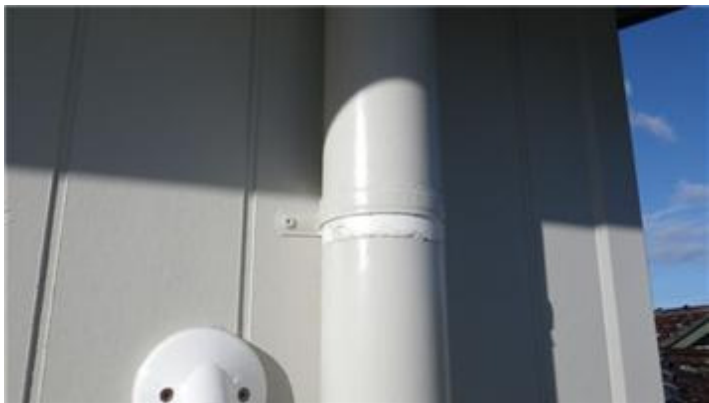
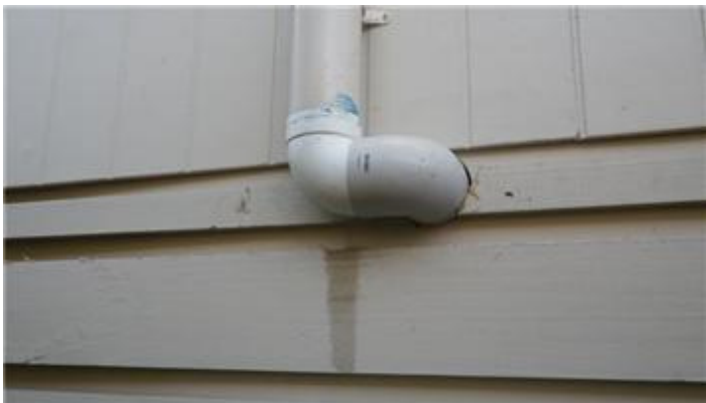
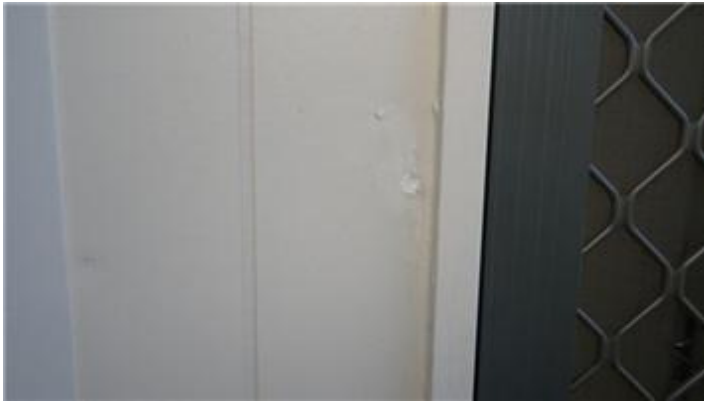
| Painting | Cement sheeting, PVC pipe | Painting required to some down pipes<br>Painting required to cement sheeting around front door<br>External painting in some areas is below standards, another final coat is required<br>Edge of sheets are rough and require this edge sanded before further painting | Condition: Defect Noted |

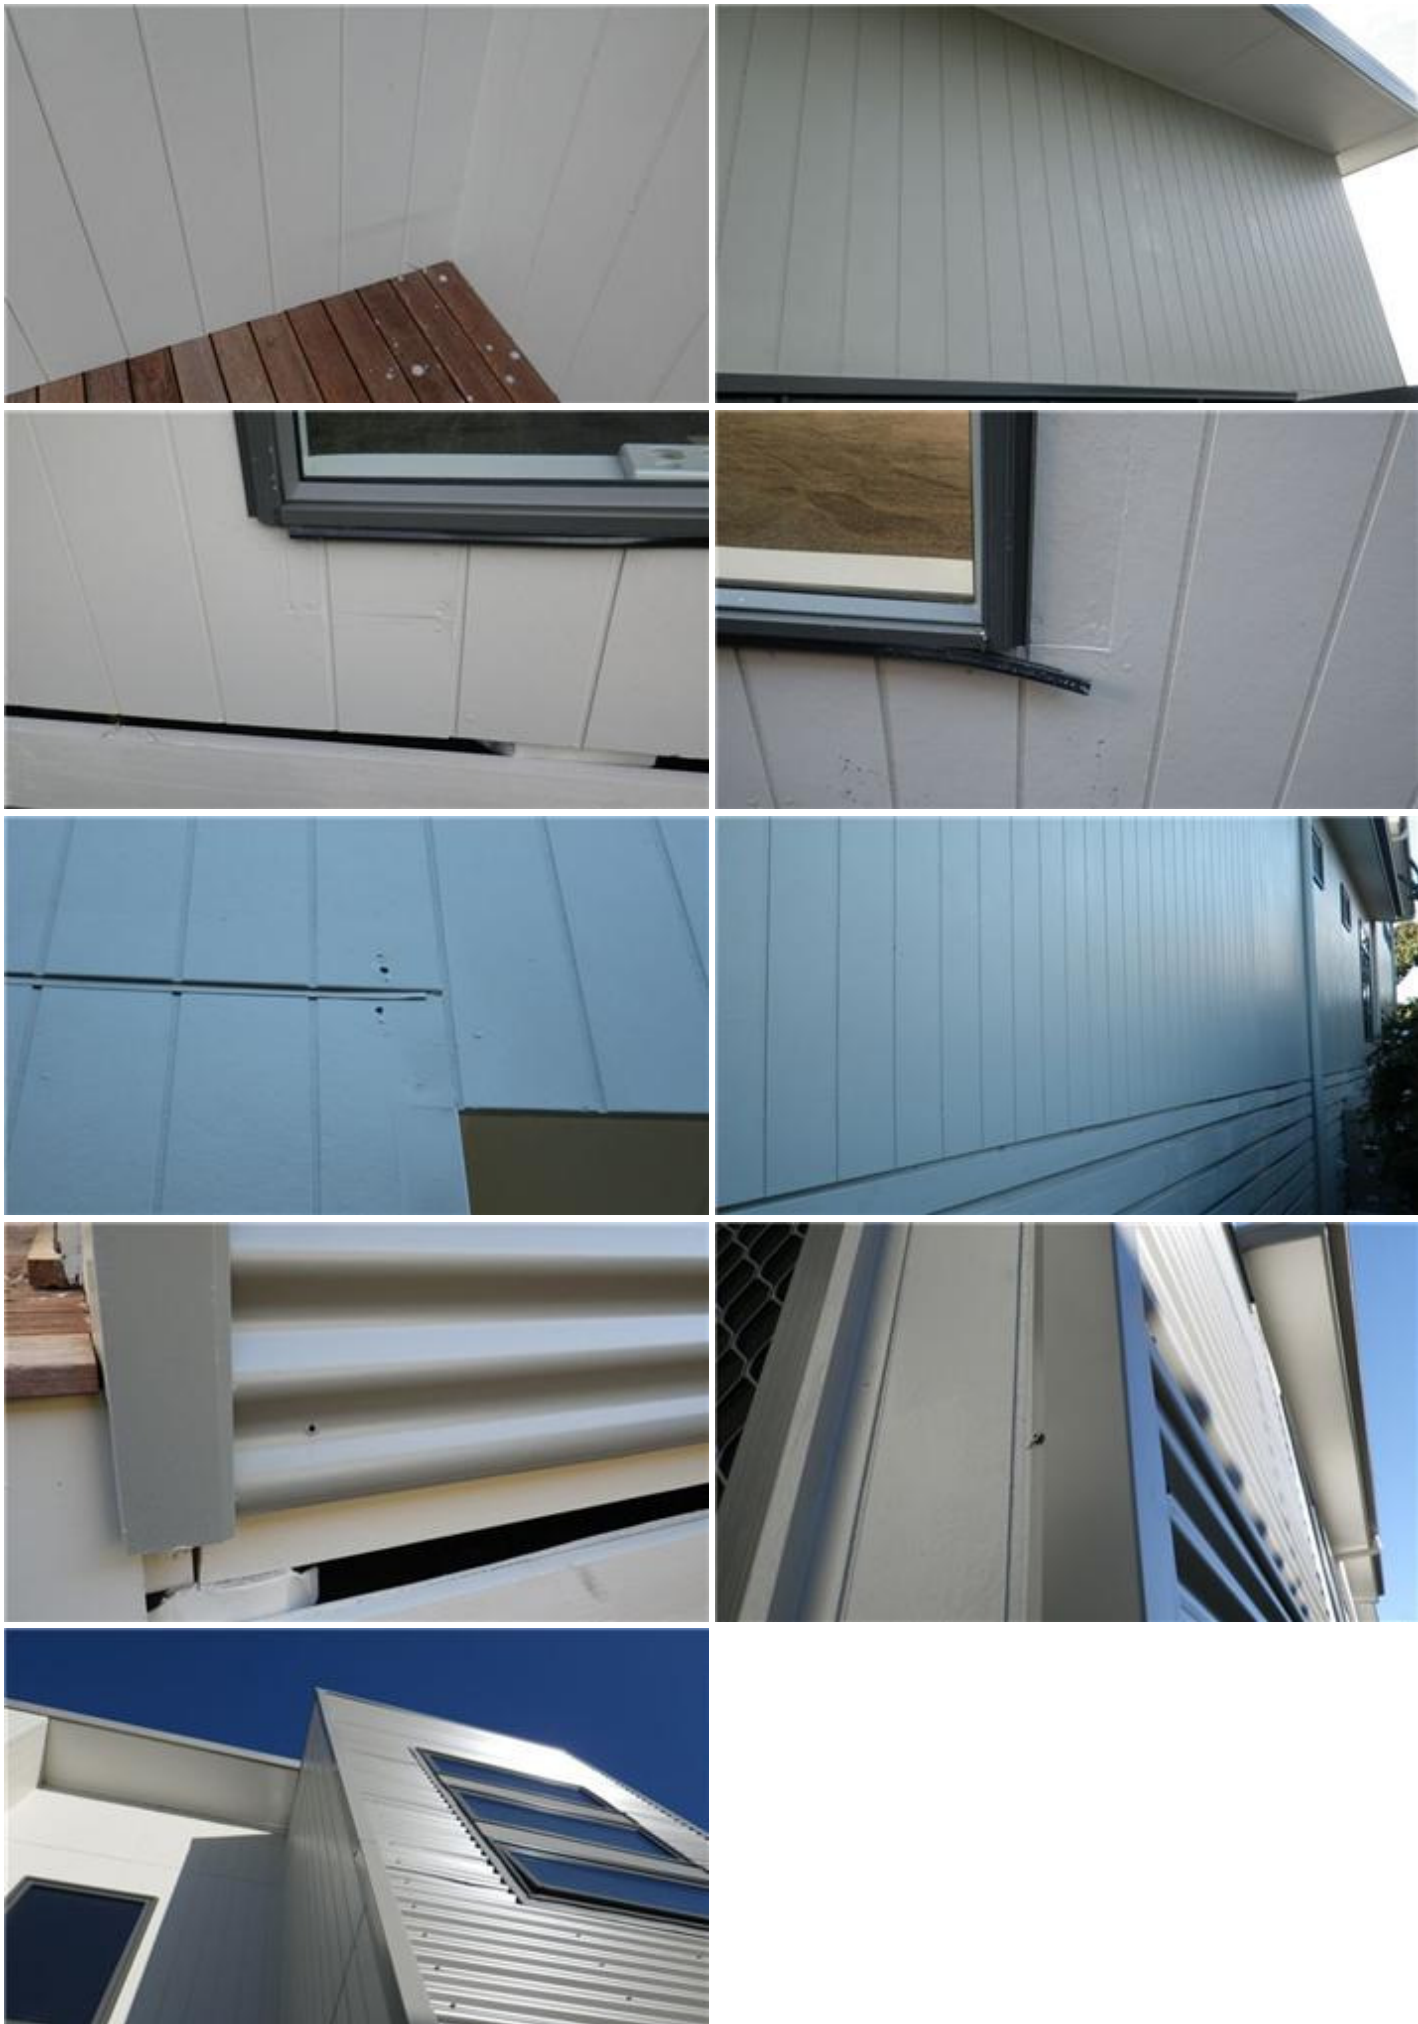
Section of cement sheeting above front deck is damage and requires replacement

Painting required above front deck as it looked blotchy  
 Some sheets around windows have been cut wrong and then patched, these require replacing as they are unacceptable

Nail holes require filling at left side

Bottom of most sheets are not fixed adequately, all sheets require nailing close to all edges and to manufactures recommendations, closest nail support is around 200mm from bottom of sheets

Corrugated iron sheets at right side require a screw where holes are located, about 5

Colorbond corner flashing has not been fixed adequately and is buckling, requires additional fixing with a more appropriate screw or rivet
