# Buy-Wise Inspection Services P/L

## PRE HANDOVER INSPECTION REPORT

### DEFECTS LIST

| Inspected Property Address: | Tootgarook | |

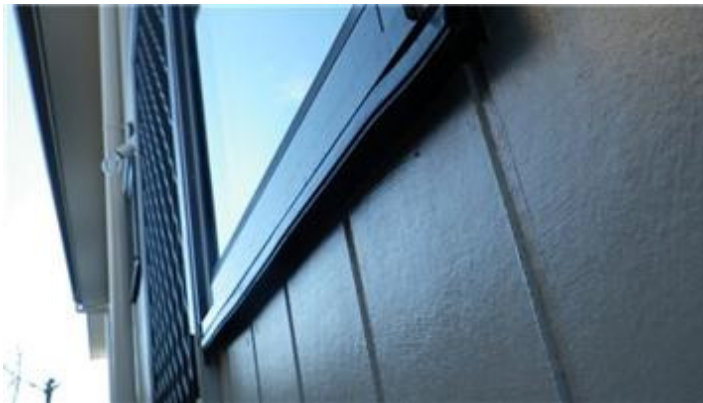
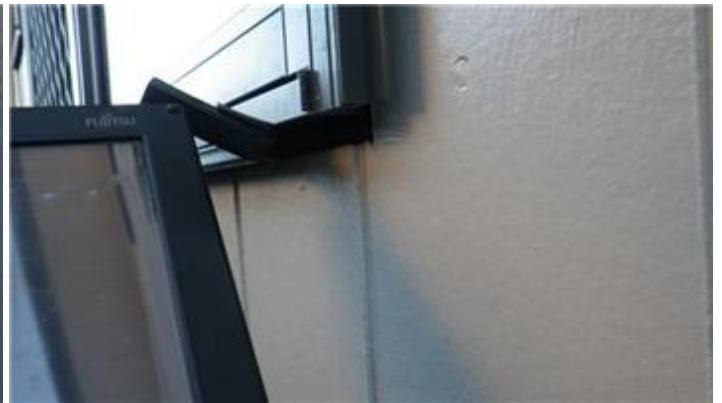
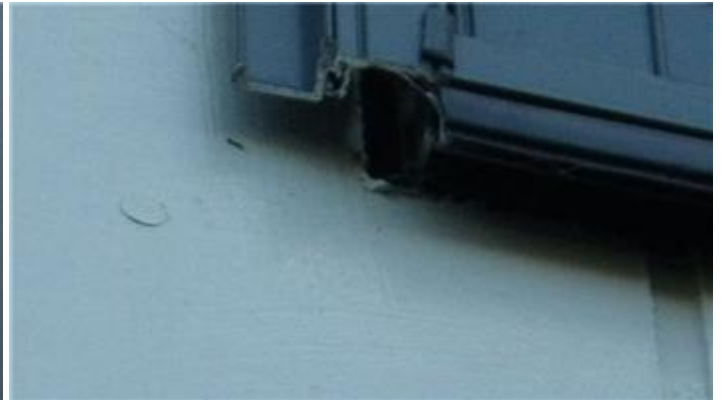
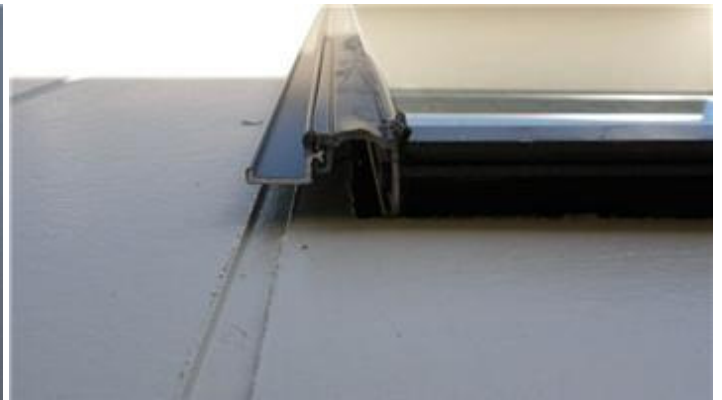
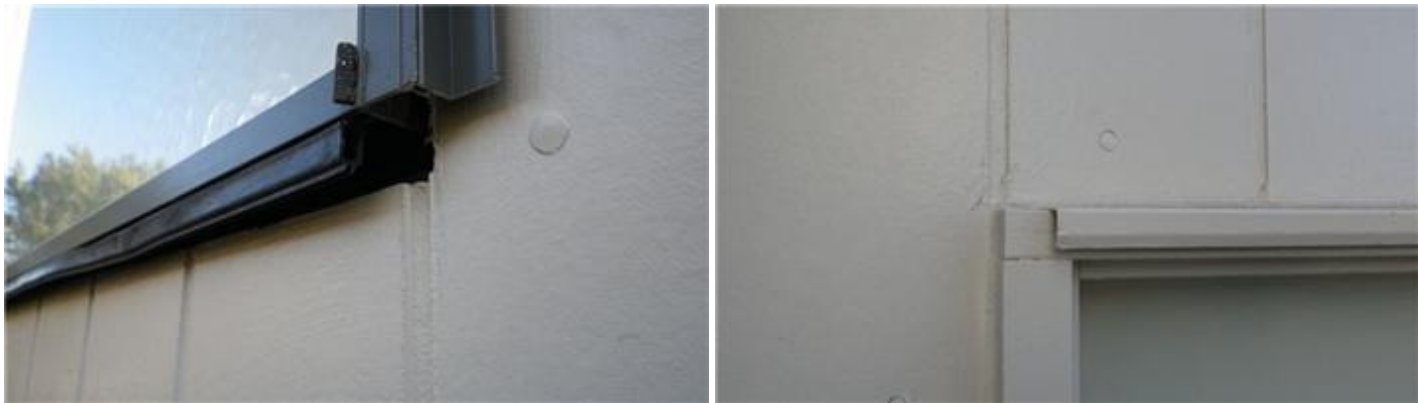
| Comments | Windows | There were gaps noted around all windows between aluminium and cement sheeting, wall framing and | Condition: Defects Noted |

timber window frame is exposed to rain

It appears that the aluminium window profile is not positioned correctly and should be closer to timber frame by about 10-20mm so aluminium angle acts as a flashing

There are gaps between window frame and cement sheeting at sides that can not be filled due to aluminium angle being in the way

Gaps under windows are up to 20mm so rubber flashing is not sitting flush with wall as it should

Some of these rubber flashings were missing as well

Flashing on top of front door frame is short one end and requires replacing

It is my opinion that either windows should be removed and timber window frame shortened so aluminium angle is against timber framing, or an aluminium profile fitted around all windows so they are water tight

If second option is taken then must be approved by window manufacturer

It is my opinion that windows should be installed to the manufactures recommendations with aluminium angle against external framing

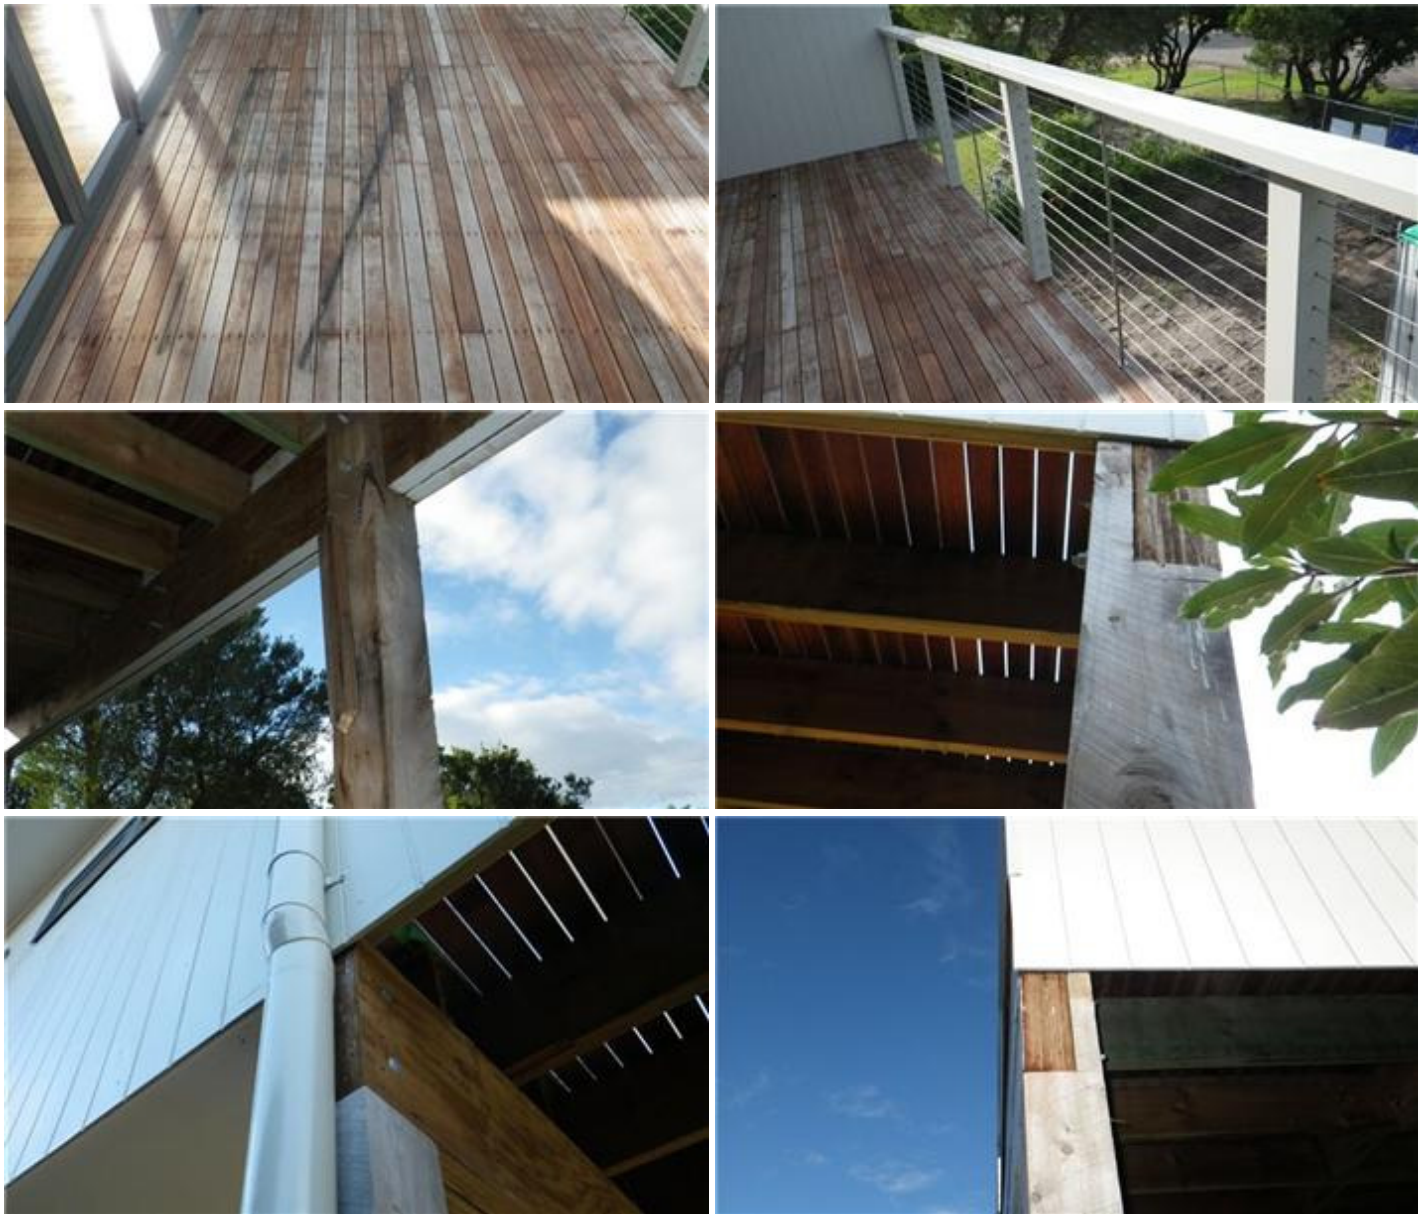
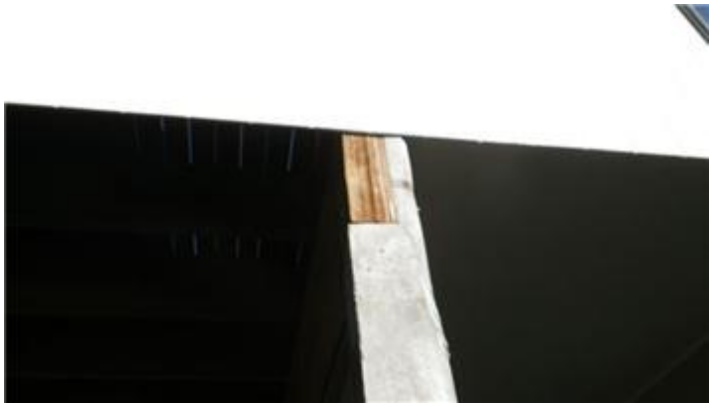
| Balcony | Merbau decking | Stains to decking require removal to front deck<br>Wire to balustrade requires tensioning as I was able to open gap well over recommended gap size<br>Nails require removal from front cypress posts<br>Ends of laminated timber beams supporting front deck are exposed and will deteriorate, they require protecting with a flashing | Condition: Defect Noted |

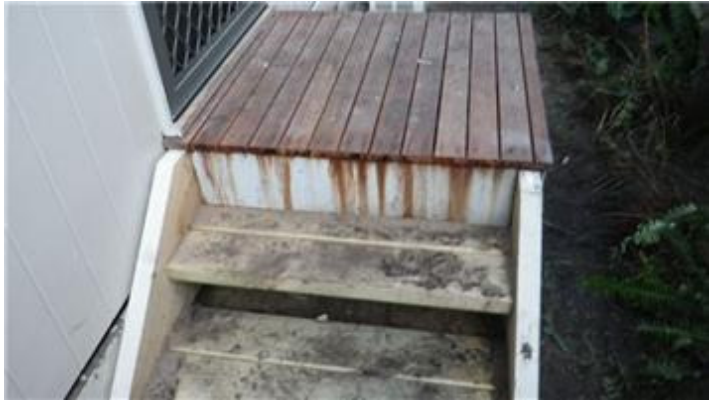
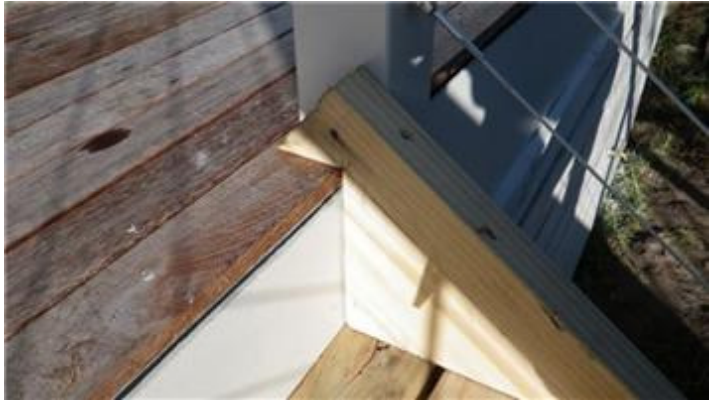
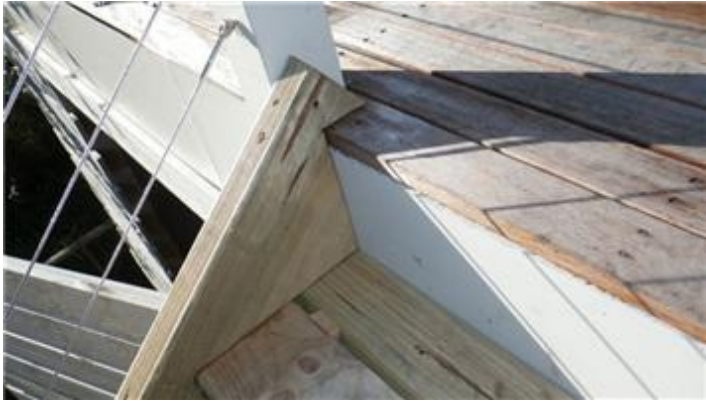
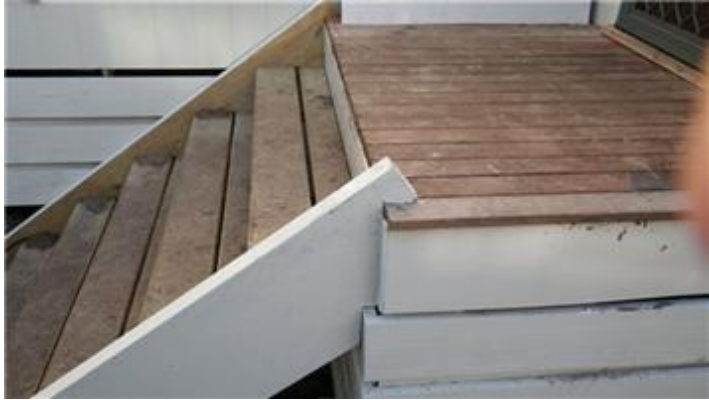
| Stairs | Timber steps | Top step out side laundry is 15mm over the 190 mm height requirements<br>Stairs to back deck are very flimsy and require bracing<br>Bottom posts dont appear to be adequately supported by a concrete pad around post in ground, additional concrete is required<br>Top of stringers appear to be only fixed at top and may split stringer if settlement occurs, added support require to bottom of stringer where meets deck<br>End grain of stringers are exposed and will deteriorate quickly | Condition: Defect Noted |

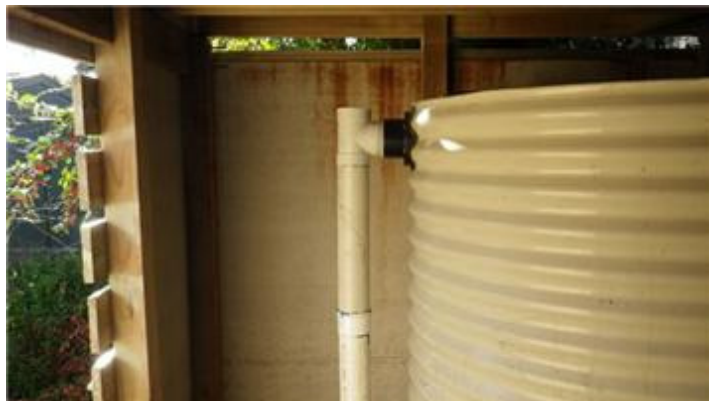
| Comments | Water tank is fitted with overflow pipe<br>Tank is mounted on 6 concrete paver's, unknown if this is to manufactures recommendations<br>All tanks should be fully supported at base to prevent | Condition: Unknown |

unnecessary stress to joins or base
