Advanced Home Inspections  
848 North Woolsey  
Fayetteville, Arkansas 72701  
Inspector: Peter Roe  
Arkansas License #HI 1611

# Home Inspection

133 Main Street  
Somewherein, Arkansas

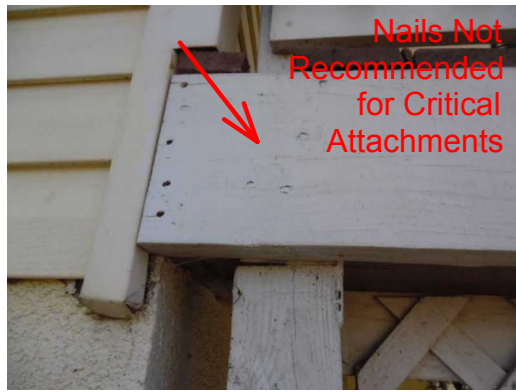
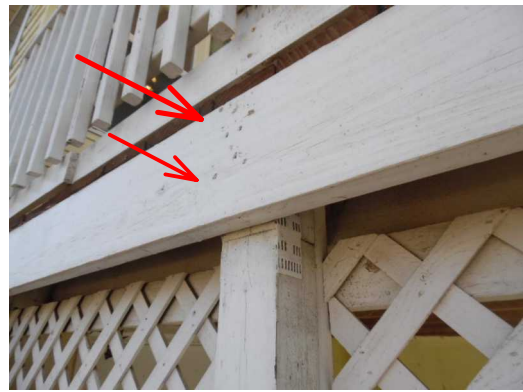
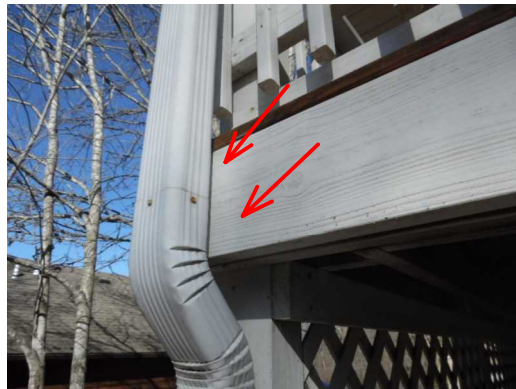
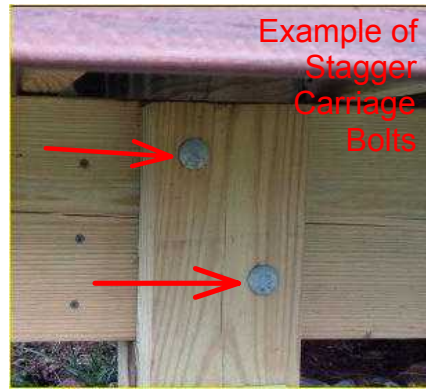
Deck: *Treated Wood* **Missing Carriage Bolts on Critical Post Attachments**

There are missing carriage bolts in a number of critical connections on the deck posts and these should be added as a safety precaution. (See Photos & Example)

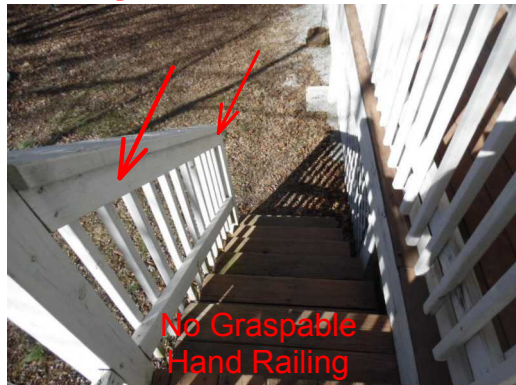
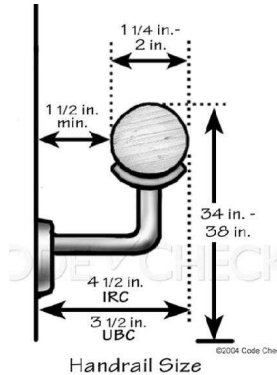
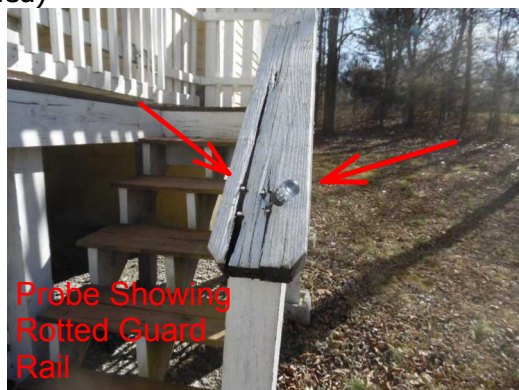
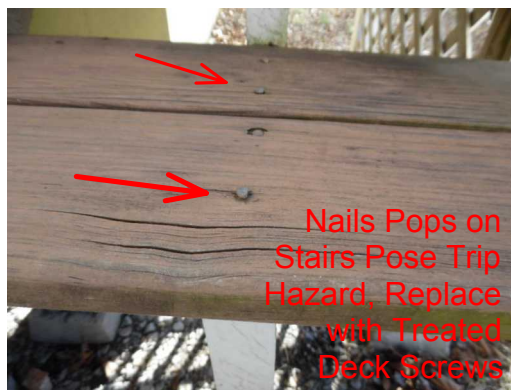
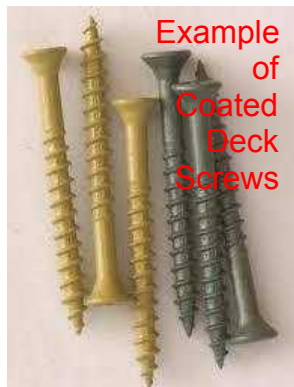
Deck Stairs: *Treated Lumber* **No Effective Hand Railing, Damaged Railing**

*The back deck stairs is missing a graspable hand railing and a code compliant railing should be added for the safety of the occupants. (See Photo & Example) The stairs guard railing is rotted and will also need to be*

replaced. (See Photo)

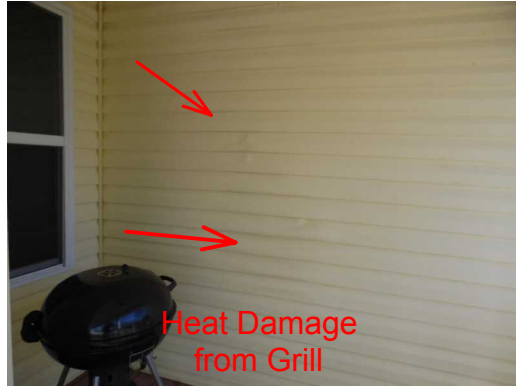
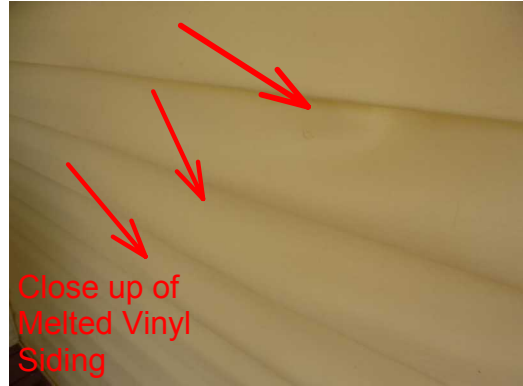
- Entire House Exterior Surface \_\_\_\_\_
1.       Type: *Brick Veneer*
- Sides & Back Exterior Surface \_\_\_\_\_
2.       Type: *Vinyl Siding Back Siding Melted from Barbecue*

There is some melted vinyl siding on the back of the house that should be replaced. (See Photos)

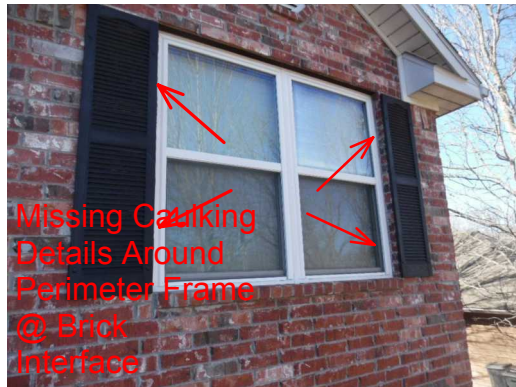
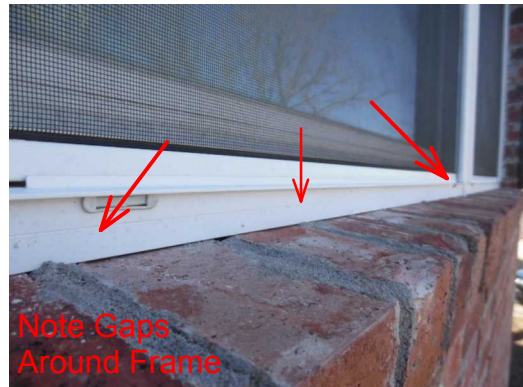
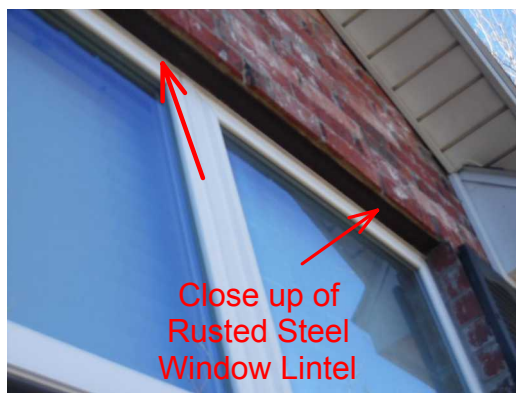
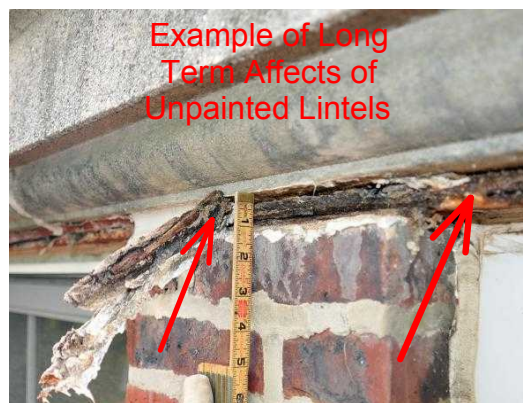
Trim: *Aluminum Clad*  
 Fascia: *Aluminum Clad*  
 Soffits: *Vinyl*  
 Entry Doors: *Insulated Steel*  
 Windows: *Vinyl Single Hung Steel Lintels Need Priming & Painting with Exterior Grade Oil Based Paint, Missing Exterior Caulking Detail Around Perimeter Frame*

The garage door steel header and some exterior windows were never properly treated and are showing signs of rust which will eventually compromise their structural integrity. (See Photos) They should be wire brushed, primed with metal primer, and painted using oil based exterior grade paint for proper protection.

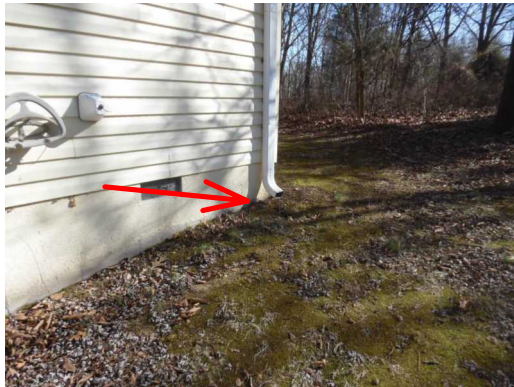
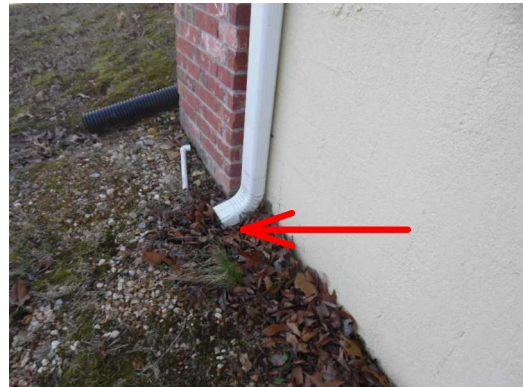
12.       Leader/Extension: *Pipe Drain, Some Missing **Splash Block Missing or not Properly Installed***

A number of exterior downspouts are dumping directly on the foundation which is not recommended and should be extended out and away from the base of the house to keep the area as dry as possible. (See Photos)

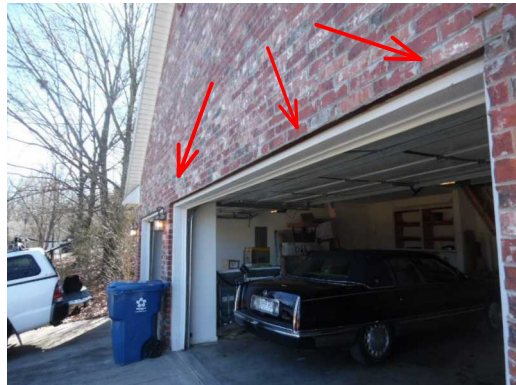
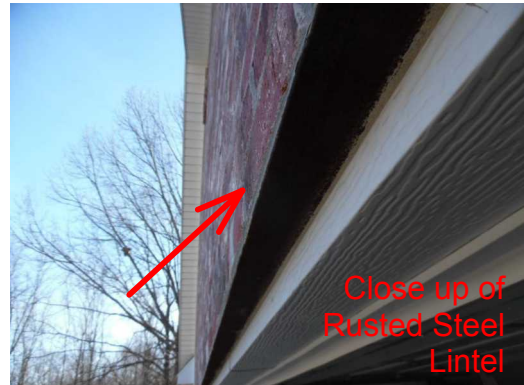
1. Type of Structure: *Attached* Car Spaces: *3*
2.       Garage Doors: *Metal Rusting Steel Door Lintel Needs Prep & Painting with Oil Based Paint*

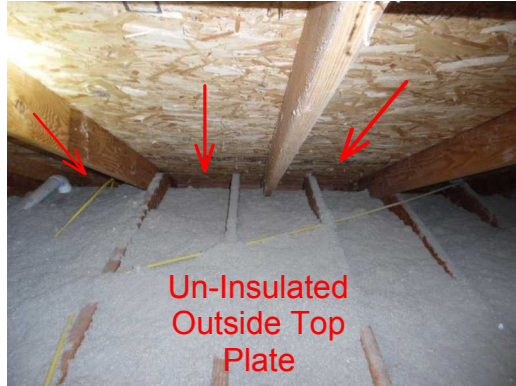
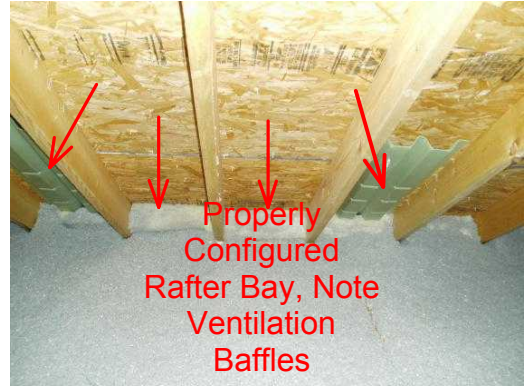
6.       Ventilation: *Soffit & Roof Vents* **Rafter Bays Not Properly Configured**

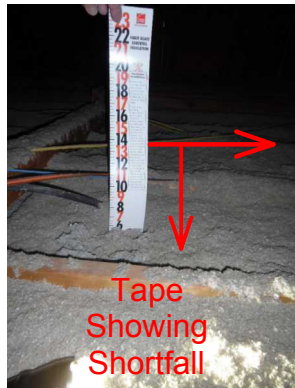
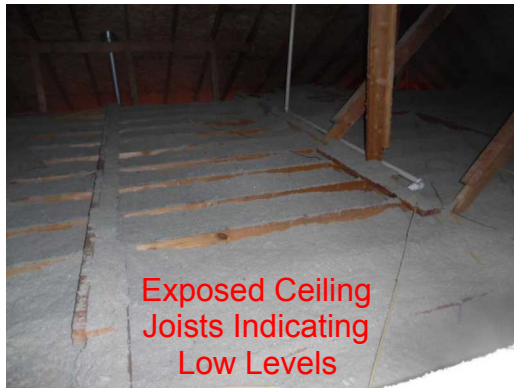
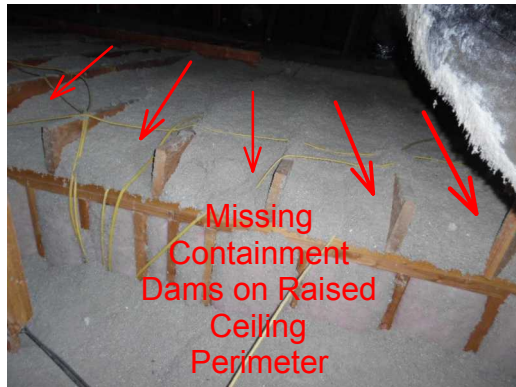
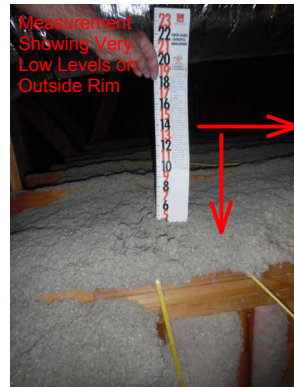
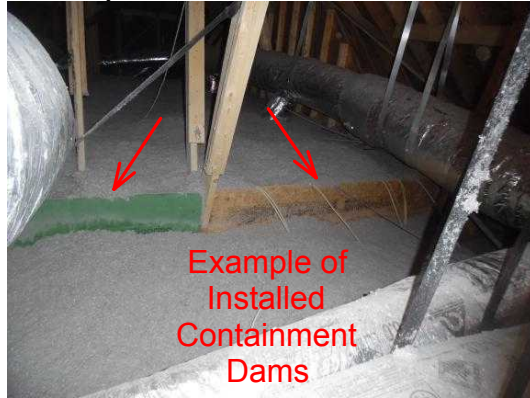
7.       Insulation: *Blown in Cellulose*  
8.       Insulation Depth: *Variable Excessive Settlement, Some Uncovered Areas, Insufficient Insulation Present*

*The outside top plate visible in the attic was not insulated correctly with very low levels around the entire perimeter of the building. (See Photos & Example) I also found missing containment dams on the raised ceiling ends which would not allow for the proper depth of insulation to be originally installed. (See Photo & Example)*

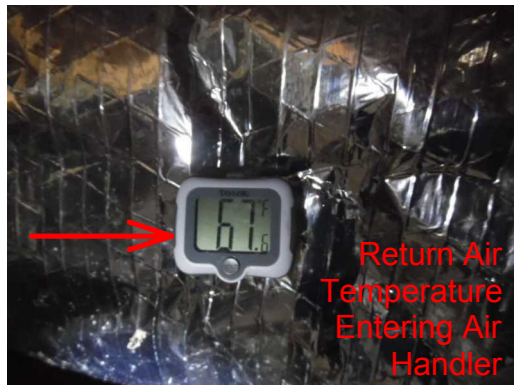
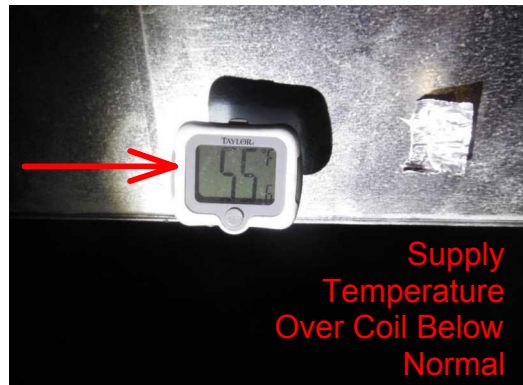
1.       A/C System Operation: *Central Air Not Performing to Industry Standards, Needs Servicing & Re-Inspection by a Qualified Technician*

*The A/C was dropping the temperature over the coil by only twelve degrees which is below the expected sixteen to eighteen degrees and I would recommend that the system be fully cleaned, serviced, and re-inspected by a qualified HVAC technician checking for function and condition. (See Photos)*

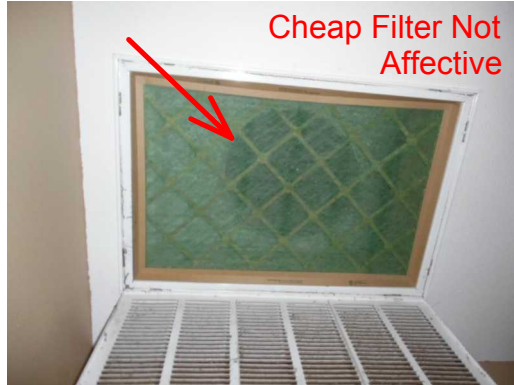
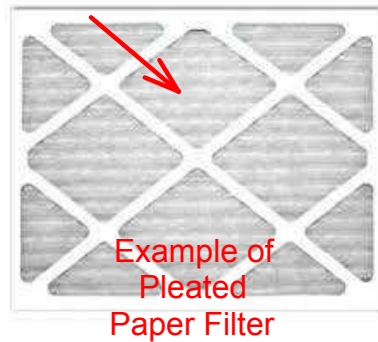
- 7.       Visible Coil: *Aluminum*
- 8.       Refrigerant Lines: *High & Low Pressure*
- 9.       Electrical Disconnect: *Pulled Fuse*
- 10.       Exposed Ductwork: *Metal & Flexible Duct*
- 11.       Blower Fan/Filters: *Direct Drive/ Disposable Filter* *Recommend the Use of Pleated Paper Filters*

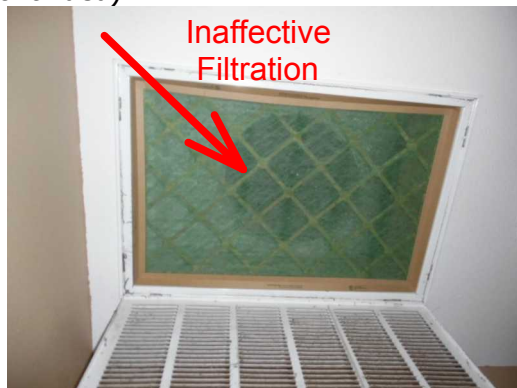
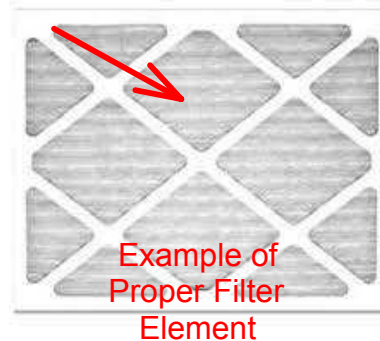
- 1.       Heating System Operation: *Adequate*
- 2. Manufacturer: *Bryant*
- 3. Type: *Heat Pump/Electric Back Up* Capacity: *Not Displayed*
- 4. Area Served: *Whole House* Approximate Age: *12 yrs*
- 5. Fuel Type: *Electric*
- 6.       Blower Fan/Filter: *Direct Drive/ Disposable Filter* *Recommend the Use of Pleated Paper Filters*

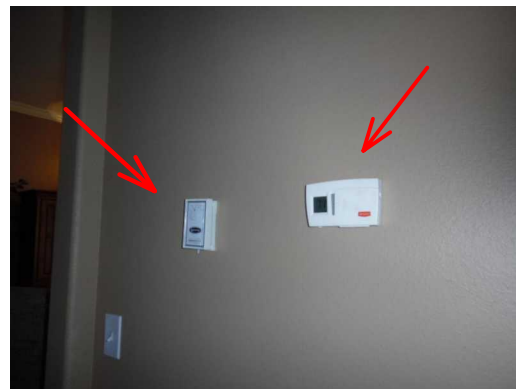
7.       Distribution: *Metal & Flex Duct*  
 8.       Thermostats: *Two Ask Sellers About Second Thermostat*

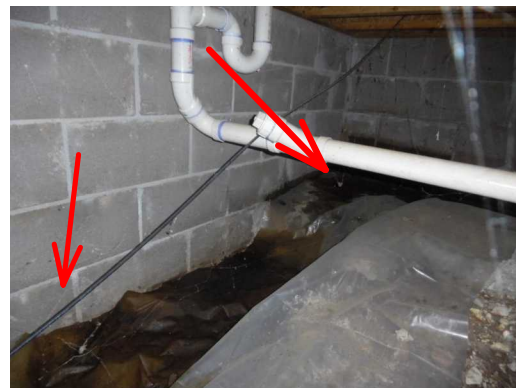
1. Method of Inspection: *In Crawl Space*  
 2.       Unable to Inspect: *25% Restricted Access*  
 3.       Access: *Side Doors*  
 4.       Moisture Penetration: *Yes Pooling Water, Unable to Determine if Chronic, Monitor*

There are signs of periodic leaking on the northeastern foundation wall visible in the crawlspace that should be monitored during extended rainfall to see if this is a chronic condition. (See Photo)

It's possible that some exterior grading may have been done in order to divert surface discharge out and away from the foundation as a long term solution.

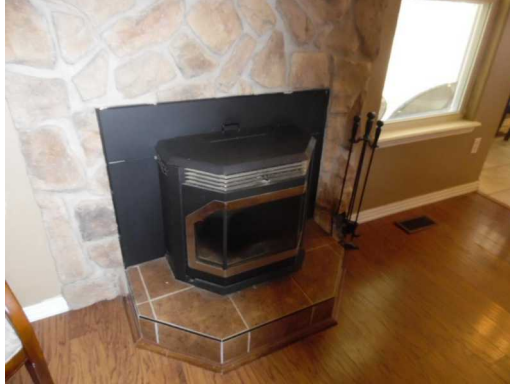
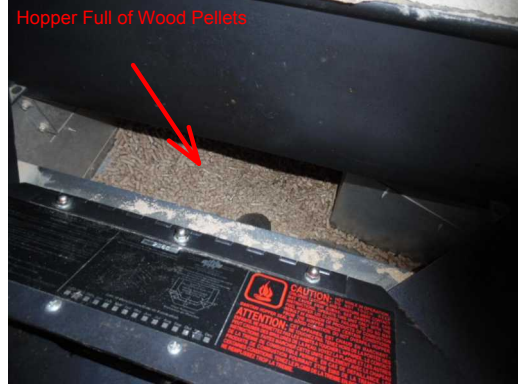
1.       Operation: *Not Included Ask Sellers to Demonstrate Function Before Closing*

2.      Fireplace Construction: *Zero Clearance*  
 3. Type: *Wood Burning Pellet Stove*  
 4.      Smoke Chamber: *Brick Lined*  
 5.      Flue: *Metal Recommend Cleaning & Re-Inspection Before Use*  
 6.      Hearth: *Tile*

*I did not inspect the wood pellet stove which is beyond the scope of a home inspection and I would recommend that a certified chimney sweep fully inspect and clean before use. (See Photo)*

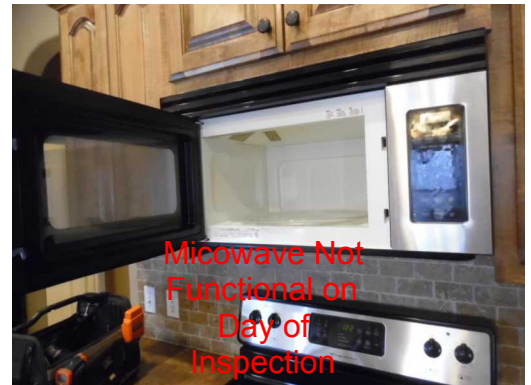
1.      Cooking Appliances: *Frigidaire*  
 2.      Ventilator: *Frigidaire*  
 3.      Disposal: *In-Sinkerator*  
 4.      Dishwasher: *Frigidare*  
 5. Air Gap Present?  Yes  No  
 6.      Refrigerator: *Whirlpool Inspecting the Function of Refrigeration is Beyond the Scope of This Inspection*  
 7.      Microwave: *Frigidaire Not Functional*

The kitchen microwave was not functional on the day of the inspection and if this is a concern would need to be repaired or replaced. (See Photo)

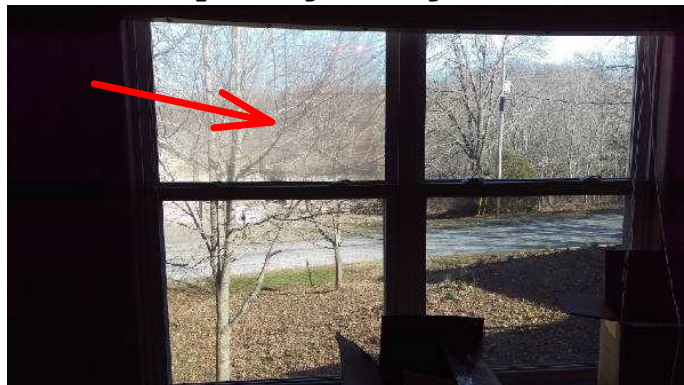
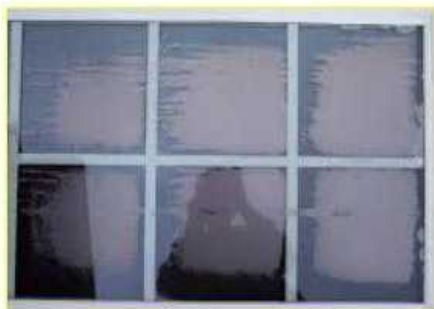
- 9.       Closet: *Single*
- 10.       Ceiling: *Texture/Paint*
- 11.       Walls: *Painted Drywall*
- 12.       Floor: *Carpet*
- 13.       Doors: *Hollowcore Wood*
- 14.       Windows: *Vinyl Single Hung Failed Low E Film*

The front facing bedroom has what appears to be either a failed thermopane or low E glass film on one of the upper window units that will need to be replaced. (See Photo)

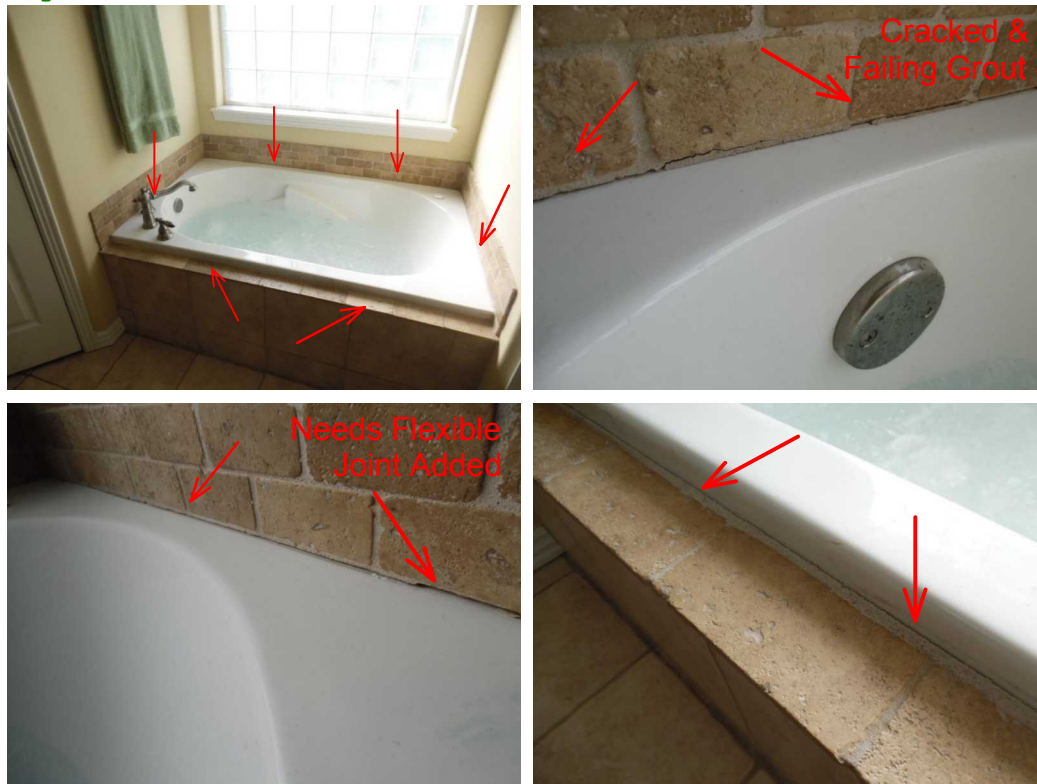
11.       Spa Tub/Surround: *Fiberglass Tub, Tile Surround Missing Flexible Expansion Joint on Tub*

The master bathroom jetted tub is missing a flexible caulking joint around the perimeter where the fiberglass abuts the tile and after removing the failed grout should have a color coded caulking detail added. (See Photo)

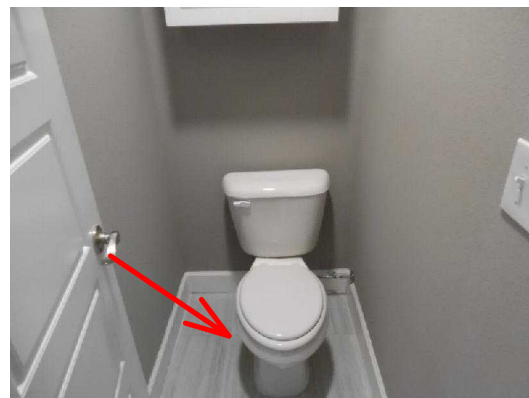
12.       Toilets: *Mansfield Toilet Loose at Base, Remove & Replace Wax Ring & Re-tighten*
