HOME INSPECTION REPORT

Bayminette, AL

Prepared by
Ellis Inspection Services, Inc.

November 8, 2008

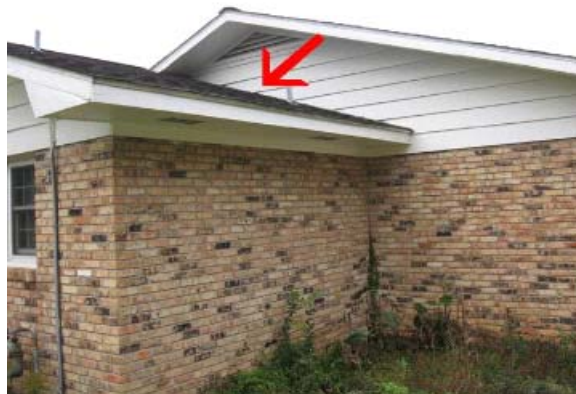
The wood siding at the rear gable should not be in contact with the shingles. This allows water to wick and creates rot. Since there is currently no rot, it can be repaired when later.(before damage occurs)

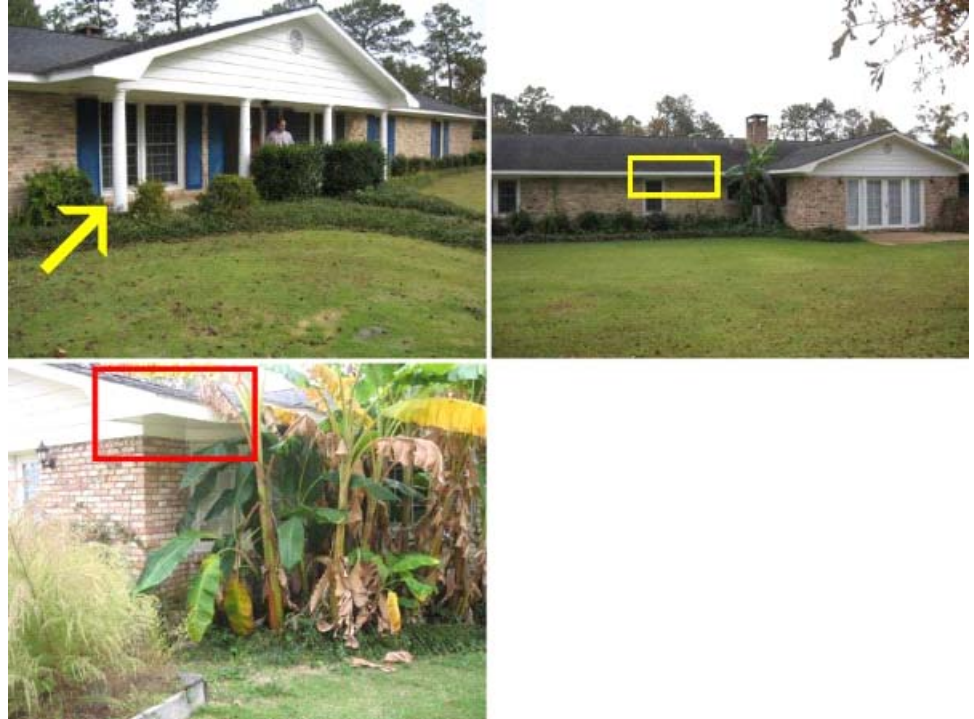
1. We found some rotted trim at the bottom of the left front column, rear fascia near the a/c and by the den near the banana trees.

We found some rotted trim at the bottom of the left front column, rear fascia near the a/c and by the den near the banana trees.

Refer to the WDO (wood destroying organism) report issued by the Pest Inspection Company for the full disclosure of wood rot and all of it's locations.

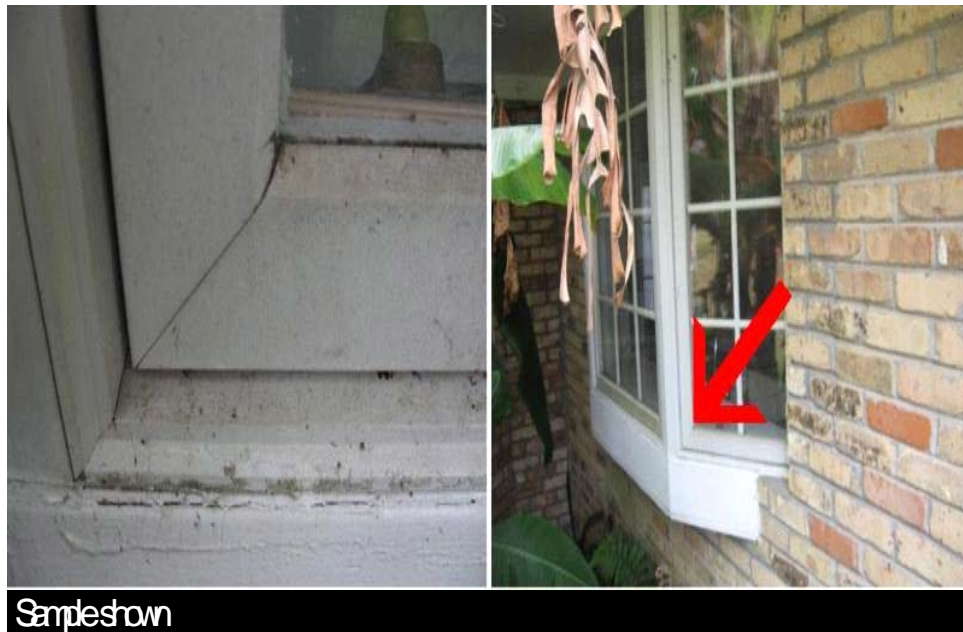
The kitchen / den windows are designed in a way that the lower corners will allow water to get into the window frame and cause rot issues. I suggest using a quality sealant and seal all the lower corners.

The kitchen window will not open fully due the window trim frame. Some modifications will be needed.

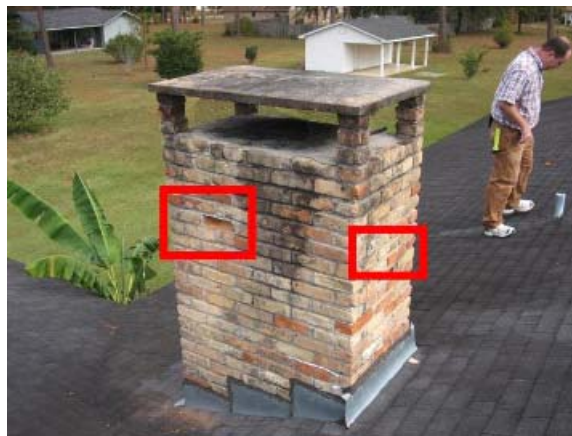
2. Deteriorated mortar will need re-pointing before water intrudes
There are a few broken bricks that need repairs and sealing to keep water out now.
Seal flashing to chimney.

Deteriorated mortar will need re-pointing before water intrudes

There are a few broken bricks that need repairs and sealing to keep water out now.

Seal flashing to chimney.

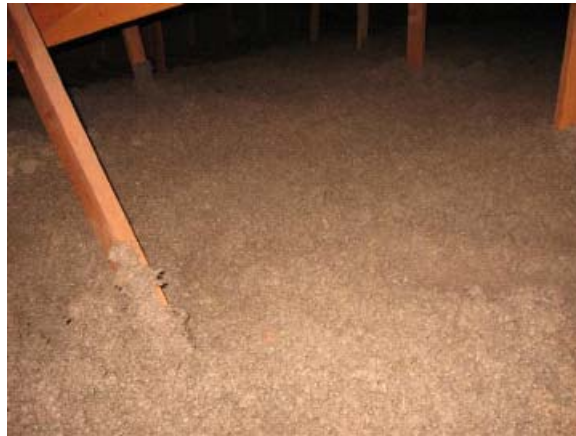
DEPTH AND R-FACTOR: R-30 Current standard is to insulate to an R-32 value.

CONDITION: *Minor stains are noted, none of them are currently active.*

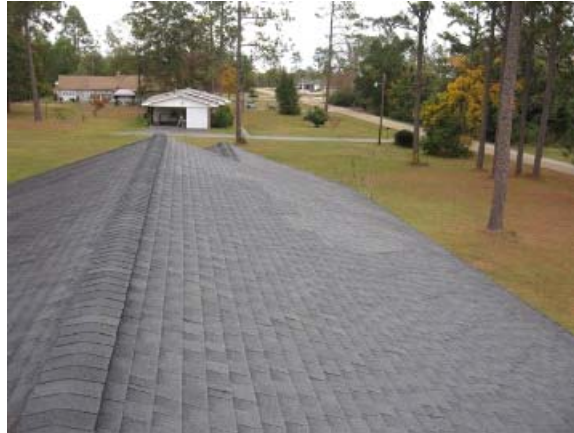
3. REPAIRS NEEDED. This consists of repair/replacement of damaged/missing shingles and sealing loose shingles at the east and rear sides.

REPAIRS NEEDED. This consists of repair/replacement of damaged/missing shingles and sealing loose shingles at the east and rear sides. This should help insure the weather tightness of the building and should be performed on a regular basis.

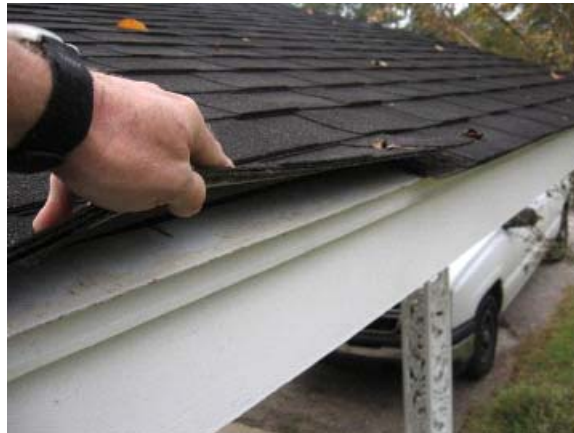
Roofing manufacturers recommend sealing the bottom shingles to the drip edge flashing in all high wind areas, this has not been done here and is recommended.

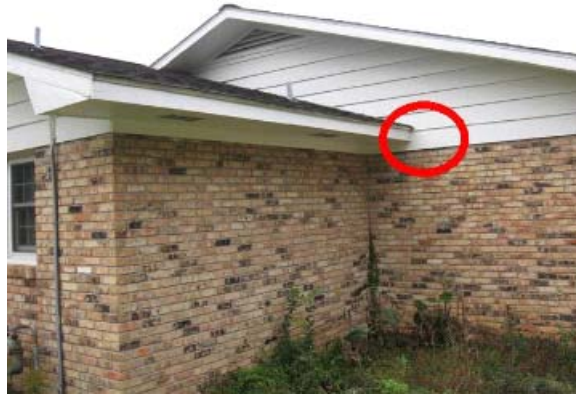
There is no kick out flashing detail at the end of the roof/wall intersection.
Though not required at the time this house was built, it would be advised to seal
the end runs to prevent moisture entry into the house.

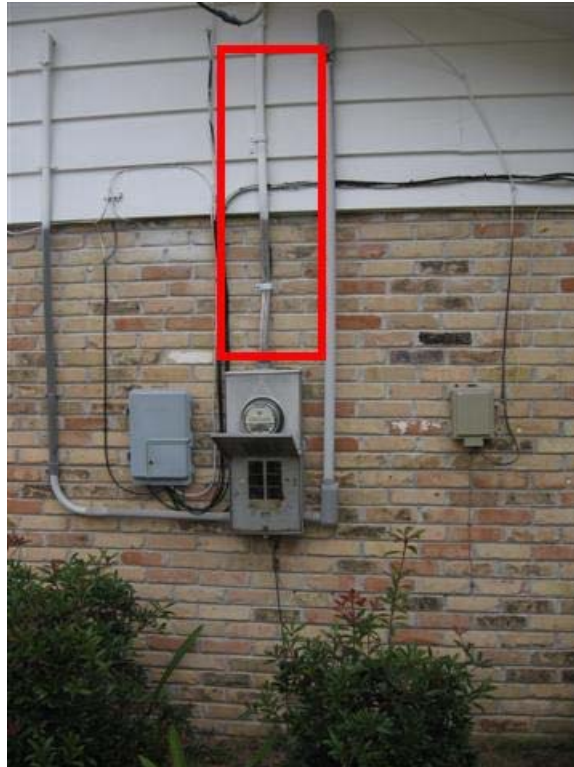
Service entrance cable is frayed and should be repaired,
Entrance wires should be 12 feet above the driveway. Call the power company for any needed repairs. This is very close to the desired height, use caution with large vehicles, ladders, poles etc.

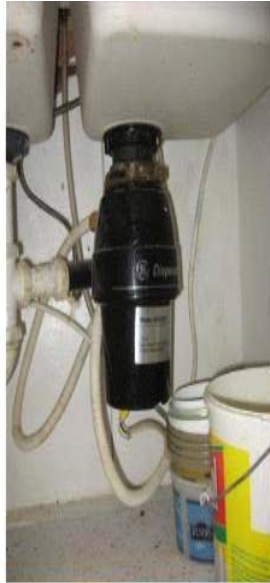
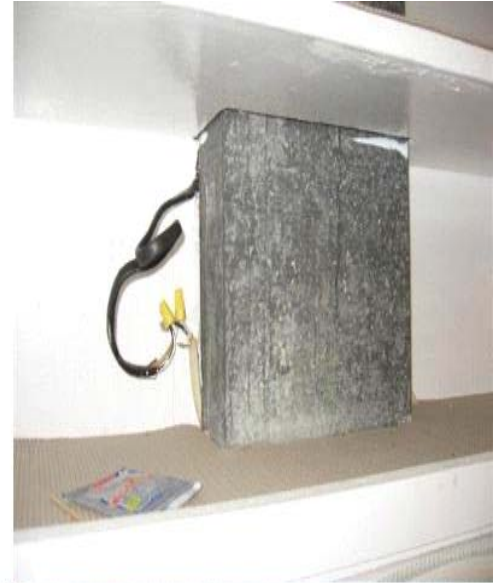
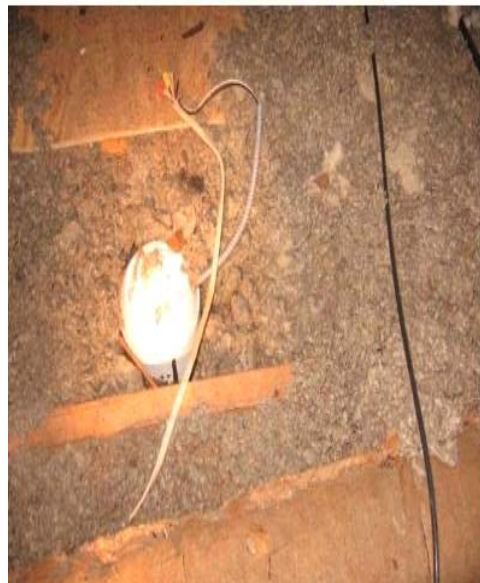
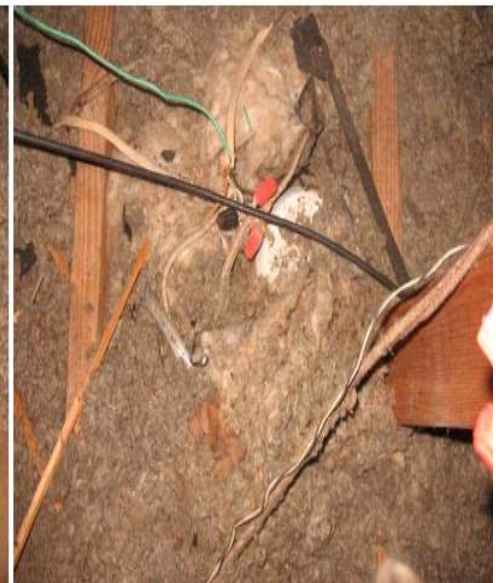
Samples shown

4. Rear doorbell does not function properly.
Spliced wires were noted in the attic, under the kitchen sink, behind the stove vent pipe in the kitchen without being installed into a junction box and cover as required
Exposed wire should be protected from mechanical damage at the rear exterior by the a/c unit.

Rear doorbell does not function properly.

Spliced wires were noted in the attic, under the kitchen sink, behind the stove vent pipe in the kitchen without being installed into a junction box and cover as required

Exposed wire should be protected from mechanical damage at the rear exterior by the a/c unit.

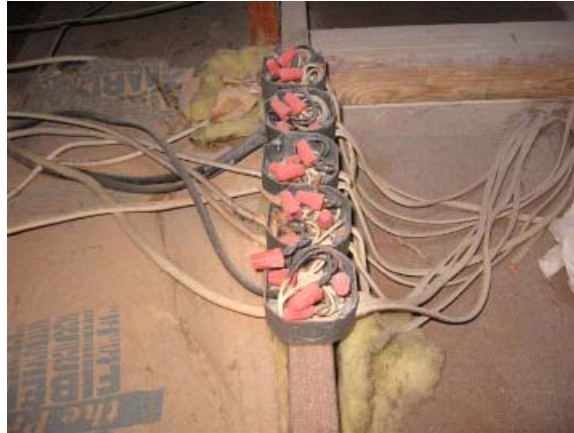
5. Wires installed into junction boxes above the interior panel in the attic are missing covers.

Wires installed into junction boxes above the interior panel in the attic are missing covers.

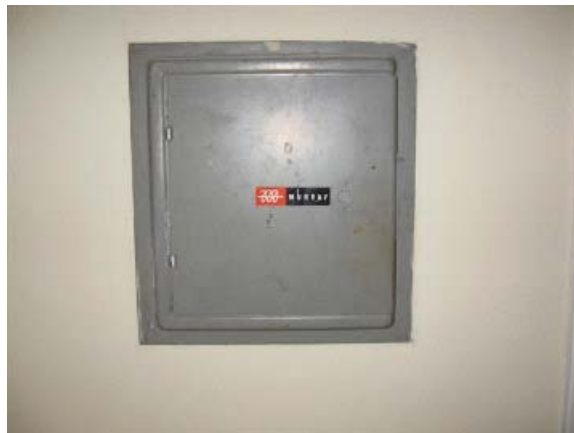
The interior sub panel needs to have all of it's breakers correctly identified and labeled.

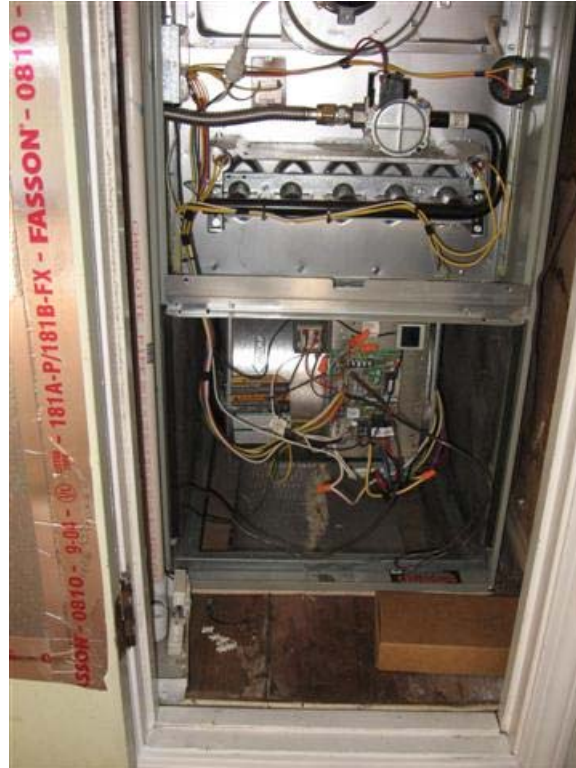
A condensate access port has been added to the drain line. This has been installed (and should be used) for the purpose of keeping the condensate line clean and free of debris, so you may be able to avoid water damage from occurring inside your house should the line become clogged.

A float switch has been added to help prevent interior damage in case of an overflow problem.

It is common practice in this area to clean the condensation line by pouring a cup of bleach down the pipe or using a cleansing tablet / powder etc. monthly during cooling season

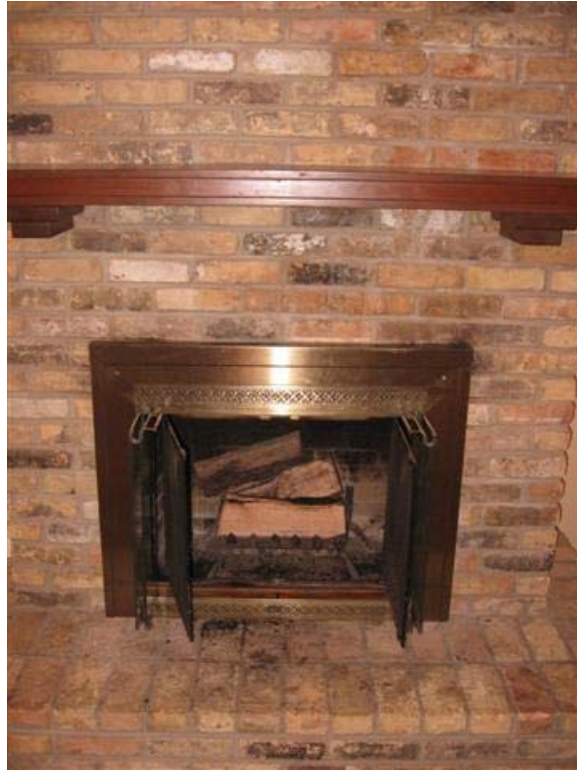
Damper is not operational

Soot / creosote noted. Recommend cleaning before use.

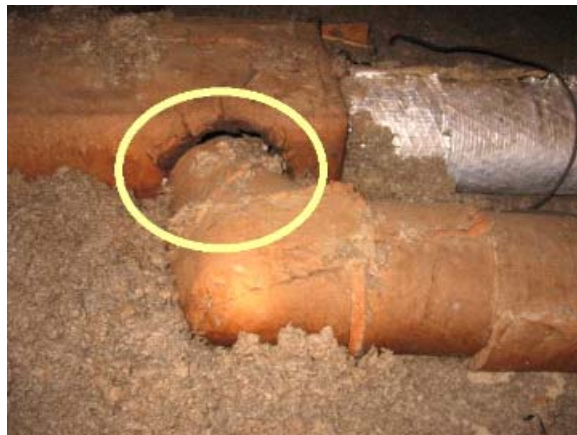
7. Ductwork is loose and disconnected.

Ductwork is loose and disconnected.

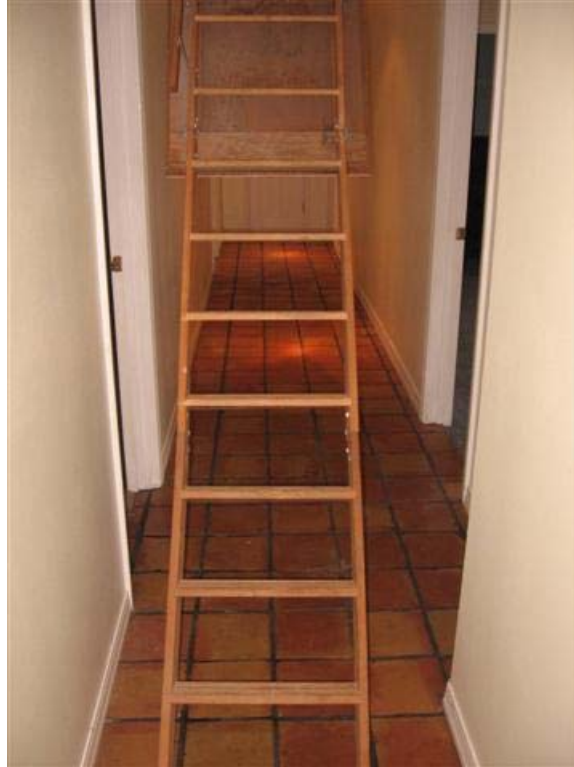
Ladder to the attic is weak and presents a safety hazard. Make improvements as needed.

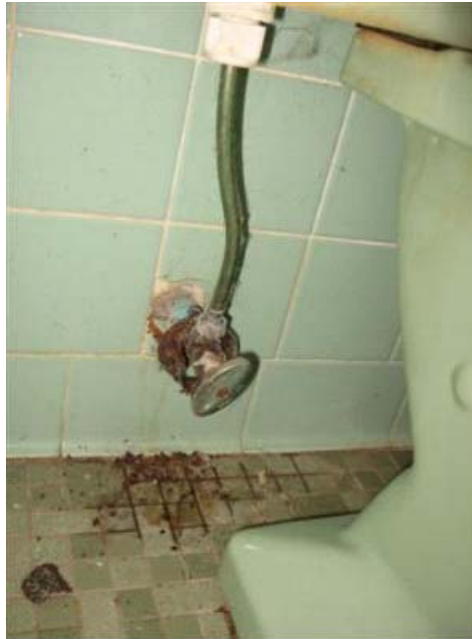
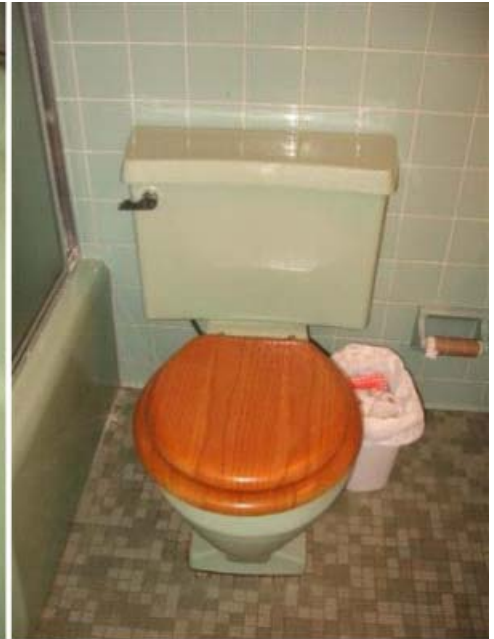
9. There is an active leak at the supply line to the toilet in the 2nd master bathroom.

This same toilet runs, adjustment / replacement of the valve and or flap are needed.

[There is an active leak at the supply line to the toilet in the 2nd master bathroom.](#)

[This same toilet runs and adjustment / replacement of the valve and or flap. General caulking and sealing \(grout\) of wet areas suggested. Damage may result if not corrected.](#)

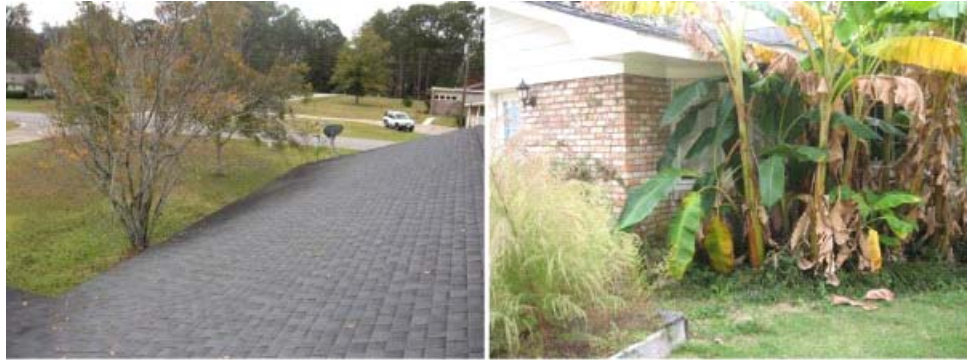
Trees are touching the roof. Damage is possible and should be trimmed as needed.

Trim plants away from structure
