CASE STUDY

Finding Disconnected Strings

Power
12.7MWp

Location
Germany

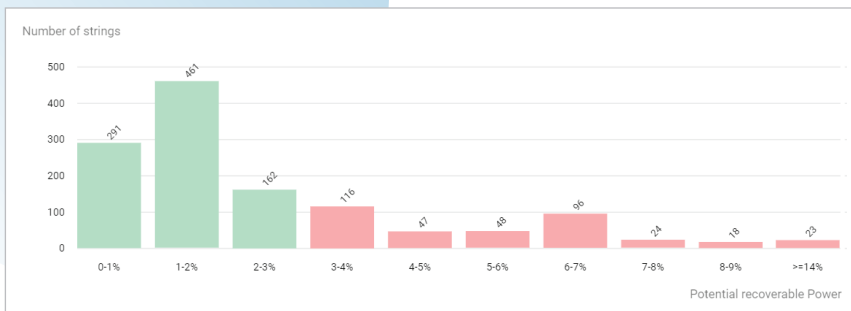
According to the system insights, 11 of the combiner boxes had performance losses that are equivalent to a full string, which indicates they contain disconnected strings. As the plant doesn't have string-level monitoring, its existing monitoring system could not detect these issues.

The diagram to the left, taken directly from DeepSolar, shows the strings recoverable energy.

Raycatch provided the customer with a list of these 11 combiner boxes with their exact location and respective losses.

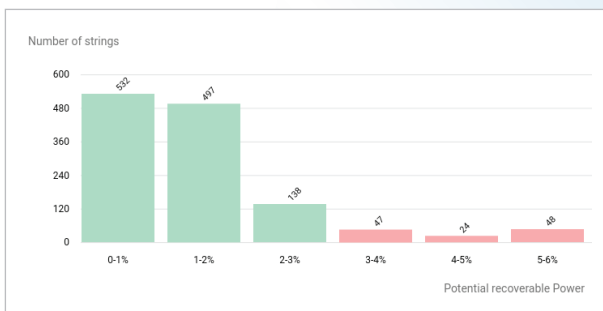
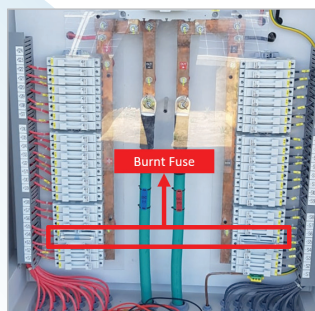
The 11 “suspected” combiner boxes contained one burnt fuse each, and each of them represented the loss of full a string’s energy. The O&M team replaced all the fuses, and the whole process took several hours overall.

The diagram below, taken from DeepSolar, shows the recoverable energy of the strings after the repairs.
