# **Report of Marine Survey**

***"Here Comes Trouble"***

**2005 Yellowfin 36 Offshore**

April 06, 2020

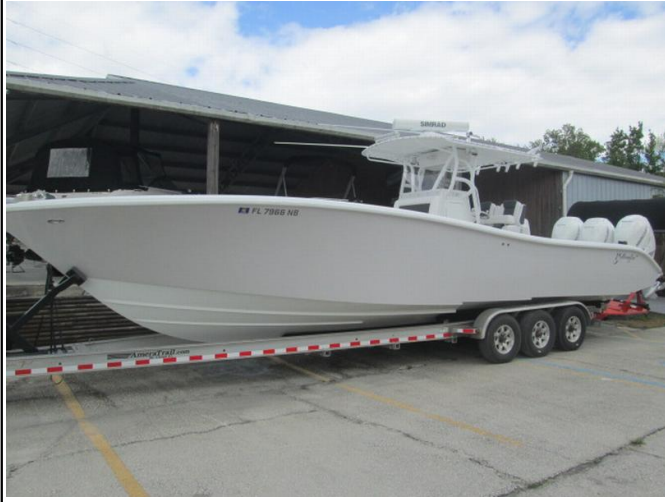
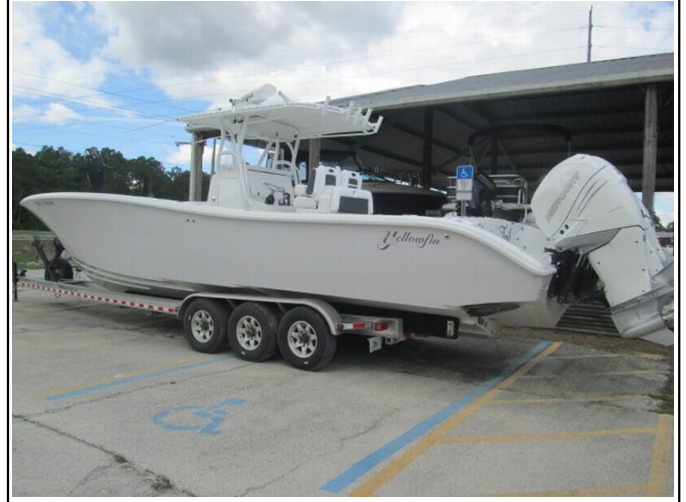
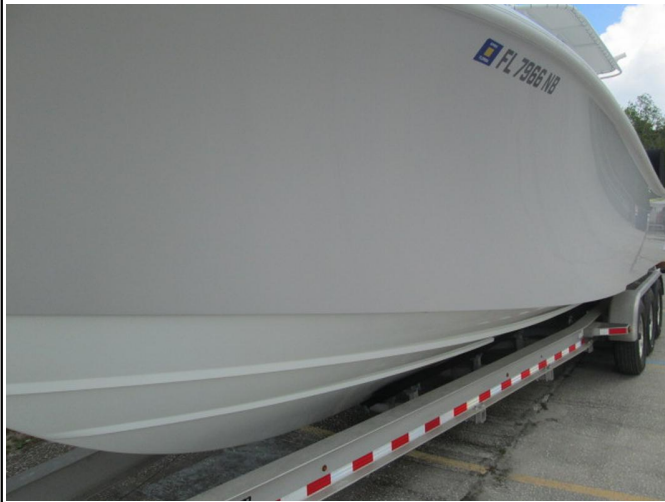
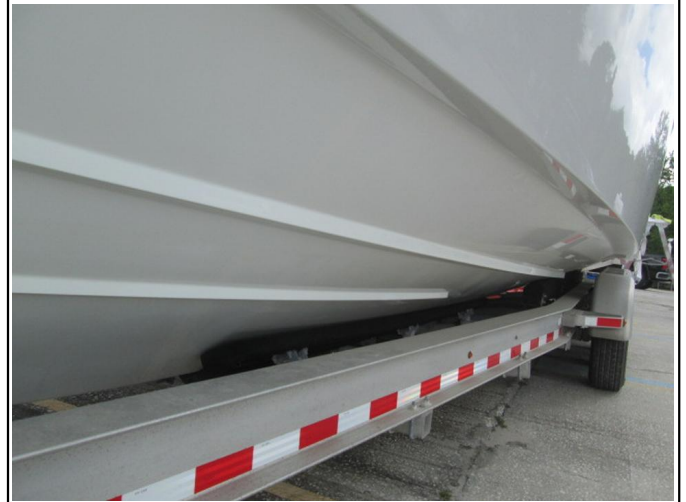
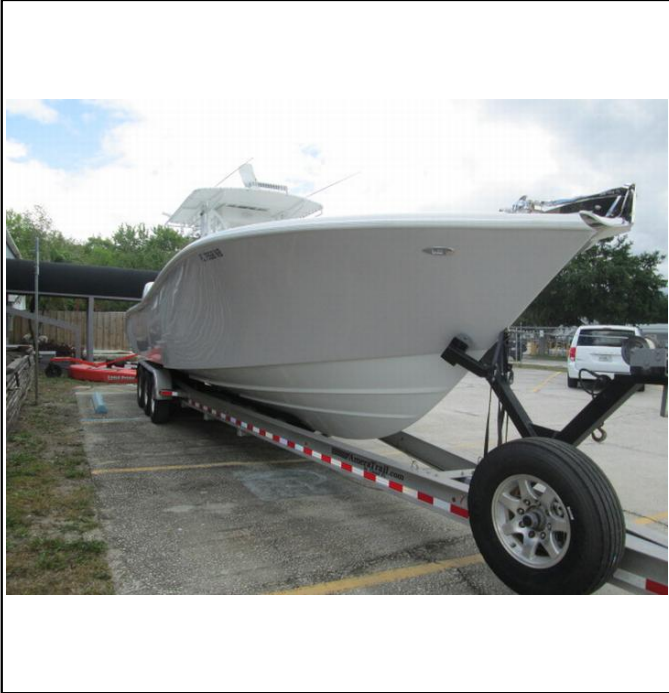
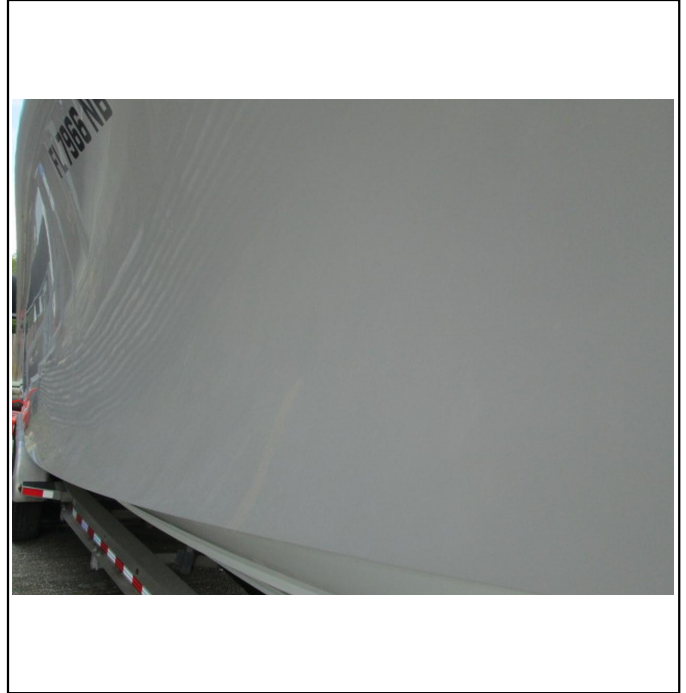
White gel coat hull bottom with Whisper Gray gel coat hull sides. Hull was found exceptionally clean with a nice shine. Hull was percussive sounded and found solid throughout. Moisture meter readings were low on the scale. No structural or cosmetic issues to report. Very nice and well kept. Serviceable. See photo's 1-10.

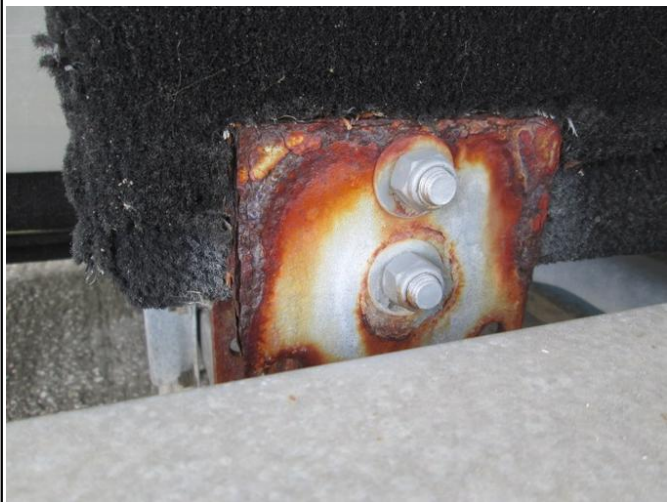
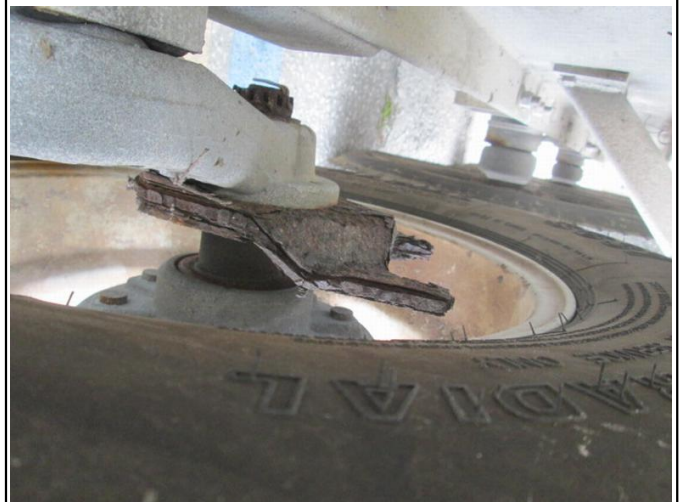
Trailer was found with heavily corroded hardware and no operational brake system.  
See photo's 24,25.

FINDINGS	RECOMMENDATIONS
<b>Trailer was found with heavily corroded hardware and no operational brake system. See photo's 24,25.</b>	<i>Surveyor recommends having a qualified trailer repair facility inspect further to determine condition and reliability of the trailer. Repair as needed for safe operation before next use.</i>

Trailer hardware, photo 24.

Trailer axle/wheel, photo 25.

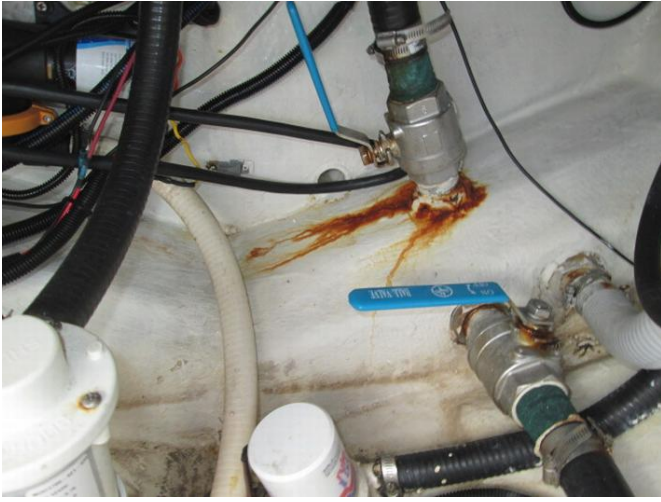
The seacock/ball valve that supplies water to the livewell shows evidence of a leak. See photo 42. Surveyor also sighted another area of concern. If you open the aft facing seat at leaning post and remove the deck plate there are several hoses laying on I believe one of the fuel tanks. The hoses were found not properly attached to the coupler and the clamps were found heavily corroded. Due to limited access the surveyor was not able to follow hoses to see what they supplied. See photo 43.

Thru-hull ball valve, photo 42.

Surveyor recommends having a qualified marine technician repair both areas before next use within the standards of marine practices.

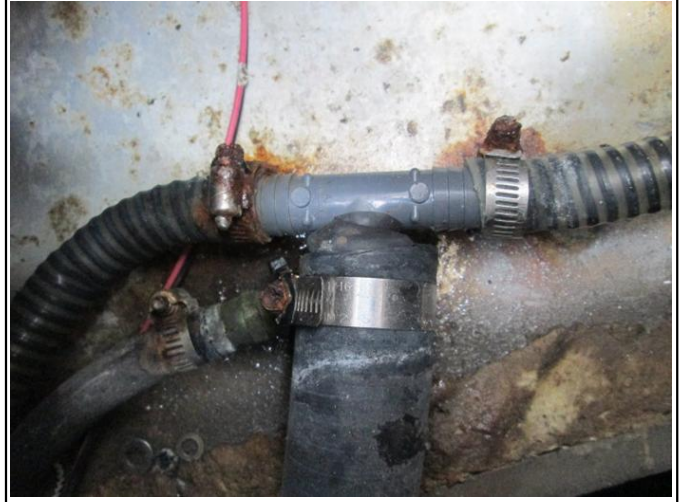
Plumbing under aft cockpit deck at aft facing seat, photo 43.

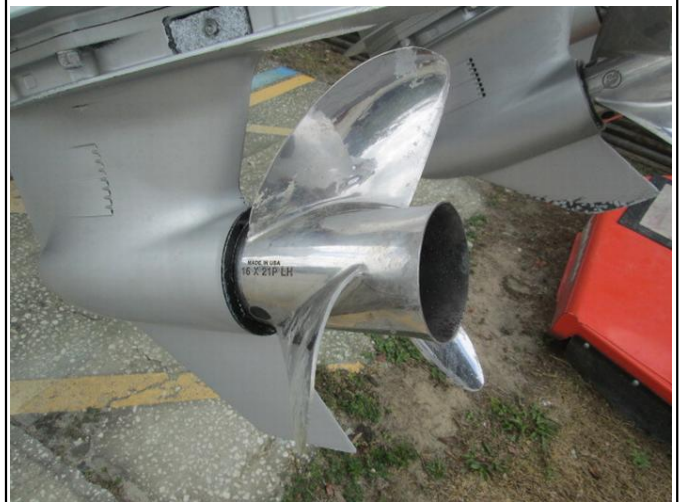
Three (3) Mercury Enertia ECO. Three blade stainless steel. All three propellers were found in good condition. Serviceable.  
Port propeller: 16x21P LH. See photo 45. Center propeller: 16x21P RH. See photo 46.  
Stb propeller: 16x21P RH. See photo 47.

Port propeller, photo 45.

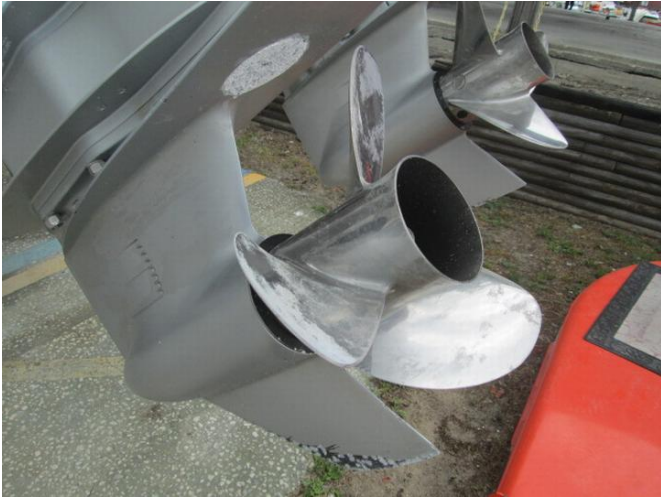
**Center propeller, photo 46.**

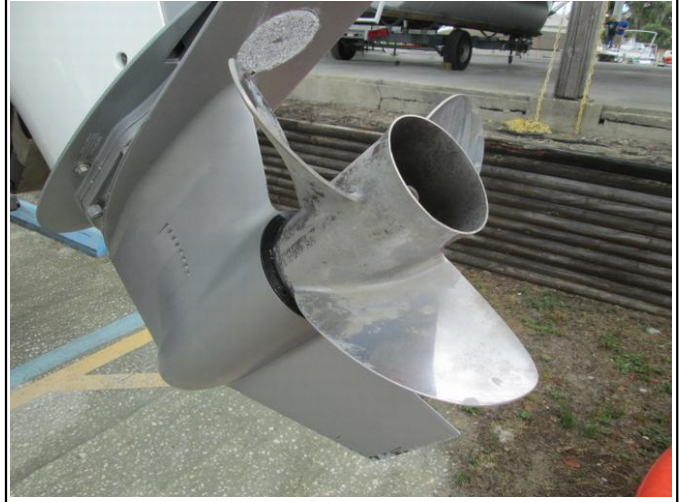
**Starboard propeller, photo 47.**

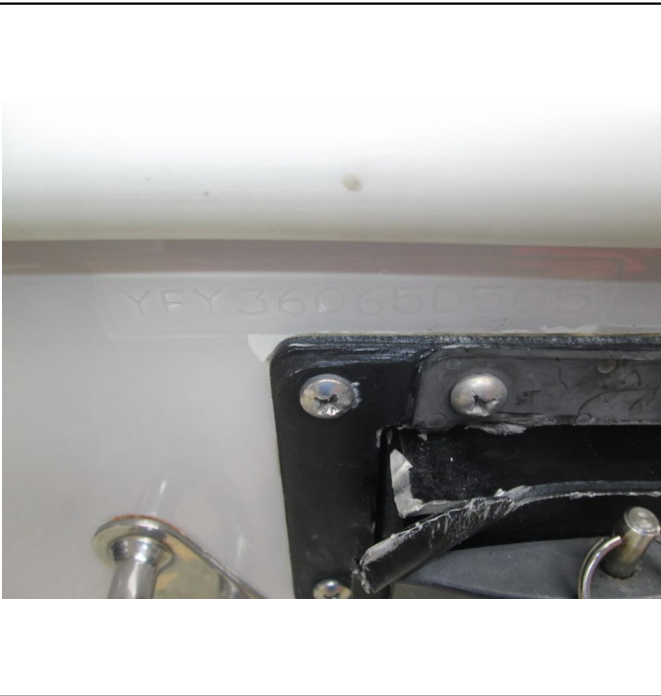
**NOTE:** It is recommend and understood that all GAS engines be surveyed by a qualified Engine Surveyor to determine the condition of the engines.  
Florida registration hull identification number does not match the engraved number on the vessel. Surveyor recommends having it corrected with the State Tax Office to prevent any future issues with law enforcement.

**Hull identification number, photo 48.**
