*Donnelly Law
Hydrogeological Review - Bacher Construction Pit and Quarry
Township of Algonquin Highlands, Haliburton County, Ontario
BRM-00255020-A0
August 16, 2019*

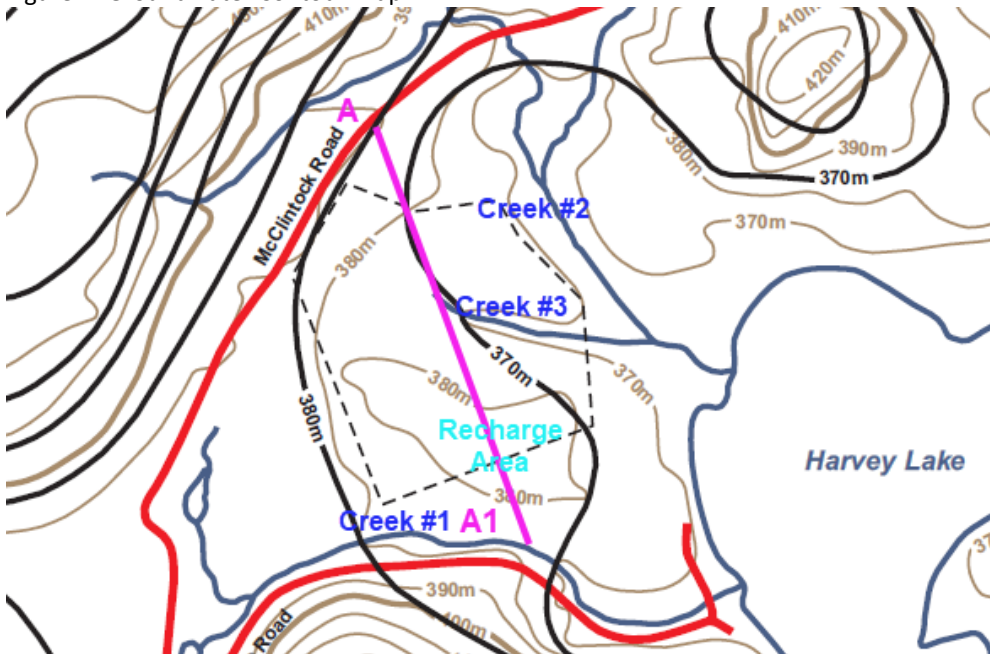
Figure B. Groundwater Contour Map

On Figure 4 of the statement, water levels are sketchily presented with 10 m interval contours, which according to Waters are interpreted to represent the highest groundwater conditions onsite. So far, the site lacks field evidence to characterize it properly, as there are no onsite monitoring wells. To EXP's knowledge, groundwater levels were not measured onsite by Waters and no monitoring program of water levels has been implemented, and no well water well records are reported within 1 km of the study area. Therefore, the claim that Figure 4 of the Waters report is representative of highest groundwater levels cannot be supported. To provide such information, onsite monitoring wells are required, and multi-year seasonal groundwater level monitoring is needed.

For that reason, EXP disagrees with the stated interpretation (representation of highest groundwater conditions), as seasonal groundwater fluctuations and especially high-water levels during spring thaw (freshet) are yet unknown. The document by Waters (2016) rightly claims to be a "Groundwater Summary Statement", which is not a detailed hydrogeological report.

The groundwater contours shown on Figure B suggest discharging conditions to creeks #1 (south) and #3 (center) and recharging conditions between these streams. The assumed horizontal water table in cross-section A-A1 of the final Site Plan by Timber Craft Consultation Inc. (2019), as depicted on Figure C, is inconsistent with the interpretation made by Waters (2016). Generally, under current recharge conditions, the groundwater surface would somewhat mirror the surface topography for low hydraulic conductivity soils/rocks, and it would flatten, if the hydraulic conductivities are high.

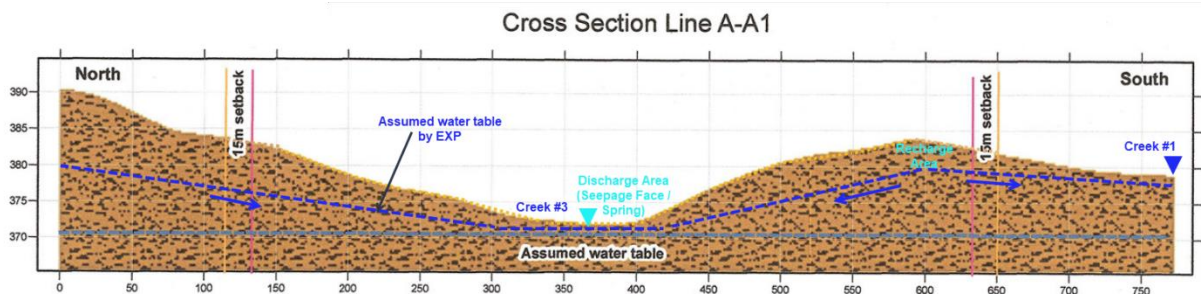
Figure C. Assumed Water Table in Cross-Section A-A1

According to cross-section A-A1 presented on page # 2 of the Final Site Plan by Timber Craft Consultation Inc., there are no anticipated potential impacts shown on the horizontal water table. EXP's view on this prediction is that this seems a very unlikely and unrealistic scenario. EXP would expect an alteration of recharge areas and contribution to surface water features, potential effects on water quality (surface and groundwater), disruption of discharge areas and potential impacts on natural features, lowering of water table and changes in flow regime as likely outcomes of the extracting activity. Potential impacts due to the proposed pit/quarry development can be assessed with a detailed hydrogeological investigation.

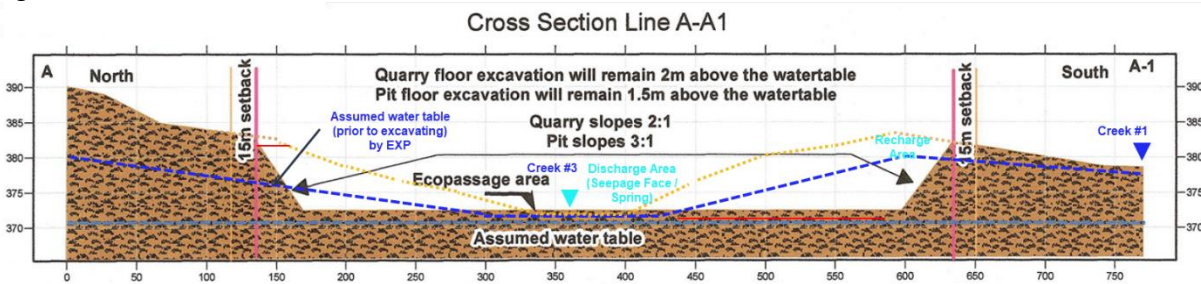
Figure D Assumed Excavation below the Water Table in Cross-Section A-A1

EXP, following the water levels interpretation made by Waters (2016), observes that the water table has relief (as depicted in Figure B) and accordingly, the proposed quarry floor is predicted to be below the water table, as shown on Figure D.

EXP has the opinion that the proposed Site Plan by Timber Craft Consultation Inc. (2019) does not conform to the description "as above groundwater extraction of pit or quarry operation", and consequently, cannot be approved for a Category 9 or 11 application under the Aggregate Resources Act.
