Beaver River Watershed Report

Prepared by
Meghan Allerton

for the
Grey Sauble Conservation Authority

August 2015

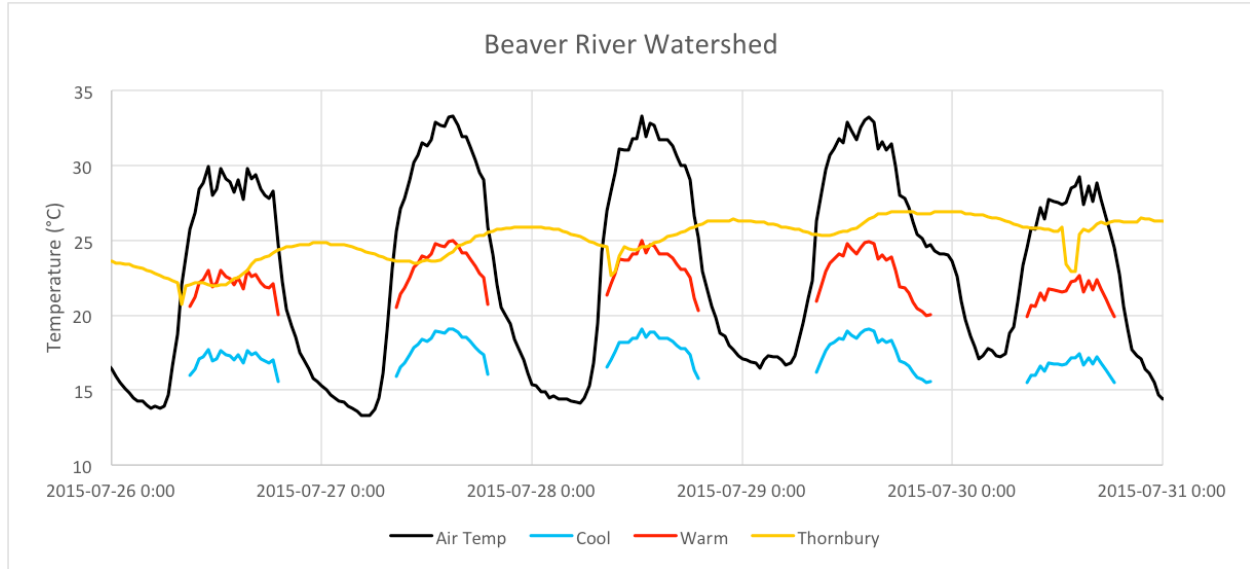
Figure 4. Water temperature measured at site 318 (Beaver River mouth at Thornbury) compared to air temperature and cool and warm water thresholds.

Figure 4 compares water temperatures measured at the mouth of the Beaver River to air temperatures over a five-day period at the end of July 2015. Note that daily water temperatures peak several hours later than daily air temperatures – a result of the high specific heat of water and the relatively large volume of water at this location. The red and blue lines represent the lower thresholds for warm and cool water, respectively, based on the classifications developed by Stoneman and Jones (1996). Water temperatures that peak above the red line are classified as “warmwater”, temperatures peaking between the red and blue lines are classified as “coolwater”, and temperatures that peak below the blue line are classified as “coldwater” (Stoneman and Jones 1996). Estimates of water temperature regimes should be based on a day that was preceded by 2-3 days with similar maximum air temperatures (Stoneman and Jones 1996). As seen in Figure 4, daily air temperatures peaked above 30°C on three consecutive days in July (July 27 to July 29). Thus, temperatures on July 29 were used to classify the thermal regime of the river. Since the maximum water temperature on this day exceeded the warmwater threshold, the

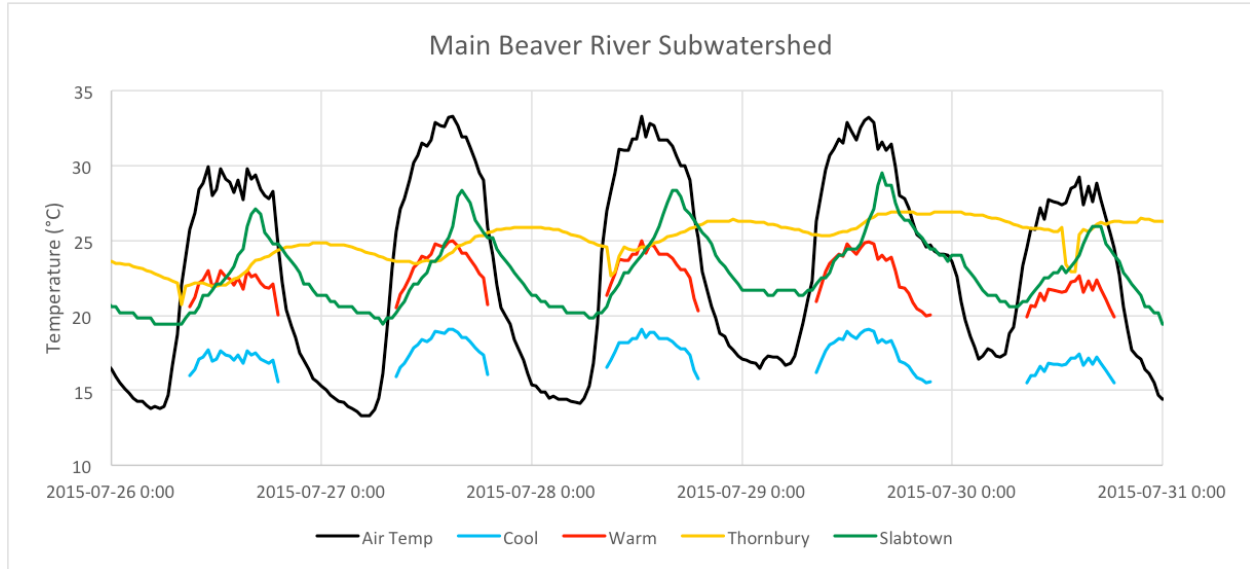
Figure 6. Water temperature measured at site 324 (Slabtown) and site 318 (Beaver River mouth at Thornbury) compared to air temperature and cool and warm water thresholds.

Despite good riparian cover in the subwatershed, there is concern about rising temperatures in the main stem of the river. Figure 6 shows the temperature at both the Slabtown monitoring site and the monitoring site in Thornbury in order to evaluate the effect of development between these two locations on water temperature. Since maximum water temperatures at both sites exceeded the warmwater threshold on July 29, the river is classified as warmwater (thermally unstable) at both locations. However, as seen in Figure 6, daily water temperatures behave quite differently at the two sites. Water temperatures at the Slabtown site exhibit much greater daily fluctuations than at the river mouth, and peak earlier in the

Temperatures at the river mouth may be buffered by the larger volume of water flowing past this point. Inputs of warm water from urban runoff also could be contributing to consistently high water temperatures at the river mouth. Perhaps more significantly, the temperature at the mouth may be reflecting the impact of several large dams located between sites 324 and 318.

Site 324 is a provincial water quality monitoring site located just below the Slabtown Dam. There are three other large dams on the river between this site and the outlet: the Clendenan Dam, the Haines Dam, and the Thornbury Dam. The Haines Dam is unlikely to have an impact on water temperatures since there is no significant ponding of the river above the dam. The Clendenan Dam and the dam at Thornbury, however, may be altering downstream temperature regimes. Both dams cause significant upstream ponding of the river. These ponds reduce the flow rate of the river, which reduces mixing, causing the water to heat more quickly. Since warmer water is less dense, it 'floats' on the top of the water column, forming a warm surface layer. Water from the surface of the Mill Pond above the Thornbury Dam flows over the top of the dam (top draw), most likely causing the downstream water temperature to be warmer and show less daily fluctuation than it otherwise would. The Clendenan Dam may have a similar effect. The Slabtown Dam causes minimal ponding of the river. The flow rate at this location is higher, allowing greater mixing of the water such that the water temperature more closely follows the air temperature.

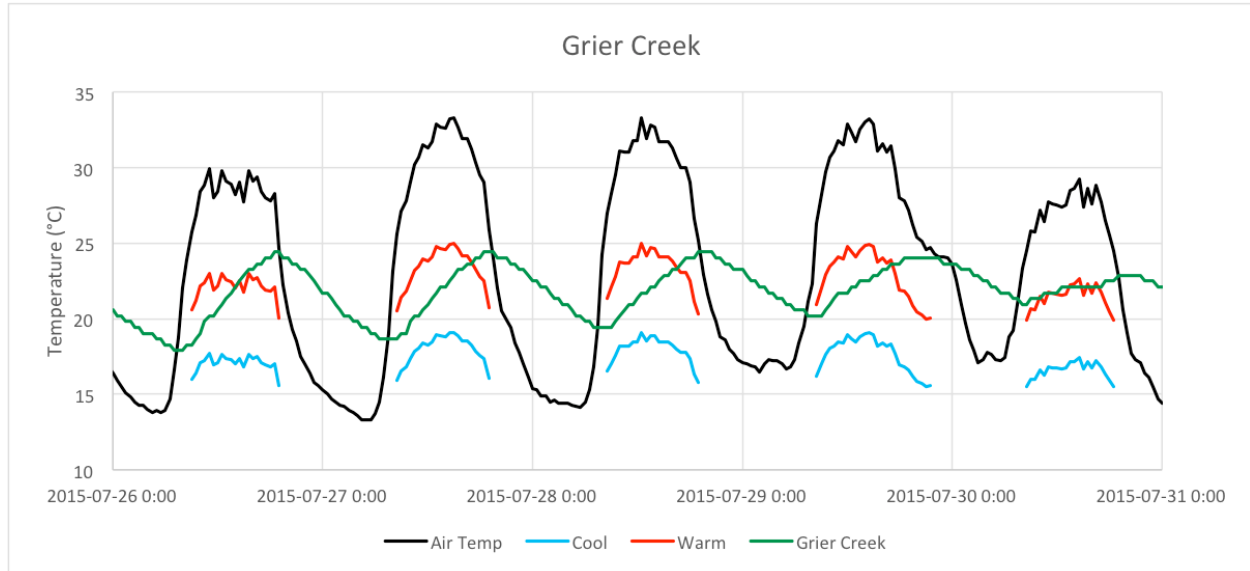
Figure 8. Water temperature measured at site 544 (Grier Creek) compared to air temperature and cool and warm water thresholds.

As seen in Figure 8, July 29 water temperatures at the Grier Creek monitoring site peaked just below the warmwater threshold, suggesting that the site provides marginal coolwater habitat. Daily maximum water temperatures were higher than would be expected for a small creek, and daily minimum temperatures were also relatively high, indicating that water temperatures did not recover significantly at night. These results suggest that groundwater inputs do not occur in the vicinity of the monitoring site and the creek temperature likely increases quickly with distance downstream from the groundwater source. Lack of riparian cover shading the creek is likely a contributing factor. The creek flows over rocks that quickly heat under the direct sun, further heating the water. The low water levels observed at the site would also exacerbate heating of the creek since a smaller volume of water heats more quickly. While the creek may still support some coolwater species, rising water temperatures and low water levels are issues to watch in this subwatershed.

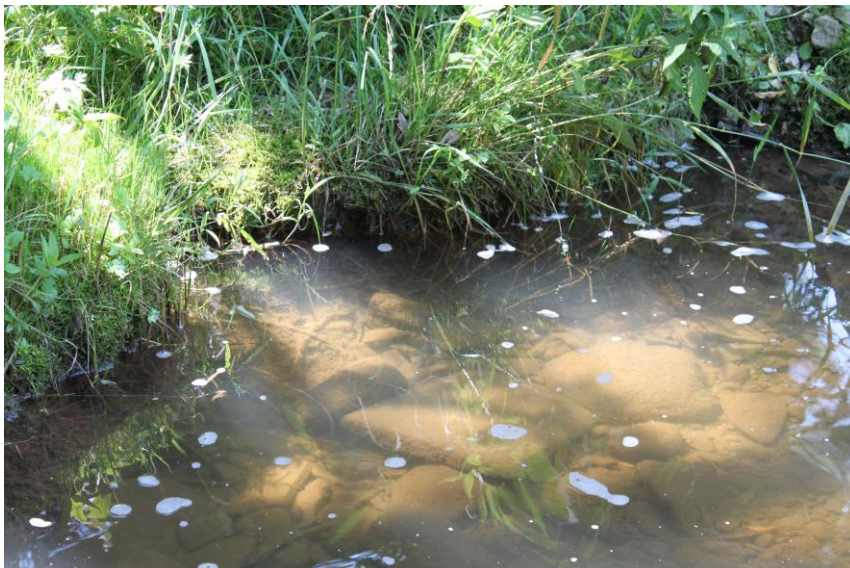
Figure 9. Mill Creek Subwatershed.

The Mill Creek subwatershed is illustrated in Figure 9, and outlets to the main Beaver River just south of Heathcote, approximately 10 kilometers upstream from the mouth of the river. The subwatershed is divided into two minor subwatersheds corresponding to two branches of the creek: the Red Wing tributary and Kolapore Creek. Data collected from site 3210, located near the outlet of Mill Creek, was used to assess surface water quality for the entire subwatershed. Water quality was also monitored at the outlets of both minor subwatersheds.

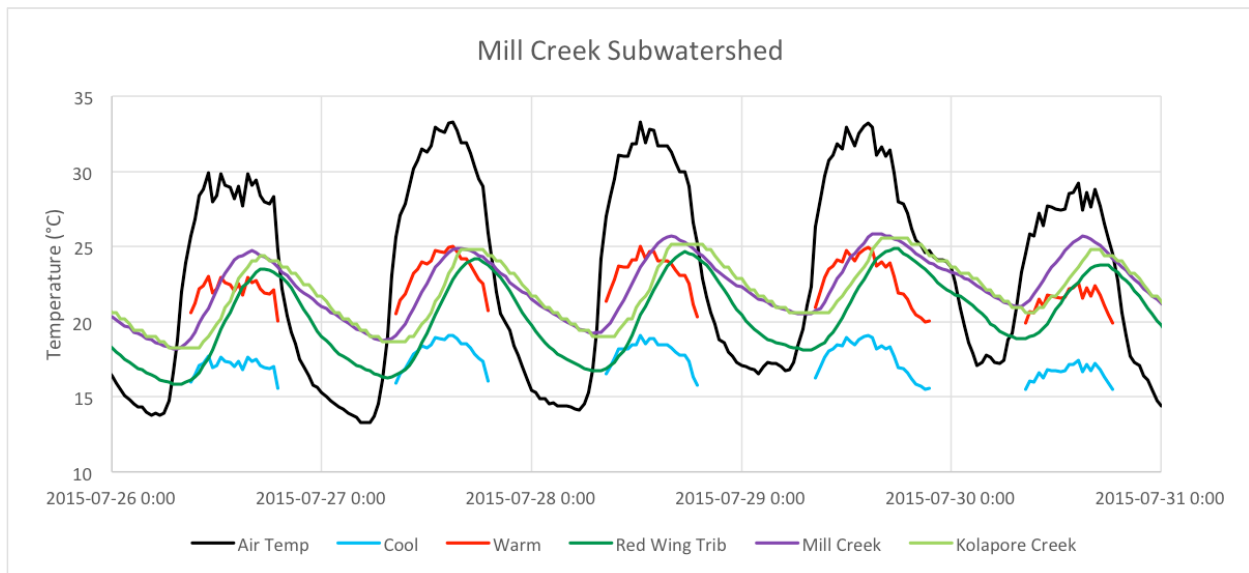
Figure 10. Water temperatures measured at sites 3210 (Mill Creek), 3214 (Red Wing tributary), and 3215 (Kolapore Creek) compared to air temperature and cool and warm water thresholds.

As seen in Figure 10, the maximum water temperature at both the Mill Creek and Kolapore Creek monitoring sites slightly exceeded the lower warmwater threshold on July 29, suggesting that both sites may be classified as warmwater, or thermally unstable. The water temperature at the Red Wing tributary site peaked just at the warmwater threshold, indicating that this site may be marginal coolwater. Daily maximum water temperatures were high, considering the size of the creek at all sites. The temperature at Kolapore Creek is particularly unusual given the high riparian forest cover in the subwatershed. The graph shows that there is some nighttime recovery of cool temperatures at the Red Wing site, but less so at the other two, suggesting that the Red Wing site is located closer to groundwater inputs than the other sites.

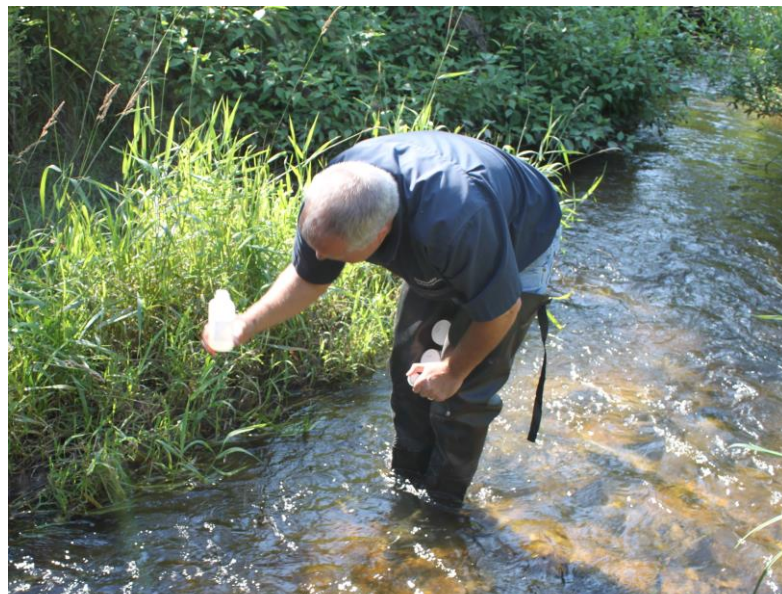
Figure 11. Wodehouse Creek Subwatershed.

Wodehouse Creek drains an area of about 33 square kilometers, most of which is located above the Niagara Escarpment on the west side of the Beaver Valley. Figure 11 shows the water quality monitoring site for the subwatershed and depicts the creek continuing southward from this point. This is not an accurate representation as these are actually two separate systems, both of which disappear above the escarpment due to the presence of large sinkholes that receive to the upper reaches of the watershed (J. Bittorf, personal communication, August 25, 2015).

Wodehouse Creek disappears just downstream from the indicated monitoring site. It is uncertain where the creek outlets below the escarpment (J. Bittorf, personal communication, August 25, 2015).

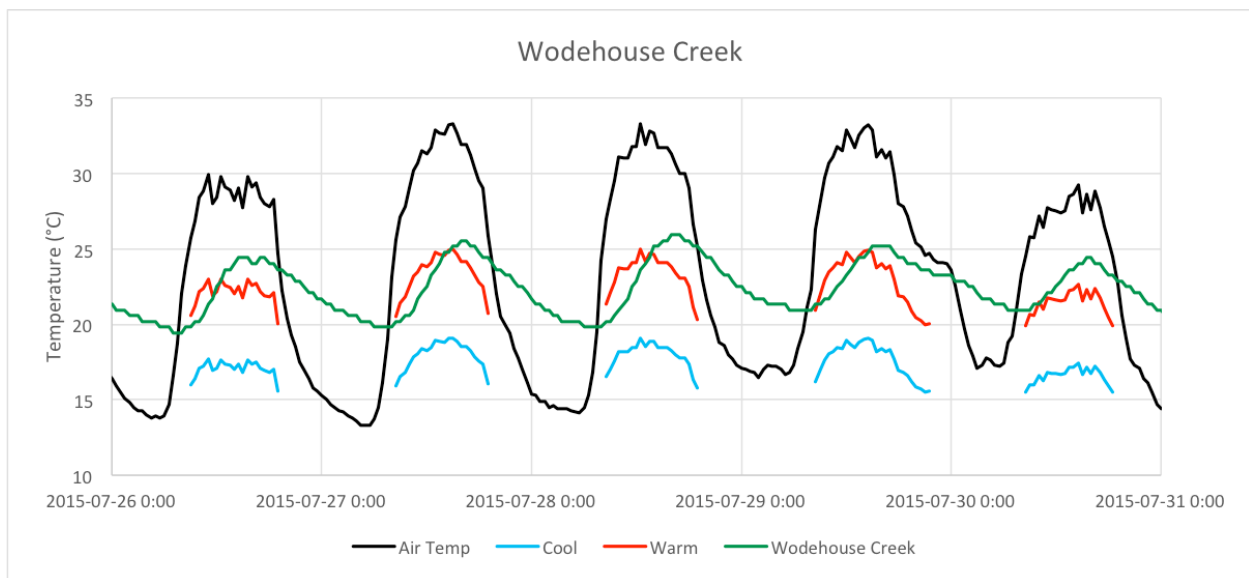
Figure 12. Water temperature measured at site 4041 (Wodehouse Creek) compared to air temperature and cool and warm water thresholds.

Temperature records for July 29 show that a maximum water temperature of about 25°C was reached at the Wodehouse Creek monitoring site, matching the lower warmwater threshold. The creek could be classified as marginal coolwater at this site. Similar to the Grier Creek site, daily maximum water temperatures were high given the size of the watercourse, most likely a

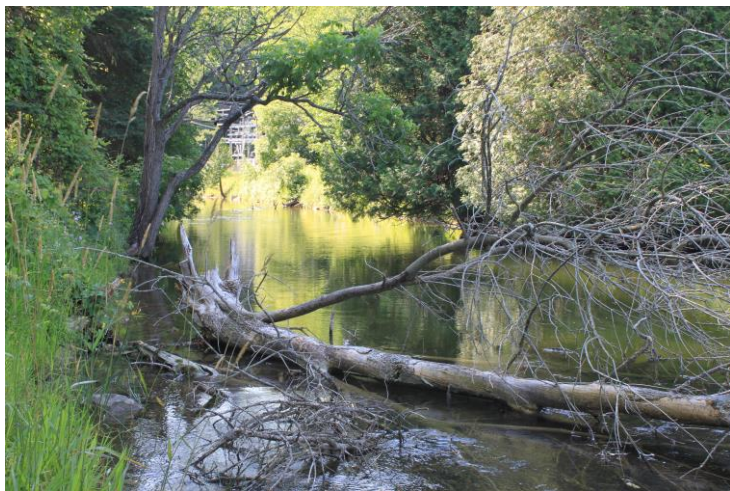
Figure 13. Lake Eugenia Subwatershed.

Lake Eugenia is an artificial lake that was created in 1915 when the upper Beaver River (above the escarpment) was dammed to create a reservoir for the Eugenia hydroelectric generating station (Ontario Power Generation 2014). Approximately 190 square kilometers of the Beaver River watershed drain into Lake Eugenia, making the Lake Eugenia subwatershed the largest considered in this report. In order to provide more detailed results, the subwatershed was divided into the Little Beaver River and Upper Beaver River subwatersheds, and the Upper Beaver River subwatershed was further divided based on the catchment areas of its north and south tributaries (see Figure 13). Water quality monitoring site locations are shown in Figure 13.

Note that the monitoring site located at the outlet of Lake Eugenia (3208) does not appear within the subwatershed boundary. This is because the boundary reflects the original course of the Beaver River. Most of the flow is now diverted

through penstocks to the hydroelectric generating station in the valley below the escarpment.

As a result, the main confluence of the Beaver and Boyne rivers occurs about a kilometer north of its original location. The Lake Eugenia Outlet monitoring site is located at the outfall of the hydroelectric station.

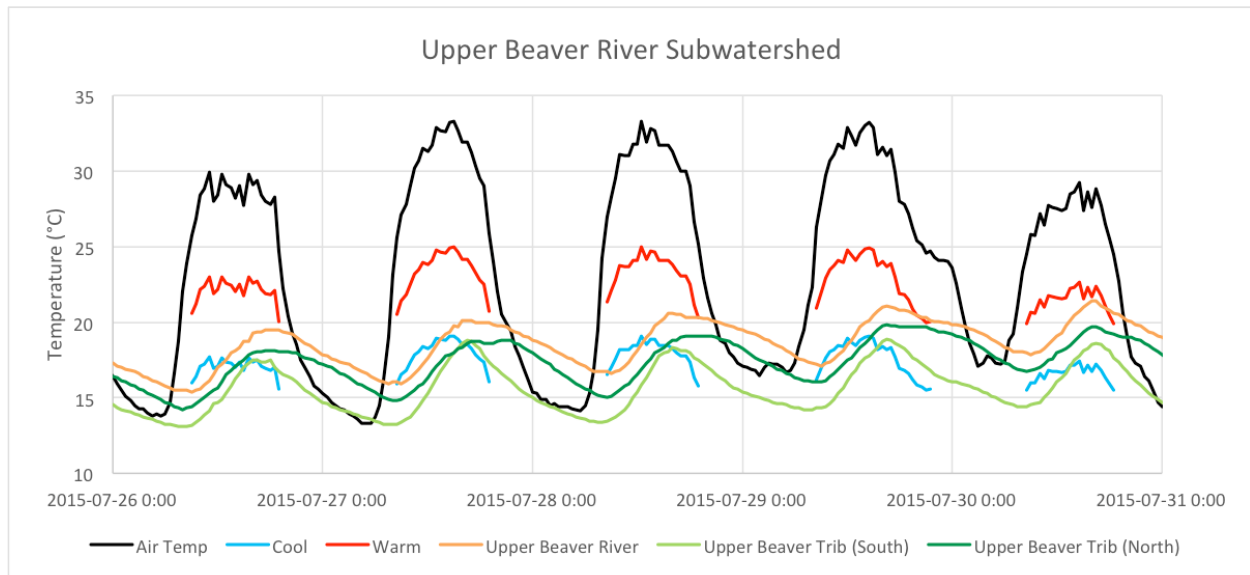
Figure 14. Daily water temperatures measured at sites 3224 (Upper Beaver River), 4170 (Upper Beaver South Tributary), and 4186 (Upper Beaver North Tributary) compared to air temperature and cool and warm water thresholds.

Daily water temperatures for the Upper Beaver River and its two tributaries are shown in Figure 14. Maximum water temperatures on July 29 indicate that both the Upper Beaver River and the North Tributary sites are coolwater. The July 29 maximum temperature at the South Tributary site matches the lower coolwater threshold, indicating that this site may be considered marginal coldwater. As expected, water temperatures at the downstream (Upper Beaver River) site are slightly higher, since the site is further from the groundwater source and is also located downstream from a small dam. Low temperatures at all three sites indicate that the Upper Beaver River is well buffered by groundwater inputs.

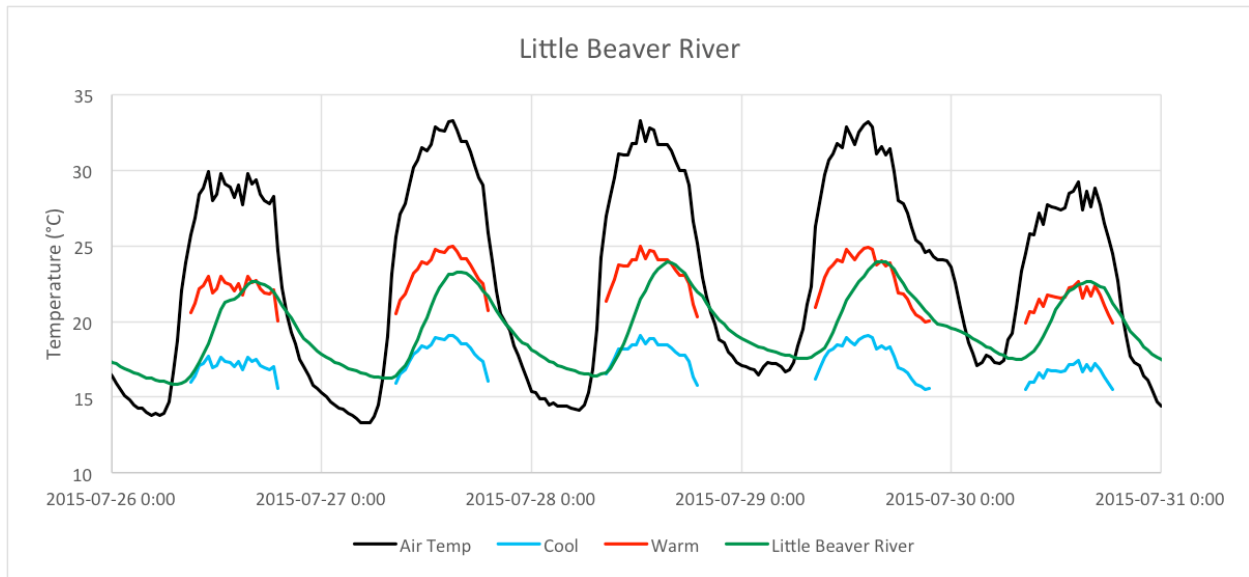
Figure 15. Water temperature measured at site 3222 (Little Beaver River) compared to air temperature and cool and warm water thresholds.

Daily water temperatures measured at the Little Beaver River monitoring site are shown in Figure 15. The July 29 maximum temperature is just within the coolwater zone. Daily maximum water temperatures are higher than expected for a small headwater creek. Nighttime recovery of cold temperatures suggests that the site is cooled by upstream groundwater inputs. Thus, the high water temperatures reached during the day are likely a reflection of relatively low forest cover in

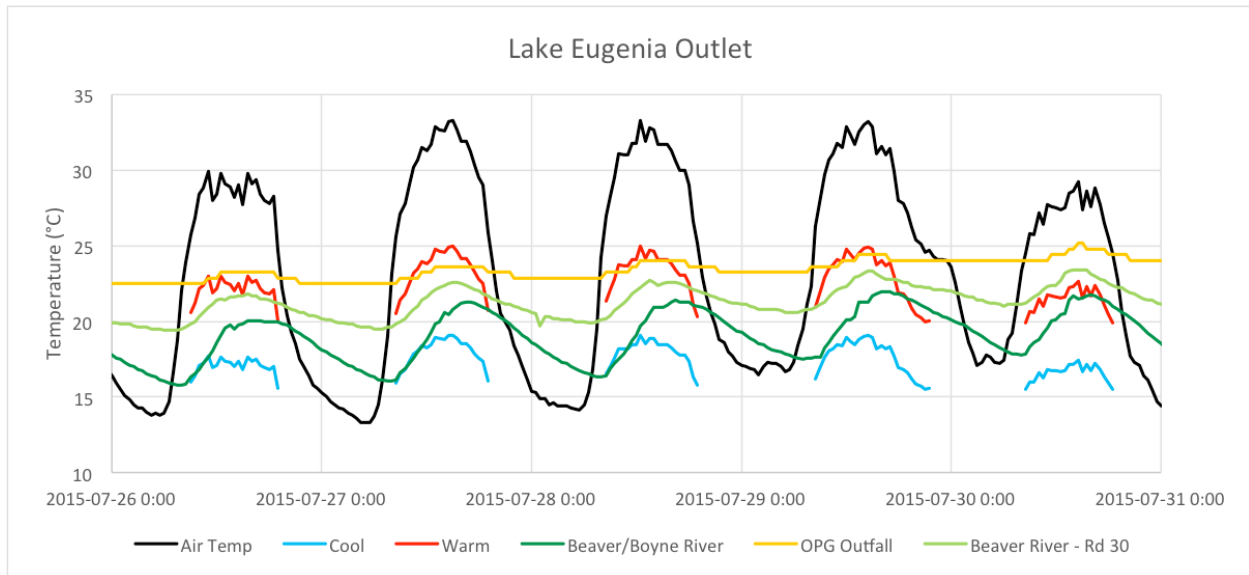
Figure 16. Daily water temperatures measured at sites 3208 (Lake Eugenia Outlet/OPG Outfall), 6479 (Beaver/Boyne River), and at a downstream location (Beaver River - Rd. 30) compared to air temperature and cool and warm water thresholds.

Figure 16 shows daily water temperatures recorded at the Ontario Power Generation (OPG) hydro station outfall. Daily water temperatures at the outlet of the Boyne River and at a site about 600 meters downstream are also shown to illustrate the effect of the hydro station on the thermal regime of the river. The July 29 maximum temperature at the hydro station outfall is at the lower threshold for warmwater. Temperatures at this site reflect those near the surface of Lake Eugenia, at the intake for the penstocks, and show almost no daily fluctuation. The Boyne River outlet is a coolwater site that exhibits a normal daily fluctuation in response to the air temperature. The temperatures recorded at the downstream site illustrate the effect of the hydro station. As the water from the hydro station outfall flows downstream and mixes with the Boyne, it causes daily maximum temperatures to increase and significantly reduces nighttime cooling.

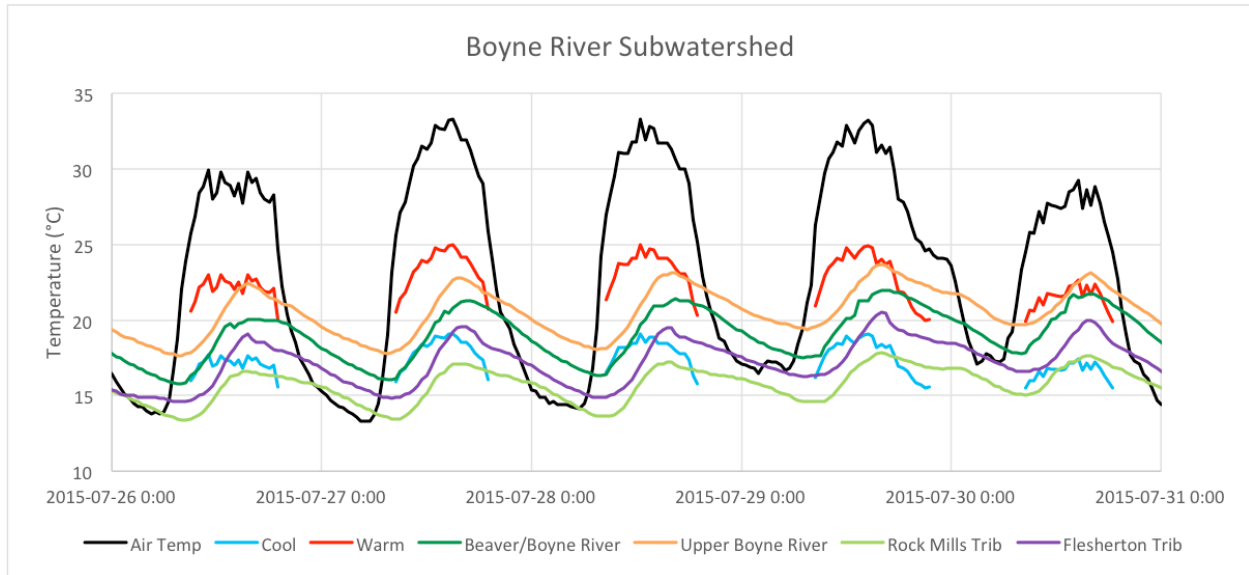
Figure 18. Daily water temperatures measured at sites 6479 (Beaver/Boyne River), 26 (Upper Boyne River), and at the outlets of two headwater creeks (Rock Mills Tributary and Flesherton Tributary) compared to air temperature and cool and warm water thresholds.

Temperature records for the Boyne River outlet (Beaver/Boyne River) and Upper Boyne River monitoring sites are shown in Figure 18, along with records from the outlets of two small creeks that flow into the Boyne River. Results from the Boyne River outlet and the Upper Boyne sites are unusual in that they show water temperatures actually decreasing downstream. The higher temperatures observed at the Upper Boyne site may be partly a result of upstream ponding of the river above the dam in Flesherton, and partly due to heating in areas where riparian cover is lacking. As suggested by Figure 18, the cool temperatures observed downstream may have been recovered due to inputs of cold water from small tributaries, such as Rock Mills Creek, that flow into the Boyne River between the two monitoring sites.
