## EXTENDING USEFUL LIFE OF F-CLASS GAS TURBINE COMPONENTS

### ABSTRACT

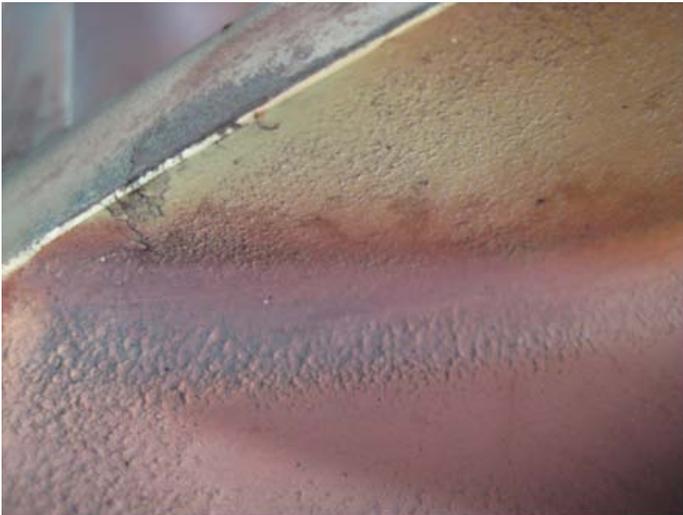
**Figure 4, F7FA 1<sup>st</sup> stage bucket platform cracking**

The bucket that completed 1st cycle and 2nd cycle were also Non Destructive Tested (NDT) including Penetrant Testing (PT) and visual after stripping of the coating – see figures 4 and 5. The results were compared to the simulations and confirmed the earlier results in most cases, the simulation was further defined in other cases as shown in figure 3.

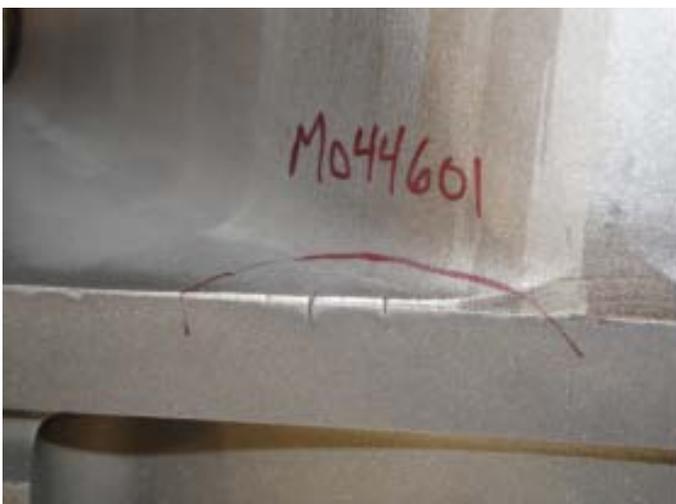
**Figure 5, Bucket platform cracking after stripping**

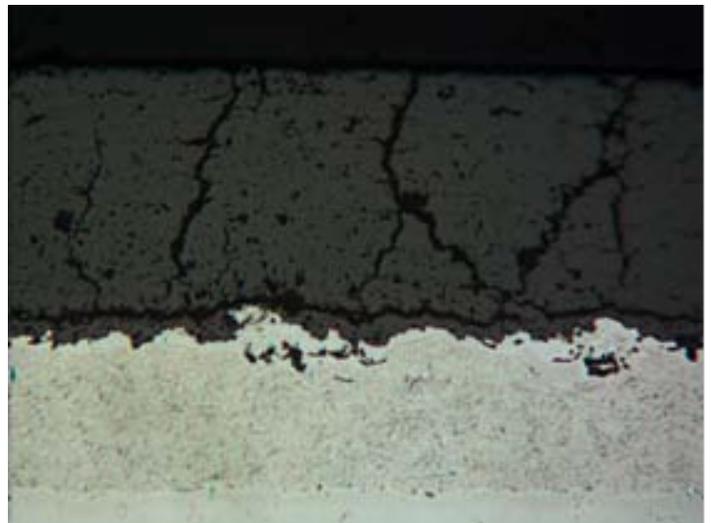
**Figure 7, DVC or DVM TBC coating after 2<sup>nd</sup> cycle**

The external coating was mostly Dense Vertical Cracked coating, however some of the repaired buckets showed high porosity TBC coating, figure 8. Delamination of the top coat just above the bond coat interface seen in the microscope was mostly of buckets with the spallation observed during incoming visual inspection. The bond coat was generally in good condition and limited or no oxidation or porosity was seen with exception of the “flash-coat”. Note flash-coat is a coating that is Air Plasma Sprayed (APS) between the original bond coat, which is typically sprayed with High Velocity Thermal Spray (HVOF) process, and the APS sprayed TBC to enhance the bonding of the top coat, see figure 7.
