GIRLING REMOTE SERVO UNIT MK IIA & MK IIB REPAIR PROCEDURE & FAULT FINDING P1

hydraulic servo unit MK 2A 6A 1a

hydraulic servo unit MK IIB 6A 2a

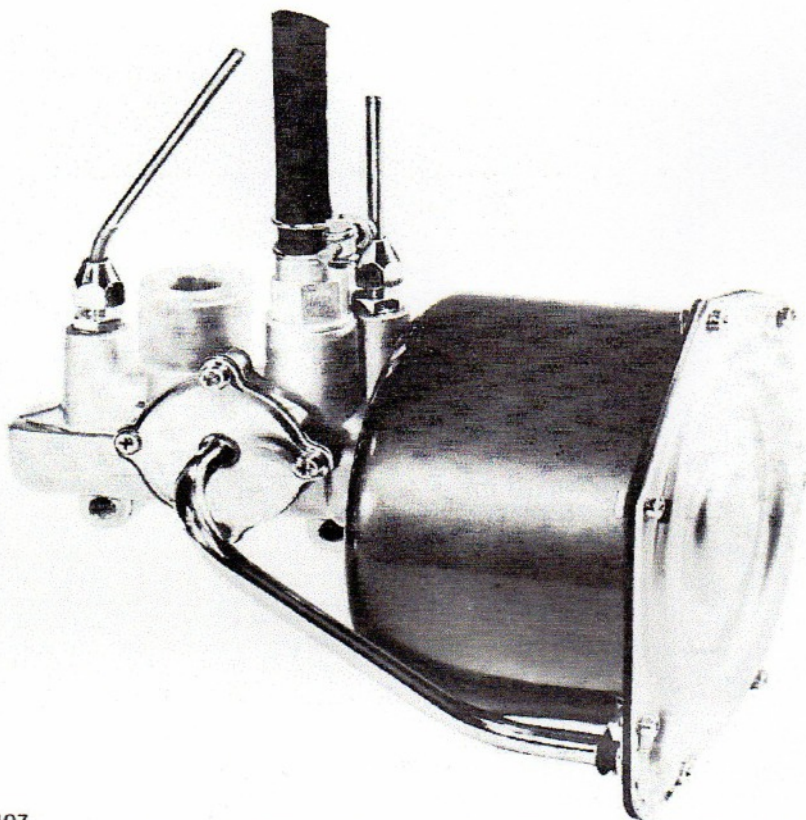
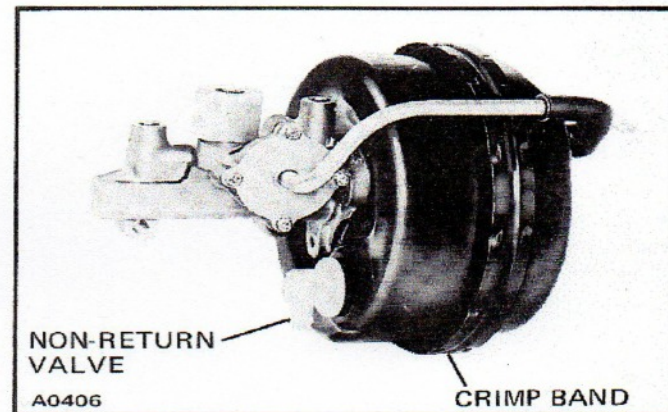
1 MK 2A SERVO UNIT

When replacing a Mk 2A unit with a Mk 2B unit, as the illustration shows, the two units are slightly different in shape and therefore minor modifications may be necessary on some installations. The changes fall into two categories:-

The vacuum hose connection on Mk 2B units is in the vacuum shell and not, as with Mk 2A in the hydraulic body. It is therefore expected that the vacuum hose will need to be longer. A longer length of hose than the one originally fitted should therefore be obtained from your Girling distributor.

Because the crimp band makes the Mk 2B unit slightly bigger overall, modifications may be necessary on some installations. In some cases, the fitting of spacers between the unit and brackets, would make alterations to the brackets unnecessary.

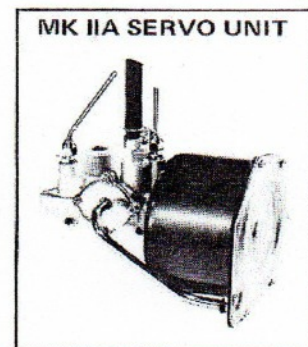
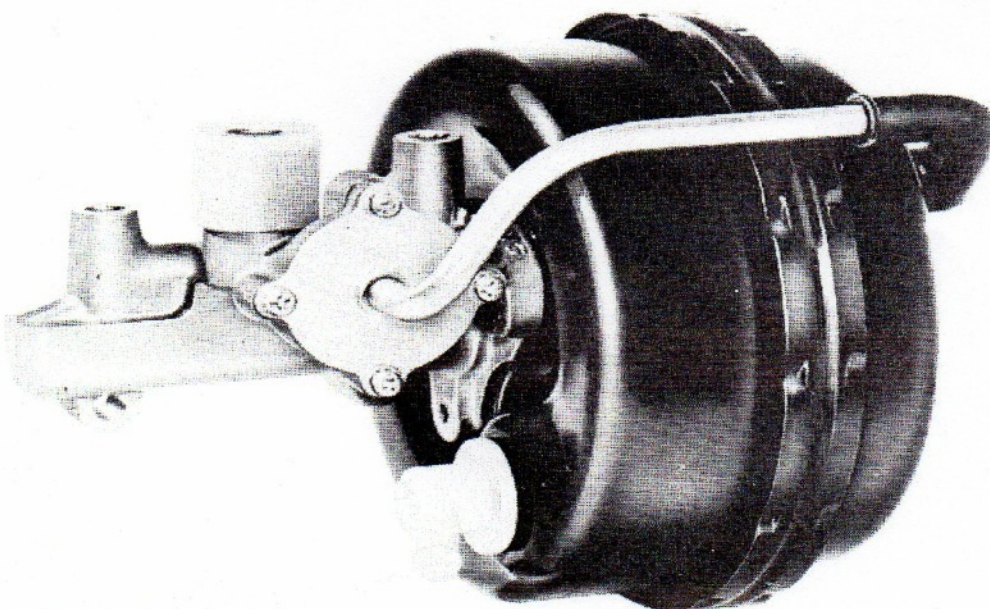
1

This manual page deals with the Mk 11B Hydraulic Servo Unit and Powerstop, which superseded the Mk 11A. The external differences between the two units can be seen from the illustration (Fig. 1). Internally the basic design is unchanged but small improvements have been made and these are (1) operational 'clonk' has been eliminated by the anti-knock output piston, (2) the vacuum piston has been replaced by a diaphragm and; (3) the vacuum connection is now in the vacuum chamber and not the hydraulic body. The design of the vacuum chamber and the retaining band, which holds the two halves of the shell together, makes the outside shape slightly different but, with few exceptions it is expected the Mk 11B unit will eventually replace the Mk 11A in service.

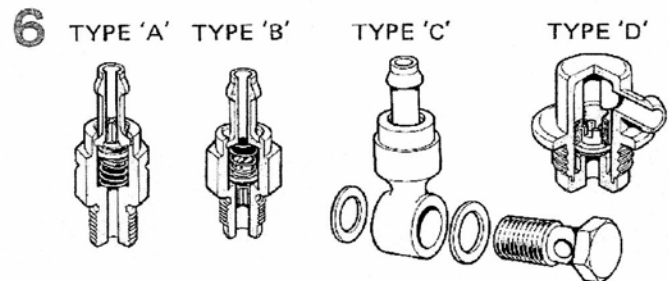
in the tank or servo unit so that power operation of the brakes is possible for a limited period, should a vacuum failure occur. Fig. 6 shows the types of non-return valves in use: Type 'A' screws directly into the engine manifold; Types 'B' and 'C' are usually fitted in the servo body of Mk 11A units; and Type 'D' which is a push fit in the rear shell of the unit and may have a straight or right angled nozzle. Type 'D' is white in colour so that it can be distinguished from the slave adaptor coloured red. If a red slave adaptor is fitted in the rear shell instead of a white type 'D' non-return valve, a non-return valve must be fitted at some other point in the vacuum line.

Type 'A' works in the opposite way to types 'B', 'C' and 'D' as the half ball, or plate valve, is in the opposite end of the valve body. The illustration shows the arrangement of the internal parts of types 'A' and 'B', and also shows the 'V' cuts in the hexagon body which identify type 'A'.

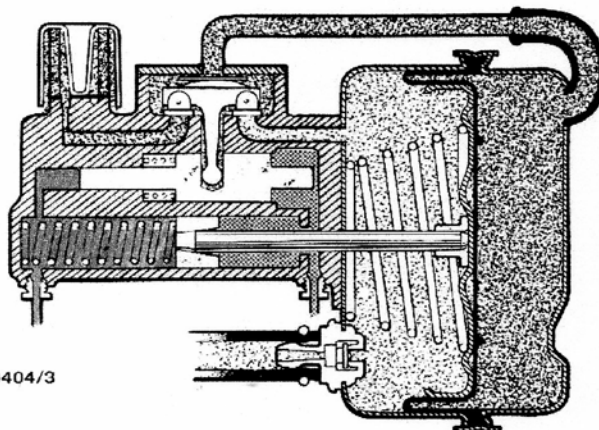
4 BRAKE HELD ON

If the force on the pedal is increased after arriving at the position shown on Fig. 4, the valve gear operates to give additional assistance from the diaphragm until the thrust on each end of the control piston is balanced or until the limit of available vacuum is reached. Conversely, if the foot pedal force is reduced the valve gear operates to reduce the pressure at the brake cylinders until again, a state of balance of the control piston is reached. The difference in area between the two opposed ends of the control piston determines the proportion of assistance provided by the unit. If, for example, the large end is twice the area of the small end, the hydraulic pressure output is built up to twice that of the input from the master cylinder before the control piston moves back to close the air valve. Such a unit therefore would have an output of twice the pressure of the input, throughout the range of the unit.

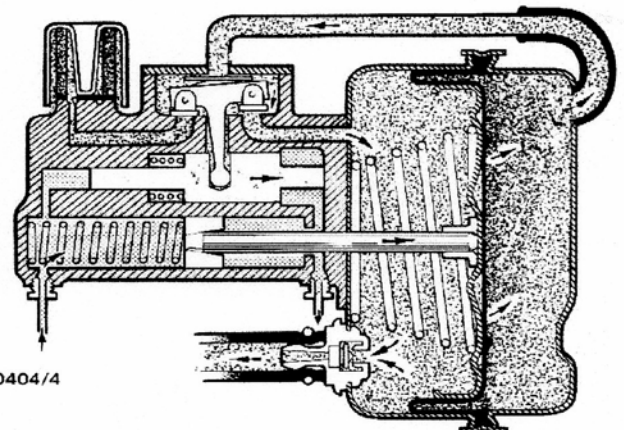
5 BRAKE RELEASED

returns and with it the output piston, relieving the pressure to the wheel cylinders as shown on Fig. 5. The piston sleeve lifts the ball and allows the fluid to move unrestricted between the supply tank and wheel cylinders.

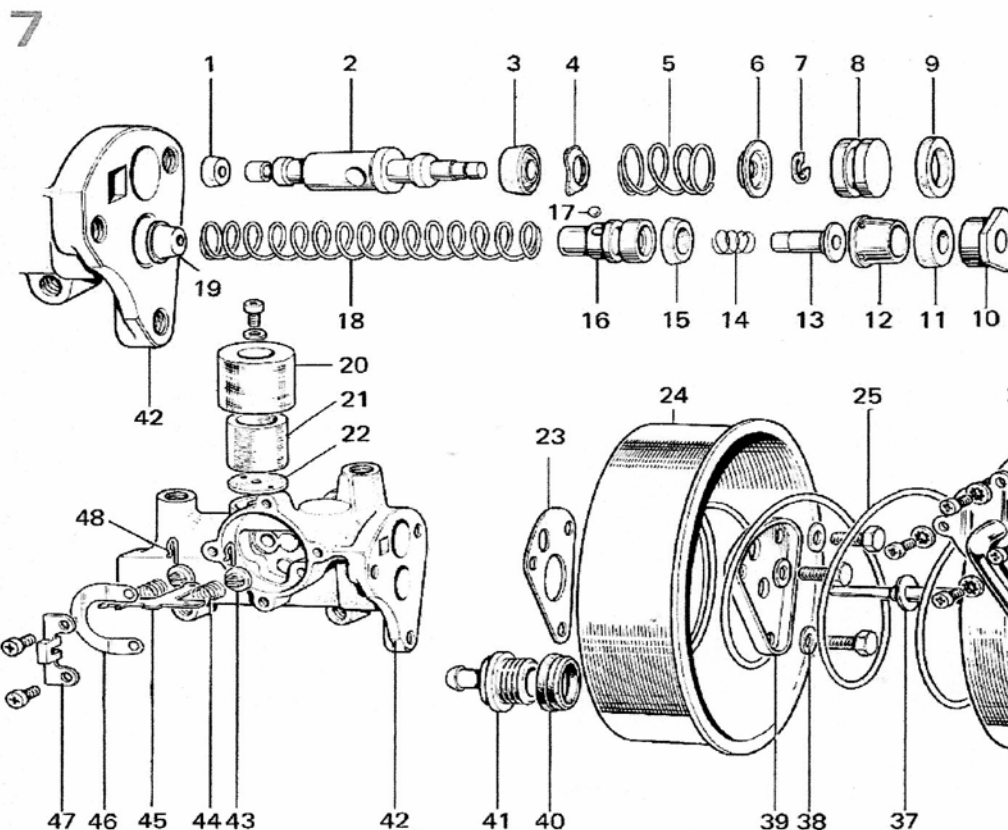
Listed below are the kits available to service the unit; the relevant parts contained in each kit can be seen on the illustration (Fig. 7).

KEY

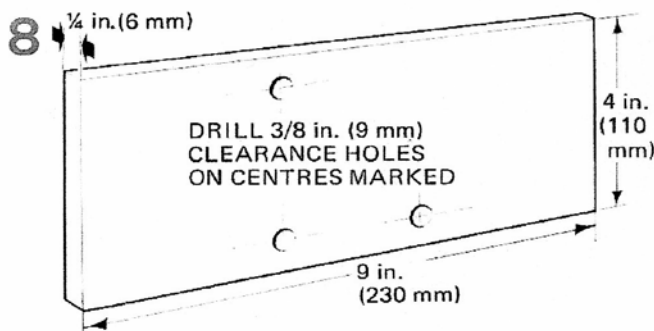
A support plate is required (Fig. 8) to dismantle and re-assemble the unit. If the unit is held in the vice by one of the body mounting lugs, damage to the lug may occur necessitating a new unit.

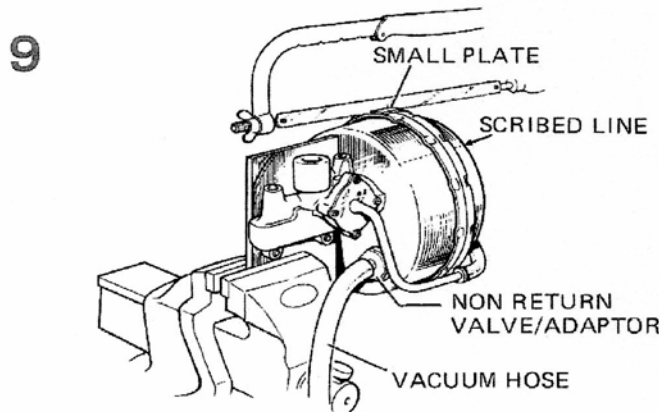
Bolt the support plate to the body and clamp the plate in the vice so that the small plate welded to the clamping ring is uppermost (refer to Fig. 9). On some units the plate may be in a diametrically opposed position on the clamping ring and the unit would therefore be in an inverted position to that shown on the illustration. Before commencing to dismantle the unit, scribe a line across the two halves of the shell adjacent to the small plate, thus enabling the shells to be re-assembled in the same relative positions.

gether. Cover or blank off the hydraulic ports to prevent the entry of filings and saw through the centre of the plate (Fig. 9) taking care not to damage the shells.

leading on the diaphragm plate. Re-position the unit in the vice in the manner shown on (Fig. 9) and place the new retaining band, with bolt and nut, loosely in position on the rear shell. Refit the vacuum hose to the non-return valve/adaptor. Fit the gasket and vacuum pipe to the valve chest and secure with the four setscrews and washers.

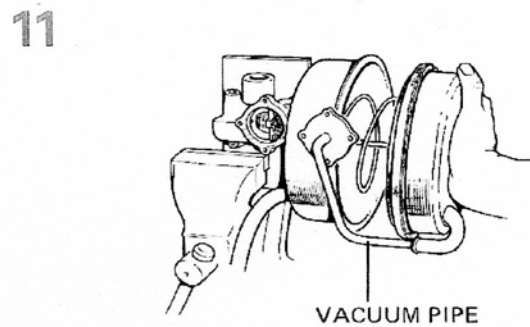
Lever the clamping ring from the shell with a screwdriver (Fig.10) and remove. To allow air to enter the unit and break the vacuum lock, loosen and remove the setscrews securing the valve chest cover. It is important to press firmly with the body against the front shell whilst using the hands to remove the setscrews with a Phillips screwdriver, otherwise the diaphragm return spring may cause the two shells to fly apart. Remove the front shell and spring (Fig. 11). Switch off the engine and remove the vacuum hose from the non-return valve/adaptor. Pull the vacuum pipe from the rubber sleeve. Lever the sleeve from the front shell with a flat screwdriver (Fig. 12), but first remove the support plug from the sleeve by inserting a Phillips screwdriver down the centre and levering it out.

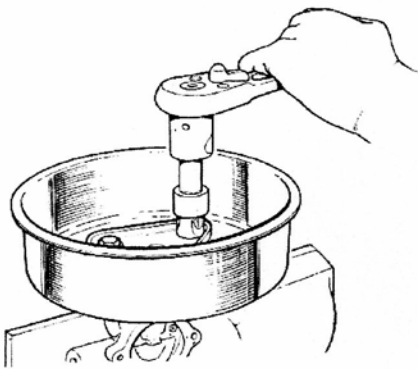
13

Re-position the unit in vice (Fig. 13) and unscrew the three bolts retaining the rear shell to the body. Remove the clamping plate with care as the output piston spring may eject the parts from the bore. If the parts are not ejected, withdraw the bush and hook out the piston rod gland seal when the output piston spring will then eject the anti-knock output piston, piston sleeve spring and ball; but provided care is used these parts will be caught in the rear shell..

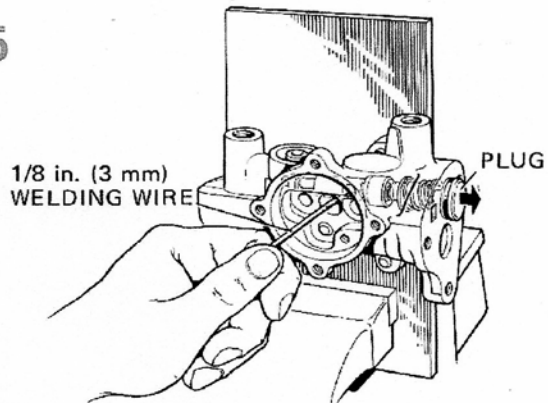
15

Insert a suitable bent rod into the hole in the control piston and lever the piston along to push out the plug (Fig. 15). Remove the control piston from the bore and compress the spring to remove the circlip, retainer and spring abutment. Remove the seals from the plug and control piston.

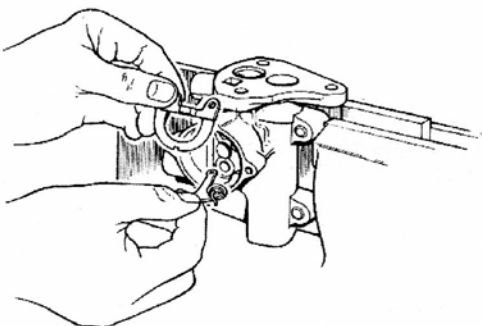
Unscrew the setscrews and remove the lever guide and spring plate from the valve chest (Fig. 14). Before the 'T' lever valve

Position the body in the vice as shown on Fig. 14 and lubricate the output piston bore and seal with clean, unused Castrol-Girling Brake Fluid. Fit the seal to the anti-knock piston so that the seal lips face the reduced end of the piston. Refer to Fig. 17 and with the rear shell in position on the body, fit the anti-knock piston and associated parts into the bore. Care must be taken to ensure the ball remains in the piston and does not drop down the bore. Until the clamping plate is fitted, the parts must be retained in the bore by hand pressure (Fig. 18). Position the plate and secure with bolts and washers. Remove the unit from the vice.

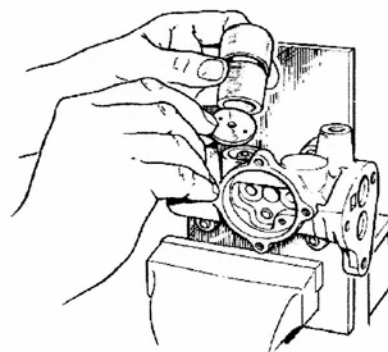
16

Unscrew the setscrew and remove the air filter and associated parts (Fig. 16).

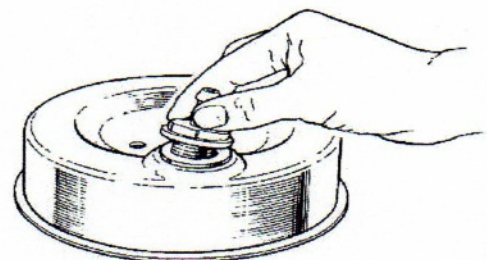
19

Fit the non-return valve/adaptor grommet (Fig. 19) to the rear shell. Lubricate the ribs of the non-return valve/adaptor with Girling Grease No. 64949009 and push fully home in the grommet.

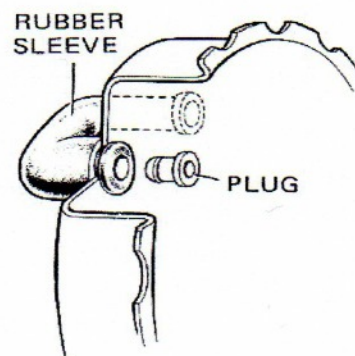
20

Fit the rubber sleeve to the front shell (Fig. 20) lubricate the plug with Girling Grease No. 64949009 and insert as shown.
