## **Case Study**

Chelsea Harbour, London.

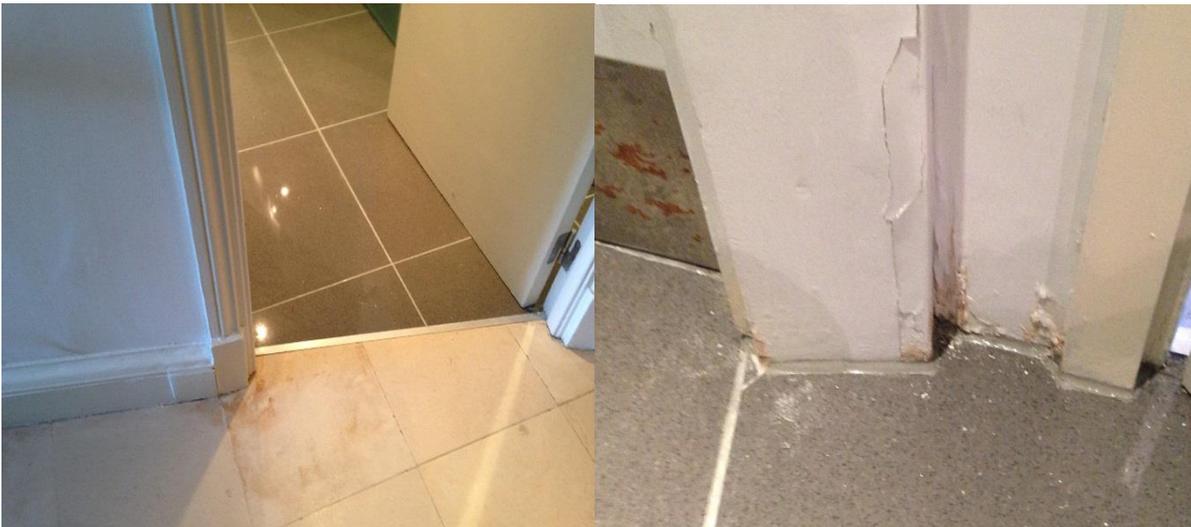
**Investigation by R E Spencer Ltd:** After carrying out thermal imagery and moisture mapping to the affected areas, it was identified that water had been coming from the bathroom shower due to a faulty seal within the shower cubicle.

The water from the shower had soaked the concrete slab under the shower cubicle and travelled through the slab into the kitchen and lounge area, causing damage to the internal stud wall of the kitchen/lounge and marble tiles to the lounge and kitchen floor.

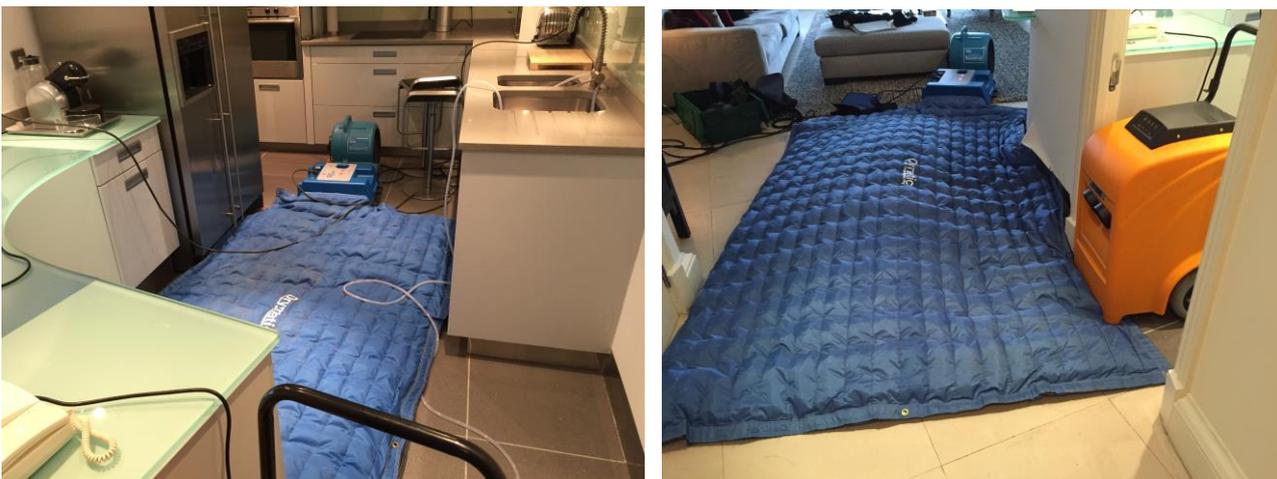
Following identification of the actual cause of moisture within the concrete slab, a specialist thermal target drying system was installed to remove the retained moisture.

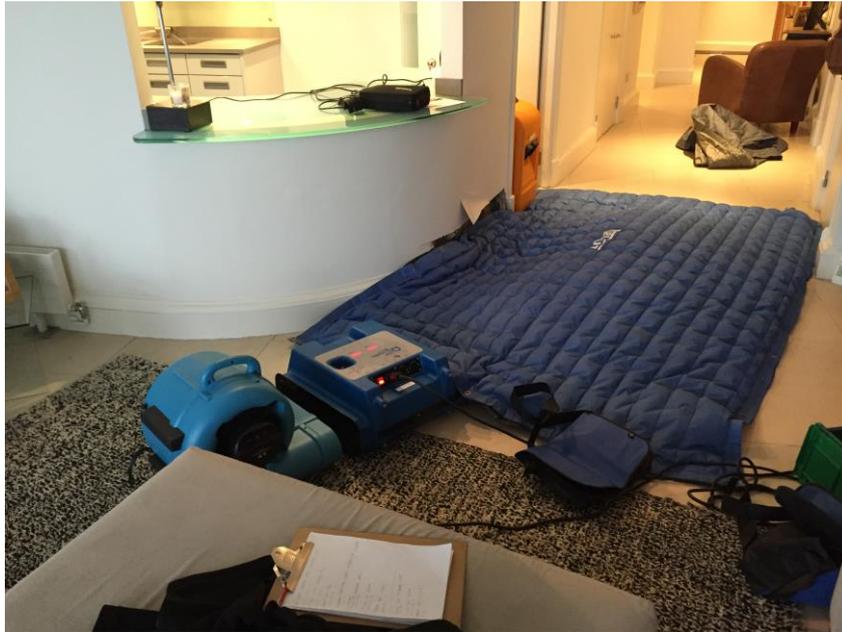
The floor was heated to 34c using a controlled heating process for a period of 15 days and then left to stabilise for a further 5 days.

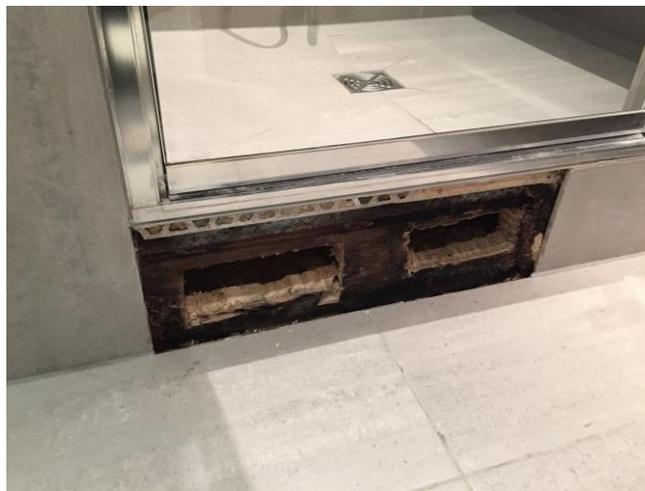
Testing of the floor was carried out after the 5day stabilisation period, the readings confirmed that the concrete slab and other affected areas including the area of concrete under the shower cubicle (cause of the water loss) were now all in a stable condition.
