Dear Member,

Howard Brewer (Secretary)  
31 March 2020

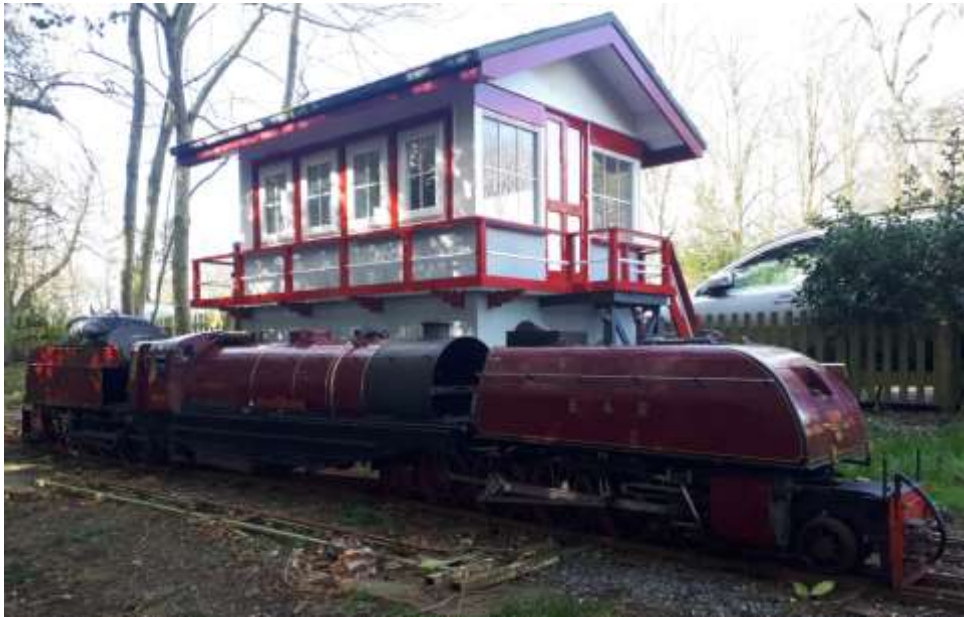
"On March 1st we finally got a break in the weather which enabled Phil to reassemble the last of the brake gear and rods on Mount Kilimanjaro. This marks the completion of the work to re-profile the wheel treads on all the locomotives wheels on both power bogies. There is some

plumbing to redo in the steam circuit which we were unhappy with following its steam test and first unofficial run, and the vacuum and air brake equipment to reassemble, but then we should be able to begin running trials. Many thanks for the work that was carried out by the two Phil's which has helped me immensely." Photo: Edward Parrott

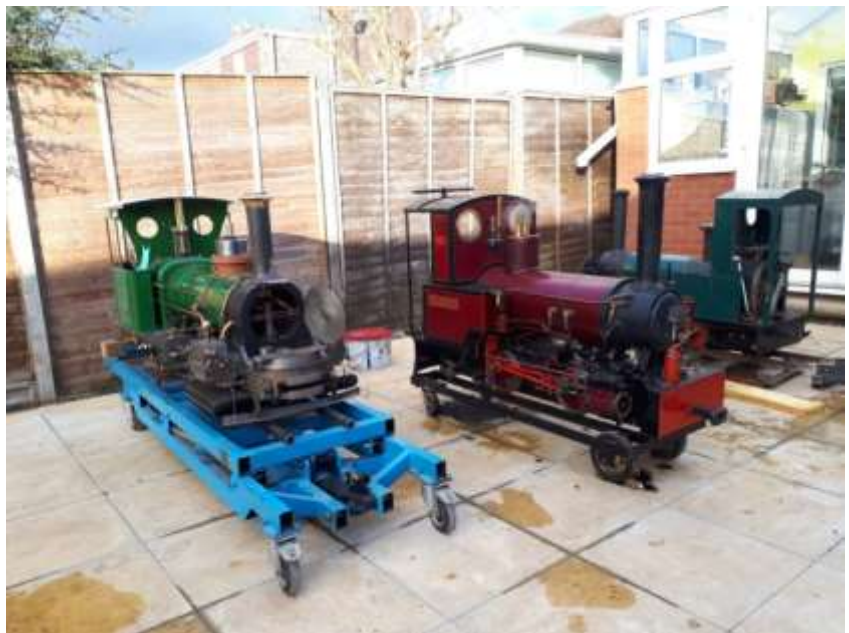
Photo: Edward Parrott

"March 1st and a boiler testing session. Members will recognise the Romulus "Myglyd" which was built by John Groom and is now owned by Edward Parrott, which has had its new boiler fitted and passed its steam test. There's a few finishing jobs to do but she will then be ready to re-join the public running roster in April.

New to the club is the second Romulus which belongs to Chris B. This has been bought as a complete unknown as a project from a garden railway. Having

had a thorough internal and external inspection by boiler inspectors Phil and Ed, it has passed a full hydraulic test, much to Chris' relieve! The loco requires quite a bit of work, but will hopefully join us for the 2021 season.

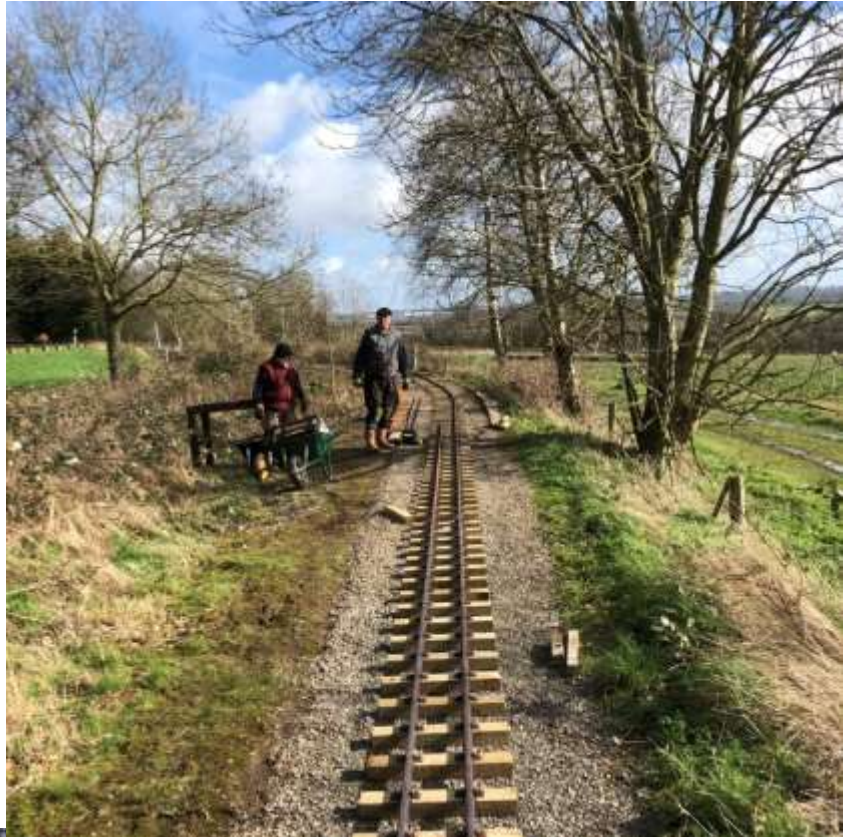
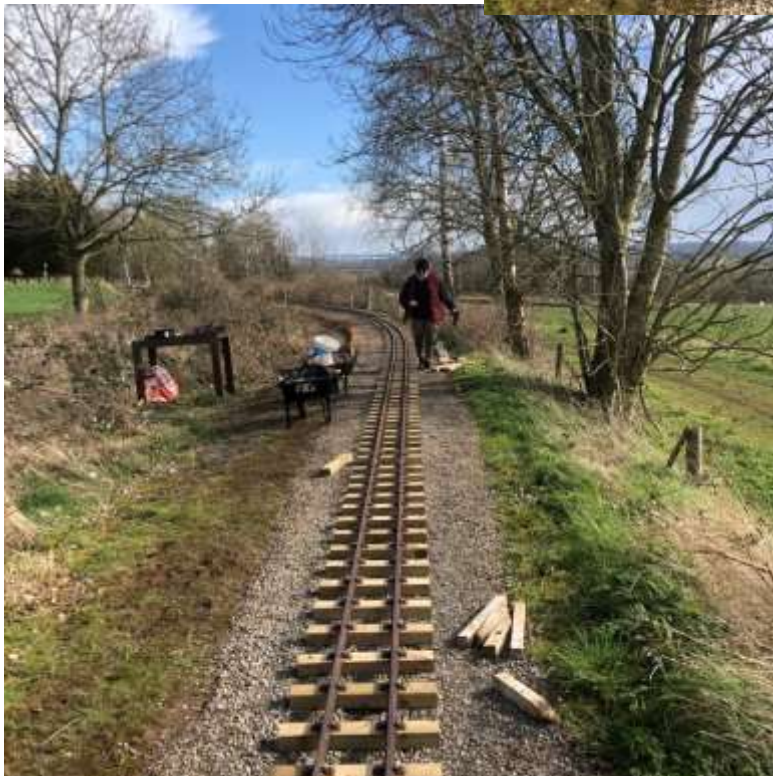
Work continues on the back straight to get our 'main line' back together! The photo below (taken on 1 March) shows the outer of the bend in final position with track gang members Tony and Rolf getting ready to bend the inner rails.

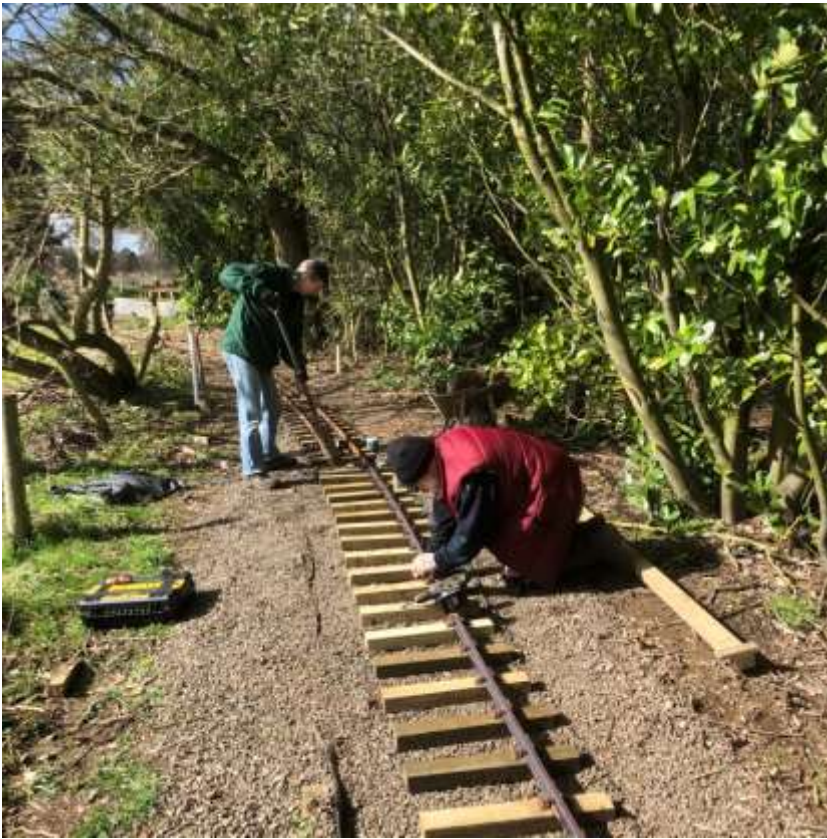
Next work session saw the inner rails bent and fitted in place on the sleepers as the photo shows.

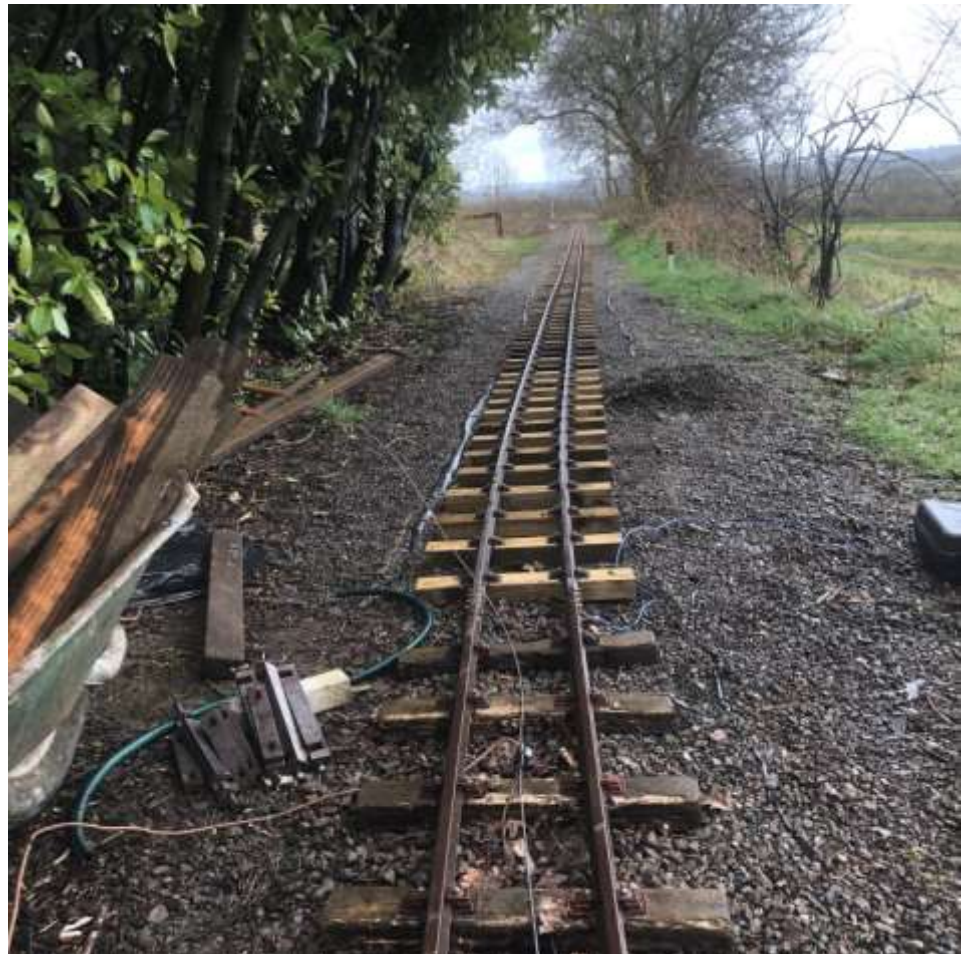
Fred Moon did a grand job producing more straight track panels for us and delivering them behind 'Rufus' and before long we had filled the remaining gap and were able to start on the final connection. The photo shows the gang at work making connection with the outer rail first, made even easier by the sunny weather!

Next work session saw the inner rail bent and the final connection made. Well done Tony McGeechan and his helpers!

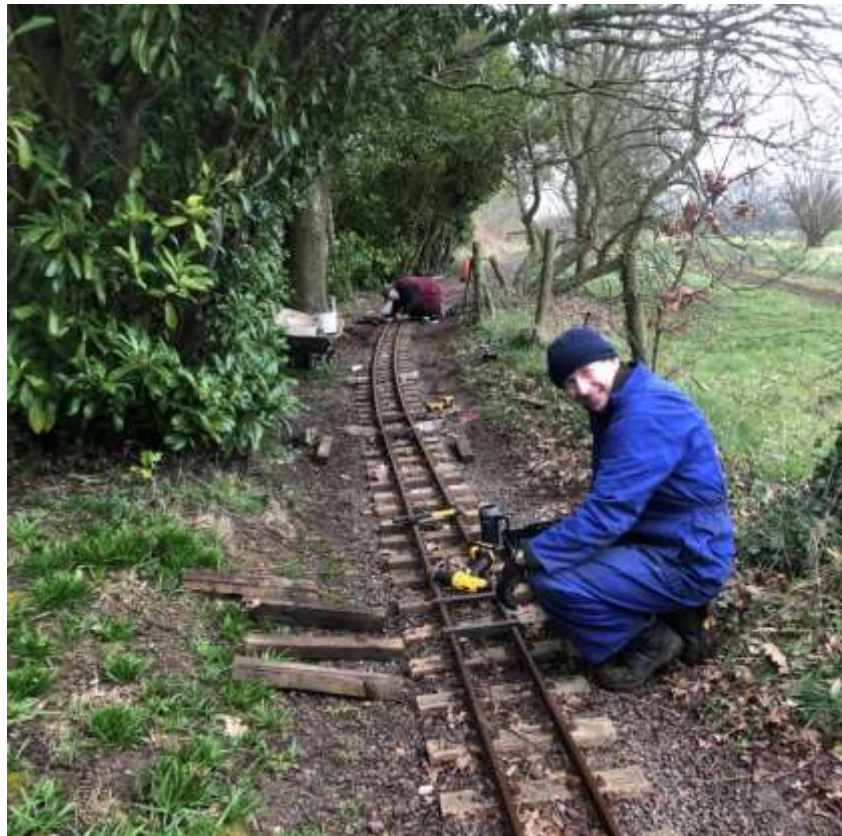
The track that we connected into was in a poor state and had to be corrected for level and gradient to match up with the re-laid track. This was lifted and packed temporarily as we did so many of the sleepers were seen to be in a poor state. So a session of re-sleeping of this section got underway. The gang members keeping their distance due to the Covid-19 precautions – see photo.

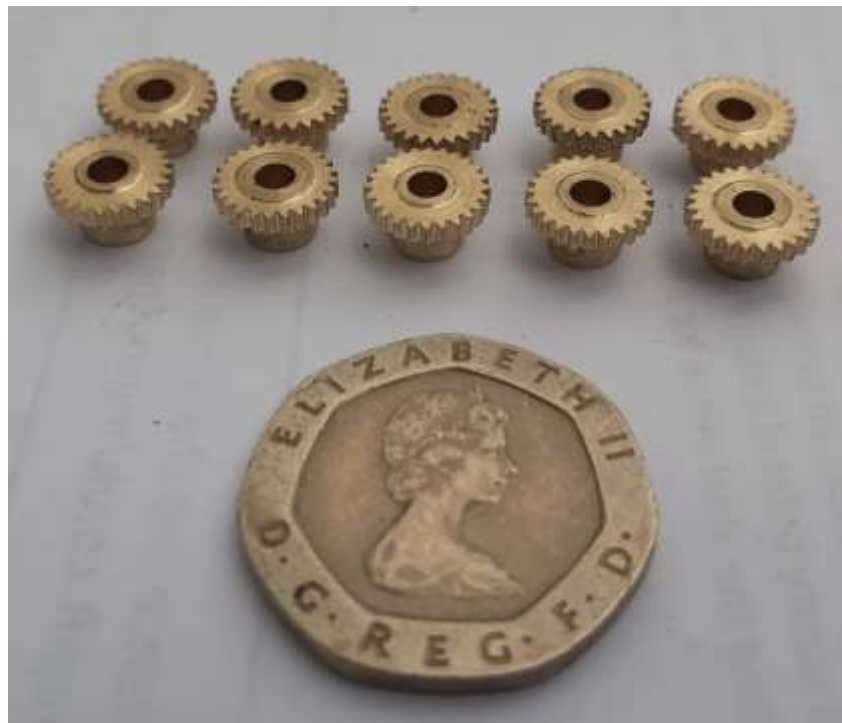
Photo: Geoff Broad

We had a request from a 00 gauge modeller who needed a very small gear cutting for an operating model of a container crane. Unfortunately this was a commercially made model and there are no spares for the plastic gear that was prone to splitting – you may remember the request a few weeks back. Both Geoff Broad and Fred Moon were up for the challenge, so Geoff was in contact with the modeller and after a sample was made in brass and tested OK, a batch of 10 were made.

Geoff did the turning and Fred the gear cutting (see photo). The gentleman was more than pleased with the result and has made a £100 donation to the club funds. Well done chaps!

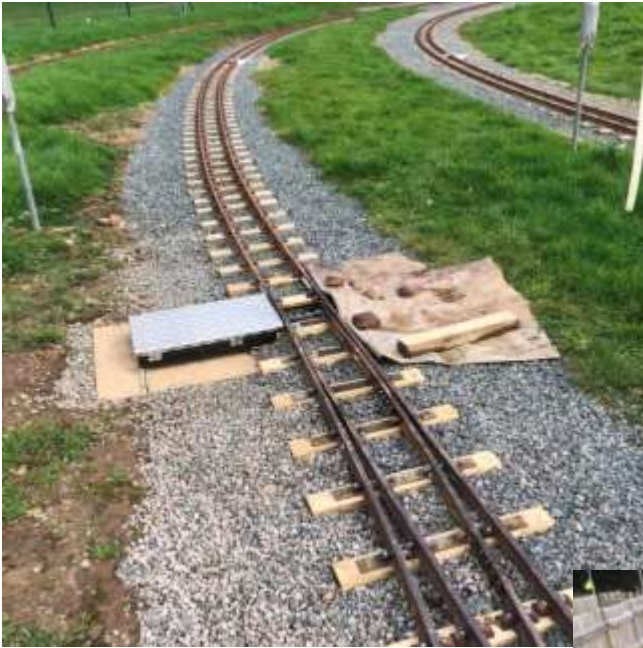
The work to complete the second crossover in the new station was well under way at the beginning of the month. The photo shows the point motor in place and final wiring and testing will need doing.

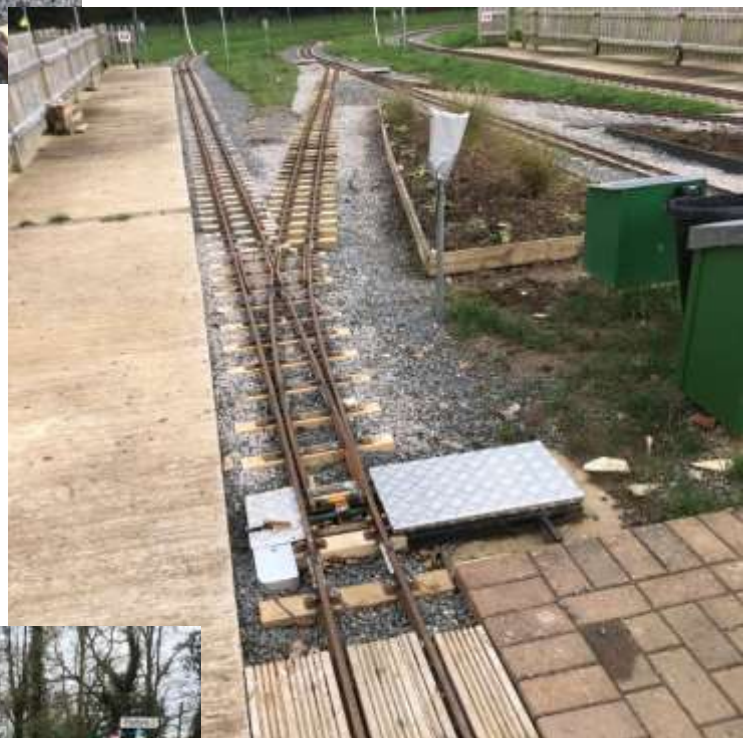
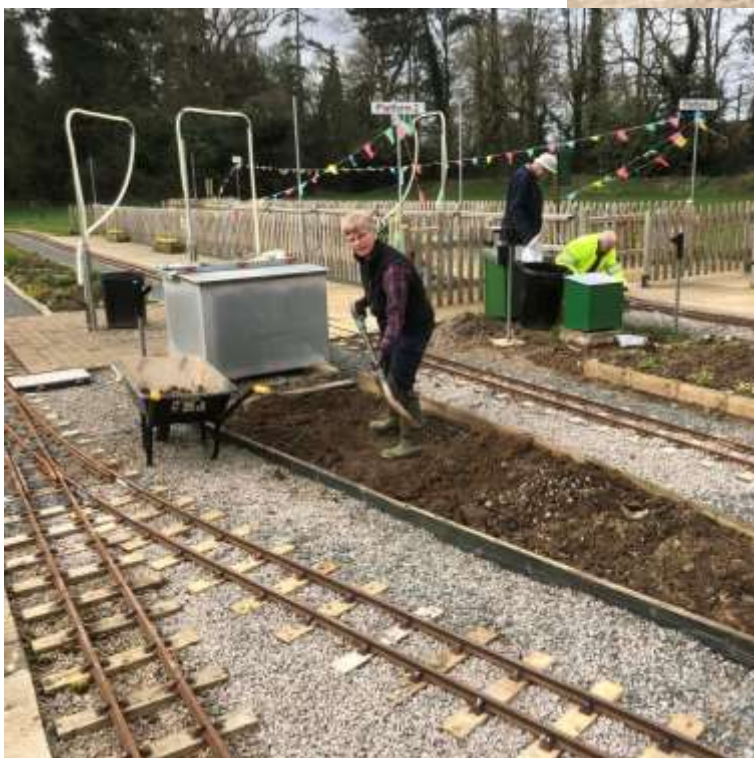
Another work session later and job done! The photo shows the completed crossover between platforms 3 and 2 with track ballasted and system tested. Well done to Mike Williams and his helpers!

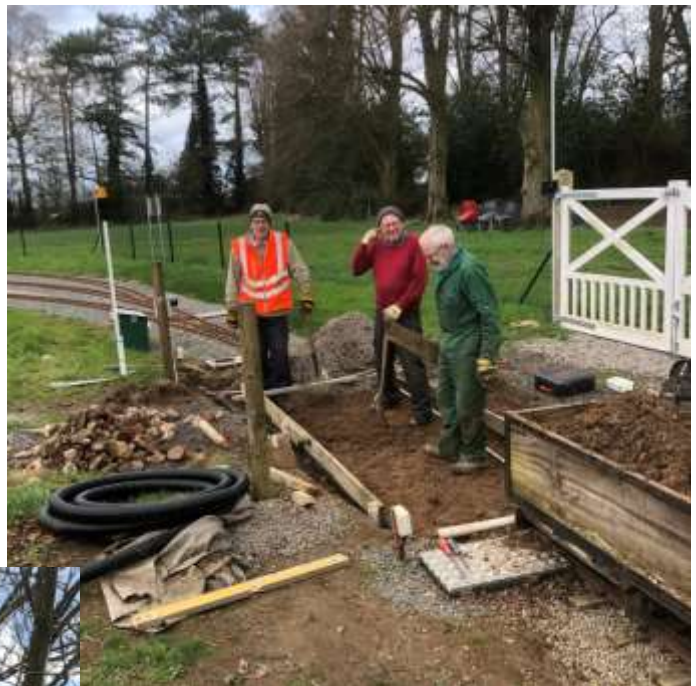
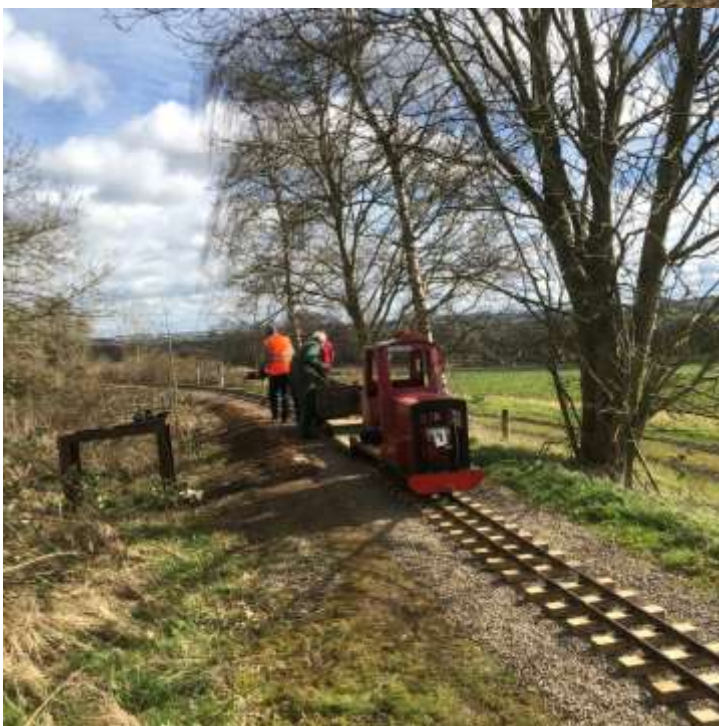
Photo: Edward Parrott

Edward informs me that Dr John is in the workshop to have worn out bushes on the side rods replaced. The driving crank pins were found to be very badly worn so the axle was removed and set up on our Bridgeport mill and the pins re-machined in situ. He hopes to have the loco back in service soon.

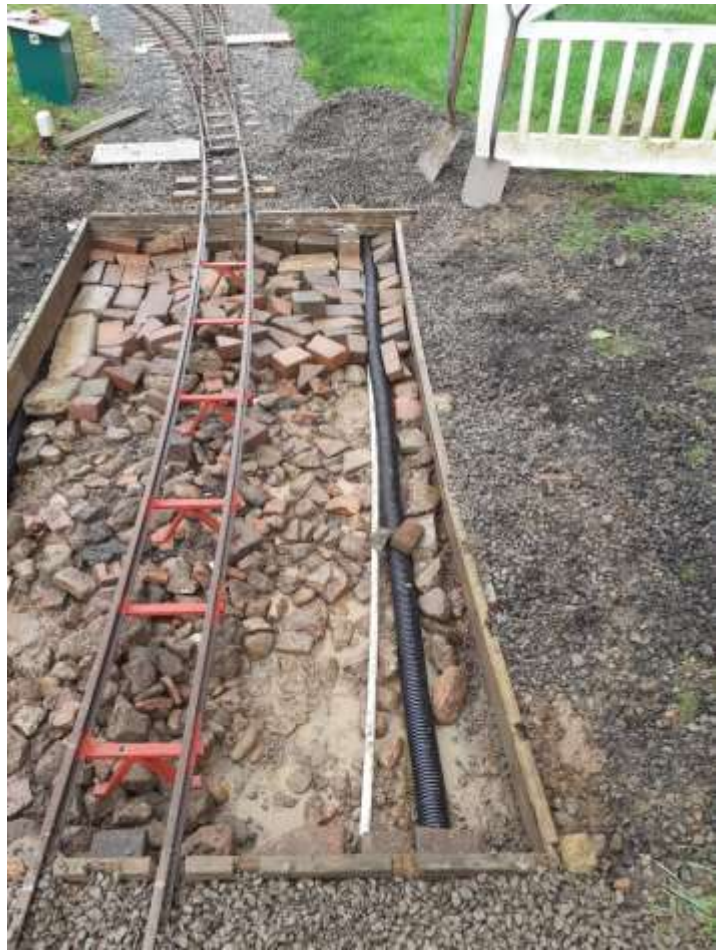
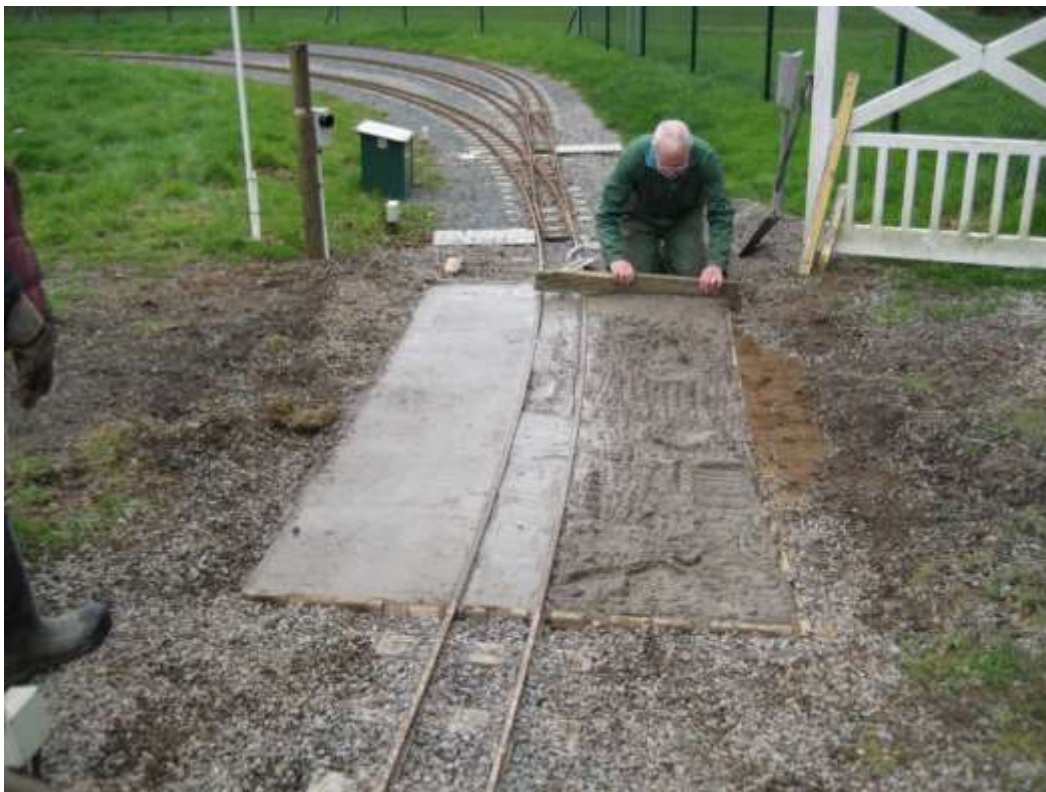
Photo: Geoff Broad

Work was also started on concreting the pedestrian crossing at the exit to the new station. Geoff Broad and his 'gang' started by excavating the area having first removed a rail section (see photo).

Meanwhile the removed section of track went into the capable hands of Fred Moon to weld steel 'straps' across the portion of rail that was to be encased in concrete. This was then re-installed as can be seen in the photo. Note the neat support legs underneath – thanks Fred!

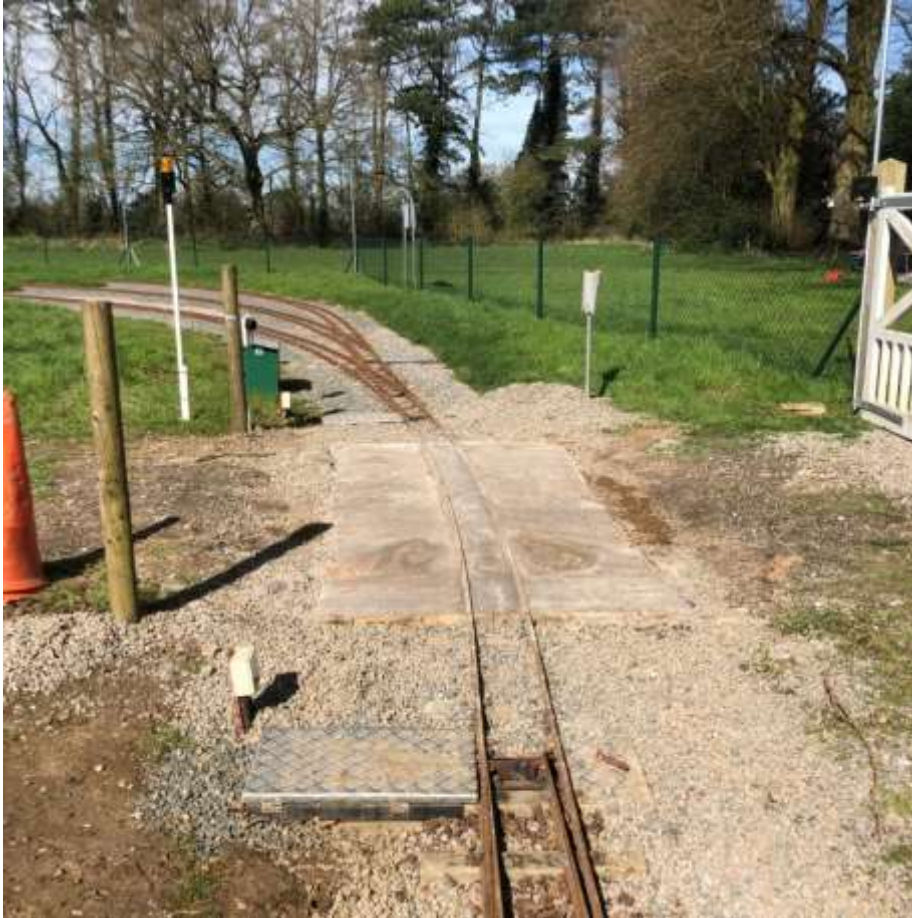
The next work session saw the concreting well underway with Geoff seen doing the laying and final finishing – well done all!

The completed crossing – the photo was taken at the next work session.

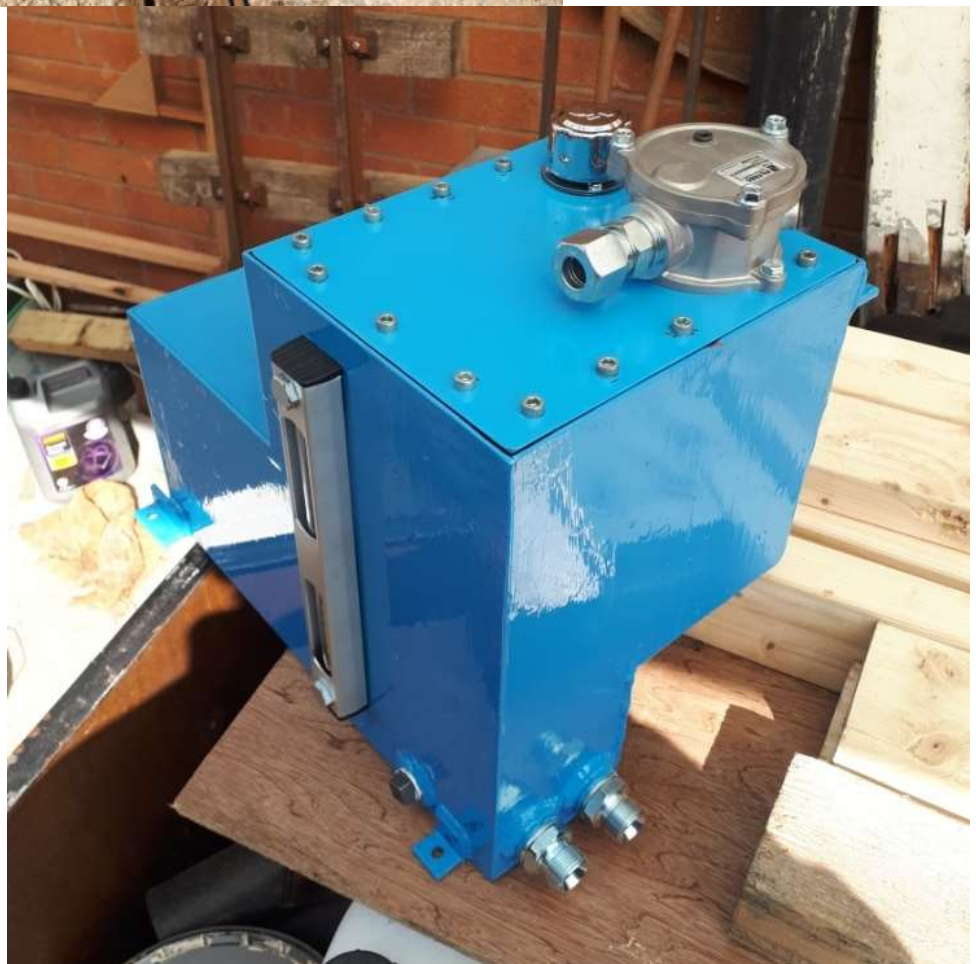
Photo: Edward Parrott

Edward has sent me a photo of the hydraulic oil tank for Criccieth Castle which is now completed with its fittings and painted ready to be installed in the loco.
