# Inspection Report

## Building Inspection

This report Complies with Australian Building Standards AS 4349.1-2007. Inspection of Buildings Part 1: Pre- Purchase Inspections-Residential Buildings- Appendix "C"

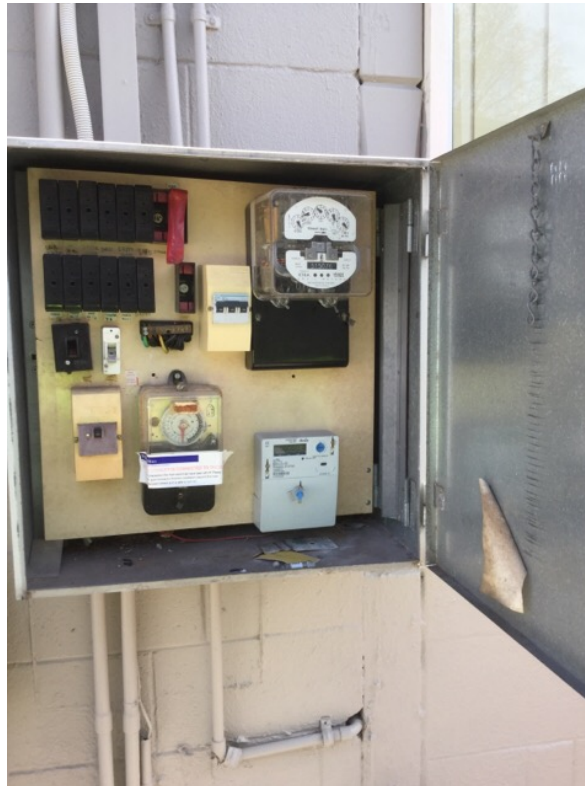
### Electricity

Electricity to the dwelling was connected. Note: We do not carry out electrical inspections for wiring or safety. This must be carried out by a licensed electrician and I recommend you have all electrical wiring and components assessed by a licensed electrician.

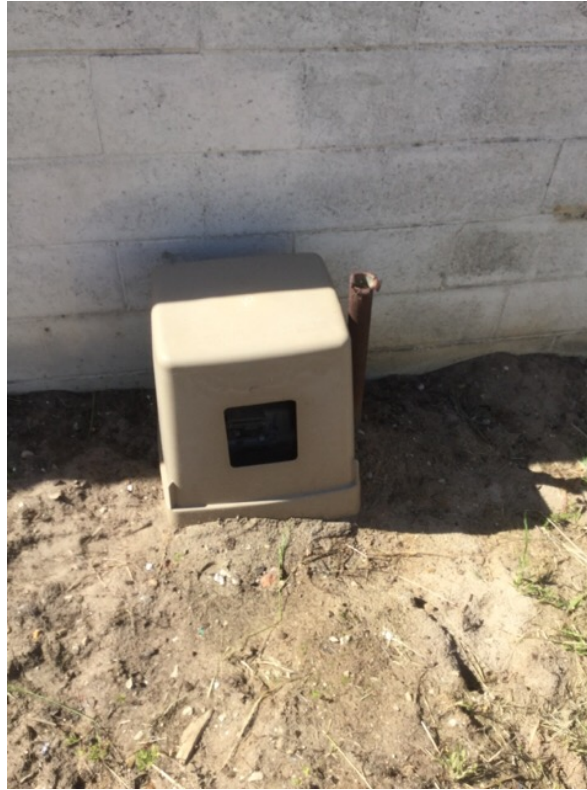
### Gas

Gas to the dwelling was connected. Note: We do not carry out gas inspections for safety. This must be carried out by a licensed gas fitter.

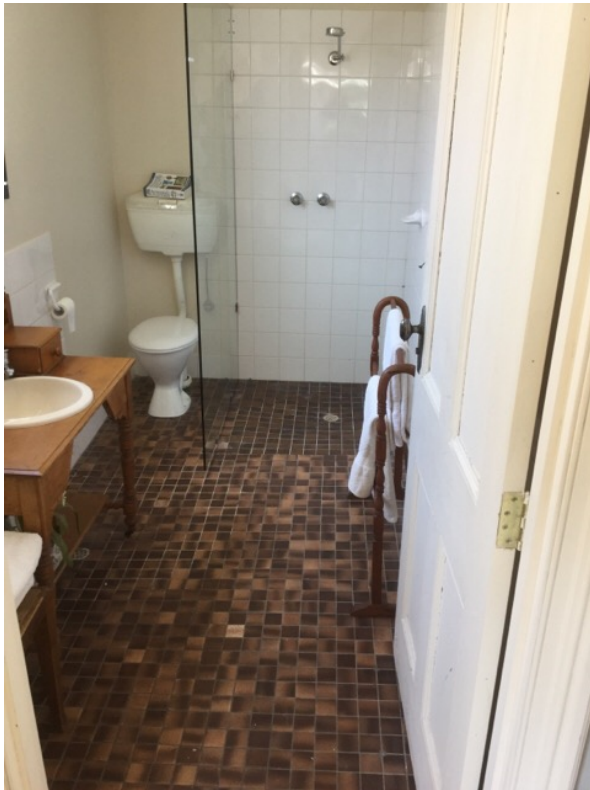
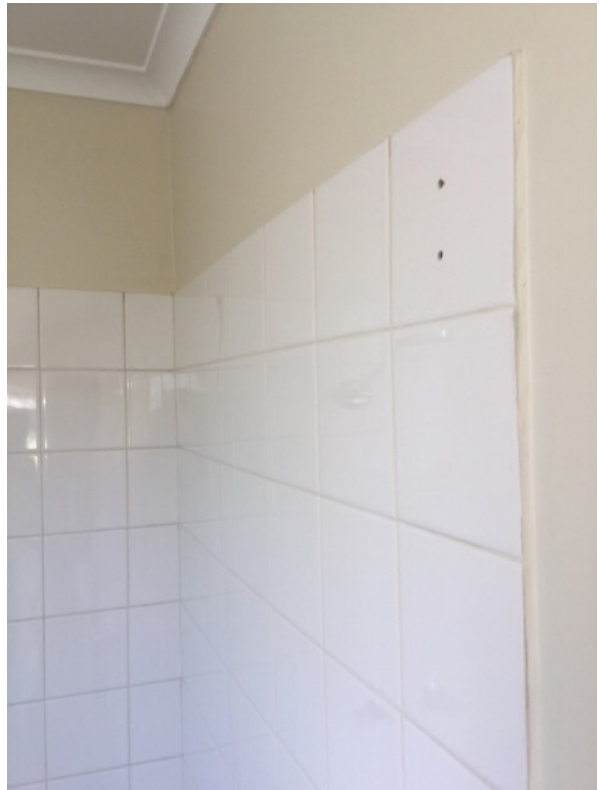
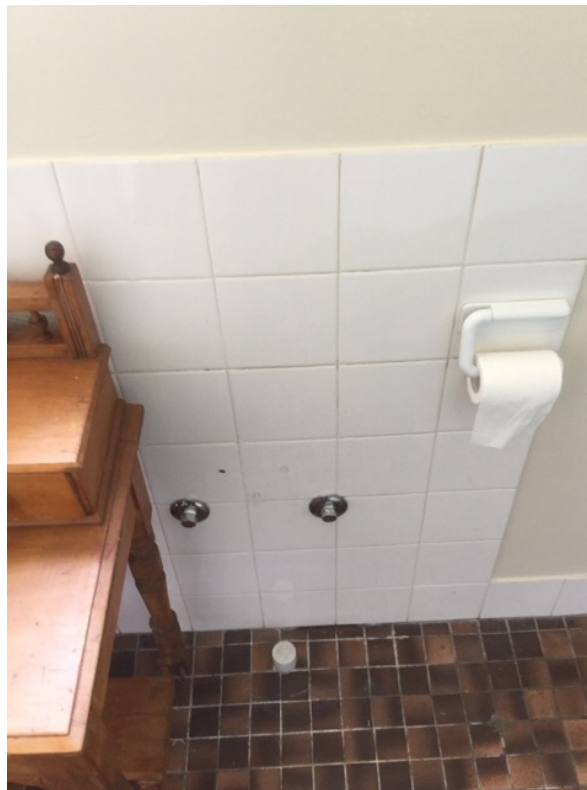
This area is in serviceable condition with no notable structural defects sighted. However it appears a converted laundry. Walls in shower are dry.

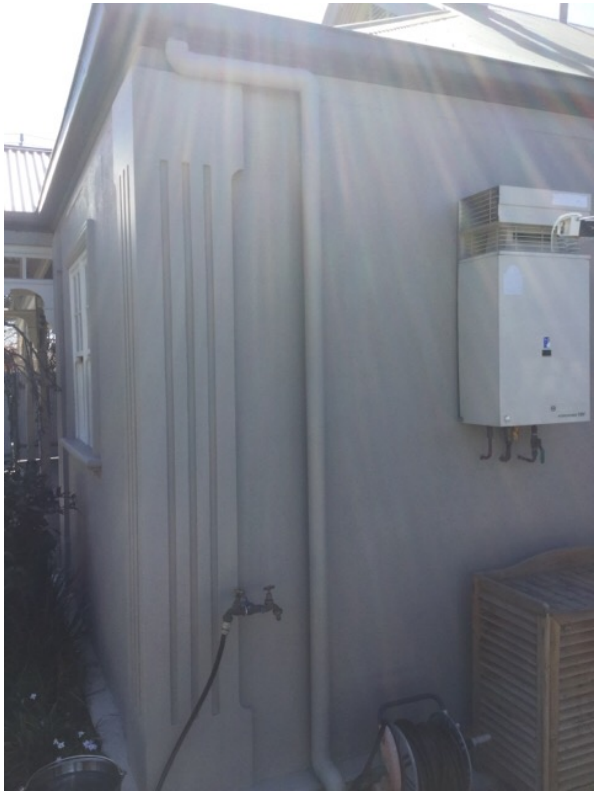
### **Down Pipe Findings**

On visual inspection no apparent defects were noted to the down pipes and are considered acceptable, however no comment can be made with regard to blockages , connections to stormwater or functionality in the absence of rain. Note: Periodic maintenance checks should be carried out for rust penetrations and leaks.

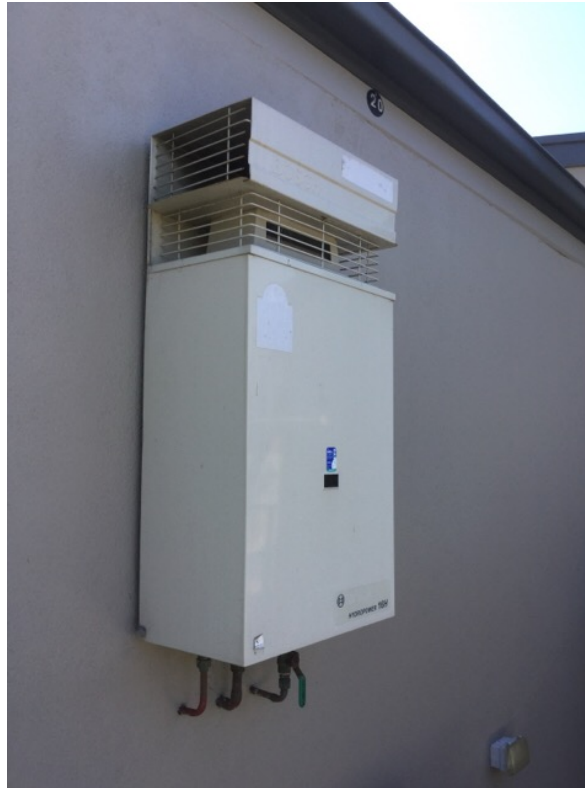
### Hot Water Unit Findings

The hot water system appears to be in a serviceable condition. No specific tests other than running the hot water from a tap was carried out. No determination has been made as to the suitability or adequacy of the hot water system in relation to capacity or otherwise.

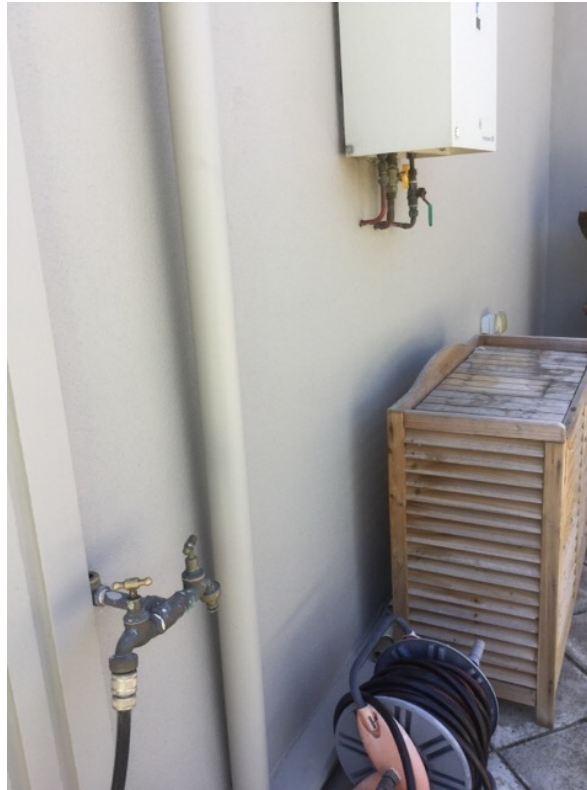
### **Plumbing Pipes**

On Visual inspection the external plumbing pipes appear serviceable, but should be checked by a qualified plumber.

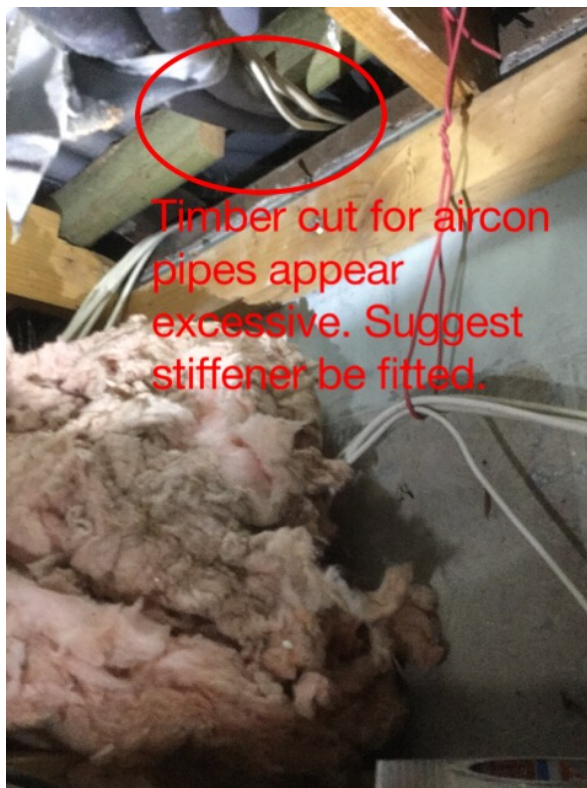
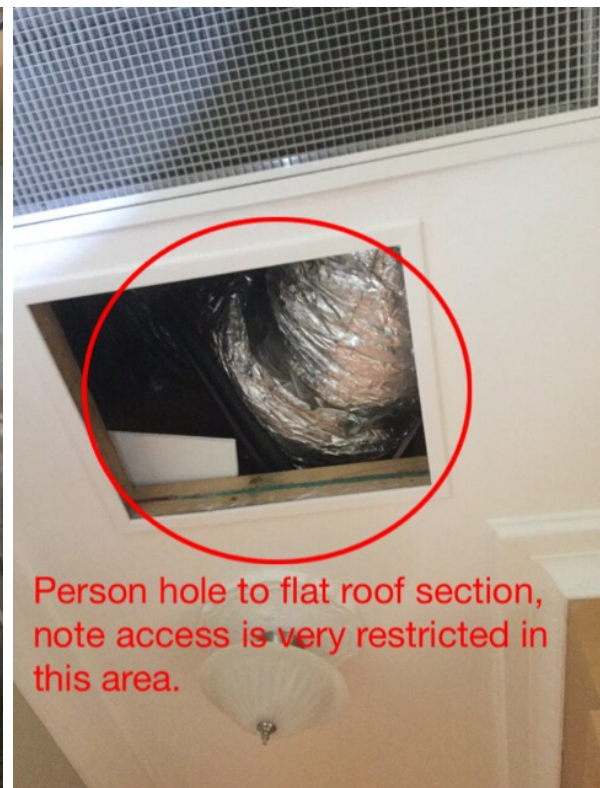
### Restricted Areas

Flat roof design - No crawl space. This is preventing a full inspection from being undertaken. It is strongly recommended that full access be gained as it could be harbouring timber pest activity, damage or defects.

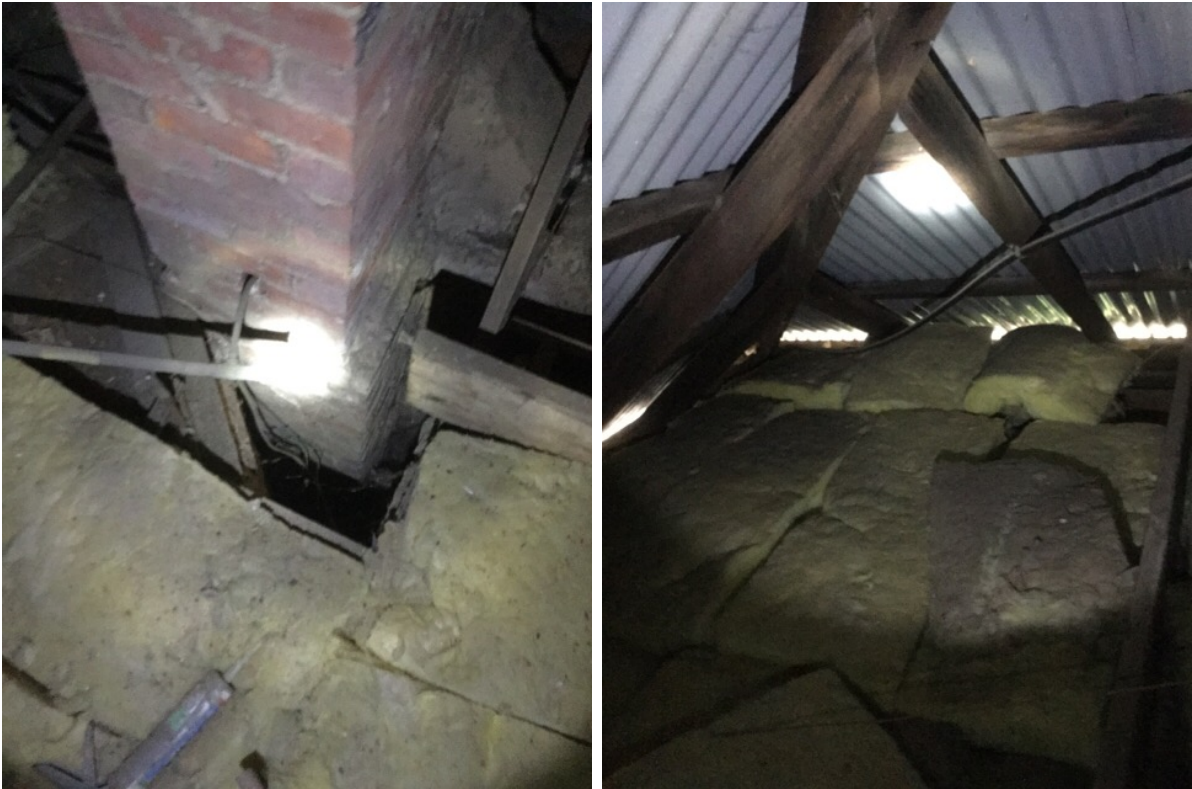
## Overall Condition

Visible sections of the roof void is in a serviceable condition for age of this dwelling.
