Residential Inspection Report

January 8, 2019

123 IBM St NW
Rochester, MN 55902

Home Doctors

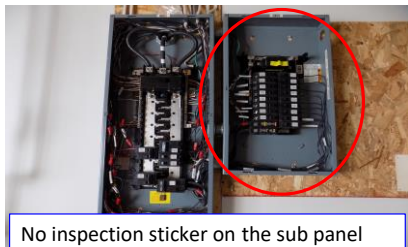
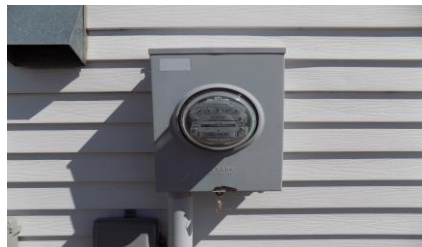
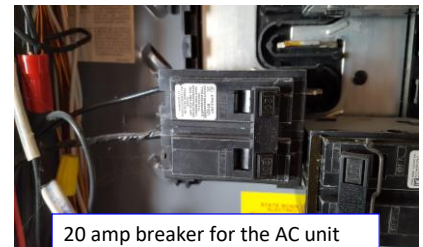
There is a questionable sub panel installed next to the main service panel - this sub panel does not appear to be inspected by the state. We recommend contacting the current owners for more information regarding this panel. We observed missing knockouts on the main service panel - this has exposed the bus bars in the panel. Open service panels pose a serious shock hazard to children. The current AC unit has a maximum breaker requirement of 15 amps and there is a 20 amp breaker installed for the unit.

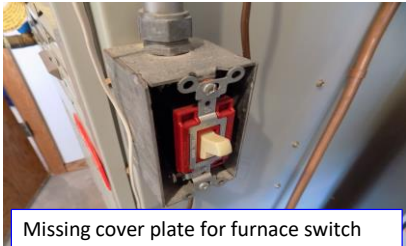
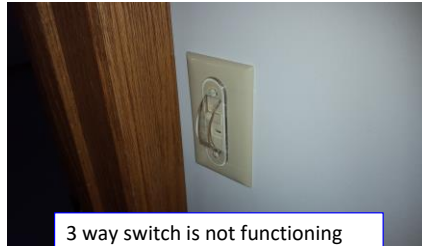
Observation: The furnace shut off switch is missing the cover plate. The 3 way switches that operate the light at the base of the stairs are not functioning correctly.

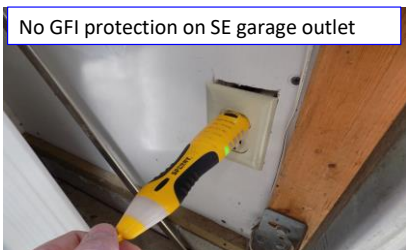
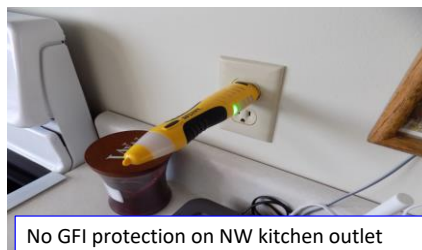
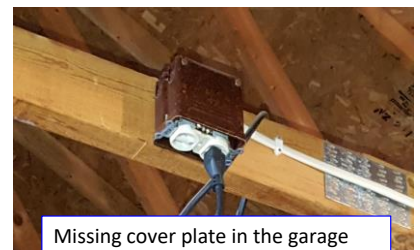
Observation: There is no GFI protection on the SE garage outlet and the NW kitchen countertop outlet. We recommend GFI protection in all damp areas. The garage door outlet is missing the cover plate.

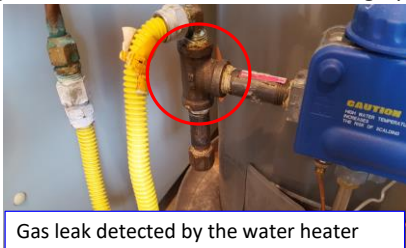
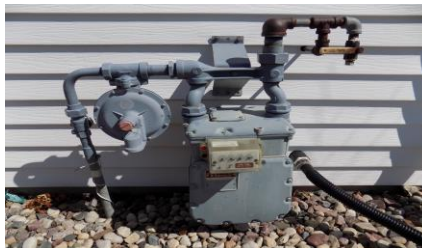
A gas leak was detected on the T fitting by the water heater.

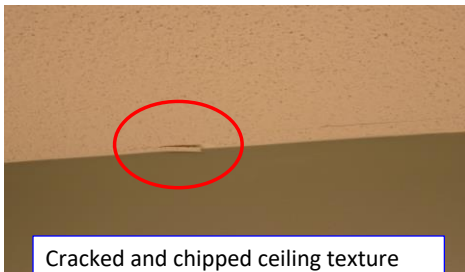
Further Comments: The living room drywall shows signs of minor settlement. The textured ceiling in the bathroom is cracked and chipped due to condensation.

Cracked and chipped ceiling texture

Recommend Minor Repair

Recommend a qualified Drywall Contractor

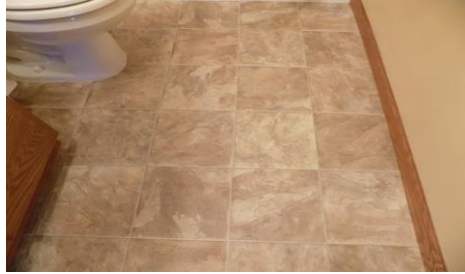
Further Comments: The upstairs bathroom has yellow stains in the floor by the toilet and the vanity.

Stained upstairs bathroom floor

Recommend a qualified Flooring Contractor

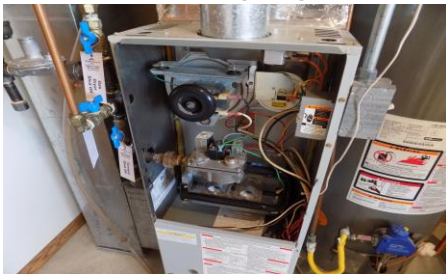
We recommend yearly service on all heating equipment and monthly filter changes. The furnace is beyond its expected service life. We recommend budgeting for the future replacement of the unit.

Recommend a qualified Heating Contractor

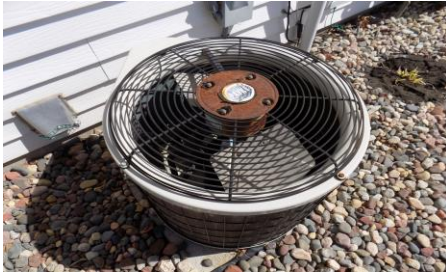
Testing AC equipment under 60 degrees can damage the AC condenser and cause liquid slugging. We recommend yearly service on all AC equipment. The AC unit is beyond its expected service life. We recommend budgeting for the future replacement of the unit.

Recommend a qualified Heating Contractor
