Inspection:

Date: March 22, 2019
Property 1 Sample Road
Address: Small Town, NY

GENERAL PROPERTY DESCRIPTION

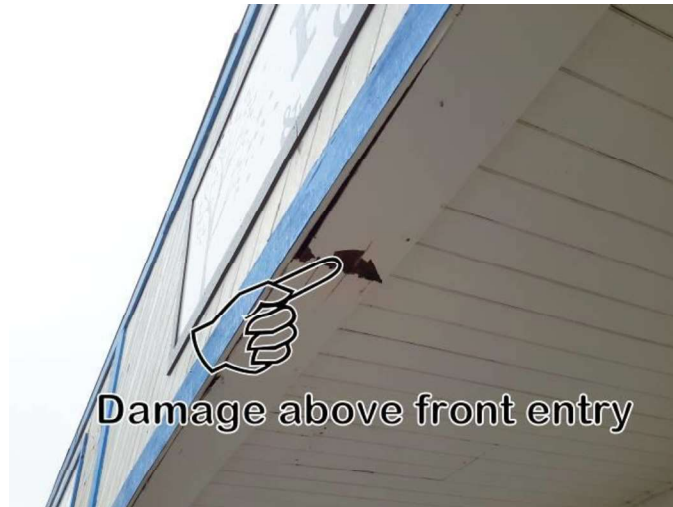
- There is a roof overhang at the front of the grocery area. We found weathered wood and damage on the exterior of this overhang. It is probably due to roof neglect. Repair is needed. It should be understood that there may be rot or damage in concealed areas, and you will need to make the necessary repairs if additional damage is found.

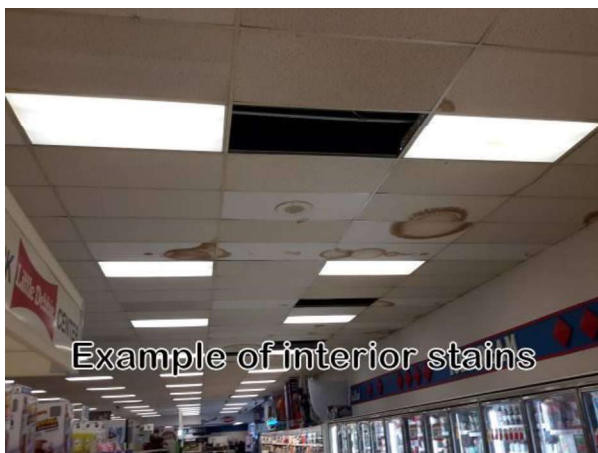
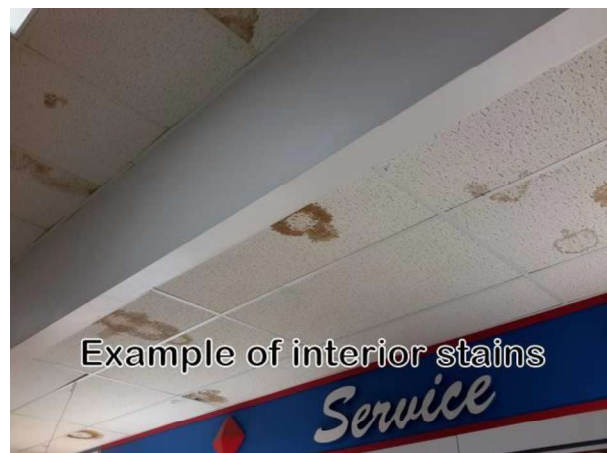
Interior stains

There are many damaged and stained areas on the ceiling surfaces. Please see the exterior portion of this report for further information regarding the roof. Ceiling stains can also be due to leakage in any piping above the ceiling. Active plumbing leaks were not found. These areas should be kept under observation over time.

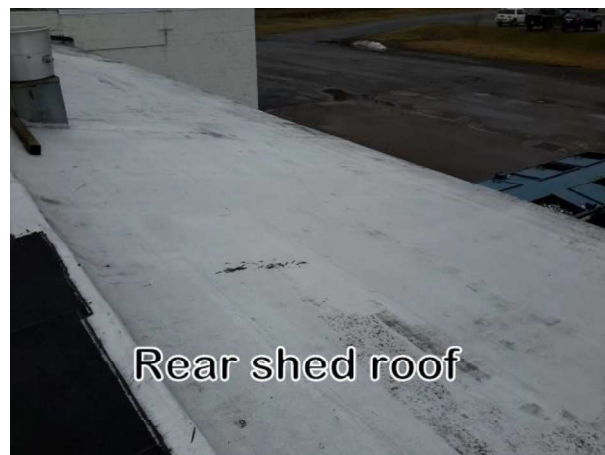
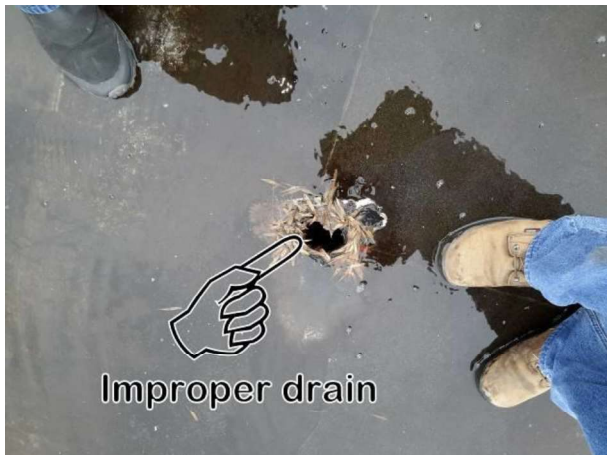
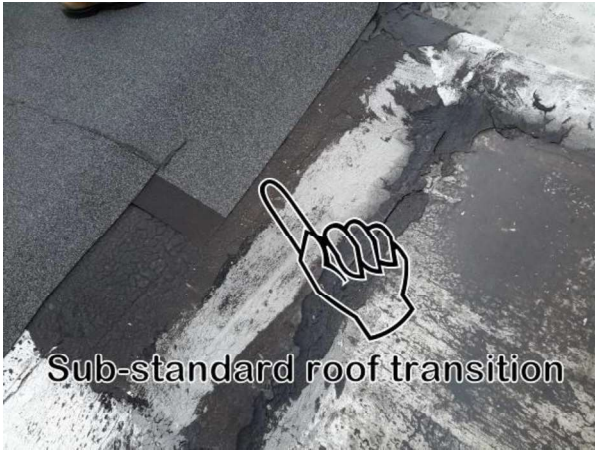
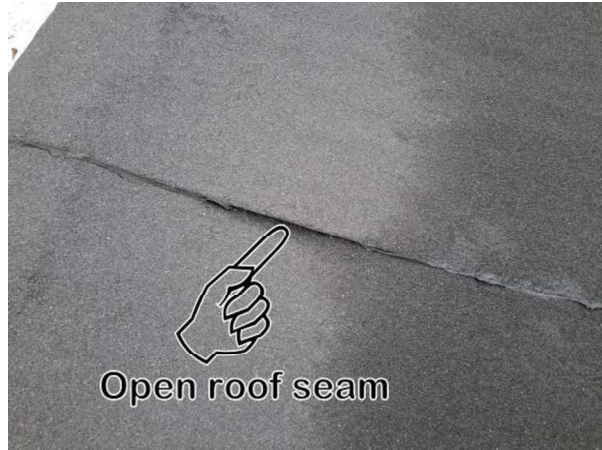
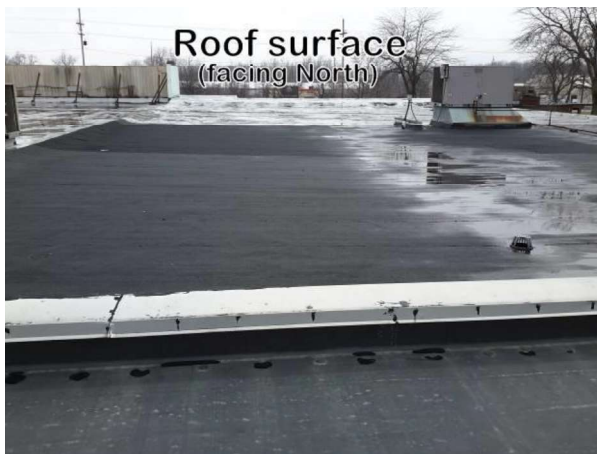
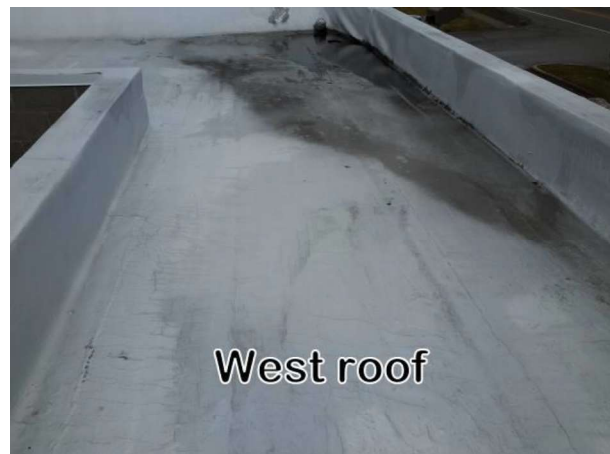
- Most modified bitumen roofs are intended to be coated. The coating protects the roofing from the ultraviolet rays of the sun. In this case, there are areas that were not coated, and there are areas where the coating is noticeably worn or loose.

- It is apparent that there has been a patchwork approach to roof maintenance. Various areas have been patched or repaired over the years, but it consists of simply installing additional roofing over the top of previous layers.

- There are a few soft spots in the roof, and there are areas where the seams of the roofing are loose. This was even found to be the case in the newer sections.

- There are areas where re-flashing is needed.
- We found puddles or various areas of standing water on the roof. Although this is not entirely unusual, these types of roofs are not intended to hold water for any extended period of time.

Otherwise, you must anticipate the need to replace the roof in the not too distant future. This can be a very costly endeavor. The exact cost can depend upon the number of layers of roofing, whether complete reinsulating of the roof system is found to be necessary, whether asbestos is found in the roof system, etc. You must budget for this significant expense.

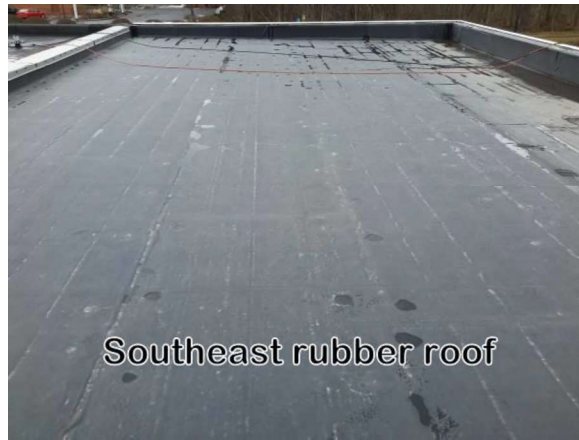
The small area at the Southeast section of the building has a modern rubber membrane roof. This roof was found to be in serviceable condition.
