Inspection:

Date: February 15, 2017

Property: 1 Sample Road
Address: Small Town, NY

Inspector: **Thomas D. Wurzer, P. E.**

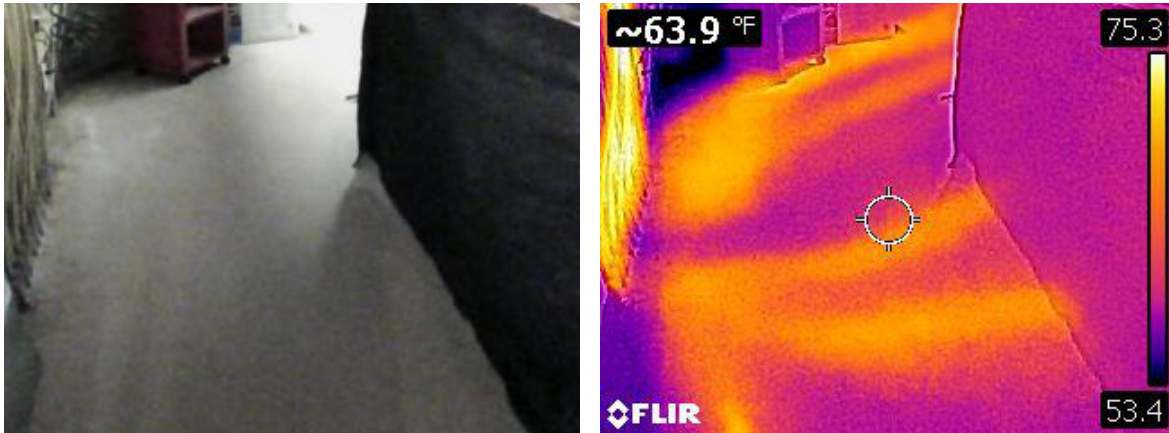
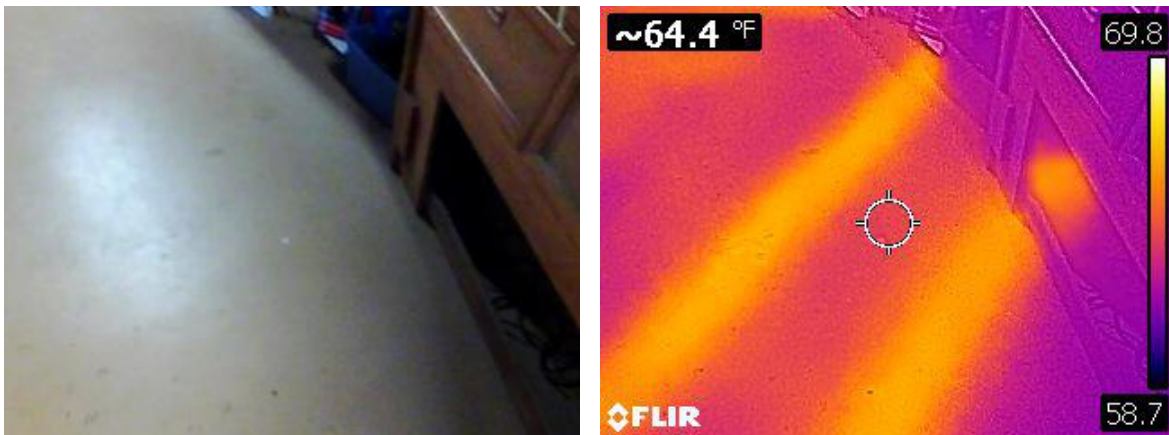
Radiant floor in the basement (thermal images show locations of under slab piping)

We noted significant corrosion on manifold piping of the radiant heating system, and related cleaning is recommended. If any leaks are found, repairs would be required. A missing temperature gauge should be replaced for this system and the compression tank is rusty and should be checked by a heating contractor.

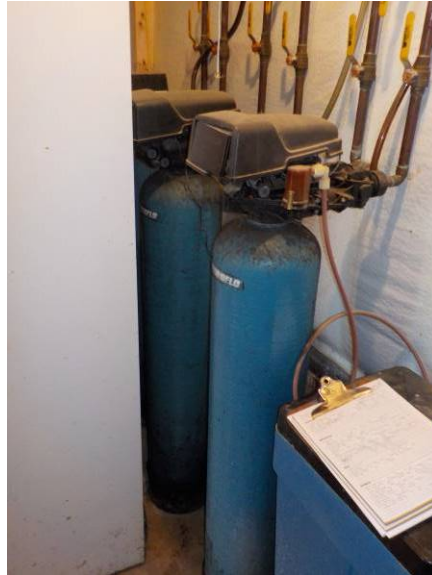
It is evident that the well water contains a good amount of minerals and requires a good amount of filtration and treatment. You may wish to have a water treatment specialist examine the treatment equipment and make recommendations on maintenance or improvements.

Water filtration equipment

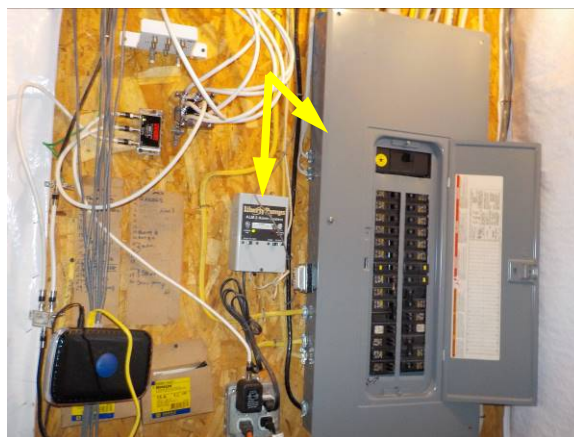
Main panel and septic tank alarm

Ground fault interrupter breakers in the panel, where found, were tested briefly and found to trip off and reset. GFI protection is recommended for wet and potentially wet areas.

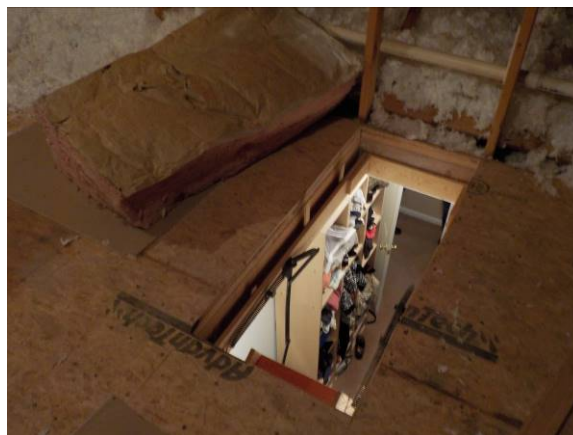
Attic access

Over the front bathroom shower the insulation has fallen out of place and this should be properly replaced to reduce heat loss. One should also maintain an insulated attic-side cover for the pulldown stairs of the attic to reduce heat loss. There is a storage platform in the attic. There are likely lesser amounts of insulation underneath the platform as compared to other areas of the attic. If one will not use this for storage, more insulation could be installed.
