Building Inspection Report

Inspection Date: 02/26/2016

Prepared By:
Napa Valley Home
Inspections
28 Blossom Court West
Napa, Ca. 94558

Report Number: 20161124

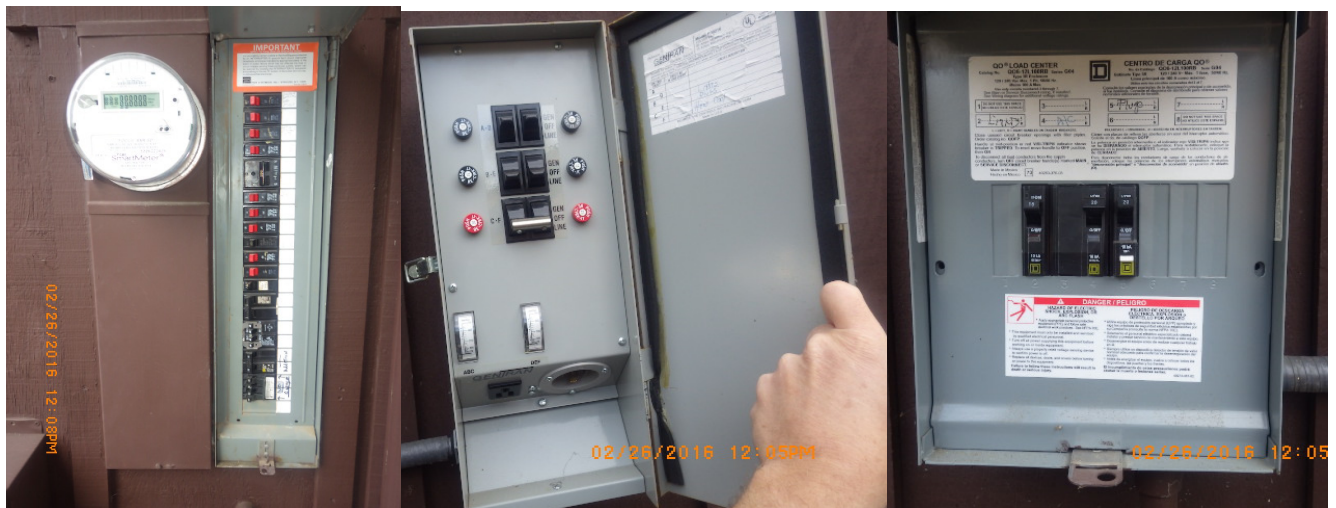
The size of the electrical service is sufficient for typical single family needs.
All 3-prong outlets that were tested were appropriately grounded.

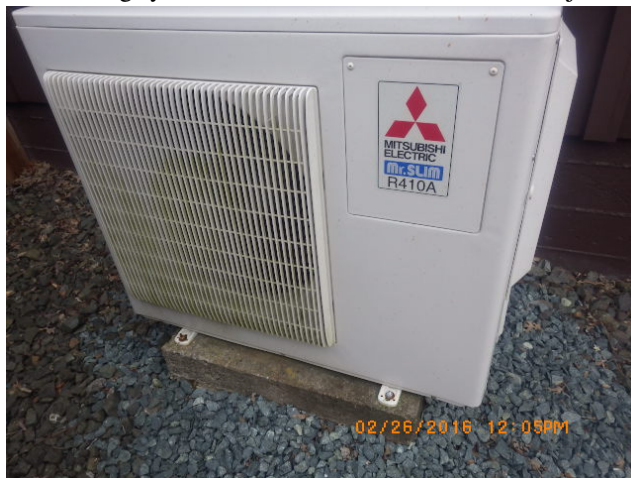
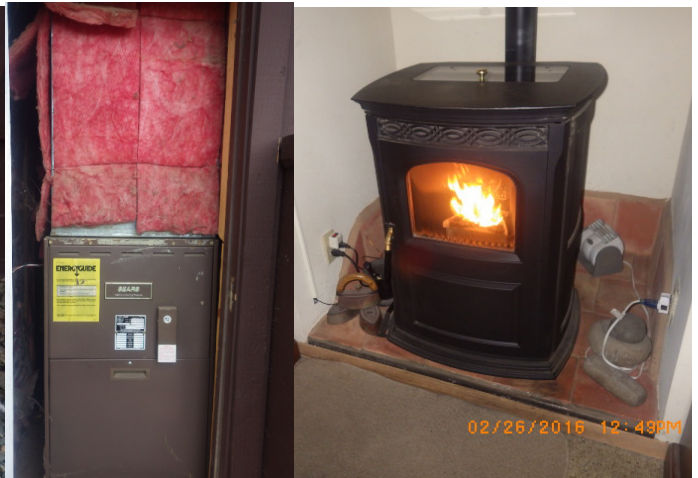
The heating system shows no visible evidence of major defects.

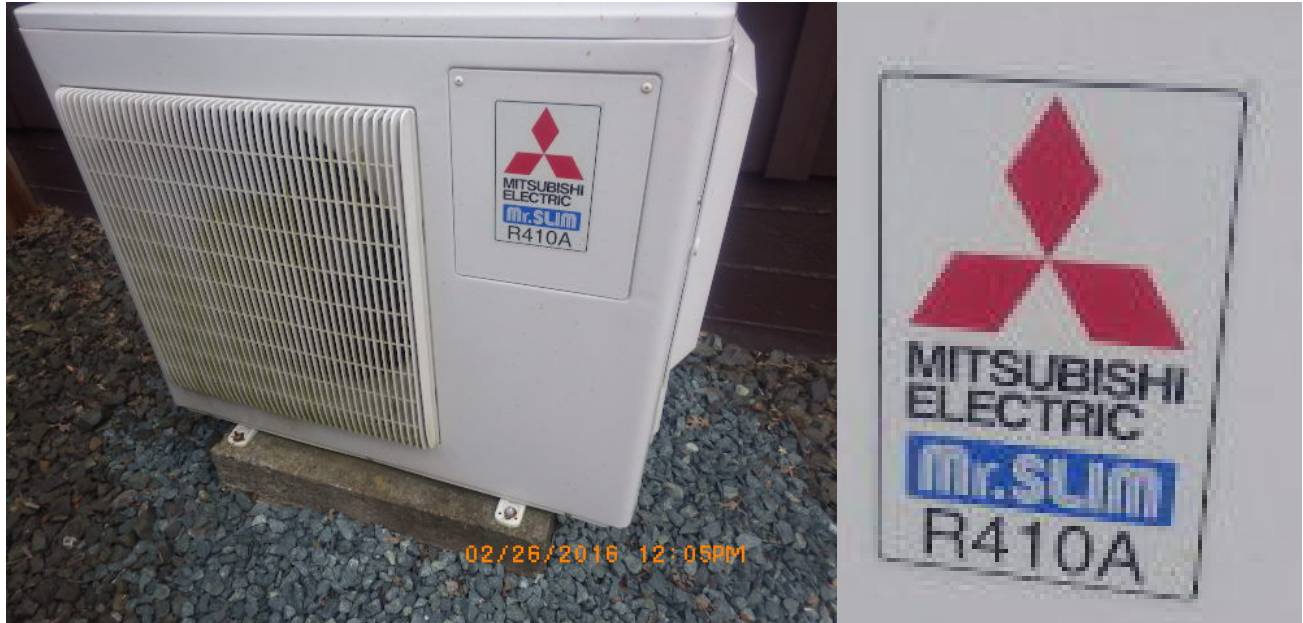
- The air conditioning system may require servicing in the spring to verify optimal performance. Air conditioners cannot be safely tested when the ambient overnight temperature is below 60 degrees F.

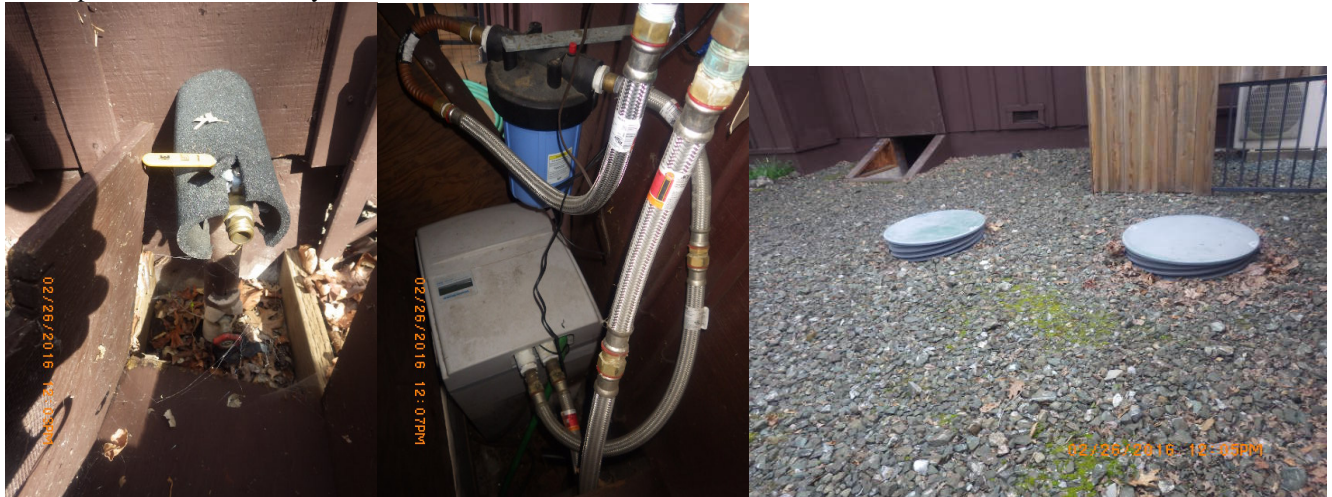
The plumbing system is in generally good condition.

The water pressure supplied to the fixtures is reasonably good. A typical drop in flow was experienced when two fixtures were operated simultaneously.
