Building Inspection Report

Inspection Date:02/24/2016
Prepared For:

Prepared By:
Napa Valley Home Inspections
28 Blossom Court West
Napa, Ca. 94558

Report Number:20161123
Inspector:Dean Alm

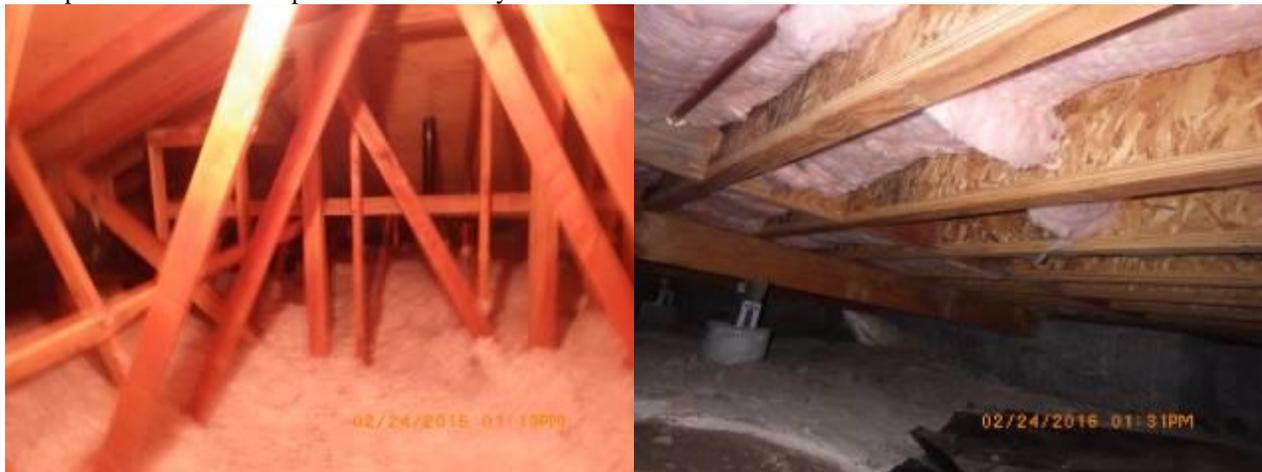
No repair to structural components is necessary at this time.

- **Monitor:** Minor hairline settlement cracks were observed in the foundation walls. This implies that some shrinkage has likely occurred. Cracks of this type should be watched for any sign of additional movement. In the absence of any sign of ongoing movement, repair should not be necessary.
- **Monitor:** Larger than typical 1/4-inch front deck settlement cracking was observed. The amount of movement which has occurred is not likely to have caused other damage to the structure but this area should be monitored. If additional movement occurs, more costly repairs might be necessary. The rate of movement cannot be predicted during a one-time inspection. These cracks may need sealing on the exterior to prevent moisture penetration.

- **Monitor:** Common minor cracks were observed on the exterior stucco walls of the house. This implies that structural movement has occurred. The location, size, shape of these cracks is common. The inspection did not find evidence of significant movement requiring immediate repairs.

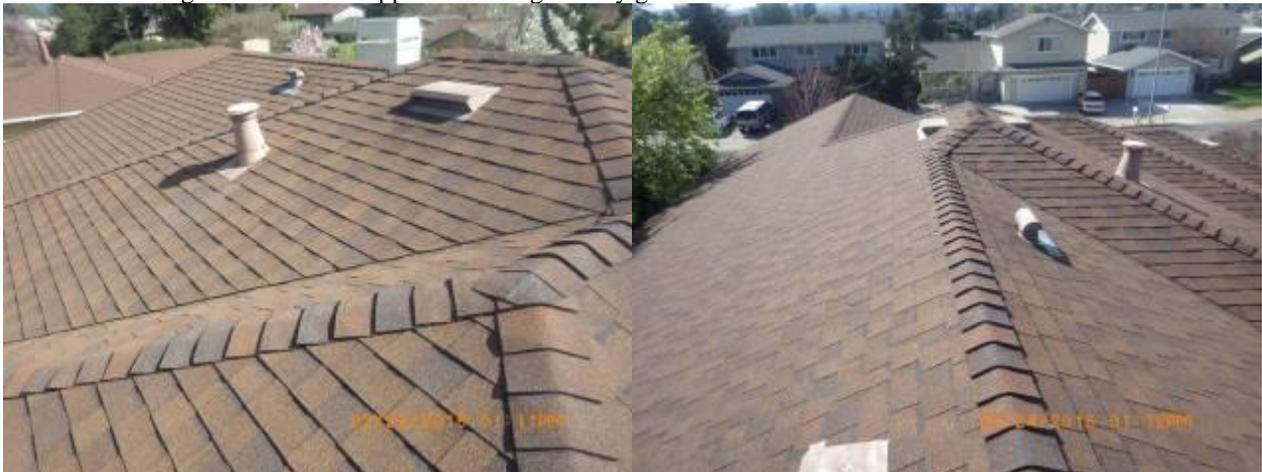
The roof coverings are newer and appear to be in generally good condition.

- **Repair:** The metal chimney flue should be cleaned to help assure safe and functional operation.

- **Repair:** The gutters require cleaning to avoid spilling roof runoff around the building – a potential source of water entry or water damage.

- **Monitor:** The downspouts that discharge below grade level should be monitored. If they are ever suspected to be clogged or disconnected below grade, they should be redirected to discharge at least five (5) feet from the building. Foundation leakage adjacent to a downspout is an indication of a problem below grade.

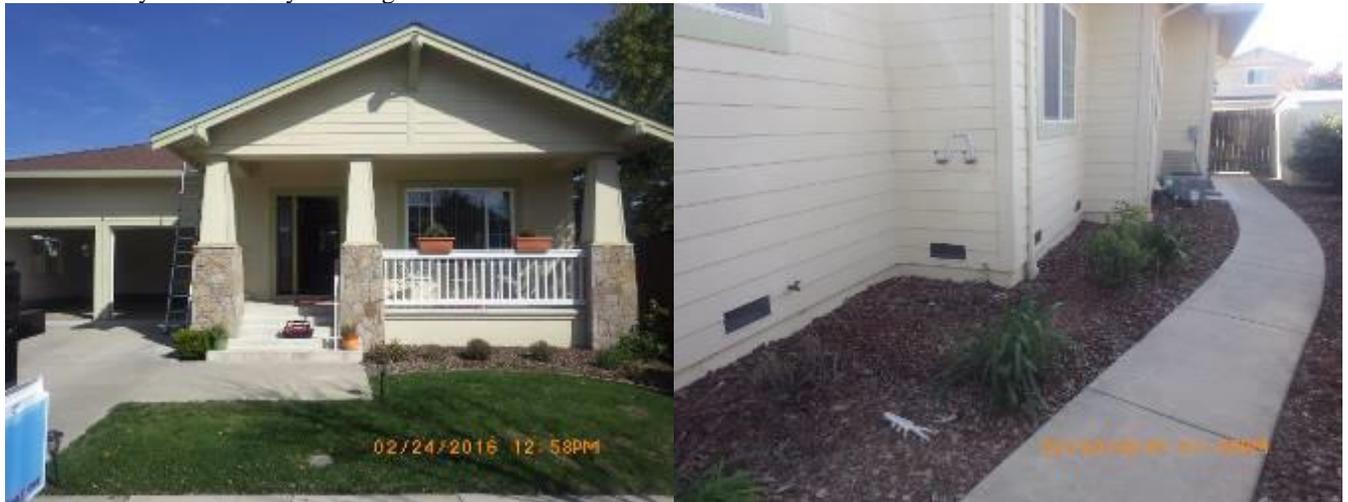
Exterior Walls

There is no significant wood/soil contact around the perimeter of the house, reducing the risk of insect infestation or rot. The driveway and walkways are in good condition.

Paint the tops of the craftsman accents (or use metalflashings) Remove all screws, repair penetrations.
