Broken Head Quarry

Enforceable Undertaking Progress Report

Report #5 – December 2018

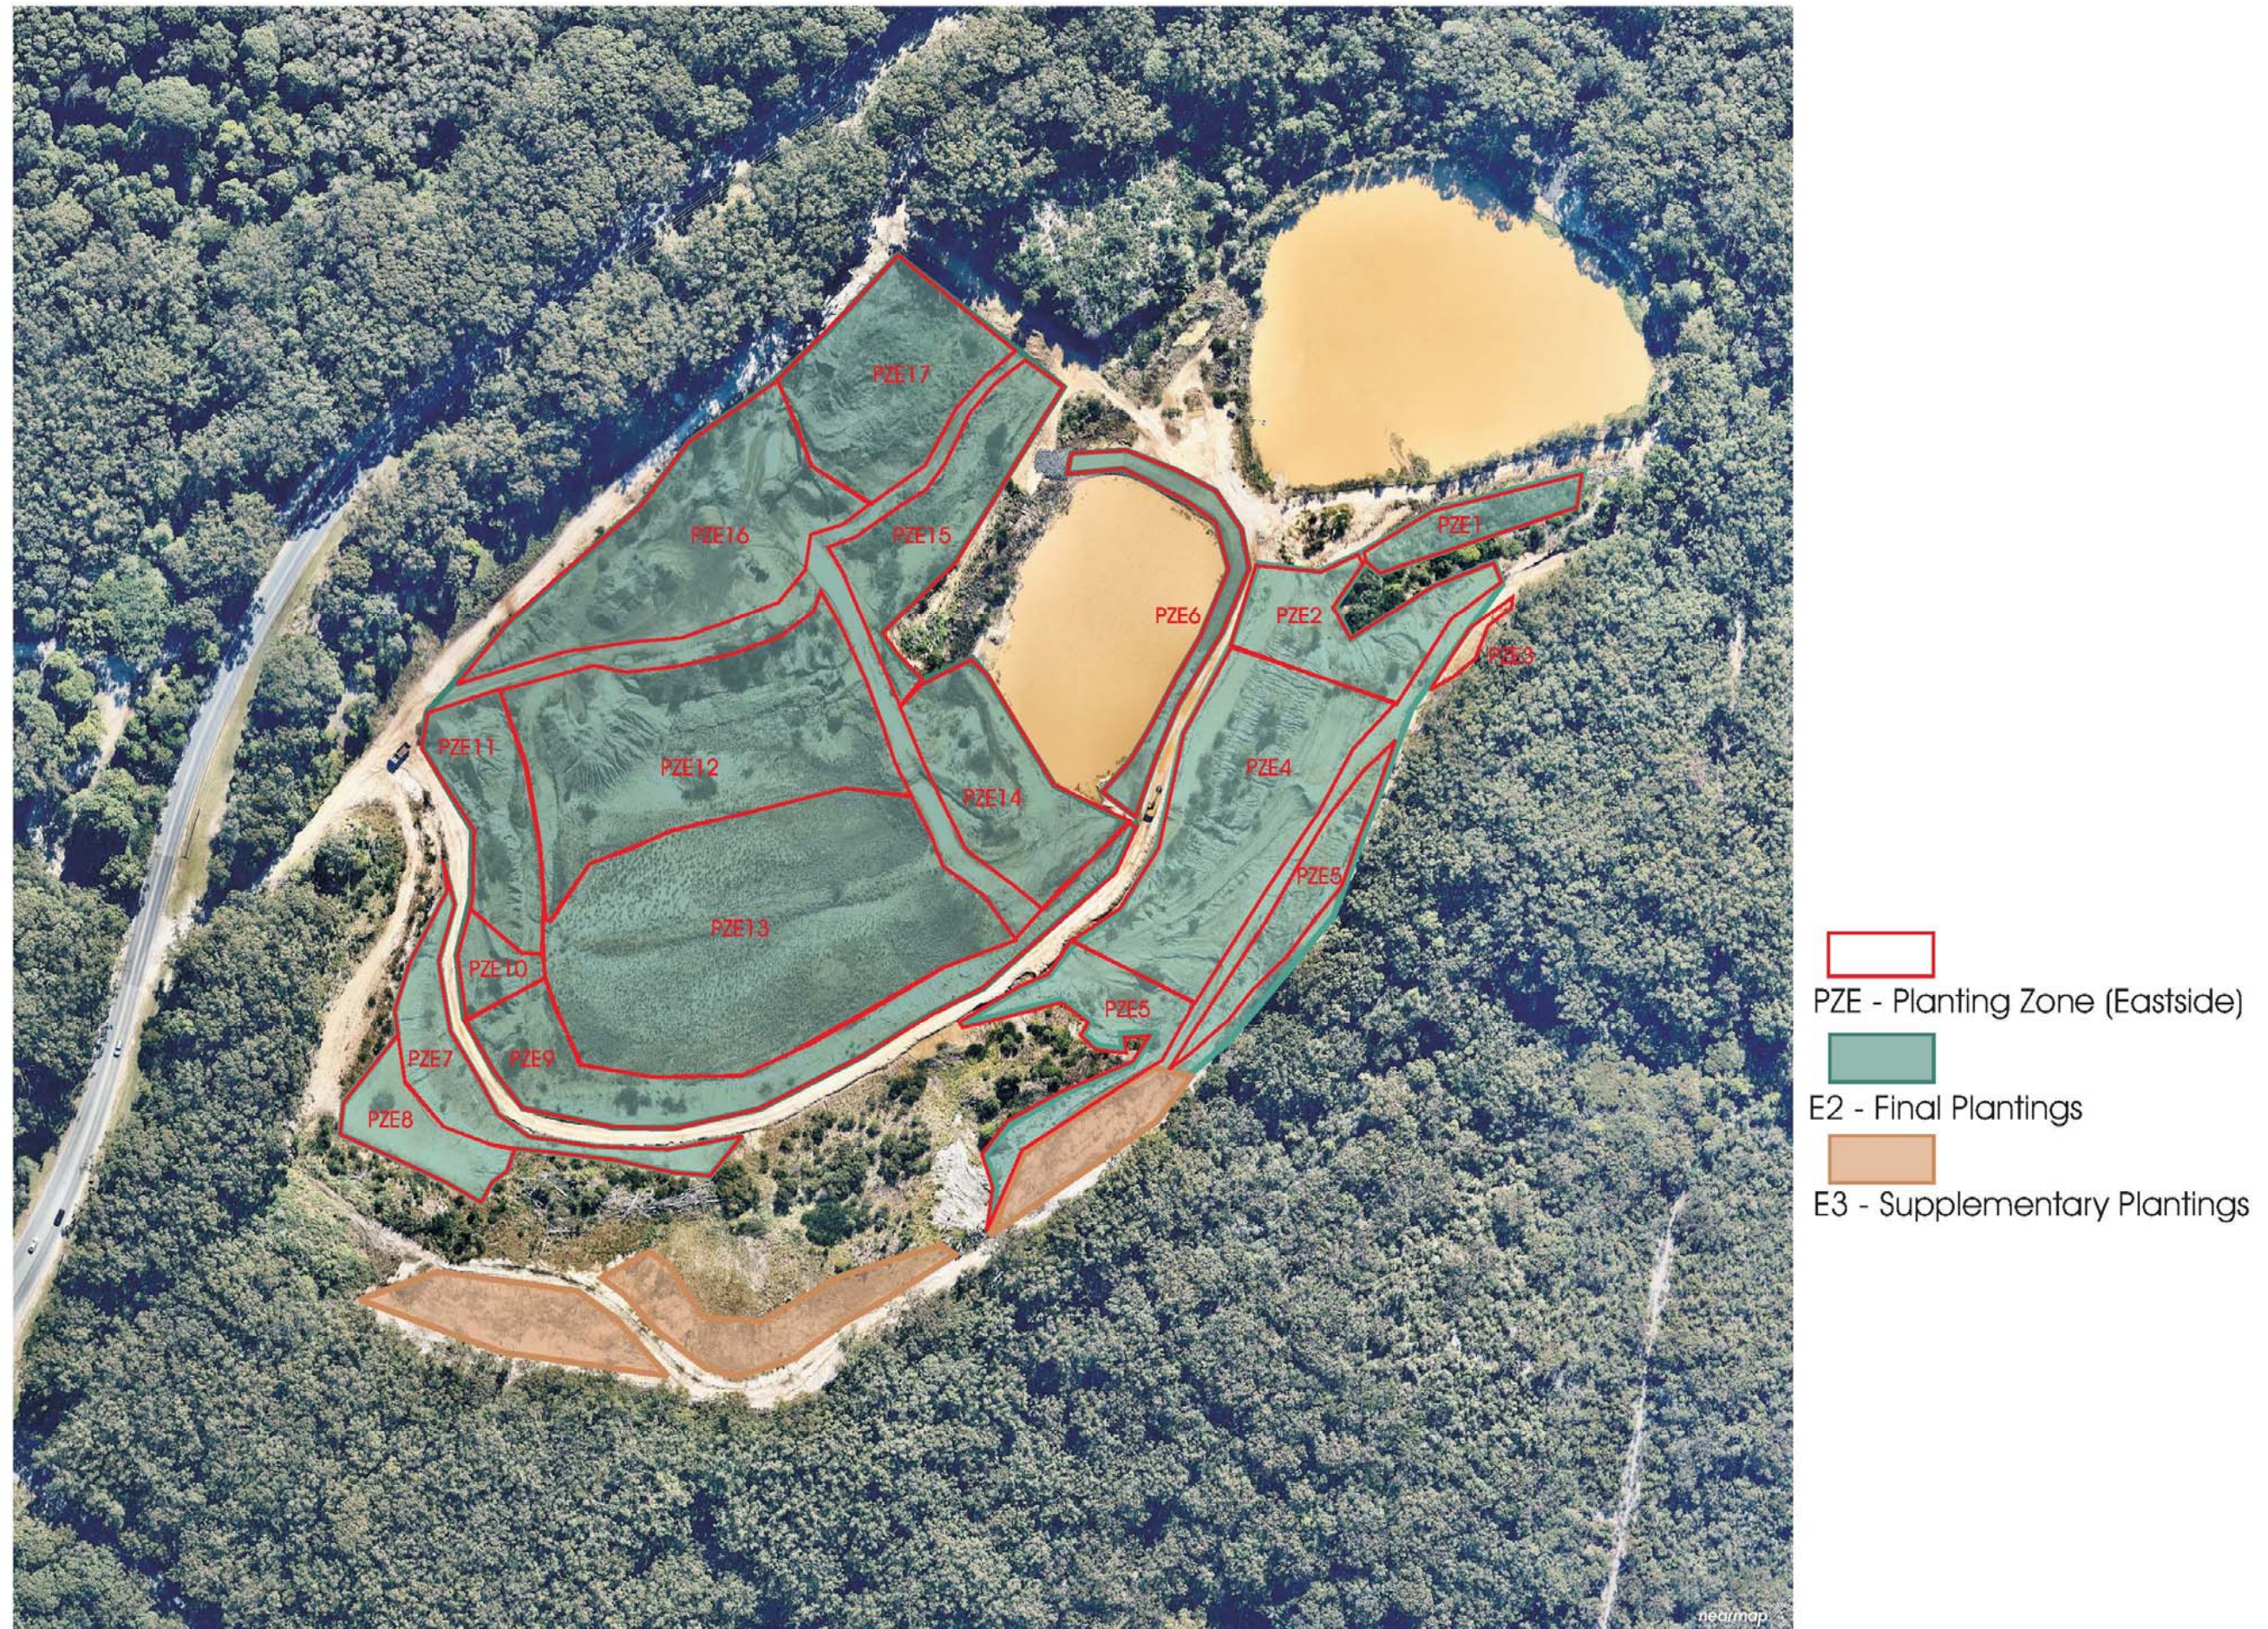
## Annexure A Eastside Sectors

Zone	Description	Status	Activity in <del>November</del> December 2018 and Future Plans
PZE1	North Facing Batter below future fire trail	Well vegetated with established semi mature vegetation. <a href="#">Unlikely any further vegetation will be required</a>	Under observation to see if any damage from earthworks above requires remedial planting. Unlikely any further vegetation will be required. No damage sustained in earthworks activities.
PZE2	Batter below future fire trail. Comprises part of Area 1 in the Rehabilitation Works Plans and Specifications	<p>Future fire trail to be re-landformed to reduce slope of batter. Area was hydromulched in January 2018 and contains some areas with semi mature regenerated plants. However, large areas are bare soil due to landforming works.</p> <p>Once fire trail is re-landformed batter to be hydromulched and planted with shrubs selected by Mark Free.</p> <p>Rehabilitation Works Plans and Specifications requires the following action:            "REGRADE AREA TO LOWER TRACK ELEVATION TO MATCH GRADES TO SOUTH EAST. TRACK TO BE PROFILED WITH SINGLE CROSS FALL SOUTH EAST DISCHARGING TO EXISTING VEGETATED SLOPES. WHERE OUTFALL IS NOT POSSIBLE MITRE DRAINS TO BE PROVIDED AT 20 M INTERVALS.</p> <p>UNVEGETATED PORTIONS OF BATTER TO THE NORTH WEST OF TRACK TO BE REGRADE TO PROVIDE MAXIMUM 50% GRADE. BATTER TO BE TRACK ROLLED, TOPSOILED THEN REVEGETATED WITH SHORT TERM COVER CROP. FINAL REHABILITATION BY PLANTING WITH APPROVED SPECIES."</p> <p><a href="#">Planting now completed and no further work considered to be required except for monitoring and maintenance.</a></p>	<p>Landforming works were undertaken during September 2018 in accordance with the Rehabilitation Works Plans and Specifications.</p> <p>Topsoil emplaced in October 2018 and planting undertaken in early November 2018.</p> <p>Planting now completed and no further work<del>ed</del> considered to be required except for monitoring and maintenance.</p>

PZE3	East side of future fire trail. Comprises part of Area 1 in the Rehabilitation Works Plans and Specifications	<p>Area outside of areas to be revegetated under Enforceable Undertaking. However, this area will be impacted by the re-landforming of the fire trail. Following fire trail re-landforming it is expected this will need some revegetation.</p> <p>Once fire trail is re-landformed batter to be planted with shrubs selected by Mark Free.</p>	<p>Landforming works were undertaken during September 2018 in accordance with Rehabilitation Works Plans and Specifications.</p> <p>Planting not required by Enforceable Undertaking, although is under consideration. Planting not undertaken in November 2018 due to possible need for further landshaping. To be reviewed after visit by Martens &amp; Associates.</p>
PZE4	Lower west facing batter above Sediment Pond No 1	<p>Area landformed and hydromulched in January 2018. Grass well established with some native plants self-generating.</p> <p><del>Area to be planted with shrubs selected by Mark Free.</del> Minor additional grassing to be undertaken at edges of reformed road.</p> <p><a href="#">Planting now completed and no further worked considered to be required except for monitoring and maintenance.</a></p>	<p>Minor alteration to location of road, relocating the lower access trail further west to allow for reduction of batter in area PZE5 Upper was undertaken during September 2018 in accordance with Rehabilitation Works Plans and Specifications.</p> <p>Initial stages or shrub plantings undertaken in early November 2018.</p> <p>Planting now completed and no further work<del>ed</del> considered to be required except for monitoring and maintenance.</p>

PZE5 (upper portion)	Upper west facing batter above Sediment Pond No 1. Comprises Area 2 in the Rehabilitation Works Plans and Specifications	<p>Area landformed to remove eroded slope and rilling in March/April 2018. Enforceable Undertaking requires area to be re-landformed to reduce batter and then revegetated.</p> <p>Once the batter is reformed to a reduced gradient area to be hydromulched (if required) and planted with shrubs selected by Mark Free.</p> <p>Rehabilitation Works Plans and Specifications requires the following action:            REGRADE BATTER FROM LOWER TRACK TO PROVIDE MAXIMUM 50% GRADE. UPPER TRACK WIDTH TO BE ADJUSTED TO SUIT. UPPER TRACK SINGLE CROSS FALL TO SOUTH EAST TO BE MAINTAINED WITH DISCHARGE TO MITRE DRAIN AT NORTH EASTERN END OF AREA.</p>	<p>Landforming works were undertaken during September 2018 in accordance with the Rehabilitation Works Plans and Specifications.</p> <p>Mitre drain at bottom of upper trail yet to be installed.</p> <p>Planting undertaken in November 2018.</p> <p>Planting now completed. Some bare patches of soil exist where grass has not taken. Expect to scour these areas, apply topsoil and possibly hydromulch in 1<sup>st</sup> <del>q</del>Quarter of 2019.</p>

Zone	Description	Status	Activity in <del>November</del> December 2018 and Future Plans
PZE10	Site of concrete pipe drain from above.	Highly eroded and disturbed area.  Rehabilitation of highly eroded batter and new drain to be installed, and then hydromulched and revegetated.	Area filled with fill sand and seeded topsoil during September 2018.  Concrete canvas drain installed to take discharge from concrete pipe in September 2018. Drain across access trail rocked in November 2018. Minor repairs and bunding of new drain to be undertaken before hydromulching and planting.  Performance observed during recent rainfall and observed to perform well, future erosion eliminated.  Area to be hydromulched in 1 <sup>st</sup> Quarter 2019 and planted with shrubs selected by Mark Free. Planting expected to be completed by 1 <sup>st</sup> Quarter 2019.
PZE11	Batter area. Comprises Area 4 in the Rehabilitation Works Plans and Specifications	Partially completed batter, awaiting further fill material and topsoil.  Rehabilitation Works Plans and Specifications requires the following action:  EXTEND BATTER WEST AND SOUTH TO PROVIDE MAXIMUM 50% BATTER SLOPES DOWN FROM ROAD. BATTER TO BE TRACK ROLLED, TOPSOILED THEN REVEGETATED WITH SHORT TERM COVER CROP. FINAL REHABILITATION BY PLANTING WITH APPROVED SPECIES.	Further fill emplacement undertaken and seeded topsoil spread during September 2018.  Now being monitored for drainage performance and erosion.  Area to be planted with shrubs selected by Mark Free.  Timing of shrub plantings not yet determined. Part of PZE12 planting extended into the northeast sector of PZE11 during the November planting campaign.

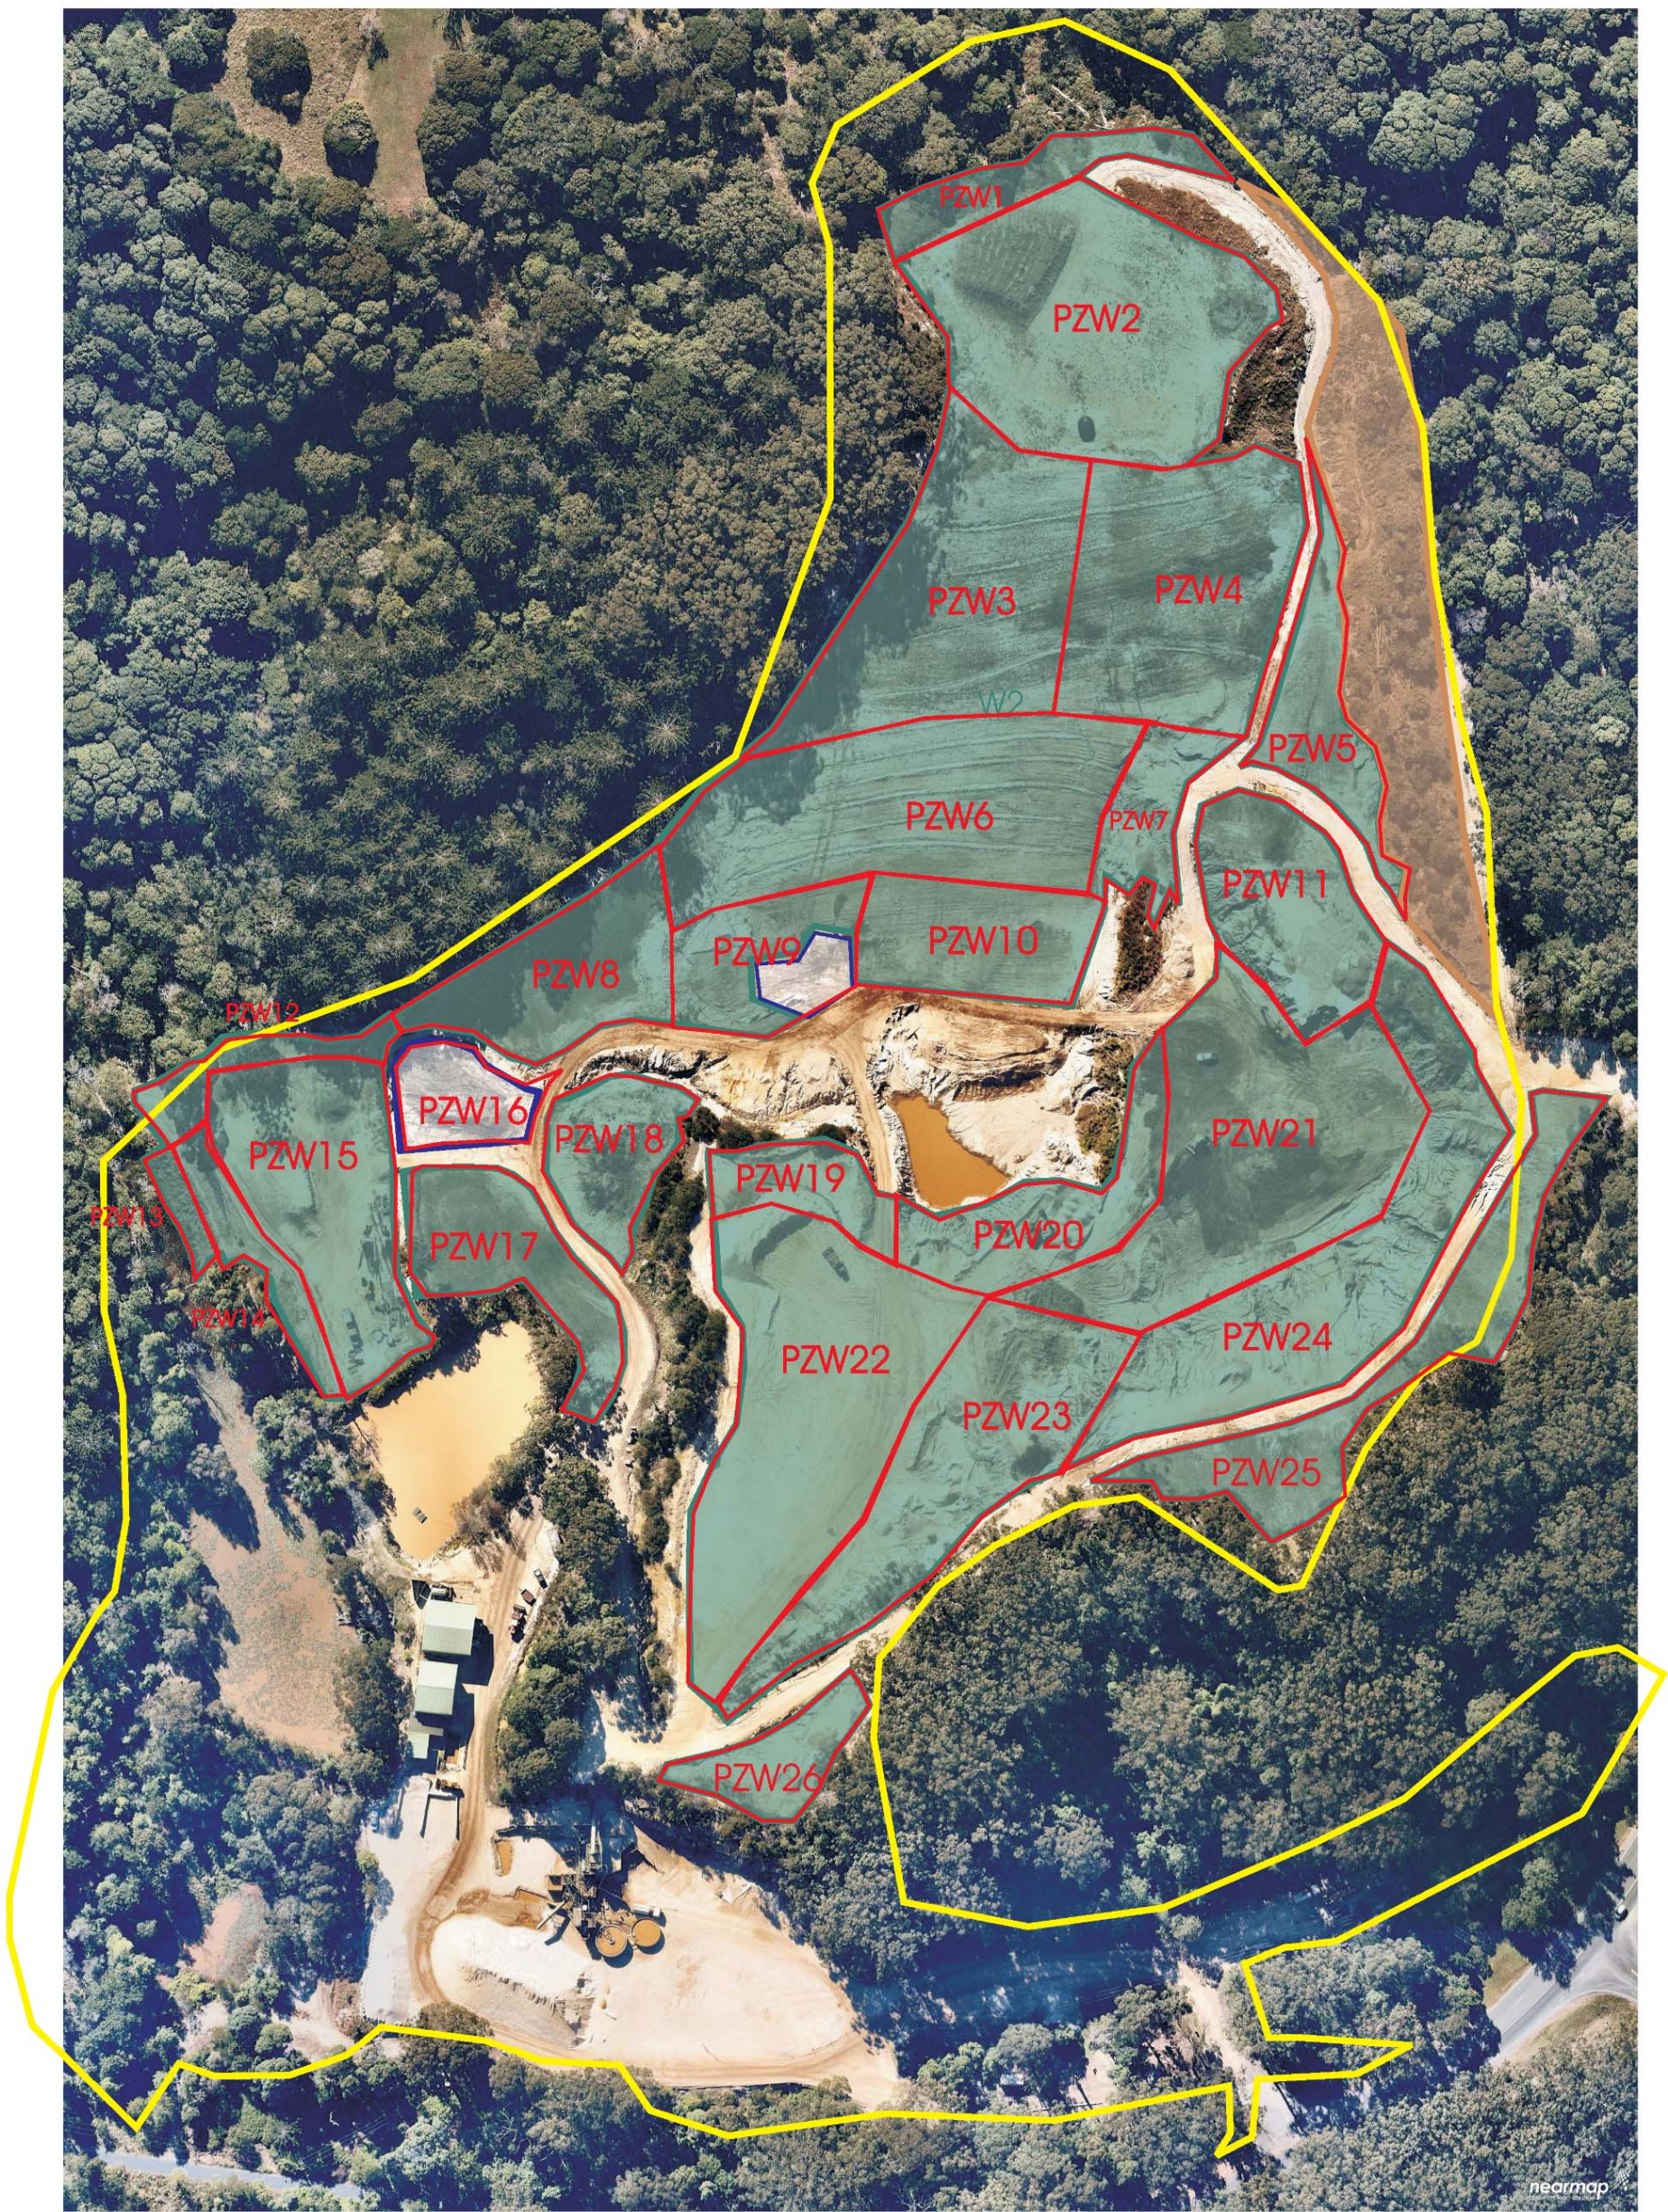
Annexure B Westside Sectors

Zone	Description	Status	Activity in <del>November</del> December 2018 and Future Plans
PZW1	Northern batter of western top pad	Well vegetated and not requiring further work. To be monitored	Nil
PZW2	Western top pad	Topsoiled and hydromulched in January 2018. Contains topsoil store.	Topsoil store required to be removed. Shrub planting expected in 2 <sup>nd</sup> Quarter of 2019
PZW3	South facing batter in lowland rainforest rehabilitation area. Contains Areas 6 and 7 in Rehabilitation Works Plans and Specifications	Topsoiled and successfully hydromulched in January 2018.	Drain rehabilitation work required in 1 <sup>st</sup> Quarter 2019 after inspection by Martens & Associates. Shrub planting expected in 2 <sup>nd</sup> Quarter of 2019
PZW4	Upper south facing batter in blackbutt rehabilitation area. Contains Areas 9, 10 and part 11 in Rehabilitation Works Plans and Specifications	Topsoiled and successfully hydromulched in January 2018.	Drain rehabilitation work required in 1 <sup>st</sup> Quarter 2019 after inspection by Martens & Associates. Shrub planting expected in 2 <sup>nd</sup> Quarter of 2019
