# Buy-Wise Inspection Services P/L

## PRE HANDOVER INSPECTION REPORT

### DEFECTS LIST

| Inspected Property Address: | Tootgarook | |

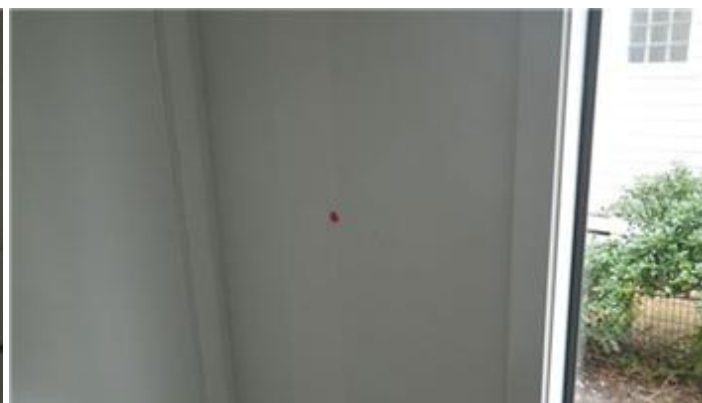
| <b>Walls</b> | Plaster | Marks noted to walls where indicated that require removal or painting<br>Paint runs noted that require sanding and touch ups<br>Hole requires filling and painting above double doors | Condition: Defect Noted |

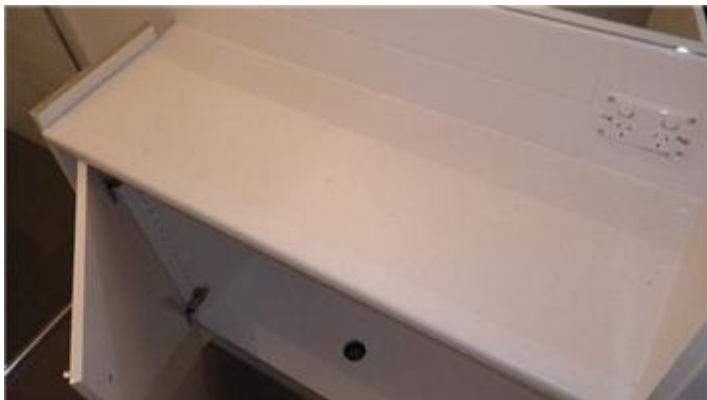
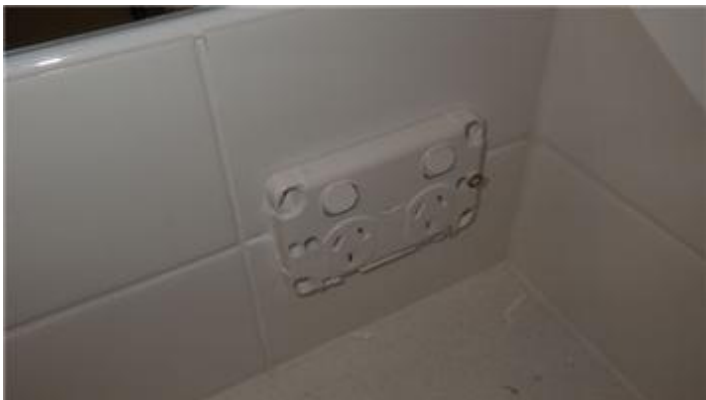
| Walls | Plaster | Marks noted to walls where indicated that require removal or painting<br>Paint runs noted that require sanding and touch ups | Condition: Defect Noted |

| Comments | Basin not fitted<br>Cover plate missing from power point<br>Towel rail missing |

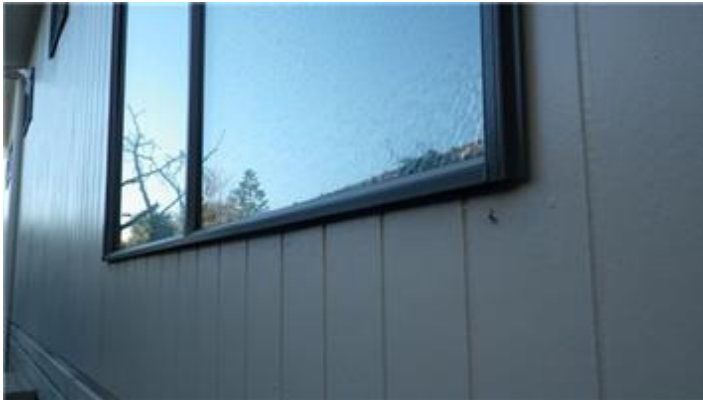
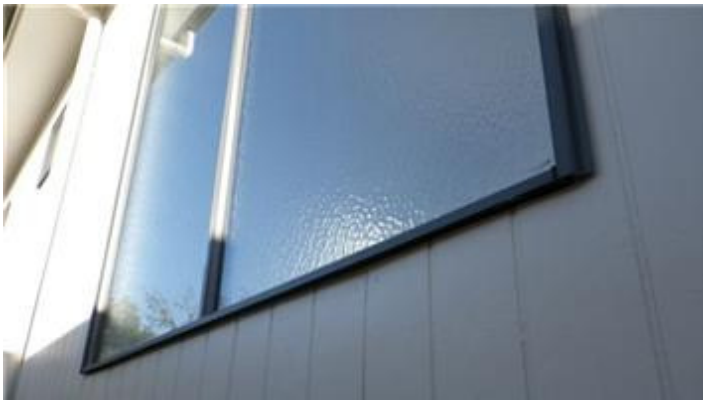
It is my opinion that windows should be installed to the manufactures recommendations with aluminium angle against external framing

Flashing on top of front door frame is short one end and requires replacing

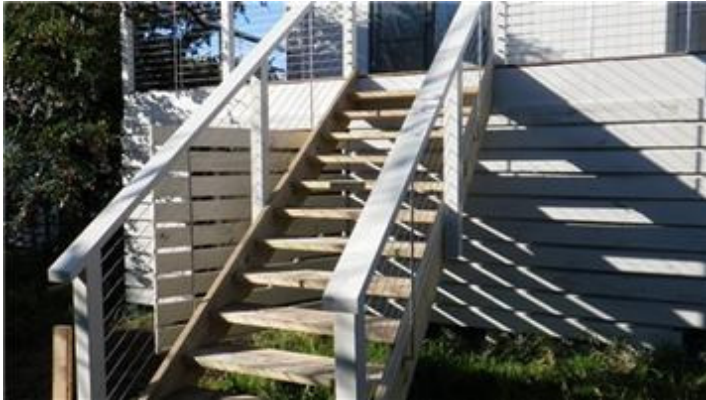
| Stairs | Timber steps | Top step out side laundry is 15mm over the 190 mm height requirements<br>Stairs to back deck are very flimsy and require bracing<br>Bottom posts dont appear to be adequately supported by a concrete pad around post in ground, additional concrete is required<br>Top of stringers appear to be only fixed at top and may split stringer if settlement occurs, added support require to bottom of stringer where meets deck<br>End grain of stringers are exposed and will deteriorate quickly | Condition: Defect Noted |

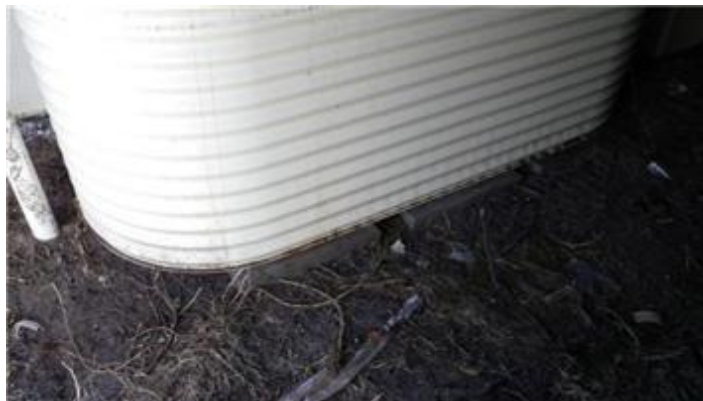
| Comments | Water tank is fitted with overflow pipe<br>Tank is mounted on 6 concrete paver's, unknown if this is to manufactures recommendations<br>All tanks should be fully supported at base to prevent | Condition: Unknown |

unnecessary stress to joins or base
