SUBSURFACE SOIL INVESTIGATION

**Lots 3 - 20
Trails at Sheep Draw - 1st Replat
Greeley, Colorado**

JOB NO. 170850

June 18, 2019

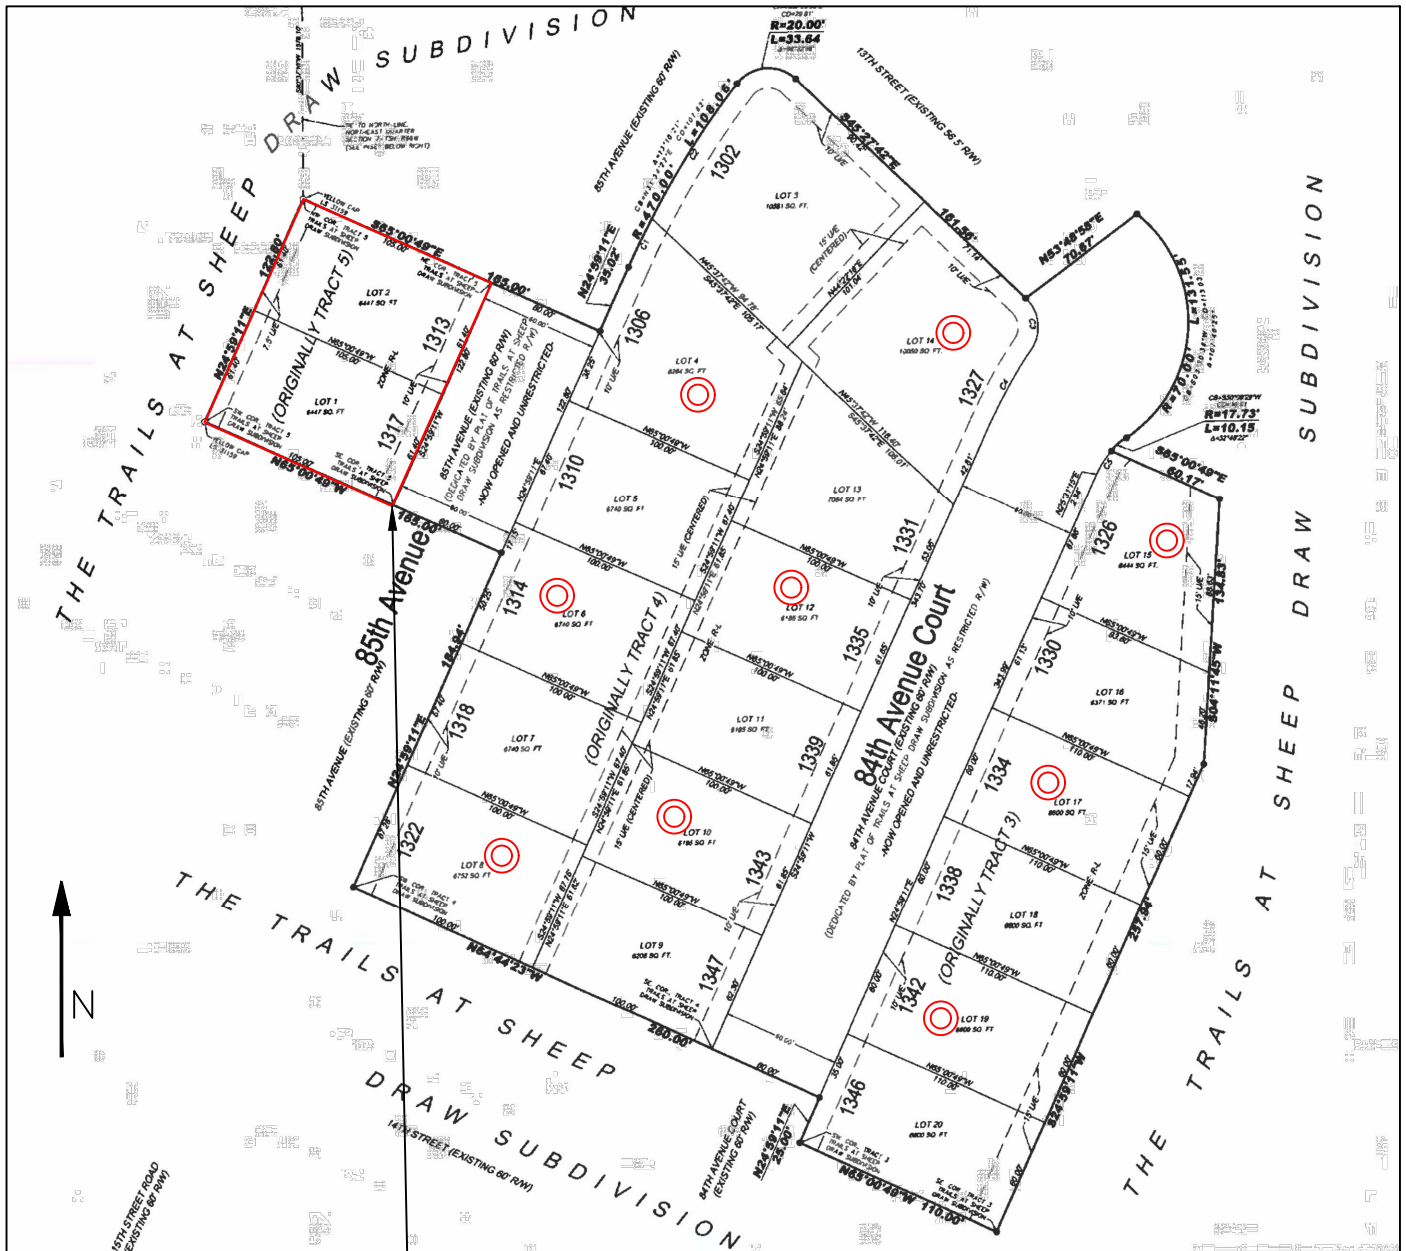
BORE LOCATION PLAN
THE TRAILS AT
SHEEPDRAW-1ST REPLAT
GREELEY, CO

INCLUDED IN PREVIOUS
RMG SOILS INVESTIGATION #160270

The subsurface conditions on the site were investigated by drilling 9 exploratory test borings; one bore on every other lot. The approximate locations of the test borings are presented in the Boring Location Plan on Figure 2.

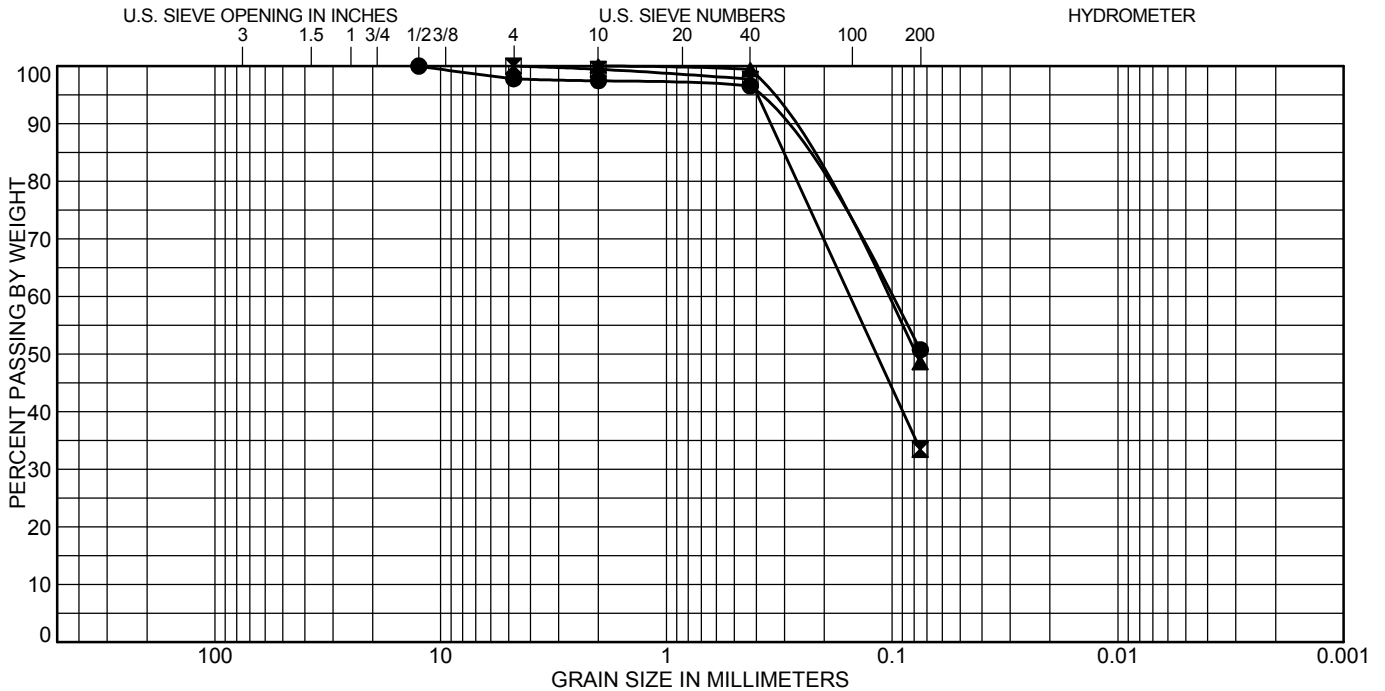
FIGURE No. 10

Test Boring	Depth (ft)	Classification	LL	PL	PI
● L06	9.0	SANDY LEAN CLAY(CL)	30	15	15
⊠ L10	4.0	CLAYEY SAND(SC)	26	14	12
▲ L14	4.0	CLAYEY SAND(SC)	26	14	12

The moisture content for the recovered samples was obtained in the laboratory. Grain-size analysis, Atterberg Limits, and swell/consolidation tests were performed on selected samples for purposes of classification and to develop pertinent engineering properties. A Summary of Laboratory Test Results is presented in Figure 8. Soil Classification and Atterberg Test Results are presented in Figure 9. Swell/Consolidation Test Results are presented in Figures 9 through 11.

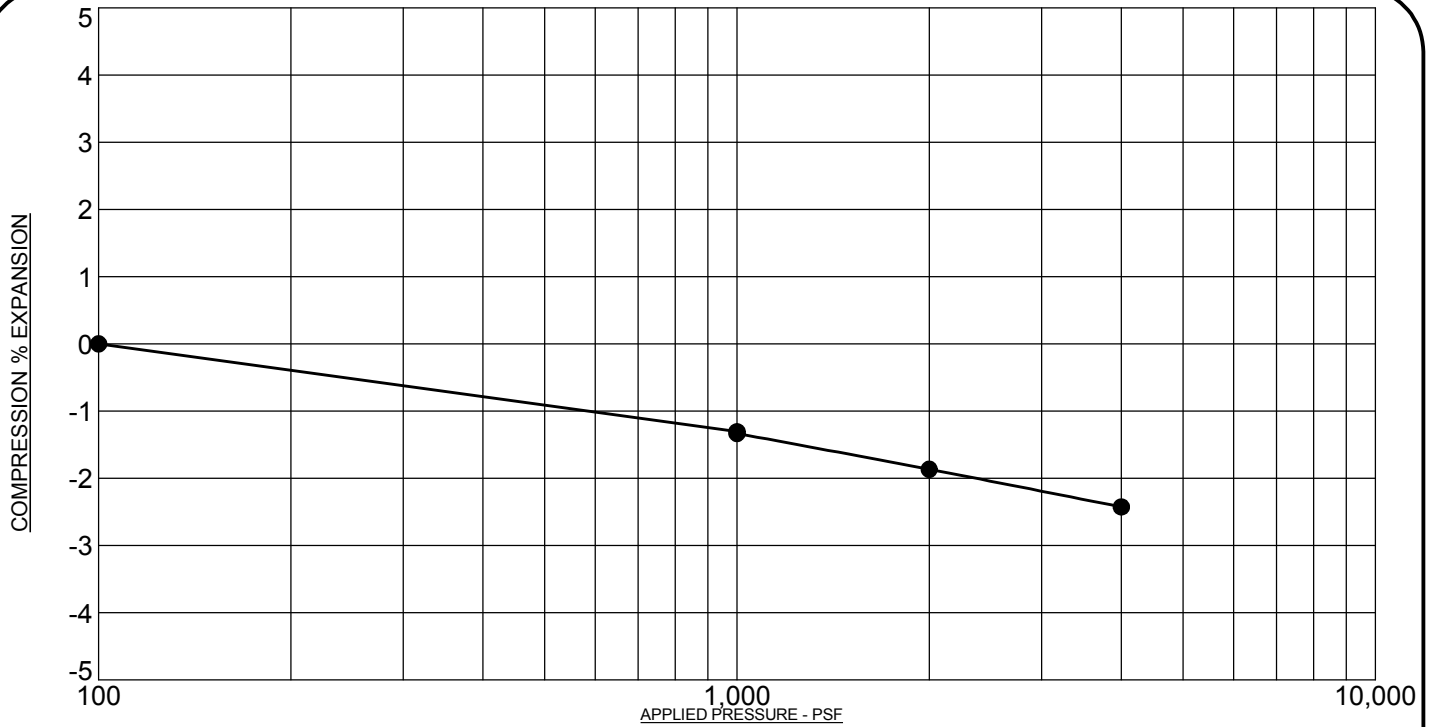
PROJECT: Trails at Sheepdraw Greeley, Colorado
 SAMPLE DESCRIPTION: sandy clay
 NOTE: SAMPLE WAS INUNDATED WITH WATER AT 1000 PSF

SAMPLE LOCATION: L06 @ 9 FT
 NATURAL DRY UNIT WEIGHT: 120.0 PCF
 NATURAL MOISTURE CONTENT: 13.4%
 PERCENT SWELL/COMPRESSION: 0.0

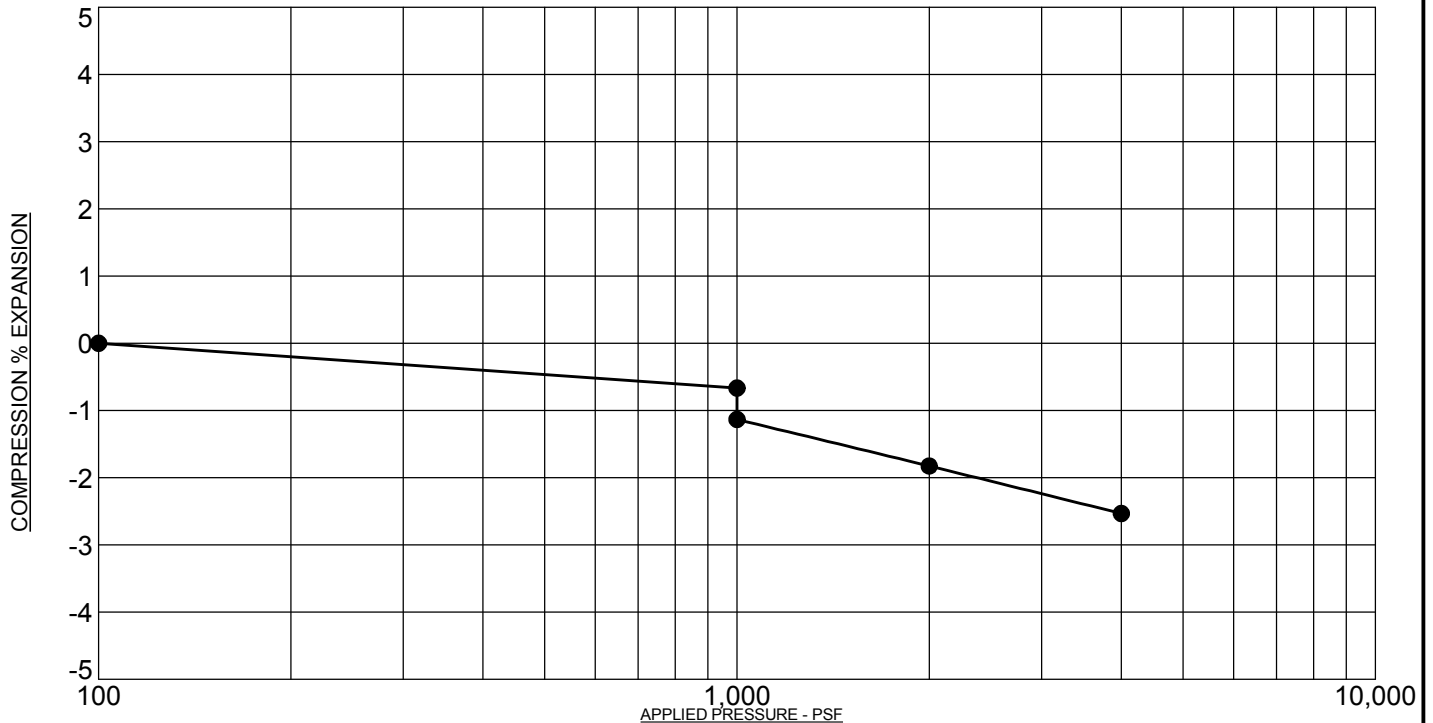
PROJECT: Trails at Sheepdraw Greeley, Colorado
 SAMPLE DESCRIPTION: sandy clay
 NOTE: SAMPLE WAS INUNDATED WITH WATER AT 1000 PSF

SAMPLE LOCATION: L10 @ 4 FT
 NATURAL DRY UNIT WEIGHT: 111.5 PCF
 NATURAL MOISTURE CONTENT: 9.8%
 PERCENT SWELL/COMPRESSION: -0.5

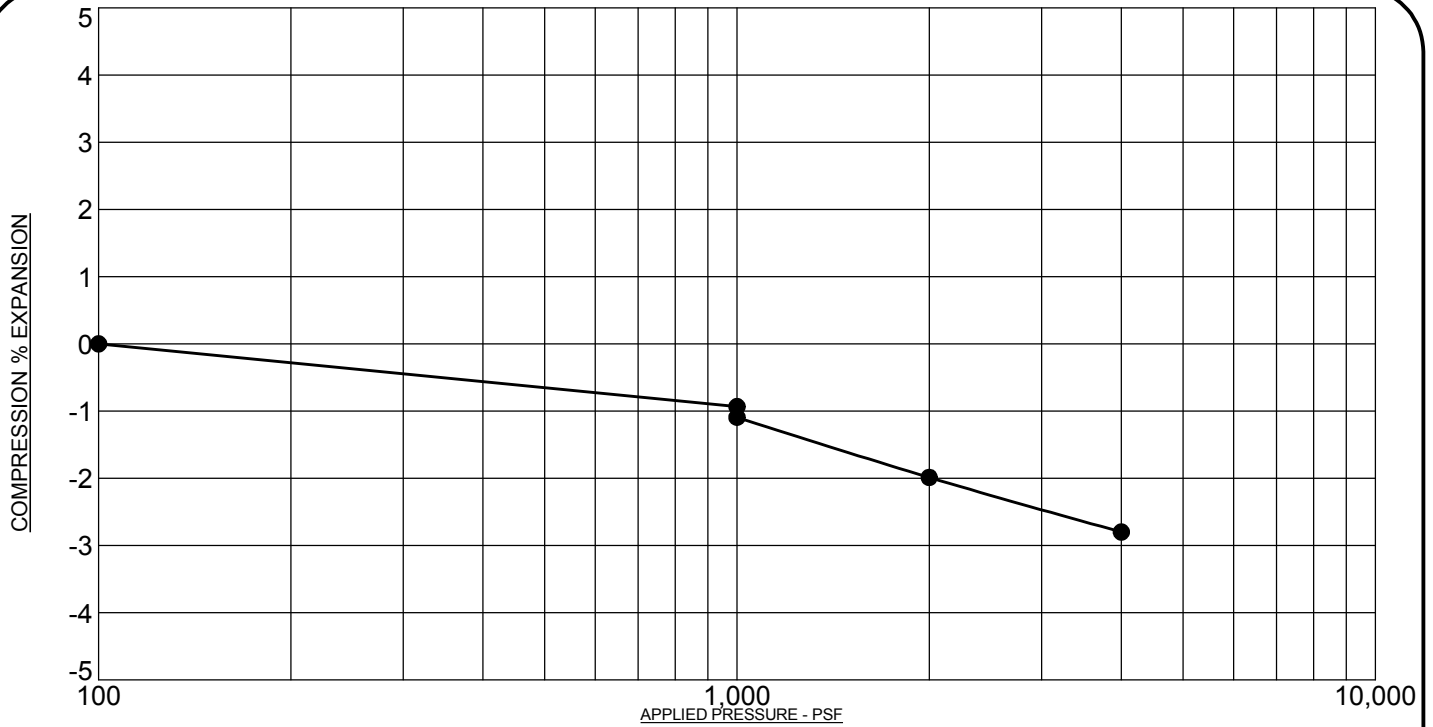
PROJECT: Trails at Sheepdraw Greeley, Colorado
 SAMPLE DESCRIPTION: sandy clay
 NOTE: SAMPLE WAS INUNDATED WITH WATER AT 1000 PSF

SAMPLE LOCATION: L14 @ 4 FT
 NATURAL DRY UNIT WEIGHT: 110.9 PCF
 NATURAL MOISTURE CONTENT: 10.9%
 PERCENT SWELL/COMPRESSION: - 0.2

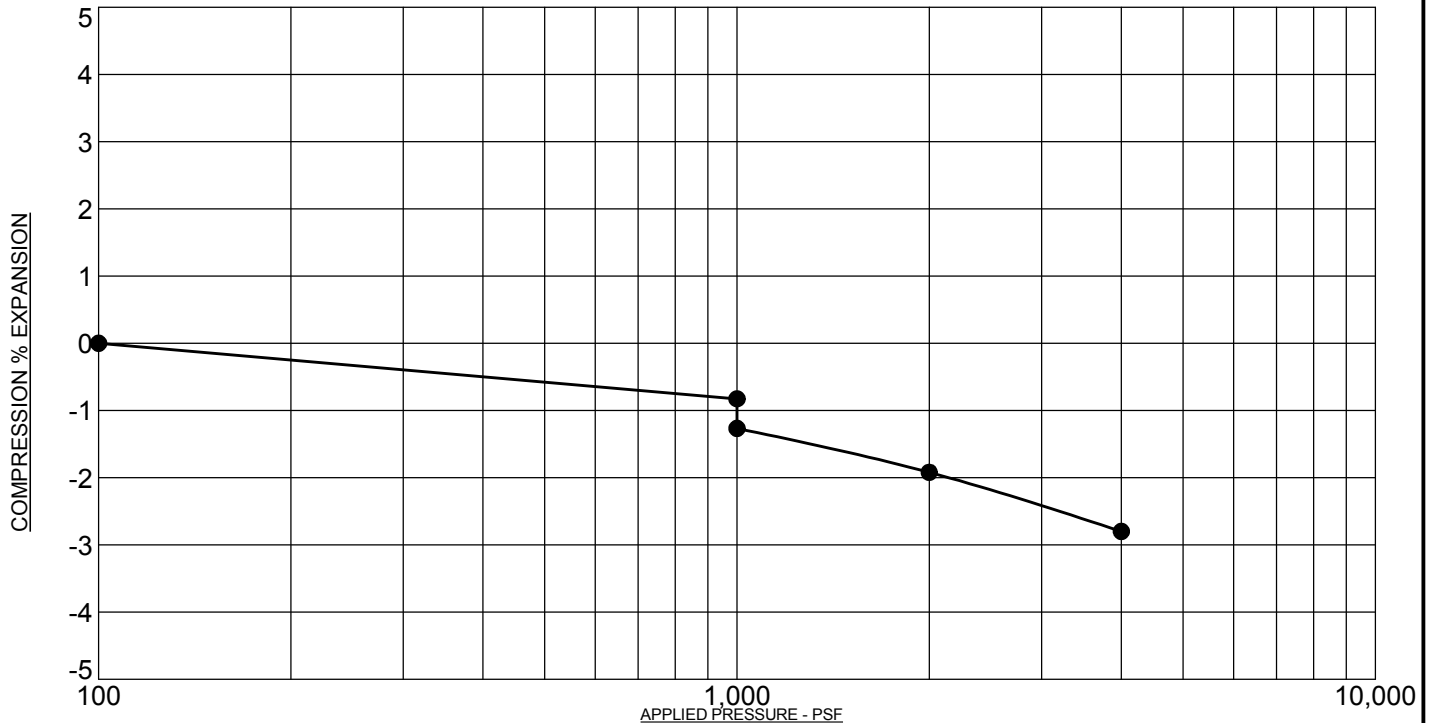
PROJECT: Trails at Sheepdraw Greeley, Colorado
 SAMPLE DESCRIPTION: sandy clay
 NOTE: SAMPLE WAS INUNDATED WITH WATER AT 1000 PSF

SAMPLE LOCATION: L17 @ 4 FT
 NATURAL DRY UNIT WEIGHT: 107.9 PCF
 NATURAL MOISTURE CONTENT: 11.0%
 PERCENT SWELL/COMPRESSION: - 0.4

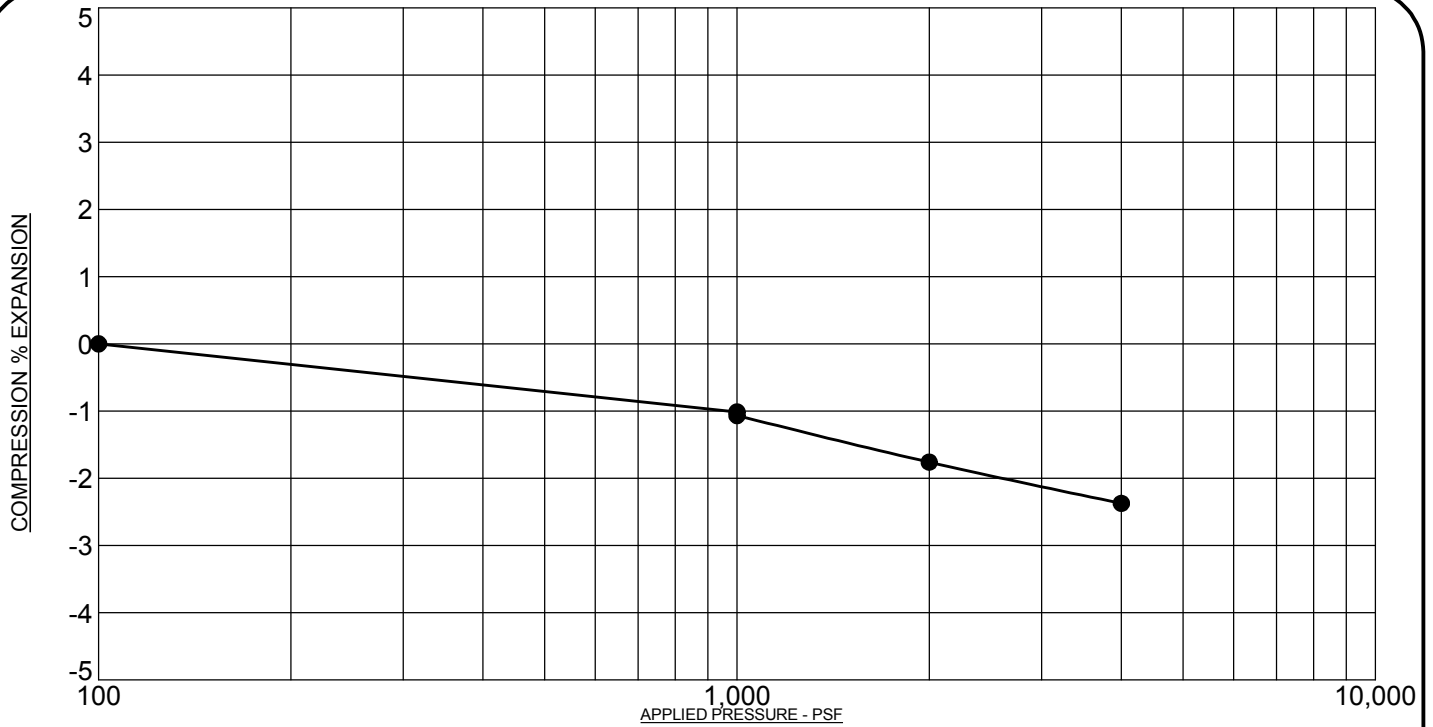
PROJECT: Trails at Sheepdraw Greeley, Colorado
 SAMPLE DESCRIPTION: sandy clay
 NOTE: SAMPLE WAS INUNDATED WITH WATER AT 1000 PSF

SAMPLE LOCATION: L19 @ 9 FT
 NATURAL DRY UNIT WEIGHT: 121.4 PCF
 NATURAL MOISTURE CONTENT: 11.6%
 PERCENT SWELL/COMPRESSION: - 0.1
