SUBSURFACE SOIL INVESTIGATION

Hunters Crossing Sec 3, T6N, R67W of the 6th P.M. Severance, Colorado

JOB NO. 167717

August 23, 2019

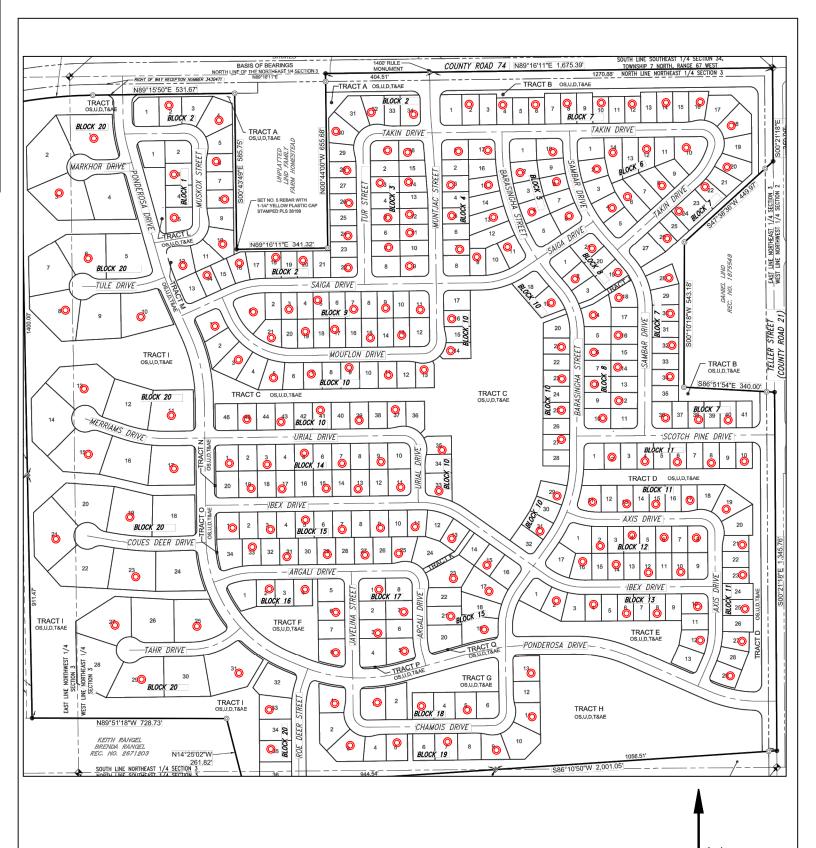
BORE LOCATION PLAN HUNTERS CROSSING SUBDIVISION

SEVERANCE, CO

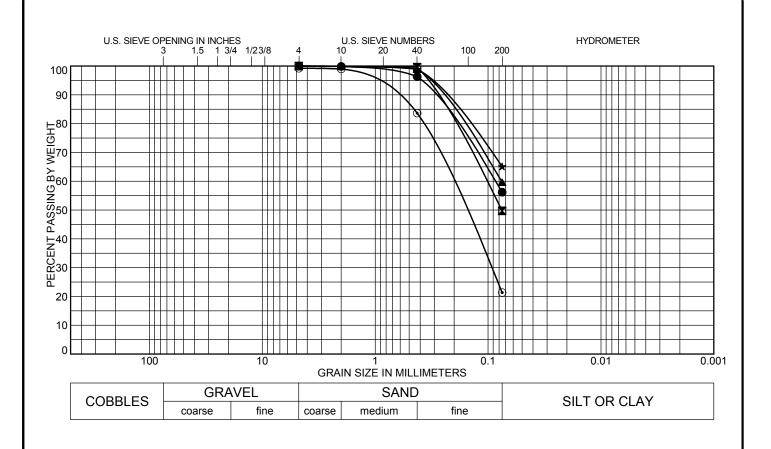
FIGURE No. 107

1	est Boring	Depth (ft)		Classification				LL	PL	PI
	B01 L03	4.0		SANDY LEAN CLAY(CL)						13
2	B01 L05	9.0		SILTY SAND(SM)						NP
4	B02 L10	4.0		SANDY LEAN CLAY(CL)					21	8
*	B02 L24	4.0		SANDY LEAN CLAY(CL)					15	13
•	B03 L05	9.0		SILTY SAND(SM)					NP	NP
	Foot Boring	Donth (ft)	9/ Croyol 9/ Card 9/ Cilt 9/ Cloy

L	est Boring	Depth (ft)	%Gravel	%Sand	%Silt	%Clay
•	B01 L03	4.0	0.0	43.8	56	5.2
\blacksquare	B01 L05	9.0	0.0	50.3	49).7
lack	B02 L10	4.0	0.0	40.4	59).6
*	B02 L24	4.0	0.0	34.9	65	5.1
•	B03 L05	9.0		77.9	21	.3

The moisture content for the recovered samples was obtained in the laboratory. Grain-size analysis, Atterberg Limits, and swell/consolidation tests were performed on selected samples for purposes of classification and to develop pertinent engineering properties. A Summary of Laboratory Test Results is presented in Figure 106. Soil Classification and Atterberg Test Results are presented in Figures 107 through 117. Swell/Consolidation Test Results are presented in Figures 118 through 144.

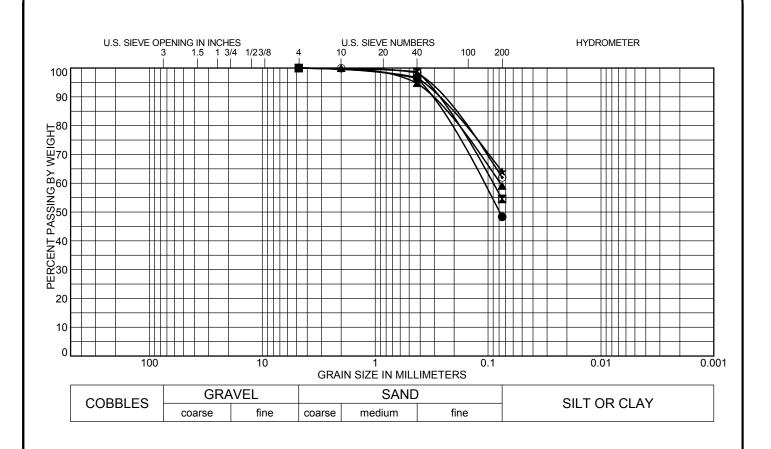
FIGURE No. 108

Ī	Test Boring	Depth (ft)		Classification				LL	PL	PI
	B06 L02	4.0		CLAYEY SAND(SC)						10
	B06 L08	4.0		SANDY LEAN CLAY(CL)						26
4	B07 L16	4.0		SANDY LEAN CLAY(CL)						22
7	B07 L26	4.0		SANDY LEAN CLAY(CL)					16	21
•	B07 L28	9.0		SANDY LEAN CLAY(CL)					15	17
-	Foot Poring	Donth (ft)	Donth (ft) 9/ Crovel 9/ Cond 9/ Silt 9/ Clov							•

L	est Boring	Depth (ft)	%Gravel	%Sand	%Silt	%Clay
•	B06 L02	4.0	0.0	51.7	48	3.3
\blacksquare	B06 L08	4.0	0.0	45.4	54	l.6
lack	B07 L16	4.0	0.0	40.9	59).1
*	B07 L26	4.0	0.0	36.0	64	l.0
•	B07 L28	9.0	0.0	38.0	62	2.0

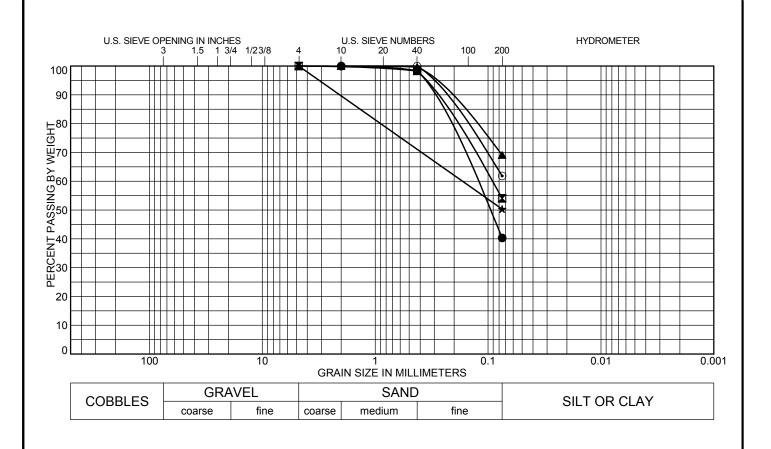
FIGURE No. 109

T	est Boring	Depth (ft)		Classification					PL	PI
	B07 L32	9.0		CLAYEY SAND(SC)						15
I	B07 L36	4.0		SANDY LEAN CLAY(CL)						9
4	B08 L06	14.0		SANDY SILT(ML)					NP	NP
*	B08 L14	9.0		SANDY SILT(ML)						NP
•	B09 L01	4.0		SANDY SILT(ML)						NP
Г	oot Poring	Donth (ft)	9/ Croyol 9/ Court 9/ City 9/ Cloy

10	est Boring	Depth (ft)	%Gravel	%Sand	%Silt	%Clay
•	B07 L32	9.0	0.0	59.7	40	.3
	B07 L36	4.0	0.0	45.9	54	l.1
	B08 L06	14.0	0.0	30.9	69).1
*	B08 L14	9.0	0.0	49.7	50	.3
\odot	B09 L01	4.0	0.0	38.2	61	.8

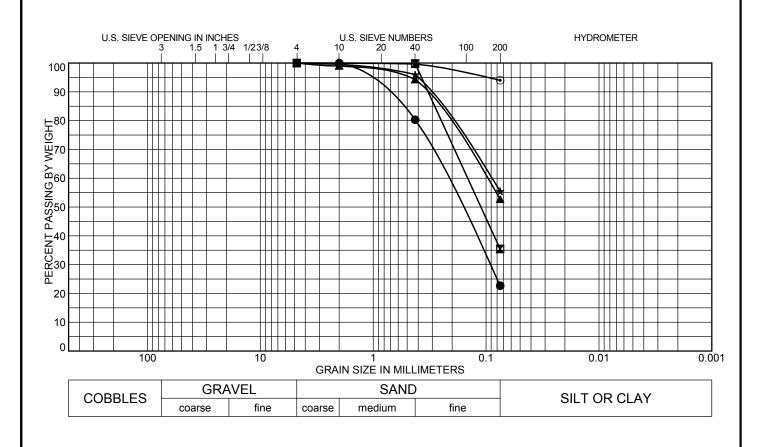
FIGURE No. 110

Т	est Boring	Depth (ft)	Classification	LL	PL	PI
•	B09 L05	4.0	SILTY SAND(SM)	NP	NP	NP
X	B09 L05	9.0	SILTY SAND(SM)	NP	NP	NP
A	B09 L15	4.0	SANDY LEAN CLAY(CL)	33	15	18
*	B09 L17	9.0	SANDY LEAN CLAY(CL)	29	15	14
•	B10 L03	9.0	SILT(ML)	NP	NP	NP
Т	ant Davisor	D = = 41= /f4)	0/ 0/2014 0/ 0/ 1			-

10	est Boring	Depth (ft)	%Gravel	%Sand	%Silt	%Clay
•	B09 L05	4.0	0.0	77.3	22.7	
X	B09 L05	9.0	0.0	64.5	35.5	
▲	B09 L15	4.0	0.0	47.3	52.7	
*	B09 L17	9.0	0.0	44.5	55.5	
•	B10 L03	9.0	0.0	6.0	94	l.0

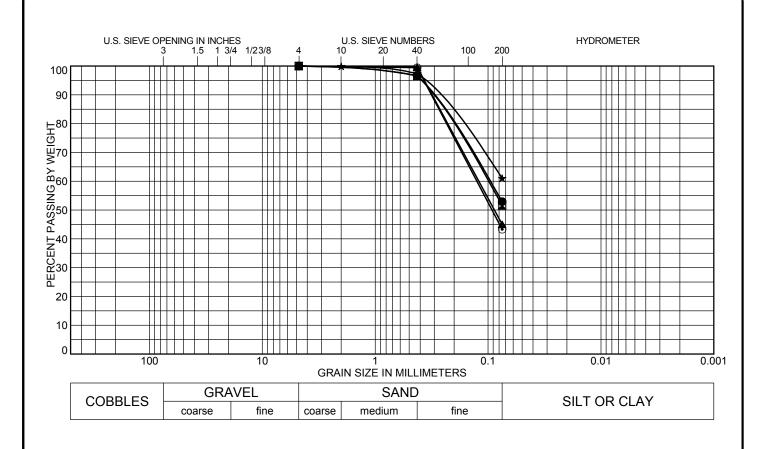
FIGURE No. 111

Т	est Boring	Depth (ft)	Classification	LL	PL	PI
•	B10 L07	4.0	SANDY LEAN CLAY(CL)	37	14	23
X	B10 L14	4.0	SANDY LEAN CLAY(CL)	35	15	20
A	B10 L25	9.0	SILTY SAND(SM)	NP	NP	NP
*	B10 L35	4.0	SANDY LEAN CLAY(CL)	28	14	14
•	B10 L41	9.0	SILTY SAND(SM)	NP	NP	NP
Г	ant Davison	D = 14 (ft)	0/ 0/2014 0/ 0/ 1

L	est Boring	Depth (ft)	%Gravel	%Sand	%Silt	%Clay
•	B10 L07	4.0	0.0	47.1	52.9	
	B10 L14	4.0	0.0	48.4	51	.6
▲	B10 L25	9.0	0.0	55.0	45	5.0
*	B10 L35	4.0	0.0	39.0	61	.0
•	B10 L41	9.0	0.0	56.7	43	3.3

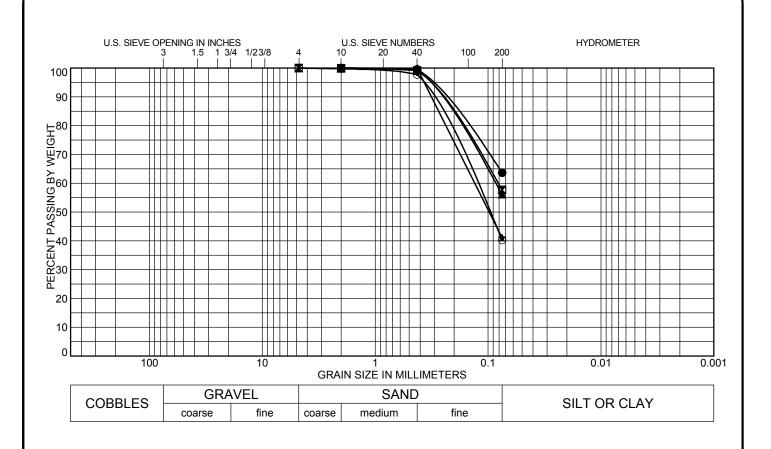
FIGURE No. 112

Т	Test Boring Depth (ft)		Classification		LL	PL	PI			
•	B11 L02	4.0		SA	ANDY LEAN	CLAY(CL)		32	16	16
	B11 L08	4.0		SANDY LEAN CLAY(CL)				31	15	16
A	B11 L27	4.0		SANDY LEAN CLAY(CL)				33	17	16
*	B12 L08	9.0			SILTY SAN	ID(SM)		NP	NP	NP
•	B13 L10	9.0		CLAYEY SAND(SC)			26	14	12	
Т	oet Boring	Donth (ft)	% Gravel	0/ Cand	0/, Cilt	%Clay			•	•

T	est Boring	Depth (ft)	%Gravel	%Sand	%Silt	%Clay
•	B11 L02	4.0	0.0	36.3	63.7	
\blacksquare	B11 L08	4.0	0.0	42.3	57.7	
▲	B11 L27	4.0	0.0	44.0	56	6.0
*	B12 L08	9.0	0.0	59.0	41	1.0
•	B13 L10	9.0	0.0	59.7	40).3

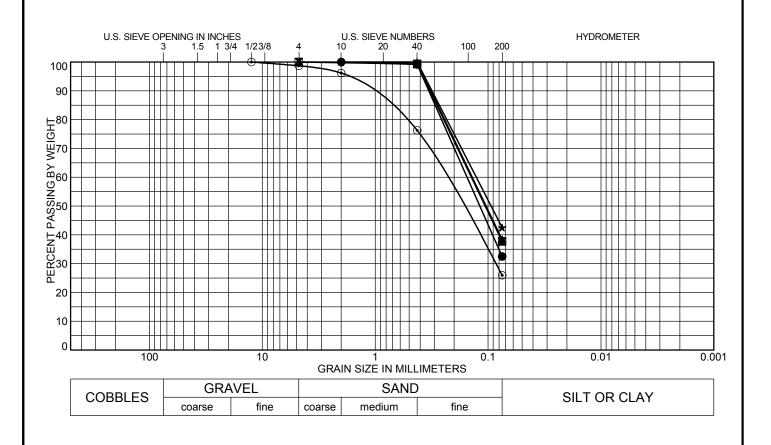
FIGURE No. 113

Т	Test Boring Depth (ft)		Classification		PL	PI
	B14 L01	4.0	SILTY SAND(SM)	NP	NP	NP
X	B14 L07	4.0	SILTY SAND(SM)	NP	NP	NP
A	B14 L09	9.0	SILTY SAND(SM)	NP	NP	NP
*	B14 L19	9.0	SILTY SAND(SM)	NP	NP	NP
•	B15 L11	9.0	CLAYEY SAND(SC)	28	15	13
Г	t D i	D 41- (ft)	0/ 0/	-	-

L	est Boring	Depth (ft)	%Gravel	%Sand	%Silt	%Clay
•	B14 L01	4.0	0.0	67.5	32.5	
	B14 L07	4.0	0.0	62.3	37.7	
▲	B14 L09	9.0	0.0	61.6	38.4	
*	B14 L19	9.0	0.0	57.5	42	2.5
•	B15 L11	9.0	1.3	72.7	26	5.0

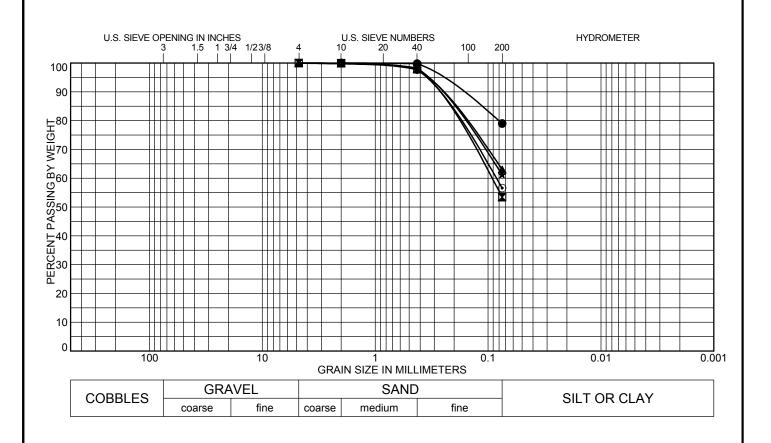
FIGURE No. 114

ľ	est Boring	Depth (ft)	Classification	LL	PL	PI
	B15 L17	4.0	LEAN CLAY with SAND(CL)	32	16	16
Z	B15 L25	4.0	SANDY LEAN CLAY(CL)	31	14	17
4	B16 L06	4.0	SANDY LEAN CLAY(CL)	35	16	19
*	B16 L08	9.0	SANDY LEAN CLAY(CL)	27	15	12
•	B17 L01	4.0	SANDY LEAN CLAY(CL)	36	16	20
1	Foot Dominor	D = = 41= /ft)	0/ 0/2014 0/ 0/ 1

10	est Boring	Depth (ft)	%Gravel	%Sand	%Silt	%Clay
•	B15 L17	4.0	0.0	21.0	79.0	
X	B15 L25	4.0	0.0	46.5	53.5	
A	B16 L06	4.0	0.0	36.9	63.1	
*	B16 L08	9.0	0.0	38.7	61	.3
•	B17 L01	4.0	0.0	43.4	56	5.6

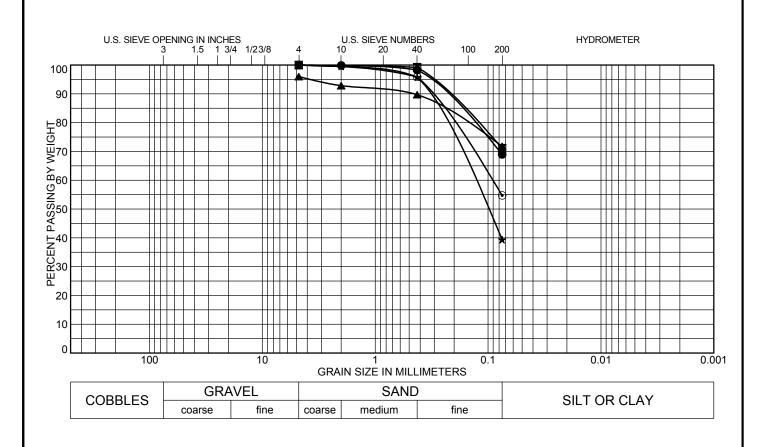
FIGURE No. 115

Т	est Boring	Depth (ft)	Classification	LL	PL	PI
•	B18 L01	4.0	SANDY LEAN CLAY(CL)	36	15	21
X	B18 L05	9.0	LEAN CLAY with SAND(CL)	29	17	12
A	B19 L01	14.0	SILT with SAND(ML)	31	26	5
*	B19 L03	9.0	CLAYEY SAND(SC)	26	12	14
•	B19 L13	4.0	SANDY LEAN CLAY(CL)	31	15	16
_	4 D!	D 41- (ft)	0/ 0/2011 0/ 0/ 1 0/ 0/14 0/ 0/ 0/	-	-

est Boring	Depth (ft)	%Gravel	%Sand	%Silt	%Clay
•	B18 L01	4.0	0.0	31.0	69	0.0
	B18 L05	9.0	0.0	28.9	71.1	
▲	B19 L01	14.0		24.2	71	.8
*	B19 L03	9.0	0.0	60.6	39).4
•	B19 L13	4.0	0.0	45.3	54	1.7

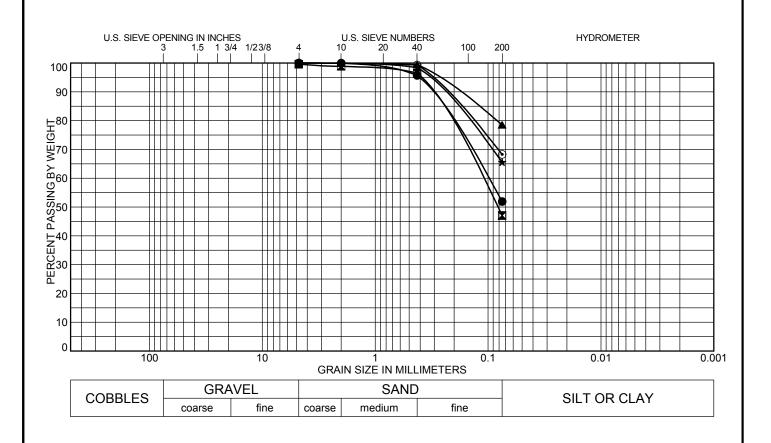
FIGURE No. 116

T	Test Boring Depth (ft)		Classification	LL	PL	PI
	B20 L01	9.0	SANDY LEAN CLAY(CL)	31	14	17
X	B20 L10	4.0	CLAYEY SAND(SC)	29	18	11
4	B20 L10	9.0	LEAN CLAY with SAND(CL)	40	19	21
*	B20 L13	4.0	SANDY LEAN CLAY(CL)	33	15	18
•	B20 L17	4.0	SANDY LEAN CLAY(CL)	37	23	14
	t D i	D 41- 750	0/ 0 0/ 0 !! 0/ 0!

1	est Boring	Depth (ft)	%Gravel	%Sand	%Silt	%Clay
•	B20 L01	9.0	0.0	48.1	51.9	
	B20 L10	4.0		52.5	47.1	
▲	B20 L10	9.0	0.0	21.5	78.5	
*	B20 L13	4.0	0.0	34.4	65.6	
\odot	B20 L17	4.0	0.0	31.7	68	.3

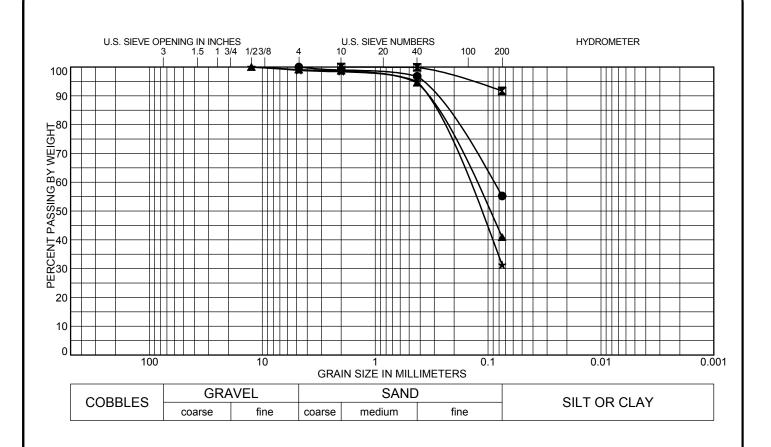
FIGURE No. 117

Test Boring Depth (ft)		Classification			LL	PL	PI		
•	B20 L17	9.0		SANDY SILT(ML)				NP	NP
X	B20 L25	9.0		LEAN CLAY(CL)				17	11
A	B20 L31	9.0		SILTY SAND(SM)				NP	NP
*	B20 L35	9.0		SILTY, CLAYEY SAND(SC-SM)				17	6
Т	Test Boring Depth (ft)		%Gravel	0/ Cand	% Silt	%Clay	•

T	Test Boring Depth (ft)		%Gravel	%Sand	%Silt	%Clay
•	B20 L17	9.0	0.0	44.8	55.2	
X	B20 L25	9.0	0.0	8.3	91.7	
▲	B20 L31	9.0	0.9	58.1	40).9
*	B20 L35	9.0	1.2	67.5	31	.3
						·
