# OHIO ASPHALT PAVING CONFERENCE

# REGIES FOR LOCAL PCC

Timothy R. Murphy, PE  
President

# ASPHALT OVERLAYS (MS-17)

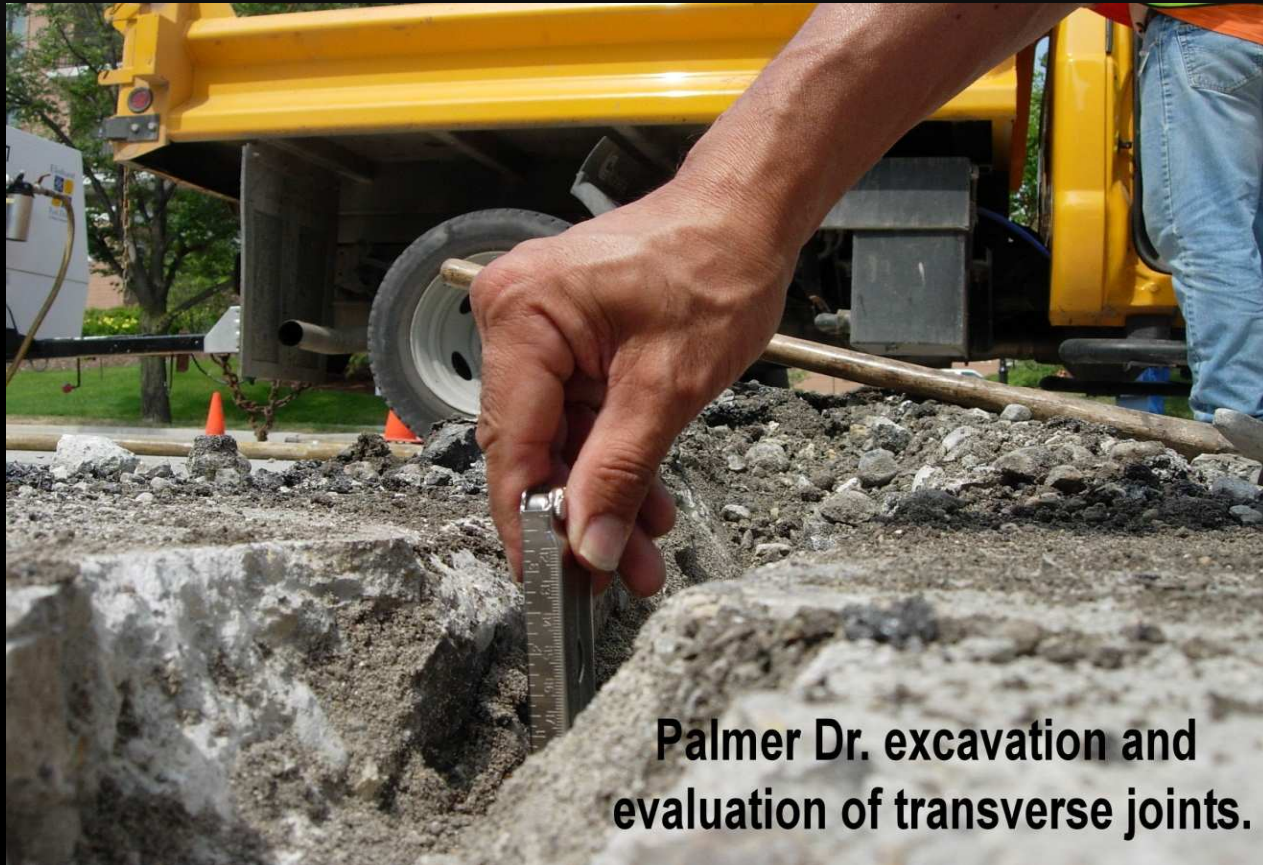
# AREA OF FAILURE WAS WELL DEFINED AND CONFINED

Palmer Dr. excavation and  
evaluation of transverse joints.

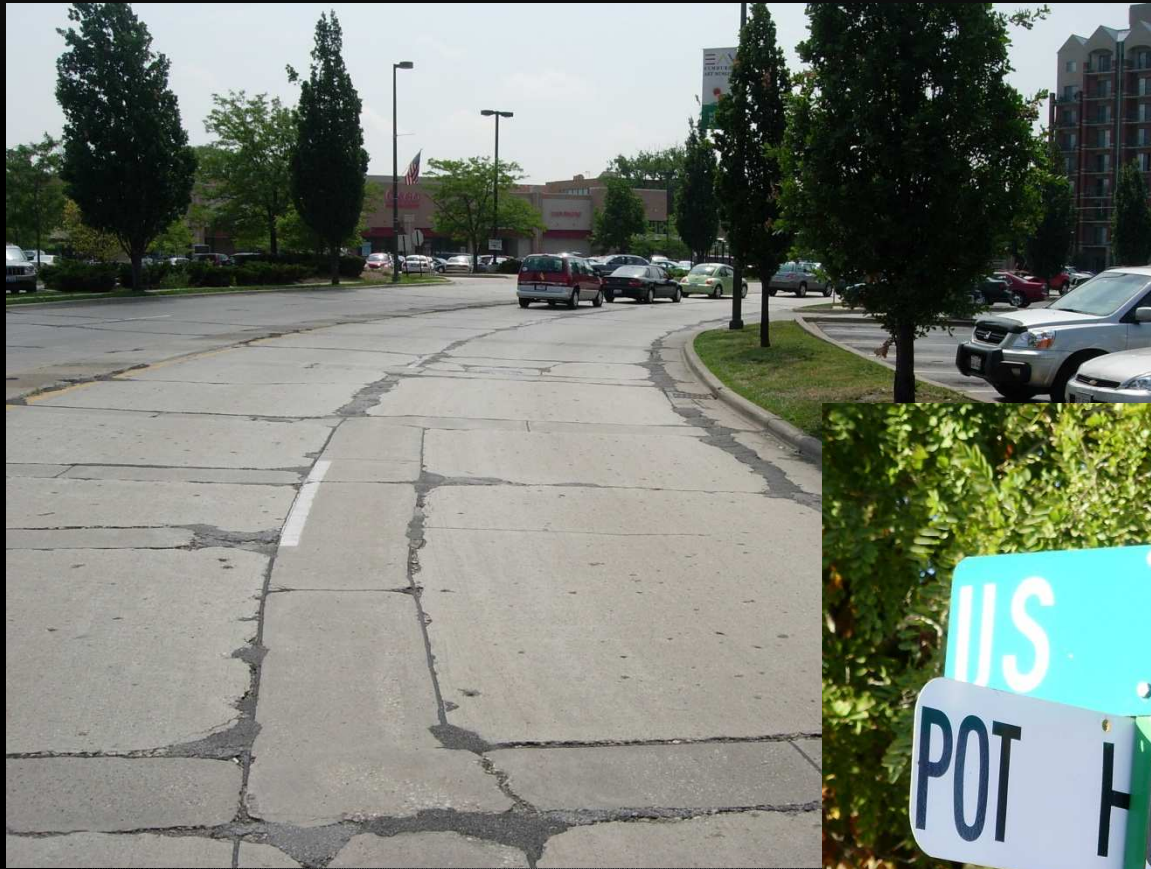
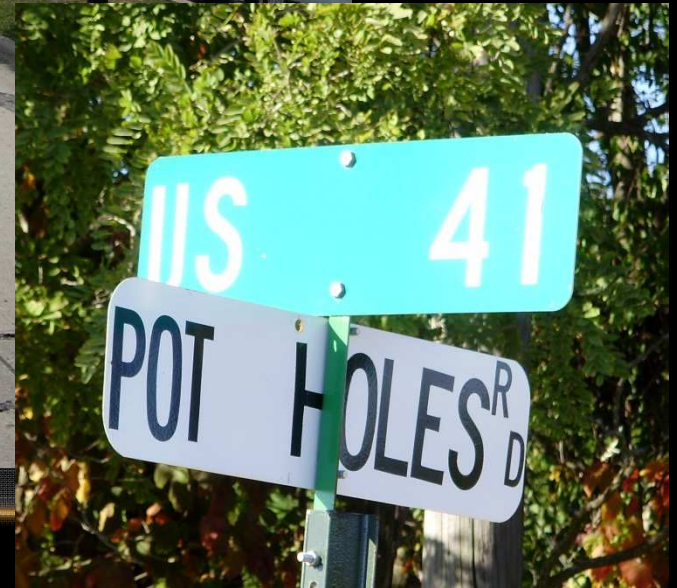
# WATERPROOFING OF THE PCC WAS NEEDED

- Waterproofing of the pcc was needed.
- Patching was surface in nature, not full depth.
- Cold milled 'rumble median' and over layed with asphalt.

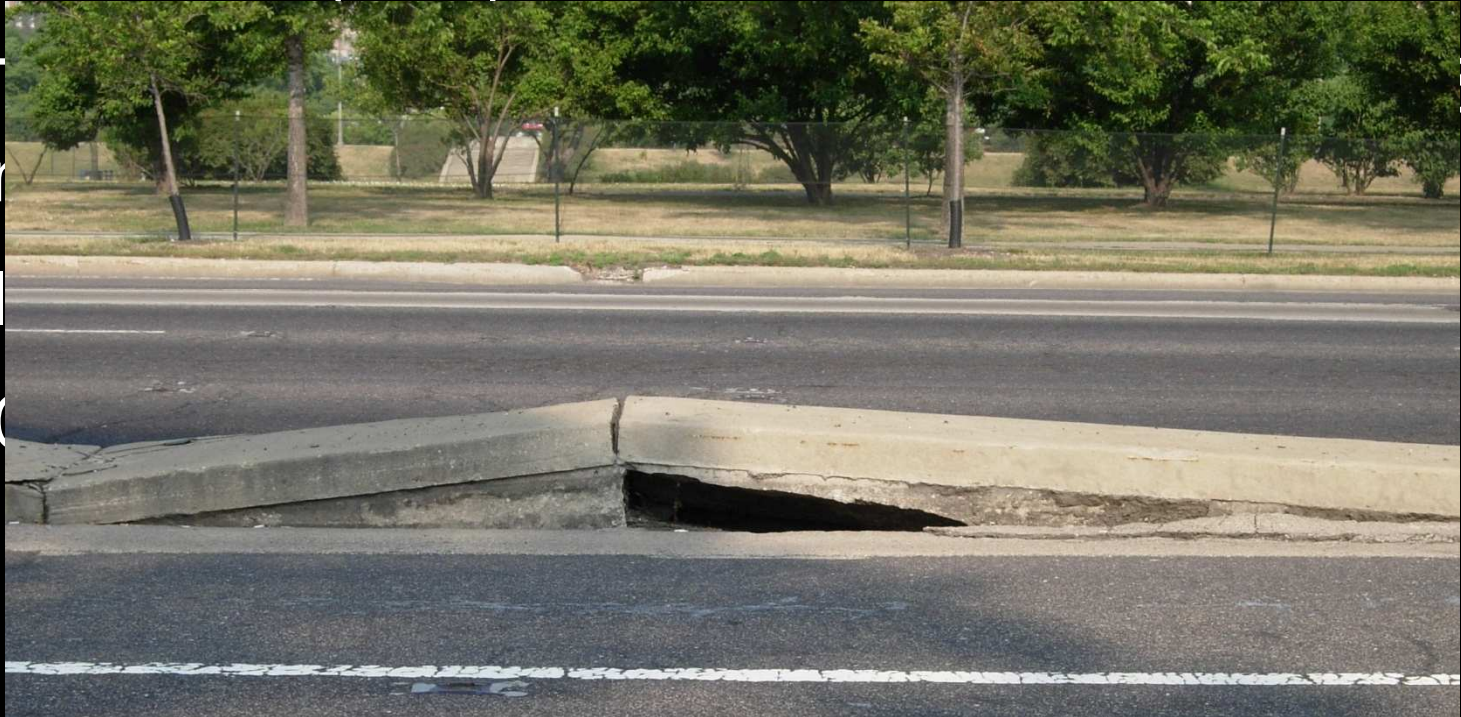
# RELAXING AND REALIGNING THE PCC WAS NECESSARY

- 6-ft. wide asphalt patches from curb to curb.

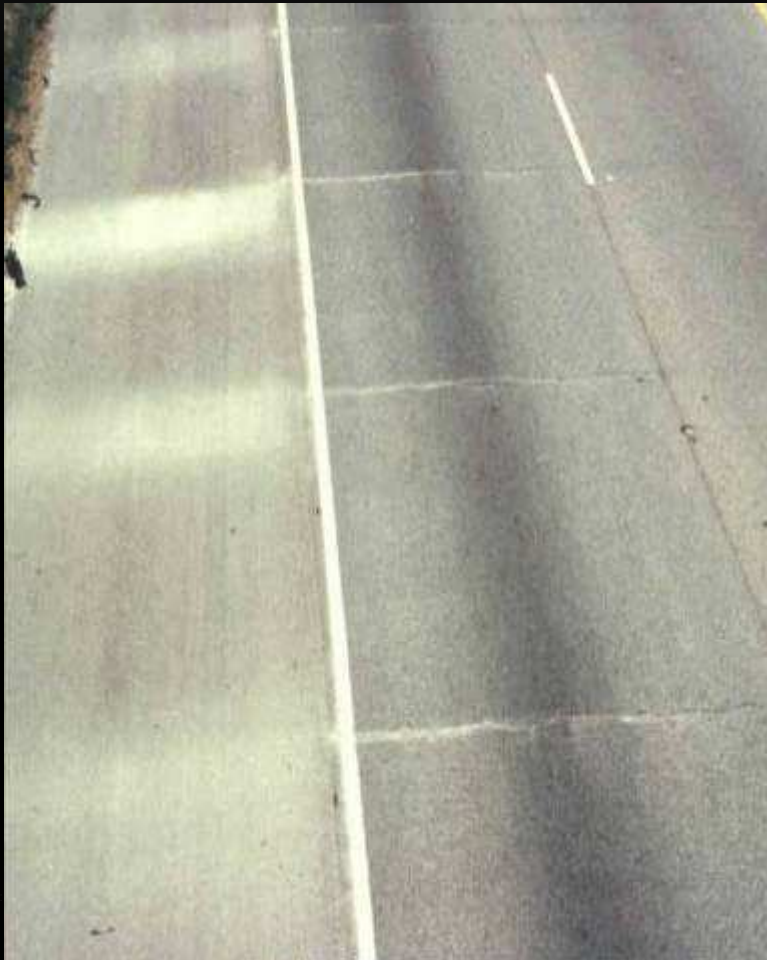
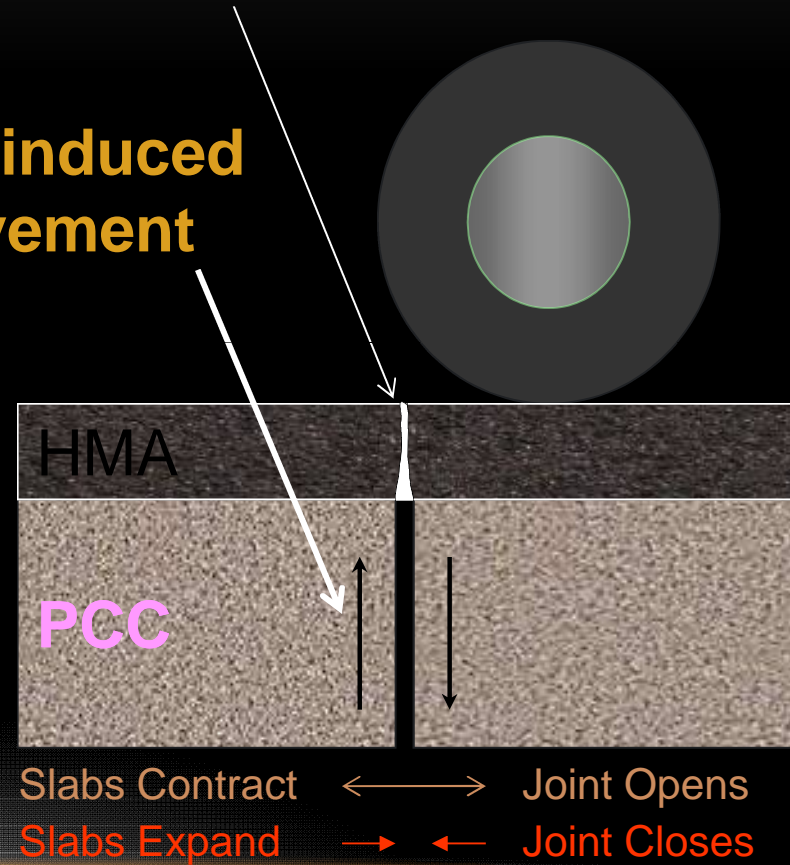
# REFLECTION CRACKING

## Reflection crack

## Load-induced movement

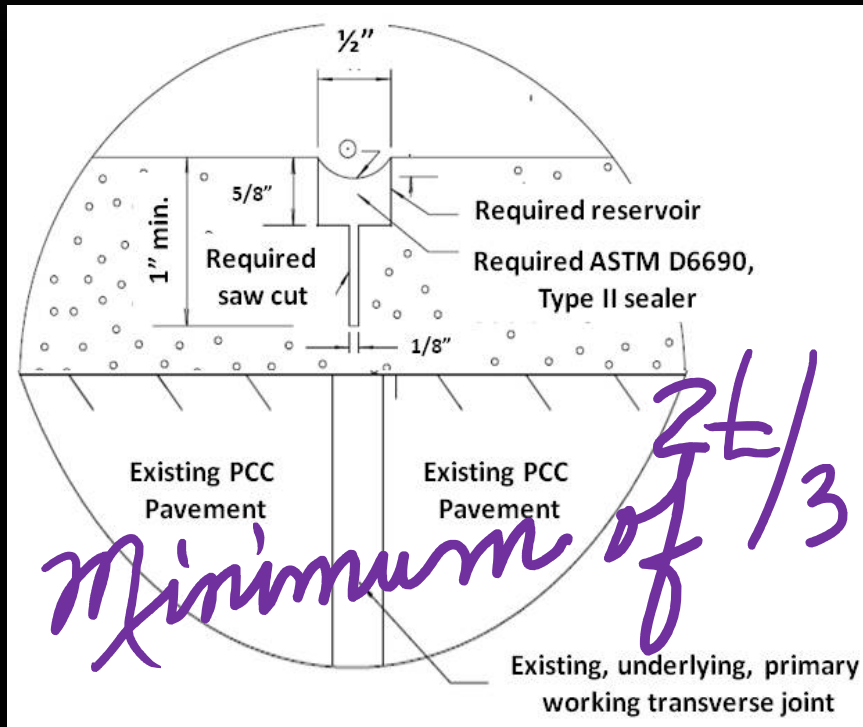
# SAW AND SEAL (ASPHALT INSTITUTE MS-17)

## Saw-Cut Dimensions

<i>Metric</i>		
PCC Slab Length (meters)	Width (mm)	Depth (mm)
≤ 15	12.5	16
15.5 - 19	16	16
19 - 23	19	16
23 - 26.5	22	19
26.5 - 30.5	25	22

<i>English</i>		
PCC Slab Length (feet)	Width (in.)	Depth (in.)
≤ 50	0.5	0.625
51 - 62	0.625	0.625
63 - 75	0.75	0.625
76 - 87	0.875	0.75
88 - 100	1	0.875

- Repair existing PCC, clean and fill joints
- Locate and reference existing joints
- Place and compact HMA
- Saw-cut overlay directly above referenced joints the following day
- Clean and dry saw-cut
- Apply sealant

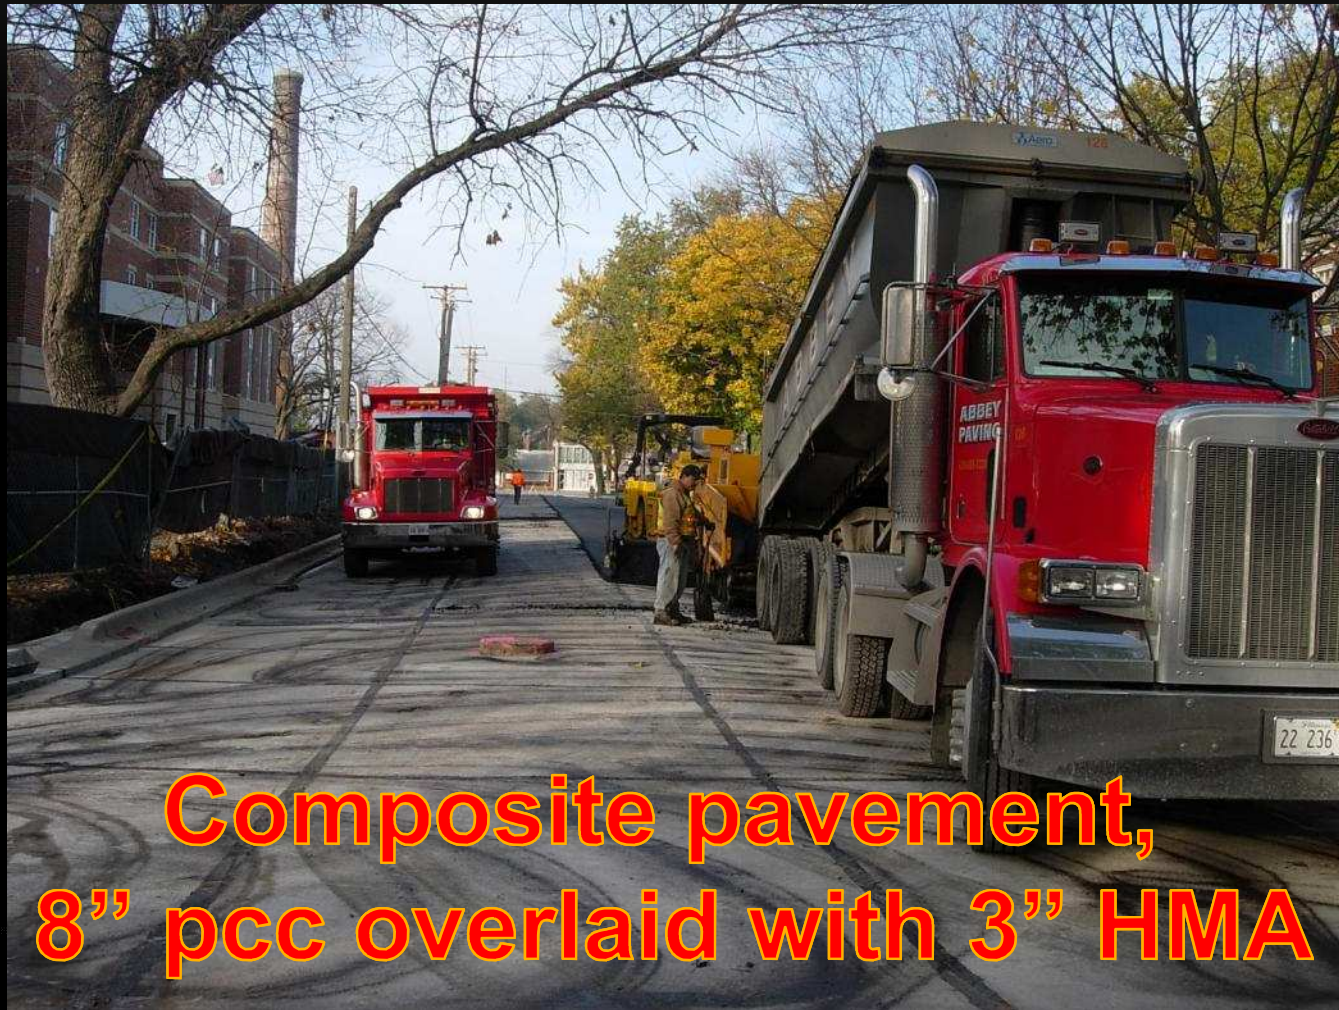
**MAY 2008**

**Composite pavement,  
8" pcc overlaid with 3" HMA**

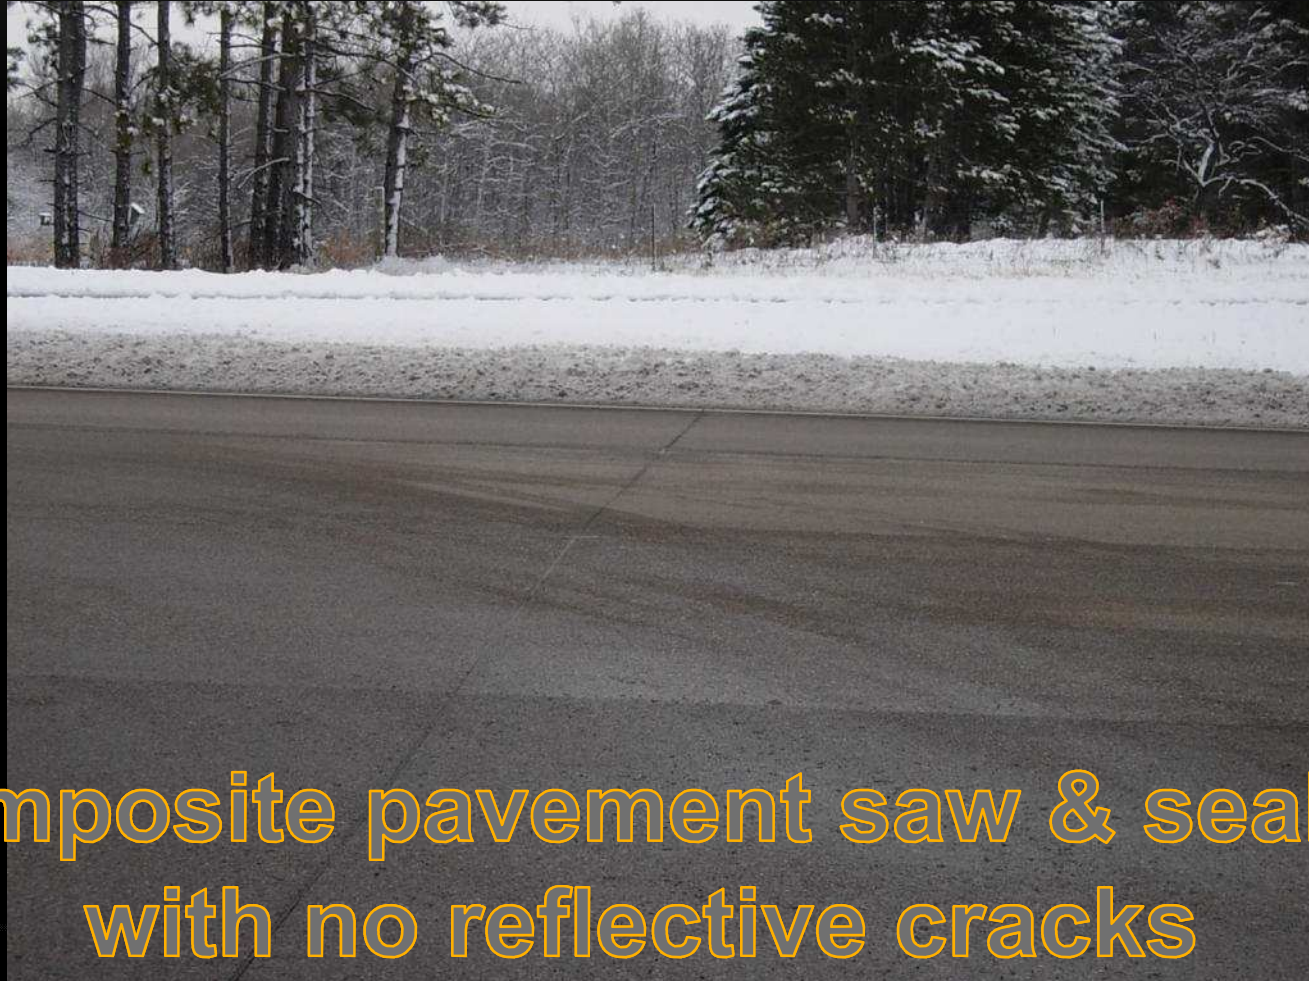
# MINNEAPOLIS, MN [10-Y/O PROJECT]

Composite pavement saw & sealed  
with no reflective cracks

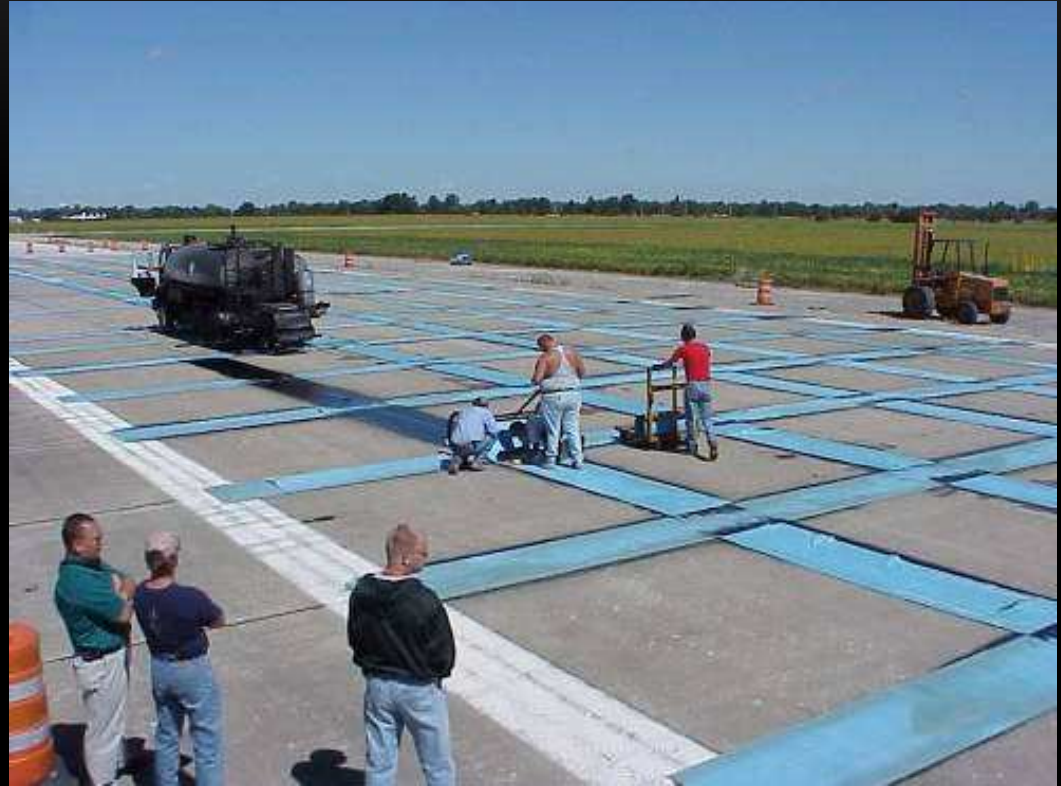
# GEOTEXTILE APPLICATION

- Easier to install
- Best on leveling course
- At least 2.5 in. HMA cover and watch traffic volume and motion

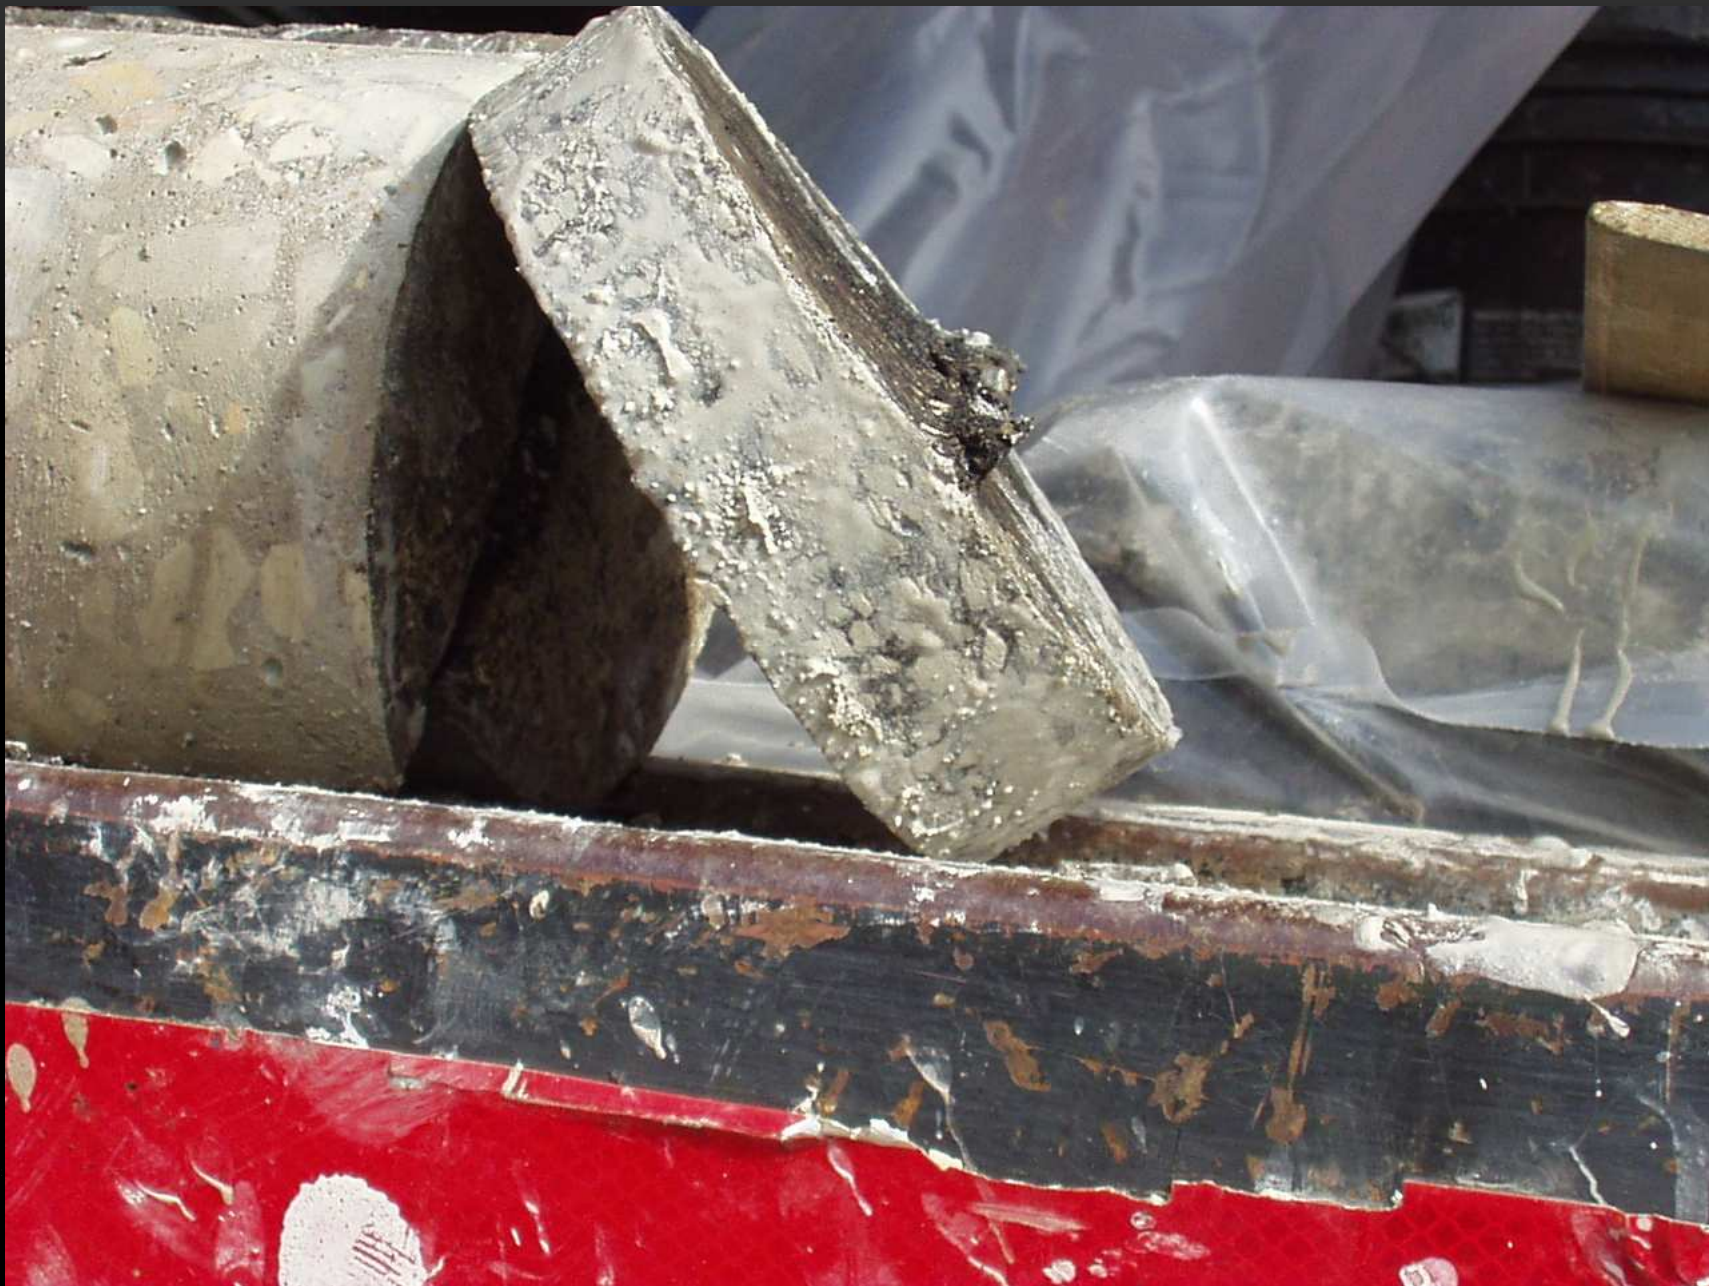
**Interlayer Stress Absorbing Composite ISAC®**

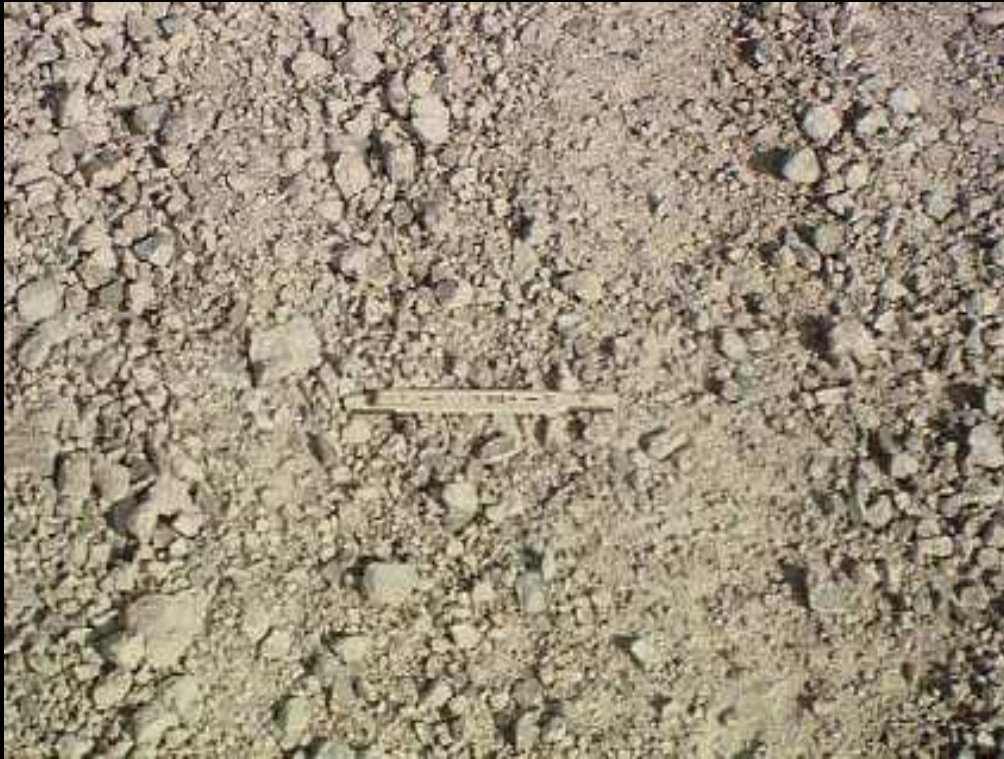
# RUBBLIZED PCC

- 6 in. or minus pieces
- Most are 1-3 in. diameter
- Aggregate interlock
- Rolling
  - ✓ Resizes
  - ✓ Knits together surface particles

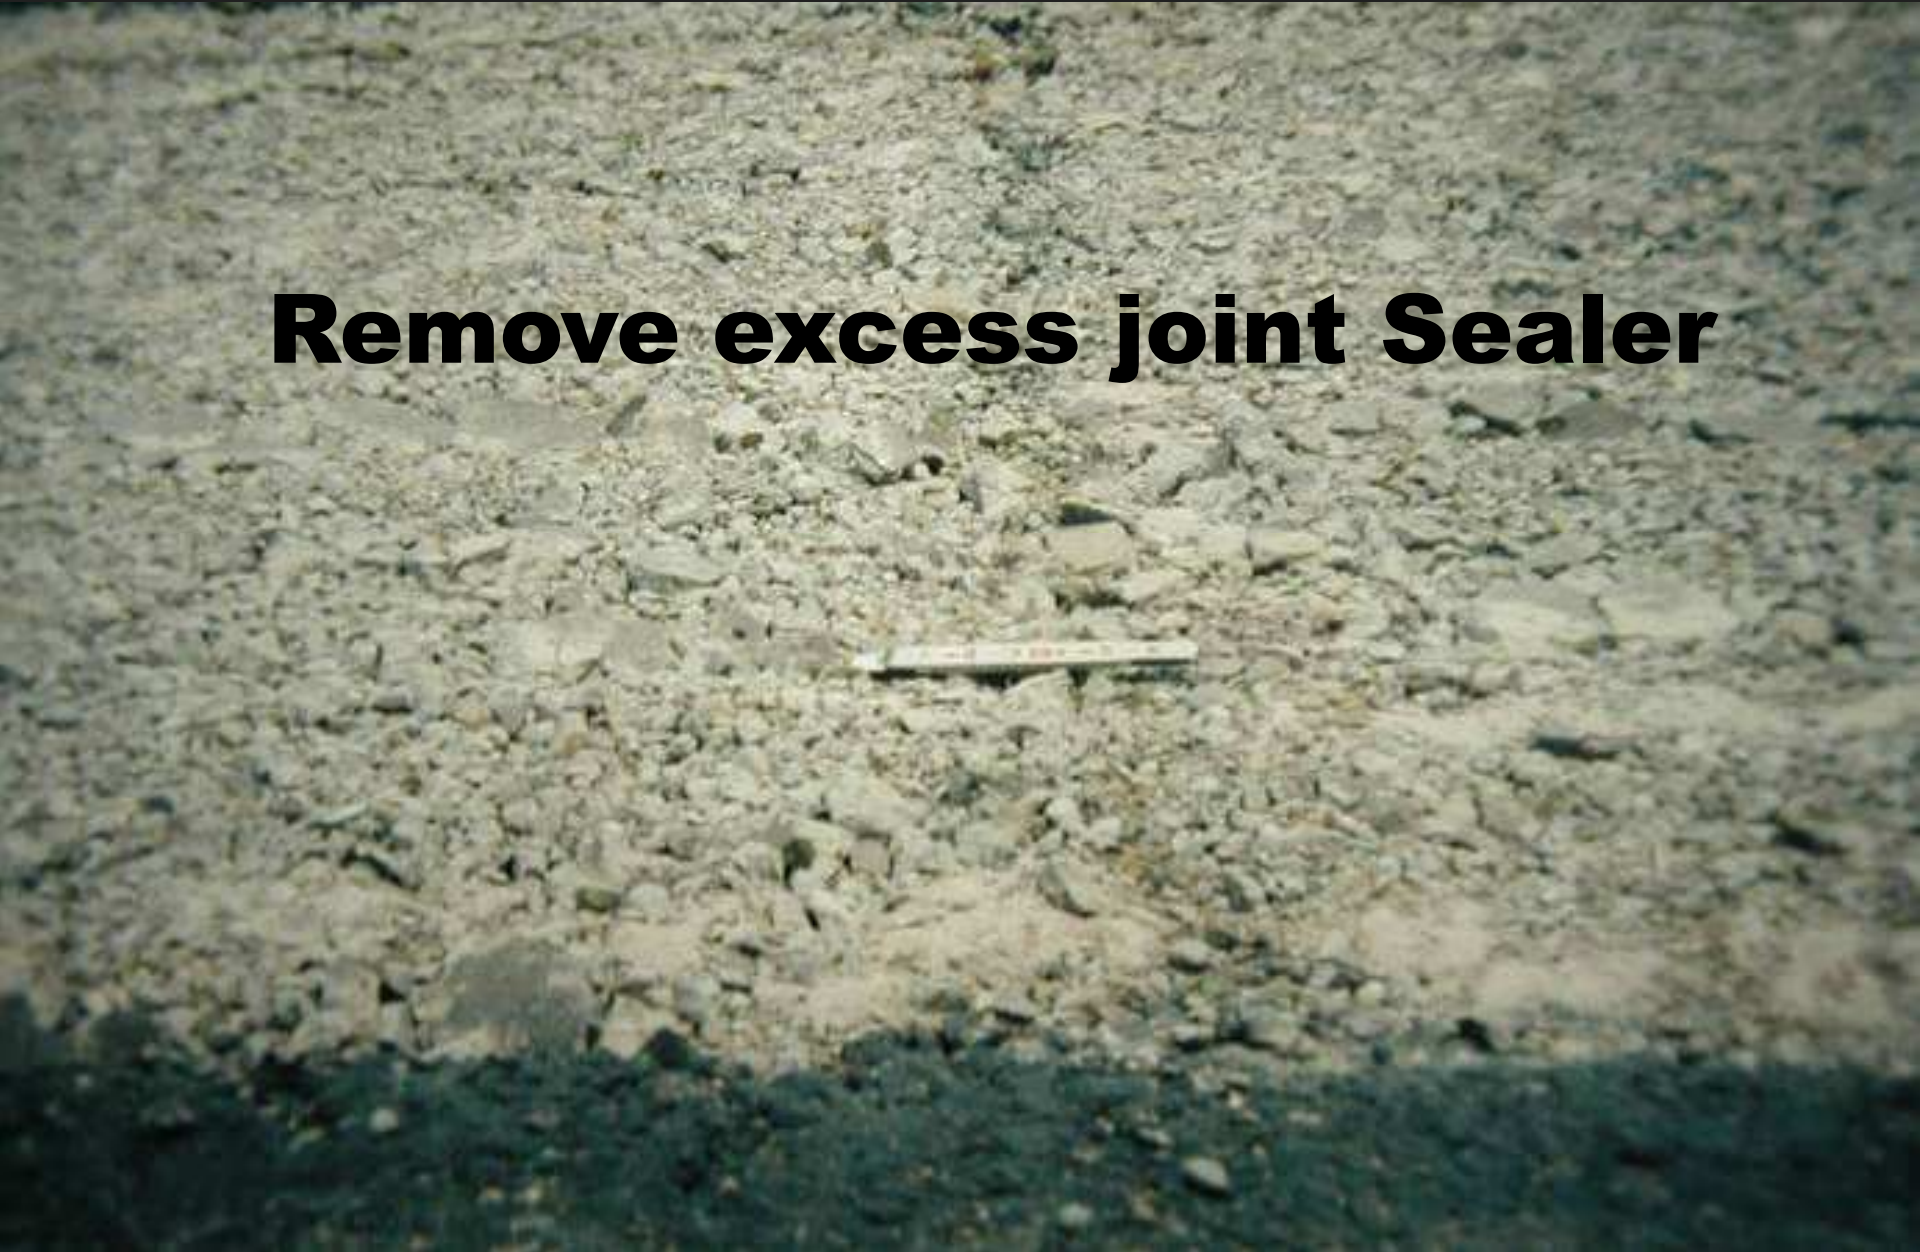
# RUBBLIZED PCC @ JOINT

**Remove excess joint Sealer**
