## **CASE STUDY**

Industry: Logistic Center
Location: Madrid - Spain
Finish: High Gloss
Surface: 4500m<sup>2</sup>

## Amazon Logistic Center

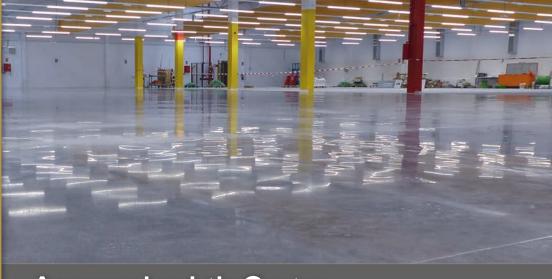
Amazon have rented warehouse space close to the city but the floor wasn't of sufficiently high quality for their needs. The floor was nearly 20 years old, crumbling and very dusty. Given the wide range of products being stored; food, drinks, sports equipment, toys, electronics and clothing, the floor needed to be abrasion resistant, dust proof and easy to clean.

Working with TWINSOL, one of our partners in Spain, the concrete floor was ground down with diamond hard BECOSAN® discs to remove all micro roughness from the surface leaving a high gloss finish. The floor was then treated with BECOSAN® Densifier which significantly increased the hardness of the surface. The final stage was a comprehensive treatment with BECOSAN® Protective Sealer.
